11-4403-cv

United States Court of Appeals *for the* Second Circuit

JOINT APPENDIX Volume 12 of 16 (Pages JA-3067 to JA-3320)

-----	x	
	:	
IN RE: SEPTEMBER 11 PROPERTY DAMAGE	:	21 MC 101 (AKH)
AND BUSINESS LOSS LITIGATION	:	
	:	
-----	:	
AEGIS INSURANCE SERVICES, INC., et al.,	:	04 CV 7272 (AKH)
	:	
Plaintiffs,	:	
-against-	:	SUPPLEMENTAL AND
	:	AMENDED SECOND
7 WORLD TRADE CENTER COMPANY, L.P.,	:	DECLARATION OF
et al.,	:	COLIN G. BAILEY
Defendants.	:	
-----	x

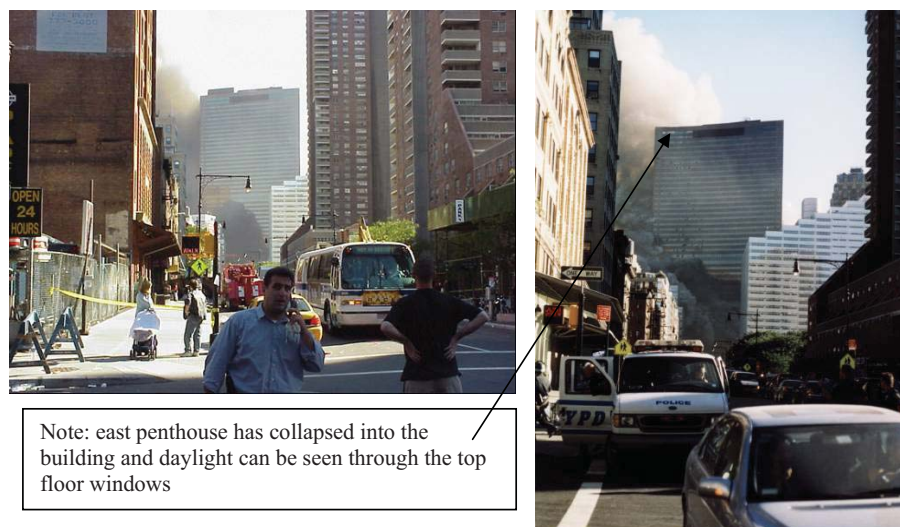
Photographic evidence (Figure 1) shows that the east roof penthouse collapsed first into the building. Figure 2 shows the location of the east penthouse highlighting that failure of column 79, or possibly column 80, occurred allowing the penthouse to sink into the building. Overall progressive collapse occurred following the collapse of the east penthouse.

Figure 1 WTC7 before collapse (left) and during collapse (right)

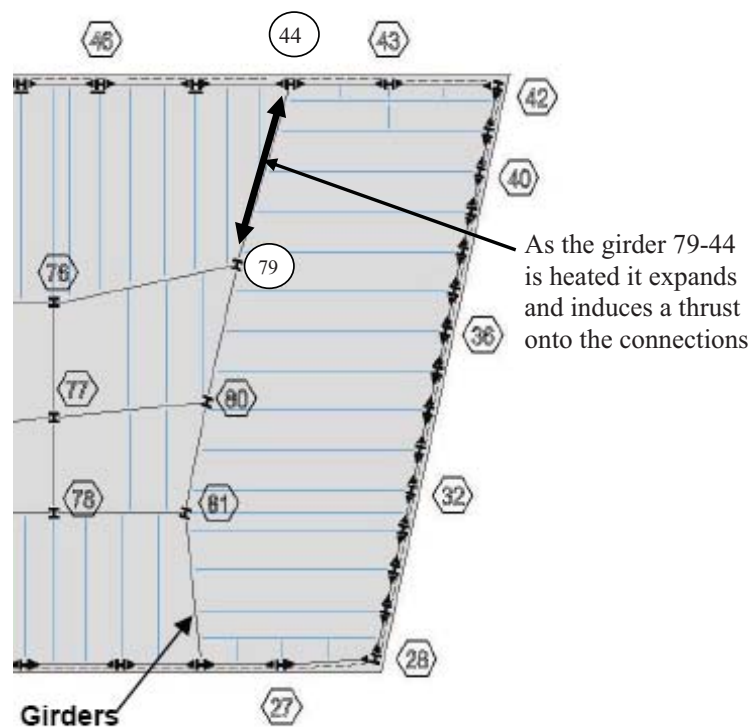
The initial failure, leading to overall collapse, occurred in the connection between column 79 and girder 79-44. During the initial stages of the fire the girder expanded longitudinally as it increased in temperature. This expansion placed a thrust onto the seated connections at columns 79 and 44 as shown in Figure 11.

Figure 11 *Expansion of girder 79-44 in the early stages of the fire*

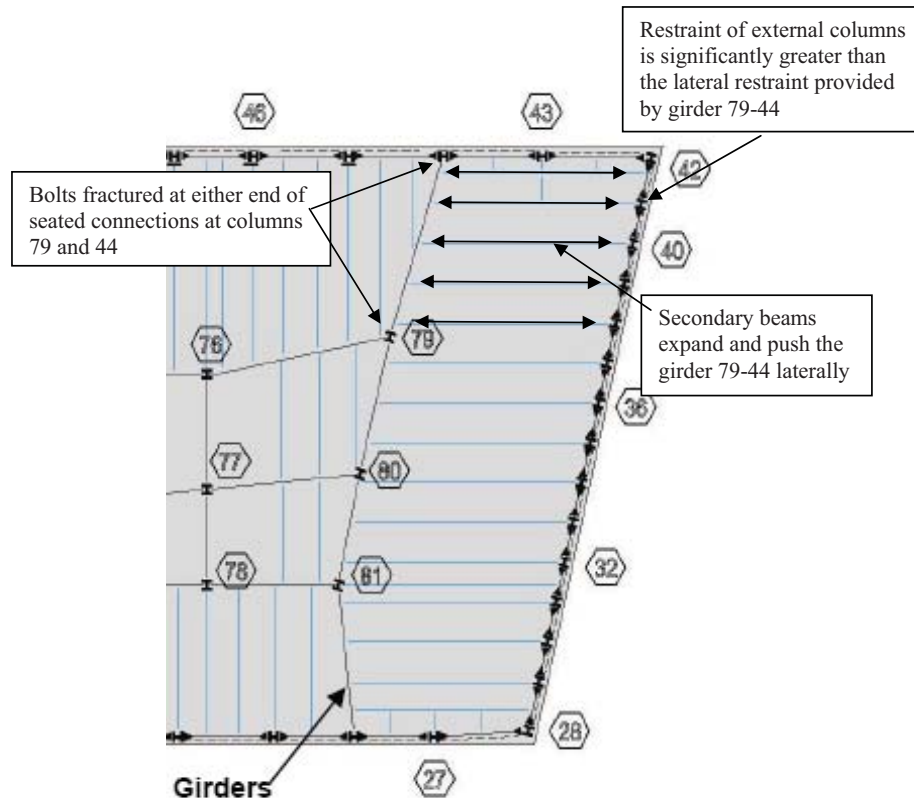
As well as thermal expansion of the secondary beams causing lateral movement of the girder 79-44, the vertical deflection of the secondary beams, as they lose strength and stiffness with increase in temperature, will cause the girder 79-44 to twist.

Figure 13 Showing thermal expansion of secondary beams

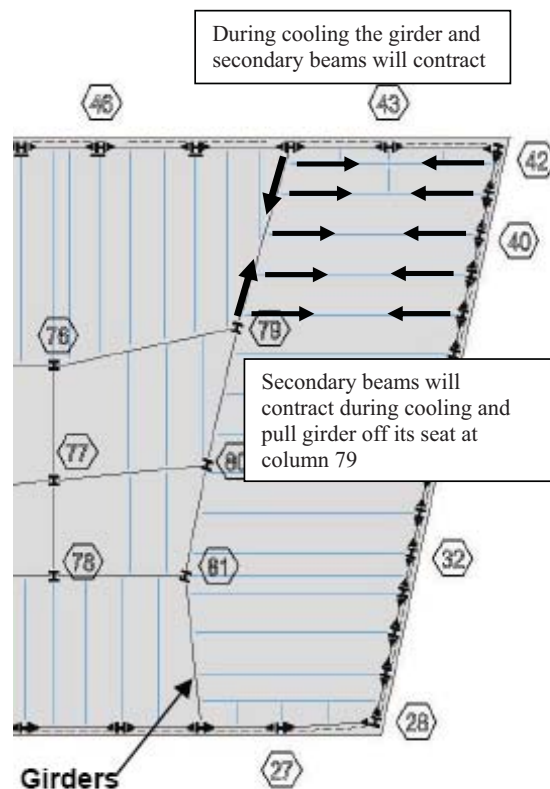
be pulled off the seat at column 79 (Figure 14) during cooling and thus initiate collapse.

Figure 14 Behavior during cooling

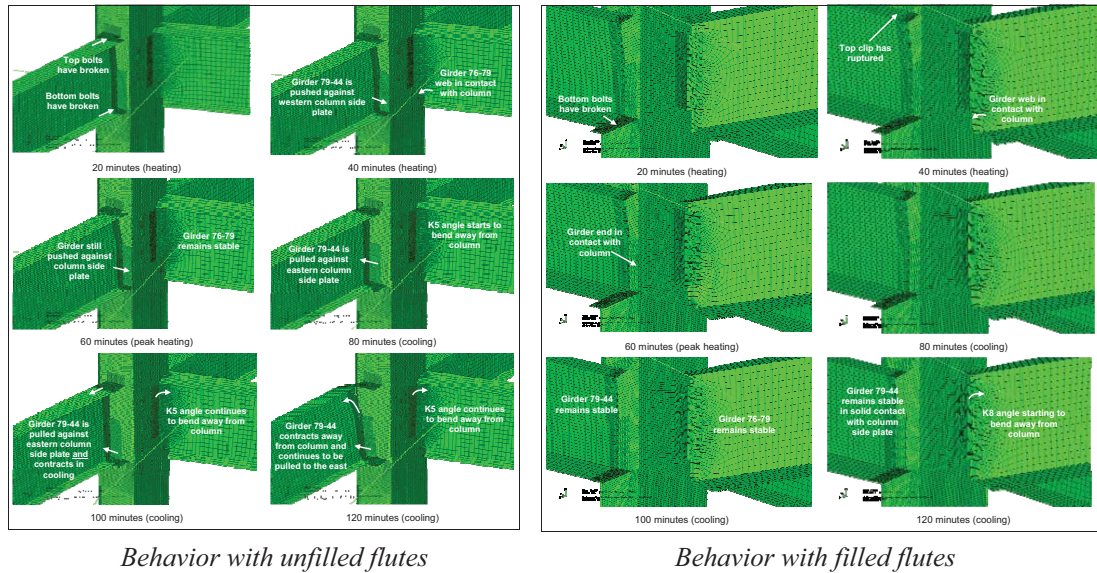
The behavior of the girder 79-44, at the connection with column 79, is shown in Figure 28 for case 1 (unfilled flutes) and case 2 (filled flutes). The important observation is the significant difference in structural behavior due to the filling of the flutes.

Figure 28 Behavior of girder 79-44 at column 79 for unfilled flutes (left-hand figure) and filled flutes (right-hand figure)

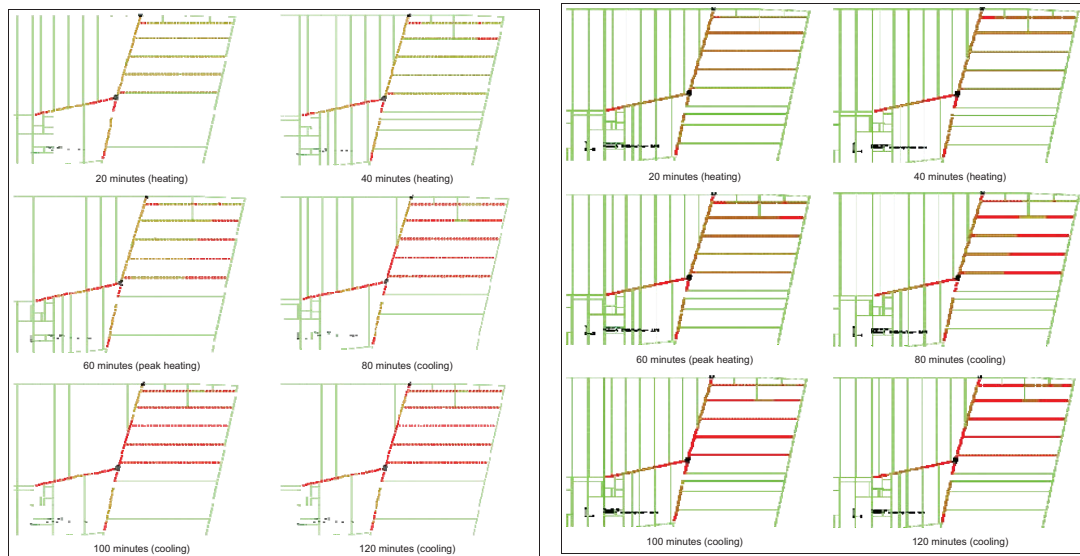
Case 1: Flutes unfilled 700°C fire

The failure of the shear studs for both case 1 and case 2 is summarized in Figure 29, where the red dots denote failure of the studs. It can be seen that most studs fail during the cooling stage of the fire, with greater stud failure occurring in case 1, where the flutes were unfilled.

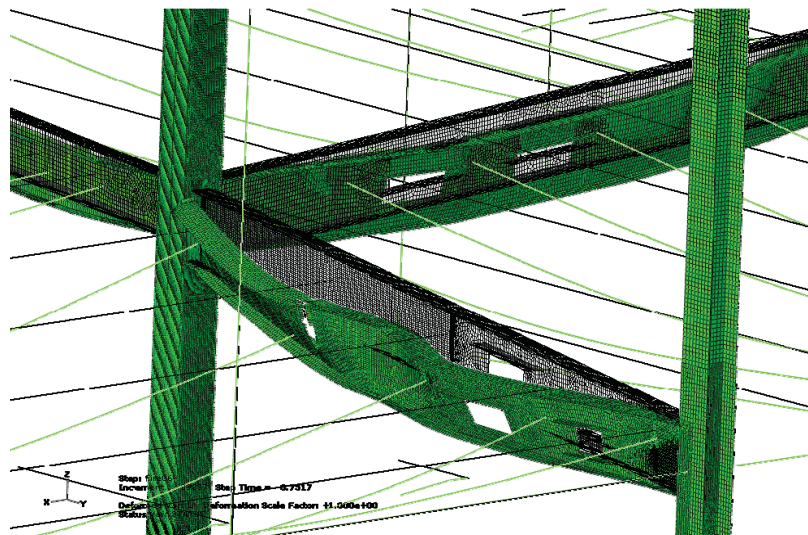
A detailed description of structural behavior is presented in Appendix D. For case 3 with the flutes unfilled, failure of girder 79-44 occurred during the heating stage at 57 minutes, as shown in Figure 30. For the identical case 4, but with the flutes filled, no failure occurred. Failure during the heating stage corresponds to the visual evidence of fire on the 9th Floor heating the 10th Floor.

Figure 30 Failure of girder 79-44 for Case 3 (unfilled flutes)

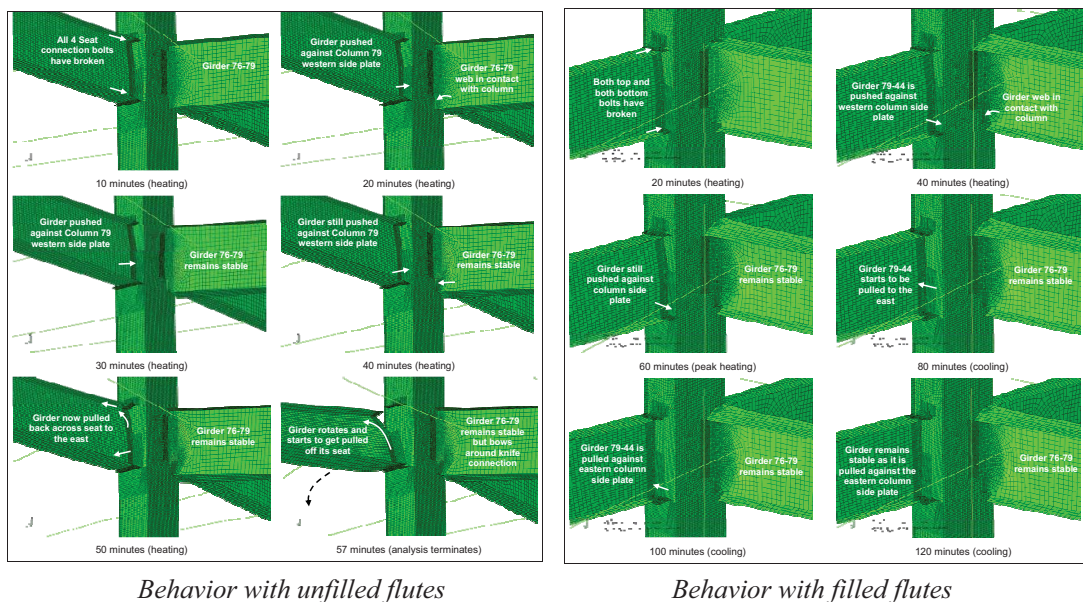
The behavior of the girder 79-44, at the connection with column 79, is shown in Figure 31 for case 3 (unfilled flutes) and case 4 (filled flutes).

Behavior with unfilled flutes

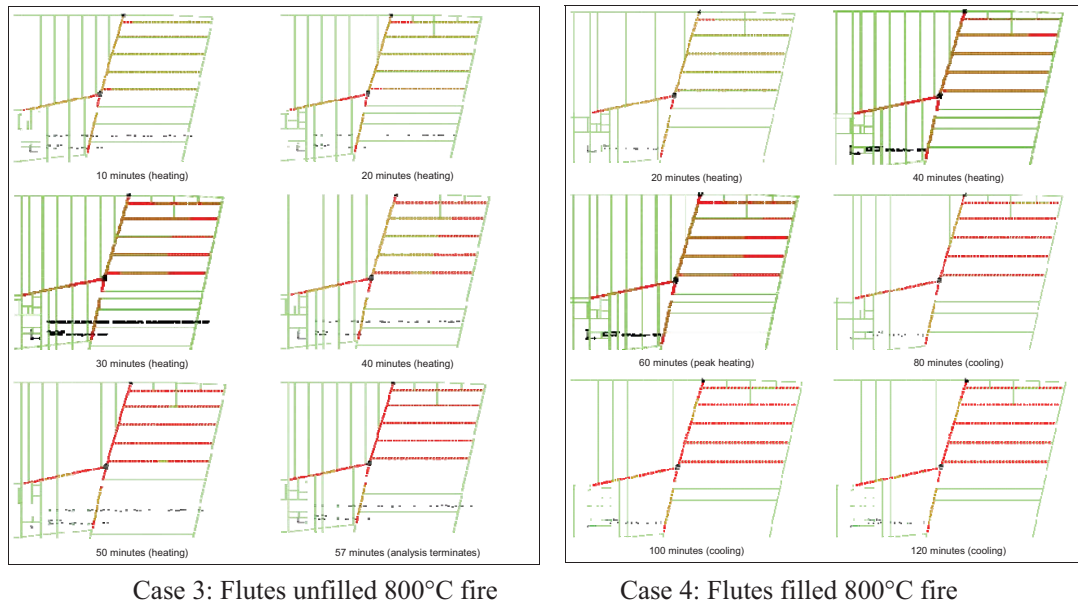
The failure of the shear studs for both case 3 and case 4 is summarized in Figure 32, where the red dots denote failure of the studs.

Figure 32 *Breakage of shear studs for case 3 (unfilled flutes) and case 4 (filled flutes)*

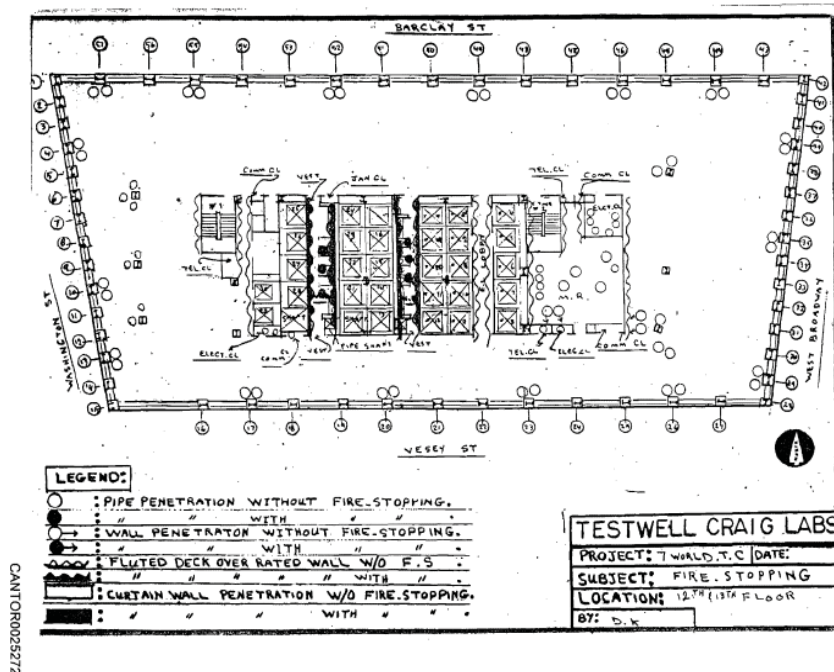
Details from Testwell Craig Laboratories reports showing unfilled flutes over fire rated walls.

Figure B1 Sketch showing unfilled flutes above fire walls which had firestopping missing (12th and 13th floors).

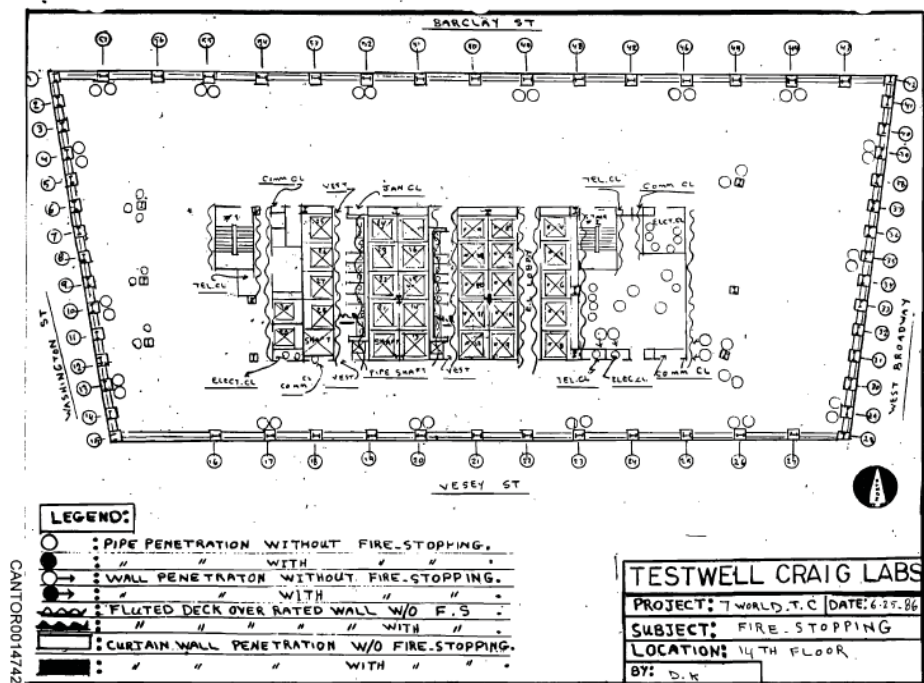
Figure B2 Sketch showing unfilled flutes above fire walls which had firestopping missing (14th floor).

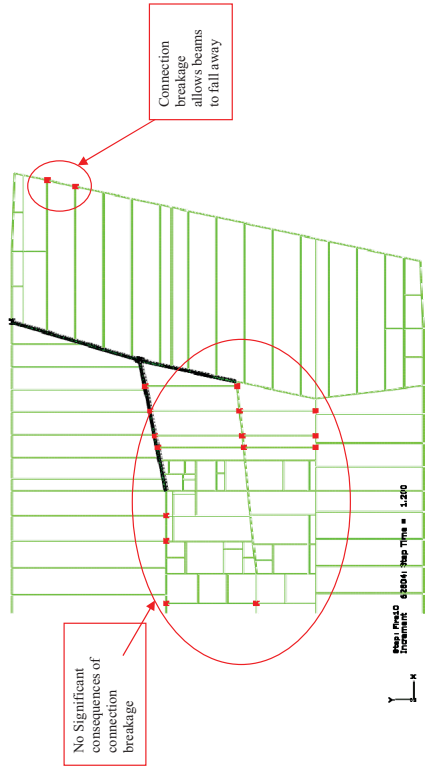
The failure of the 2 connectors in the NE corner of the building after 80 minutes of analysis time is related to the tensile forces induced during cooling. This breakage leads to the falling away of the secondary beams as they have also lost composite connection to the slab above. This response leads to larger residual deflection in the north-east bay compared to the rest of the structure.

Figure 81: 800°C Filled Flutes Case 4 - Breakage of Simplified Connections

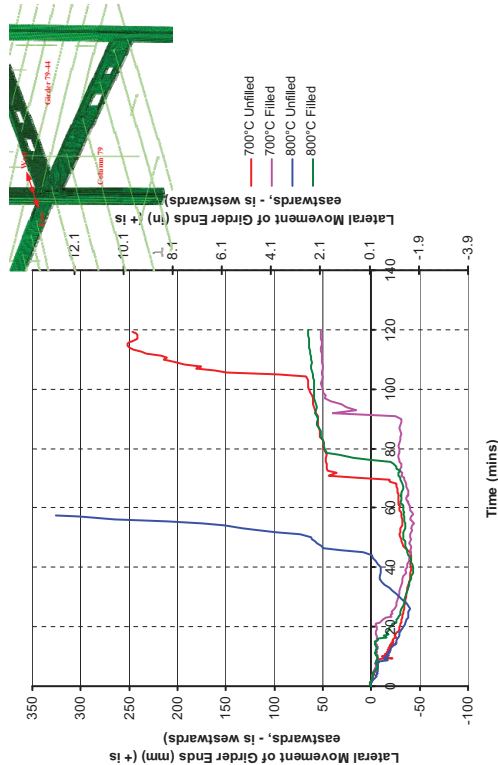
Figure 88 shows the comparison of lateral movement of the top flange of Girder 79-44 at Column 79 for all four cases. It is seen that in all cases, the initial movement is to the west as a result of the secondary beams expanding and pushing on the girder. In all cases the top flange of the beam is then pulled back (eastwards). In the 800°C flutes unfilled (Case 3) the sudden eastward movement observed after approximately 40 minutes of the fire is due to the failure of the girder during the heating phase as described in Section 7. The sudden eastward movements observed in the other 3 Cases occur at the times when significant shear stud failure begins to take place in each model. In each case the contraction of the cooling secondary beams is able to pull the girder end eastward as it is no longer rigidly attached to the slab.

Figure 88: Comparison of east-west movement of top of Girder 79-44 at Column 79 for all four Cases
In cases 1, 2 and 4, the eastward movement of the top flange is then restrained as the flange contacts the inside face of the column side plate. In Case 3 Girder 79-44 collapses before this stage is

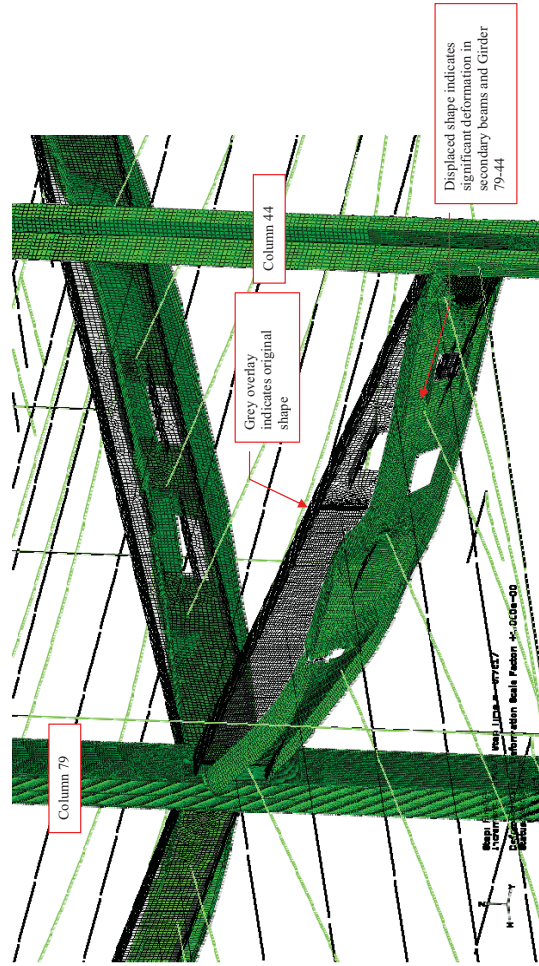
Figure 58: 800°C Unfilled Flutes Case 3 - Failure Mechanism of Girder 79-44 at Analysis Termination
