CORE DROP HYPOTHESIS

PRELIMINARY

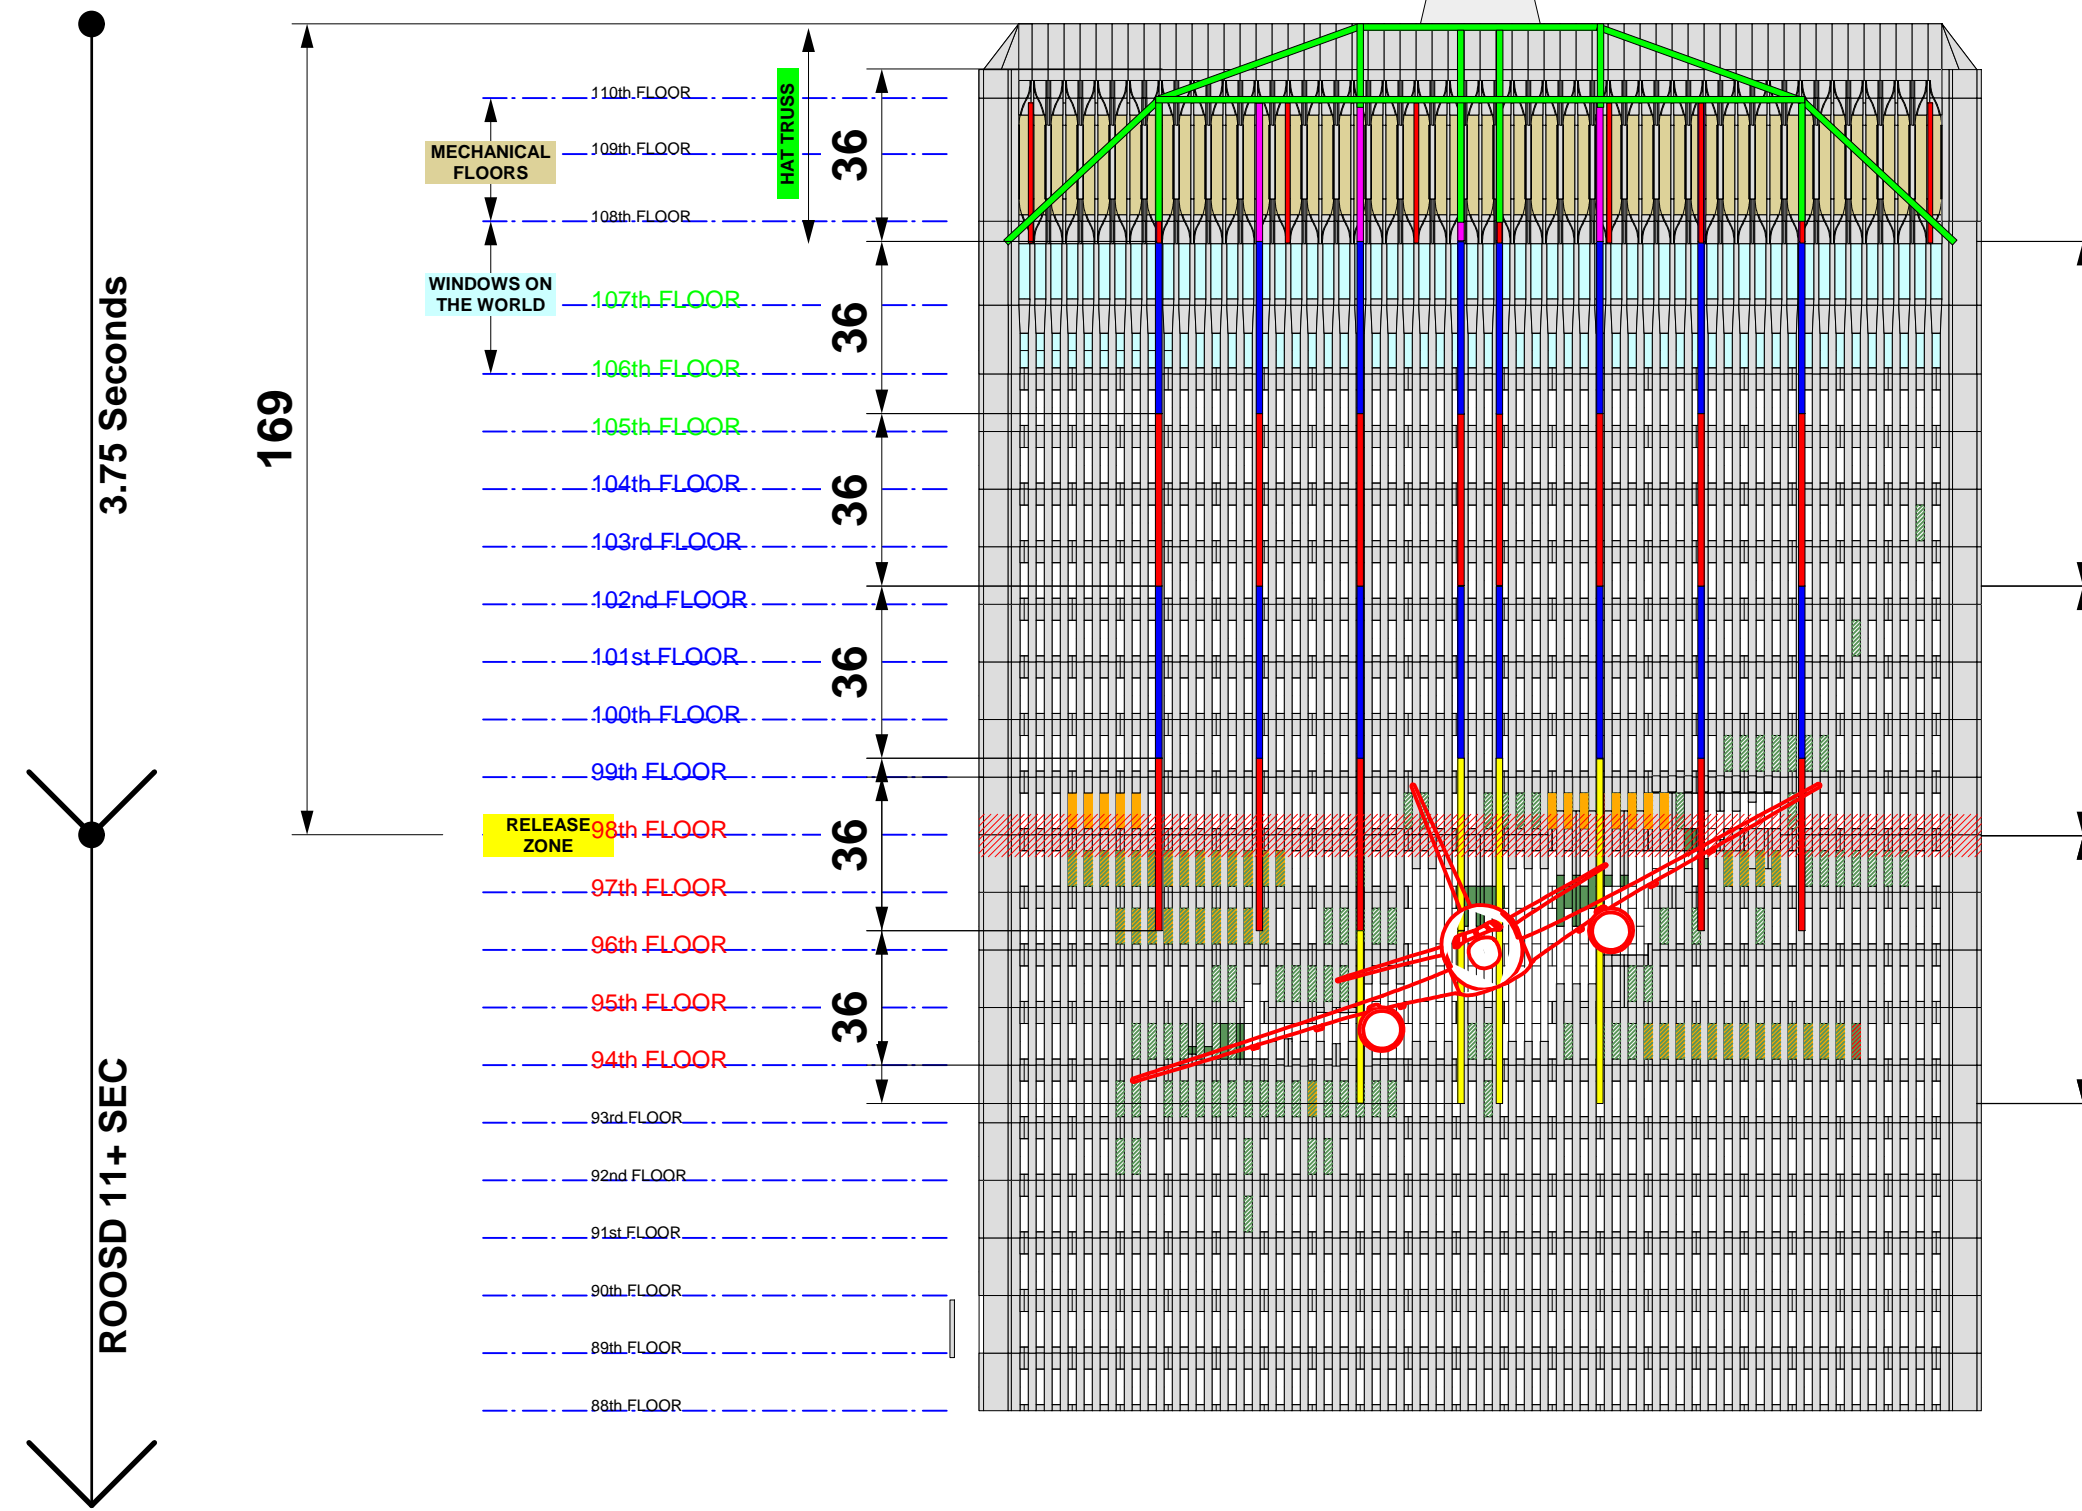
AT PLANE IMPACT THE FLOORS AND COLUMNS ABOVE THE MECHANICALLY DESTROYED COLUMNS DROP DOWN. THE COLUMN BEARING CONNECTIONS DO NOT PERFORM UNDER TENSION (HANGING THE COLUMNS AND ATTACHED FLOORS FROM THE HAT TRUSS). THIS CAUSES LOCAL AREAS OF FLOOR TO DROP DOWN THROUGH THE PLANE STRIKE REGION. CONTINUED HEAT WEAKENING OF CONNECTIONS OF BRACING BETWEEN COLUMNS ENSUES CAUSING ADDITIONAL FLOOR AREAS TO DISENGAGE AND DROP FREE OF COLUMNS. AS THE FIRE PROGRESSES UNABATTED FOR 1.5 HRS EVENTUALLY THE HAT TRUSS COLLAPSES MID SPAN UNDER THE MASSIVE ANTENNA WHICH DROPS INTO THE CORE REGION. AT THIS POINT IN TIME THERE ARE SO FEW PERIMETER CORE COLUMNS UNDAMAGED AND ABLE TO CARRY THE BELT GIRDER SURROUNDING THE CORE. THE OPEN OFFICE SYSTEM FLOORS PLUNGE DOWN INTO THE MASSIVE HOLE HOLLOWED OUT BY THE DROPPED CENTRAL CORE COLUMNS. THE UPPER SECTION ABOVE THE STRIKE ZONE IS REDUCED TO A FAÇADE, A STEEL CAGE, WITH ONLY SOME LOCAL AREAS OF ATTACHED FLOORS. THE PLUNGING OPEN OFFICE FLOORS AND ANTENNA JOSTLE THE FAÇADE CAGE PUSHING IT LATERALLY BREAKING IT FROM THE FAÇADE BELOW CAUSING IT TO DROP AND BREAK UP AS IT IMPACTS THE STANDING FAÇADE AS IT DESCENDS.

NOTE:
APPROXIMATE BOUNDARIES OF DAMAGE AND HEAT DESTROYED COLUMNS ARE ASSUMED. THERE IS NO DATA TO SUPPORT THESE ASSUMPTIONS
