A Structural Reevaluation of the Collapse of World Trade Center 7

Final Report

INE Report 18.17

March 2020

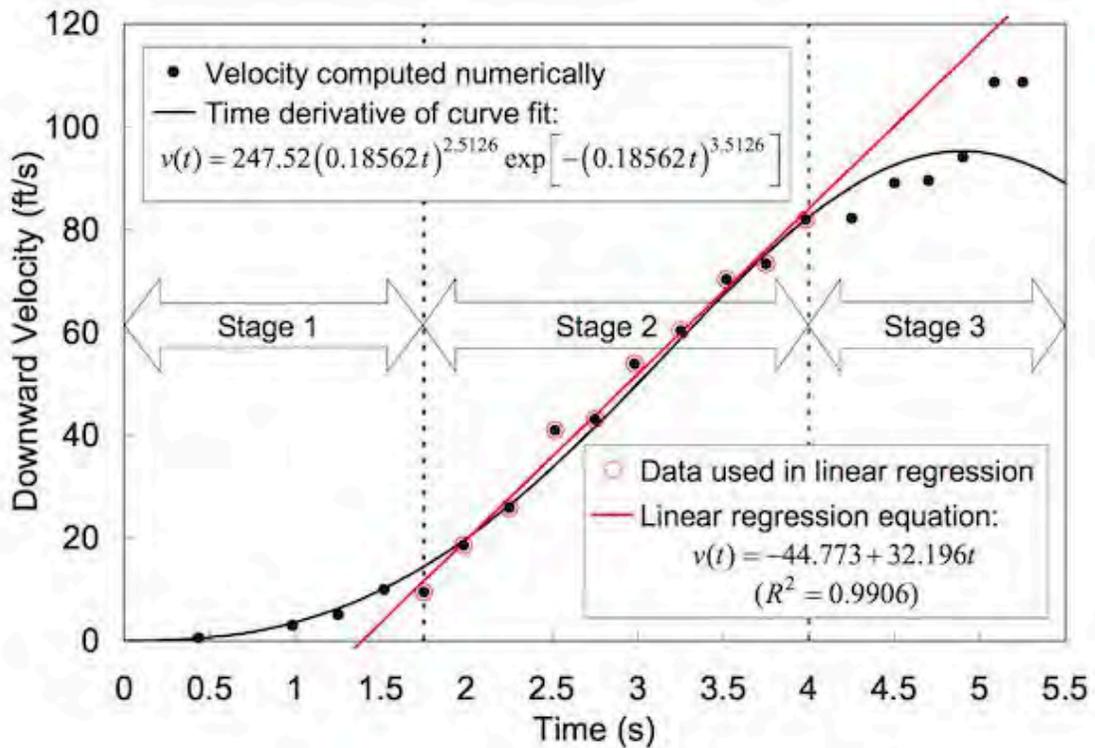
Figure 1.6 WTC 7 was in free fall for approximately 2.25 seconds over a distance of approximately 8 stories or 32.0 meters (NIST, 2008, NCSTAR 1A).

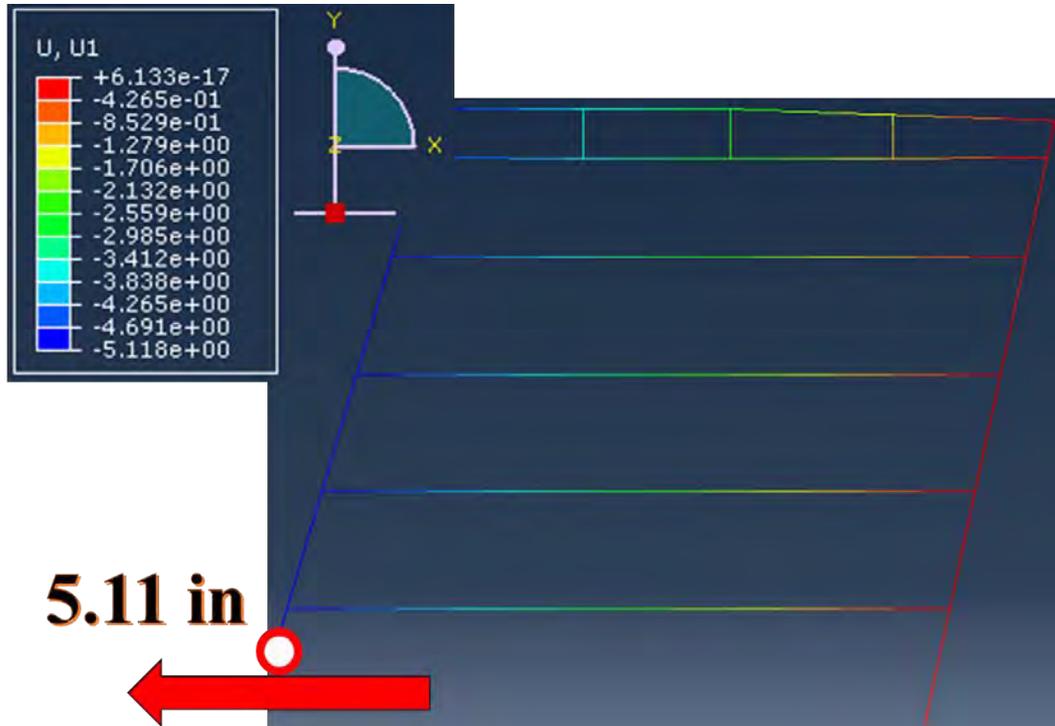
were not sufficient to displace girder A2001 to the point that it walked off its seat (the initiating failure alleged by NIST). Whereas NIST asserted that the differential westward displacement of girder A2001 relative to Column 79 was 5.5 inches and later revised its calculation to 6.25 inches, we found that the westward displacement of girder A2001 relative to Column 79 would have been less than 1 inch under the fire conditions reported by NIST.

Figure 2.66 Transverse displacement at the end of A2001 using the NIST assumptions.

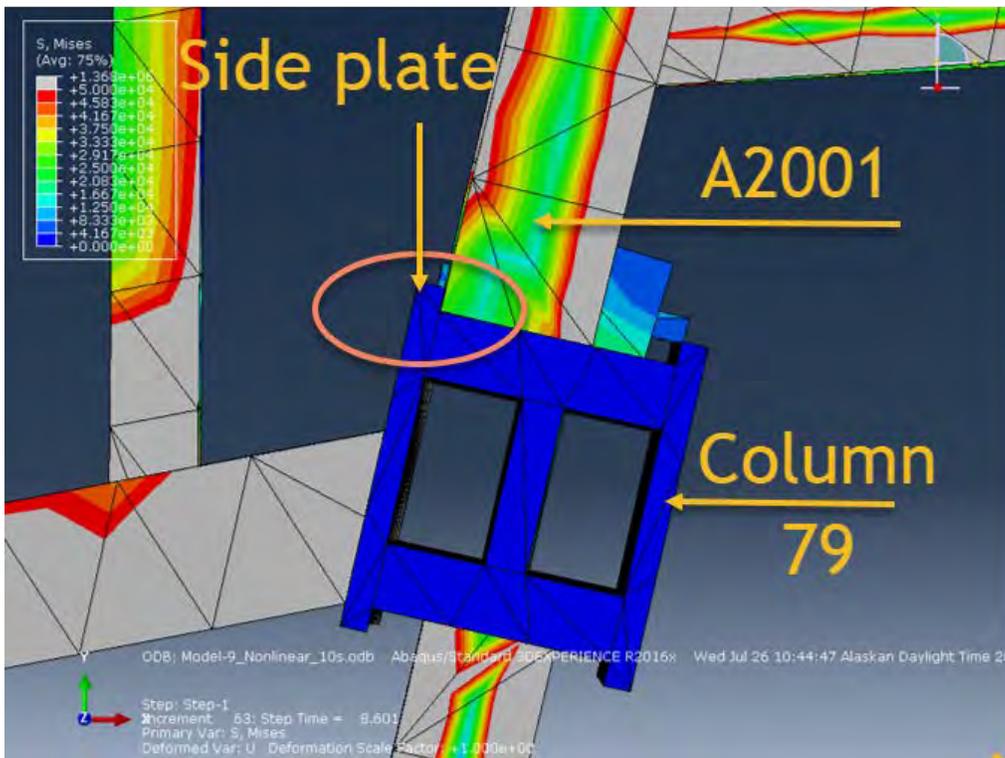
Figure 3.4 Plan view showing girder A2001 trapped by the Column 79 side plate.

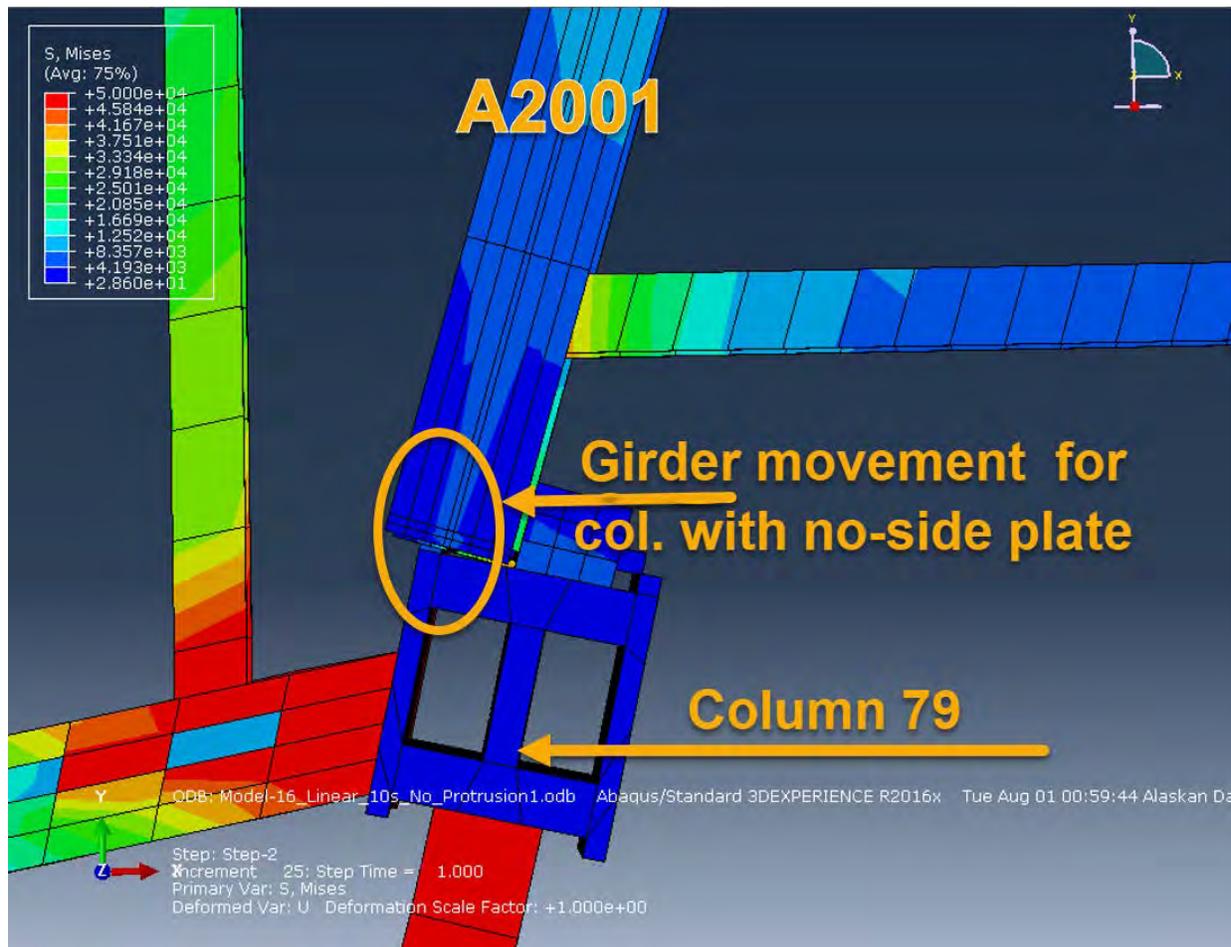
Figure 3.7 Plan view shows girder A2001 being pushed laterally past notched western side plate.

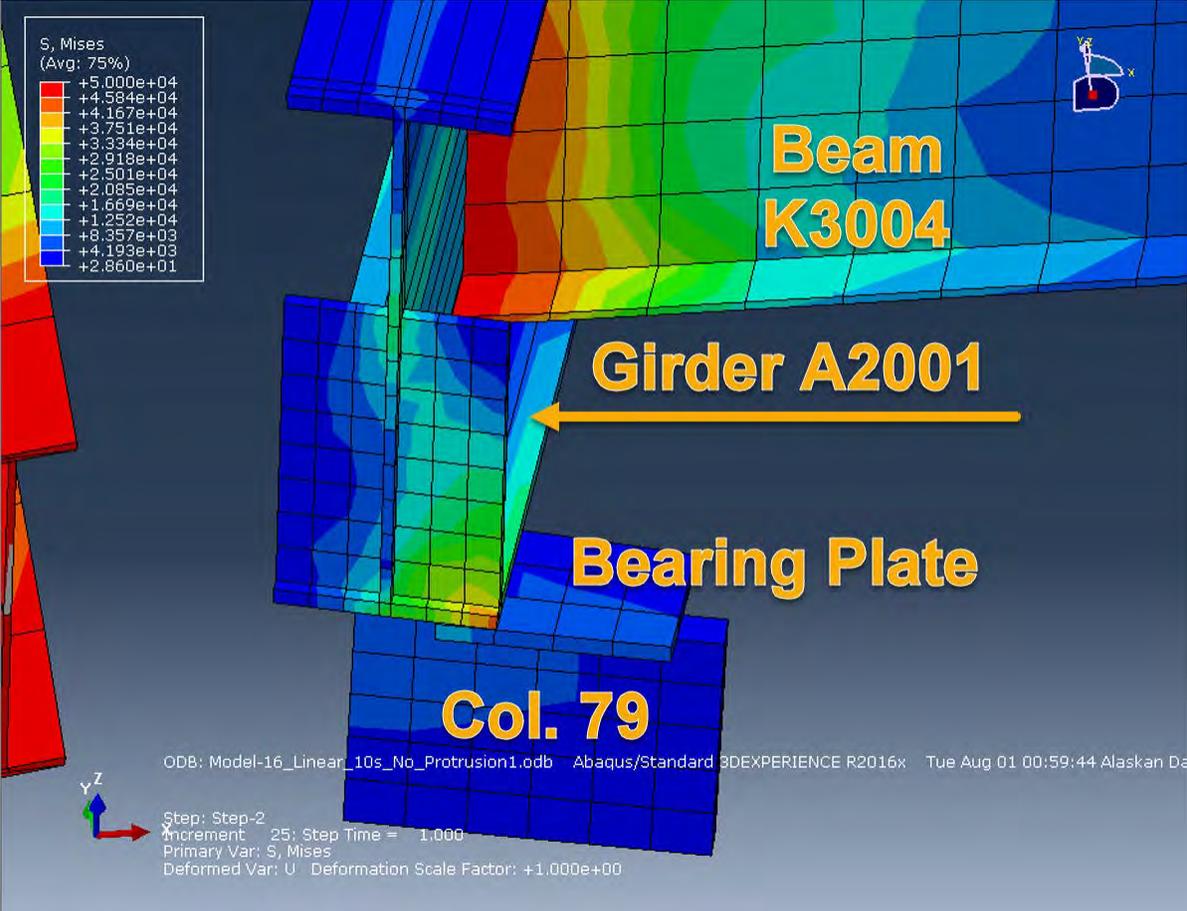
Figure 3.8 Analysis showing girder web A2001 pushed laterally past the bearing seat at Column 79. The column is removed for clarity.

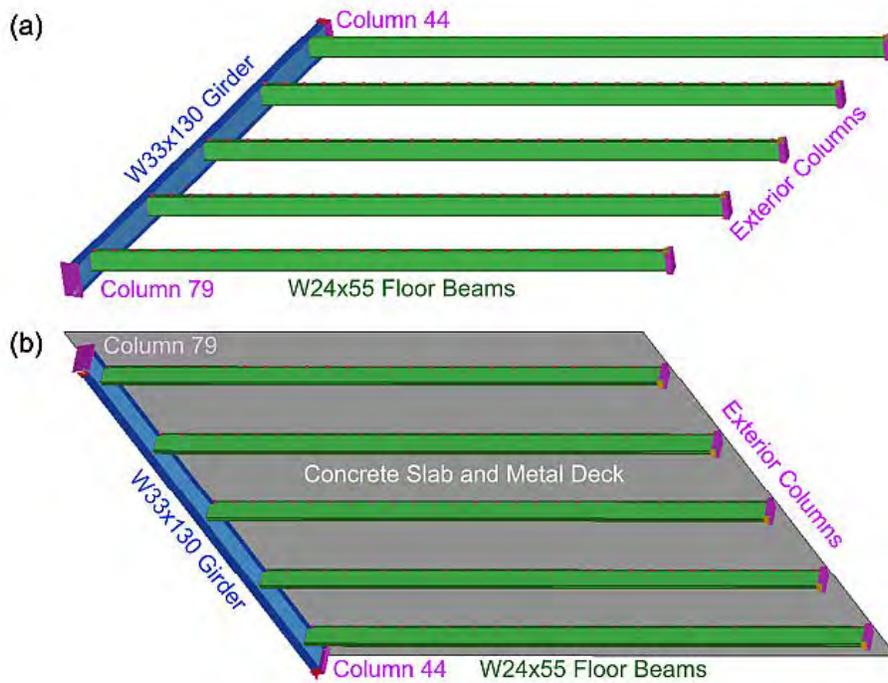
- In a preliminary collapse initiation hypothesis, NIST posited that beam G3005 buckled because its thermal expansion was restrained by girder A2001. We found that this can

happen only when the three lateral support beams S3007, G3007, and K3007 spanning from beam G3005 to the north exterior wall are not included in the model. While these short beams are observed in some of the figures in the NIST report, they are missing from the model(s) used in the thermal and structural analysis shown in the report (Section 3.2.3).

Figure 3.12 Figure 8-22 in the NIST report shows model for girder A2001 and five beams to the east of it with no lateral bracing for beam G3005 (NIST, 2008, NCSTAR 1-9, Vol. 1, Page 350).

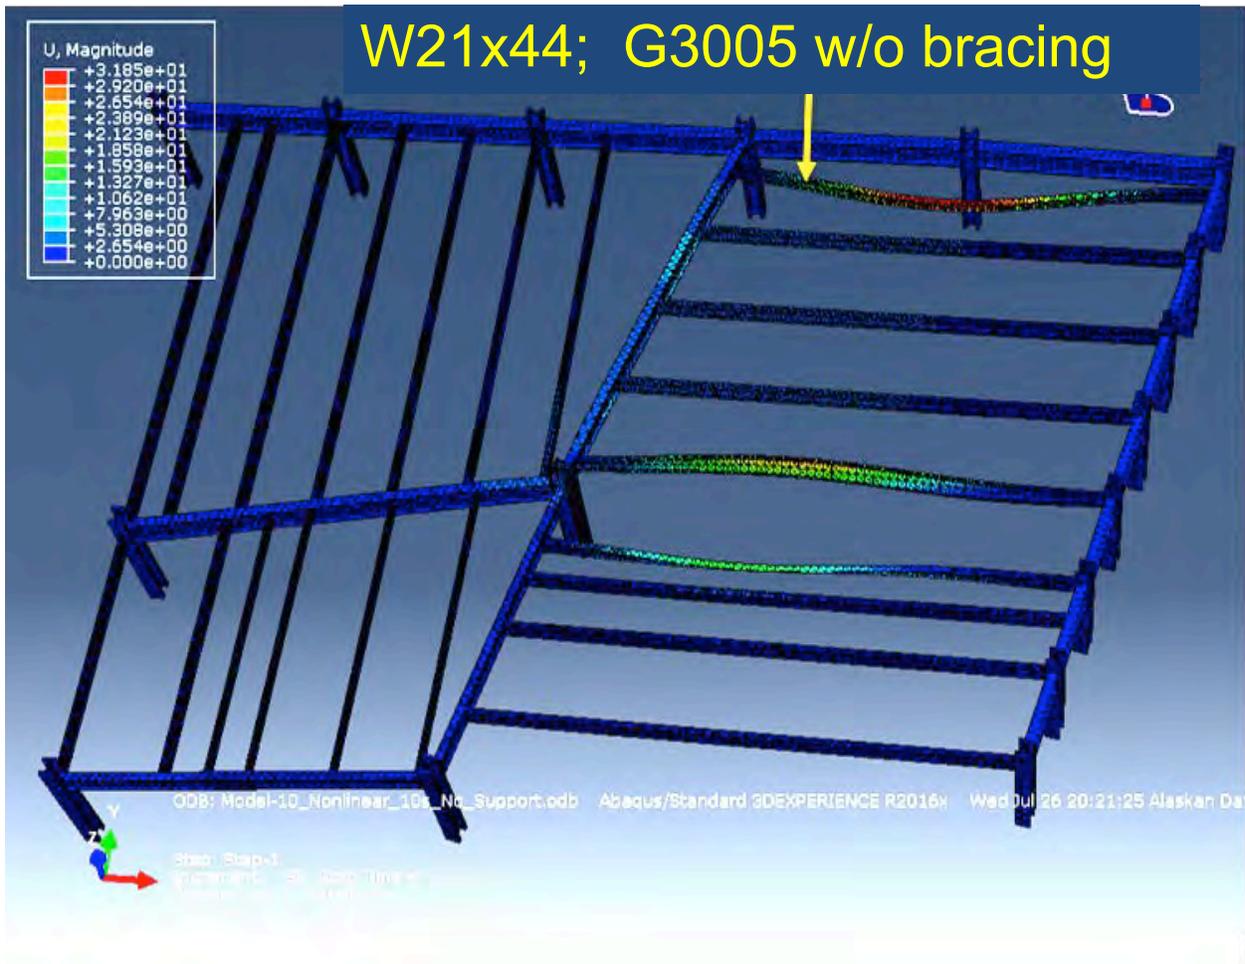
Figure 3.14 UAF analysis of the W21x44 G3005 with no lateral support beams included.

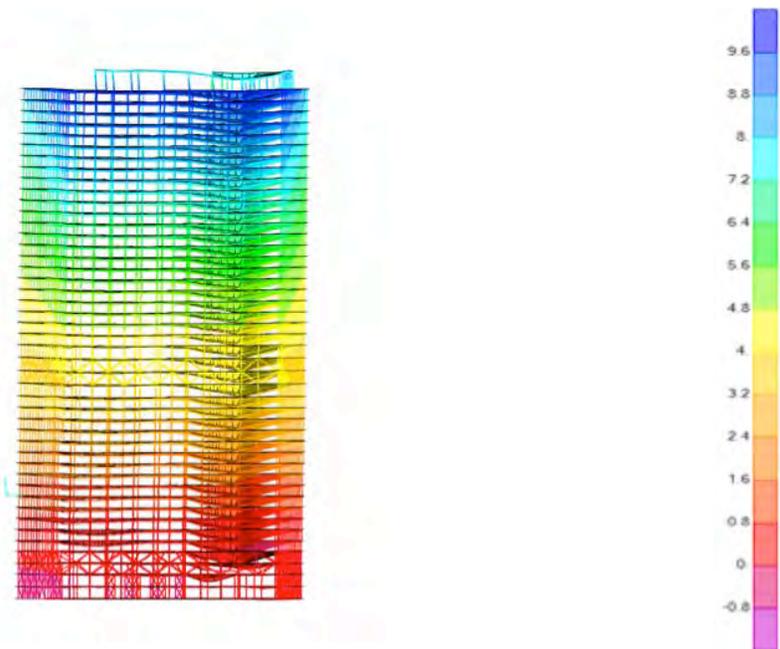
Figure 4.2 Columns 79, 80, and 81 are removed from Floor 6 to Floor 13. The key to the right is expressed in inches of movement. The building tilts to the east almost 10 inches. The penthouse does not collapse.

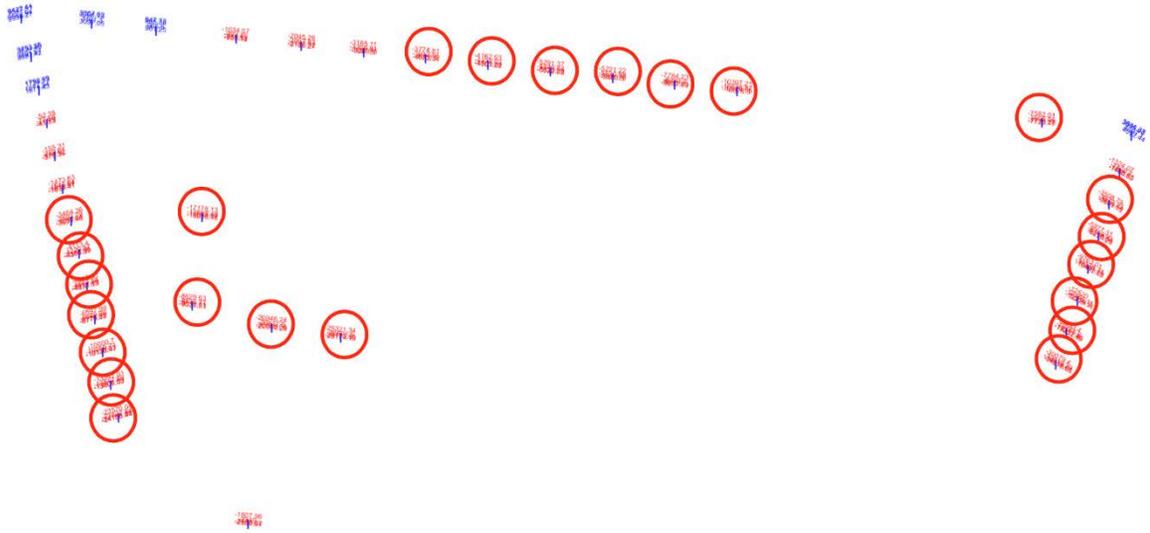
Figure 4.12 Linear static analysis results show that the failure of additional columns (shown in Figure 4.11 above) leads to the failure of the remaining core columns and many exterior columns (circled in red). The columns with blue values are in tension rather than compression, indicating the building is tipping away from those columns.

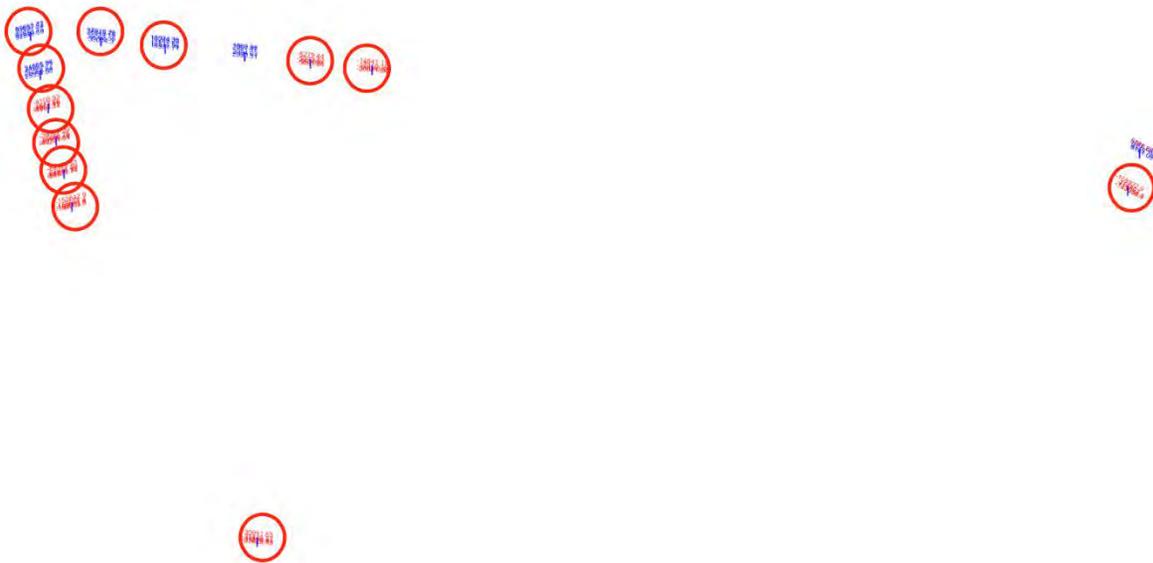
Figure 4.13 Linear static analysis results show that the failure of additional columns (shown in Figure 4.12 above) leads to the failure of nearly every remaining column (circled in red).

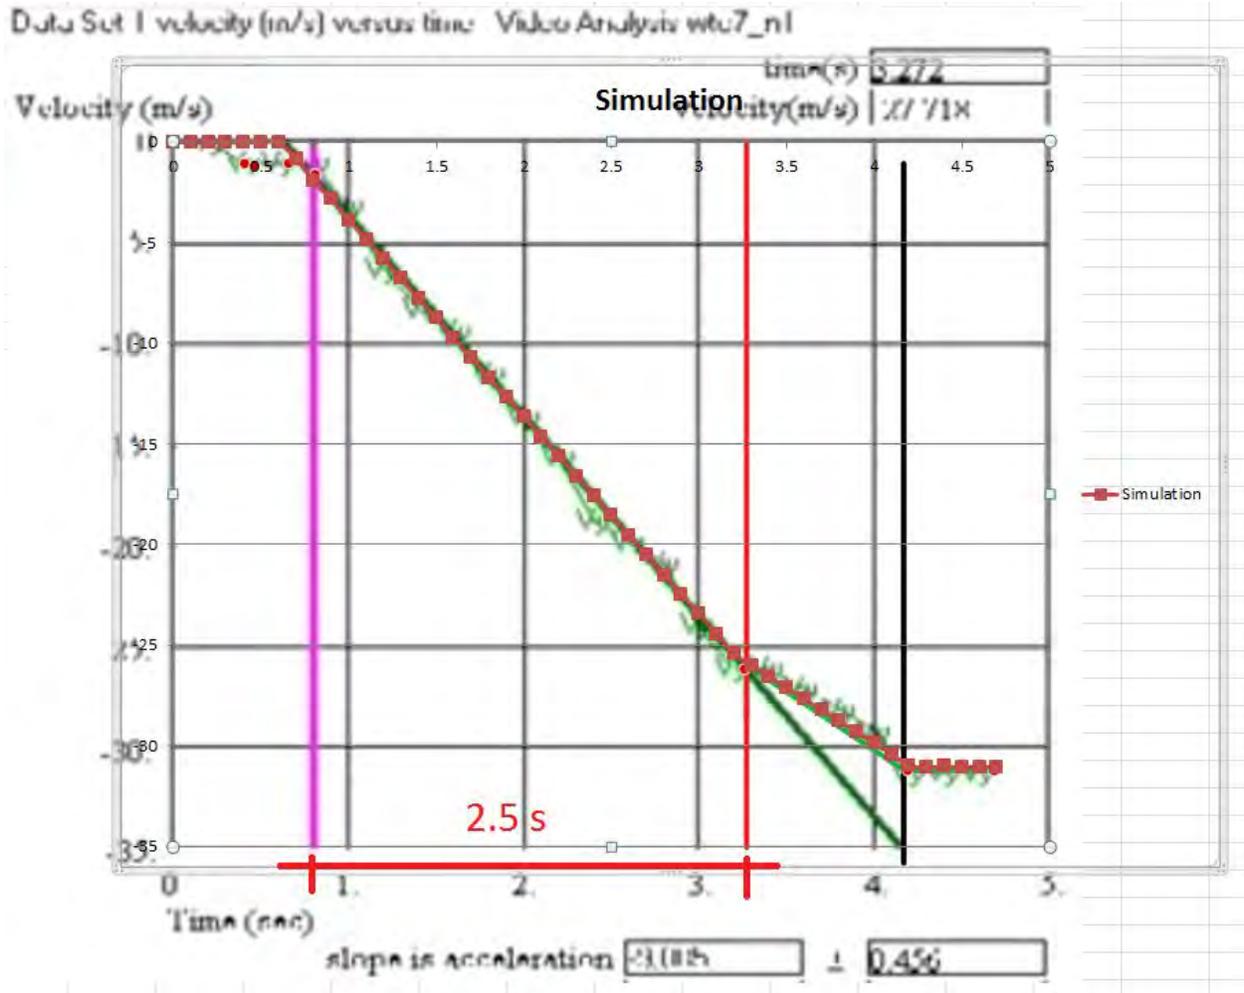
Figure 4.20 Velocity comparison between Chandler measurement (green plotted line) and UAF simulation (red plotted line). Bold green trend line illustrates free fall.
