**NIST NCSTAR 1A**

# **Final Report** on the **Collapse of** **World Trade Center Building 7**

November 2008

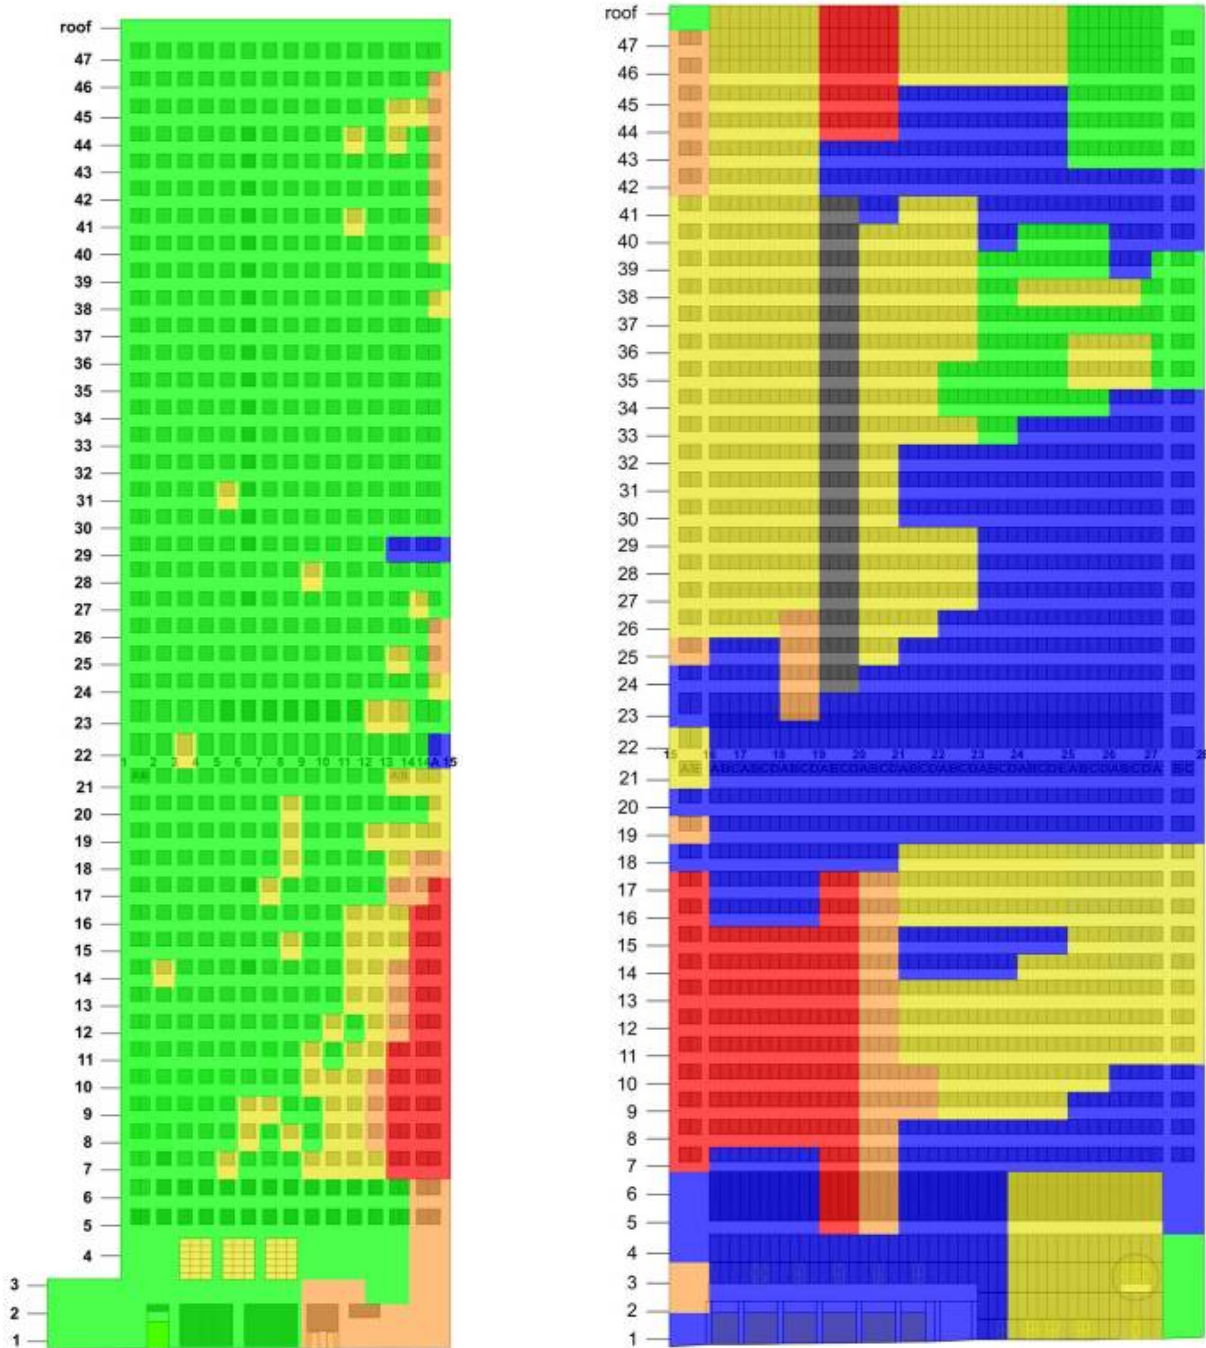
**Figure 2-1. Observed damage to WTC 7 following the collapse of WTC 1.**  
West face (left) and south face (right)

The damage is color coded as follows: green (■)- no visible damage, yellow (■) – window glass broken, orange (■) – granite and underlying truss damage, red (■) – damage to exterior structural steel, gray (■) – possible structural damage, and blue (■) – not visible due to smoke, dust, and intervening buildings.

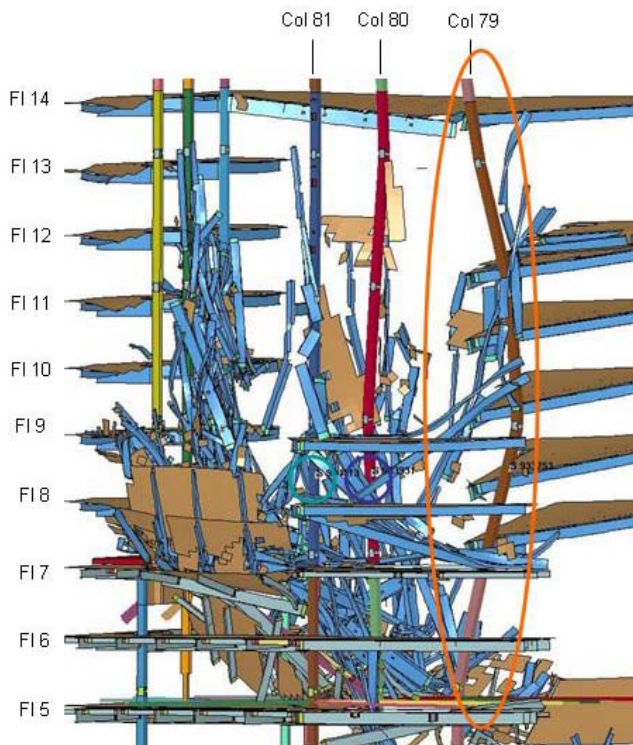
Fire-induced thermal expansion of the floor system surrounding Column 79 led to the collapse of Floor 13, which triggered a cascade of floor failures. In this case, the floor beams on the east side of the building expanded enough that they pushed the girder spanning between Columns 79 and 44 to the west on the 13<sup>th</sup> floor. (See Figure 1–5 for column numbering and the locations of girders and beams.) This movement was enough for the girder to walk off of its support at Column 79.

The unsupported girder and other local fire-induced damage caused Floor 13 to collapse, beginning a cascade of floor failures down to the 5<sup>th</sup> floor (which, as noted in Section 1.2.3, was much thicker and stronger). Many of these floors had already been at least partially weakened by the fires in the vicinity of Column 79. This left Column 79 with insufficient lateral support, and as a consequence, the column buckled eastward, becoming the initial local failure for collapse initiation.

**Figure 2–2. Eastward buckling of Column 79, viewed from the southeast.**

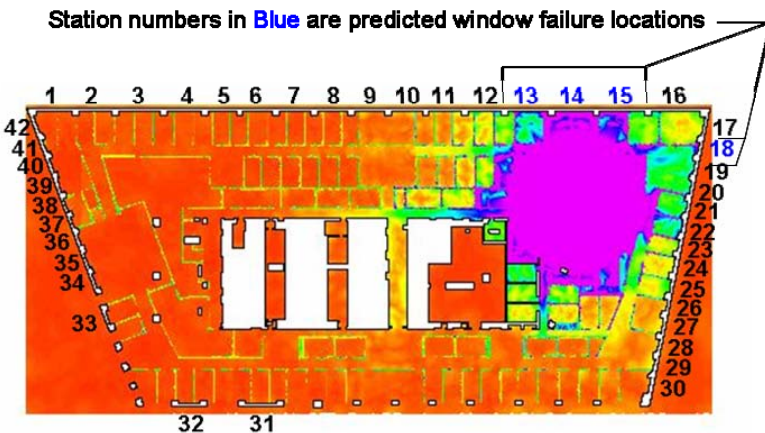
Figure 3–1 shows the results for the two shaped charges applied to Column 79 on a tenant floor that was highly partitioned, such as Floor 12. Nearly all the windows on the northeast section of the floor subjected to a blast would have been broken, even by the smaller charge. Simulations for a floor that was not highly partitioned led to more extensive window breakage.

**Figure 3–1. Peak overpressure and broken window locations.**

Top: 9 lb shaped charge; bottom: 2 lb charge.

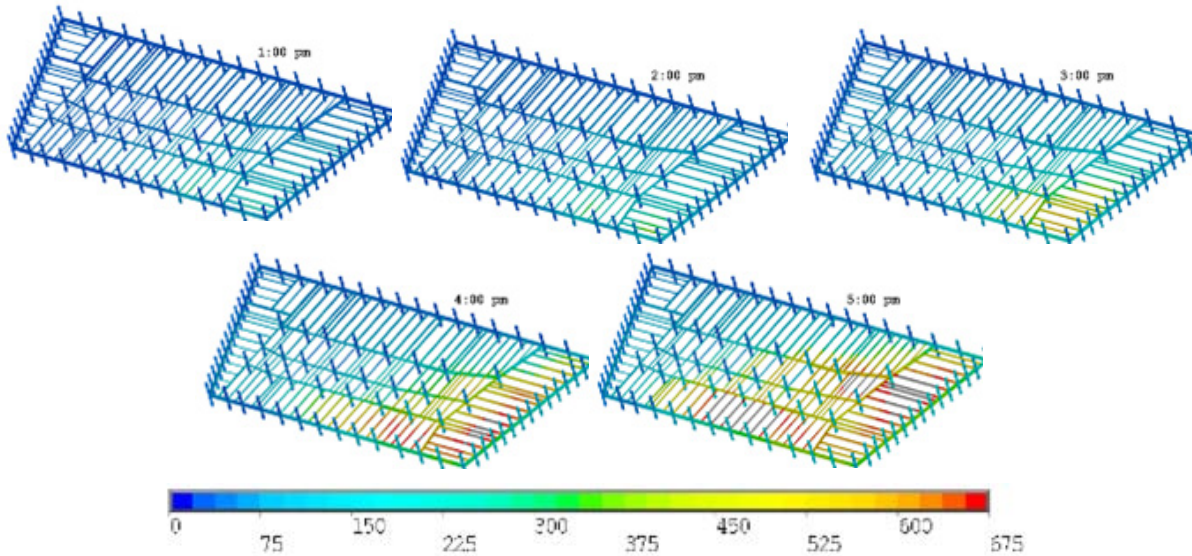
Figure 3–7 shows the calculated heating of the structural steel on the lower 16 floors of WTC 7 for the Case B temperatures from the fire simulation. The floor slabs have been removed from the figure for clarity. Figure 3–8 is a typical rendition of the calculated heating of the top of a floor slab as a result of the Case B fire.

**Figure 3–7. Computed temperature distribution (°C) of Floor 13 steel framing at five different instants in time.**

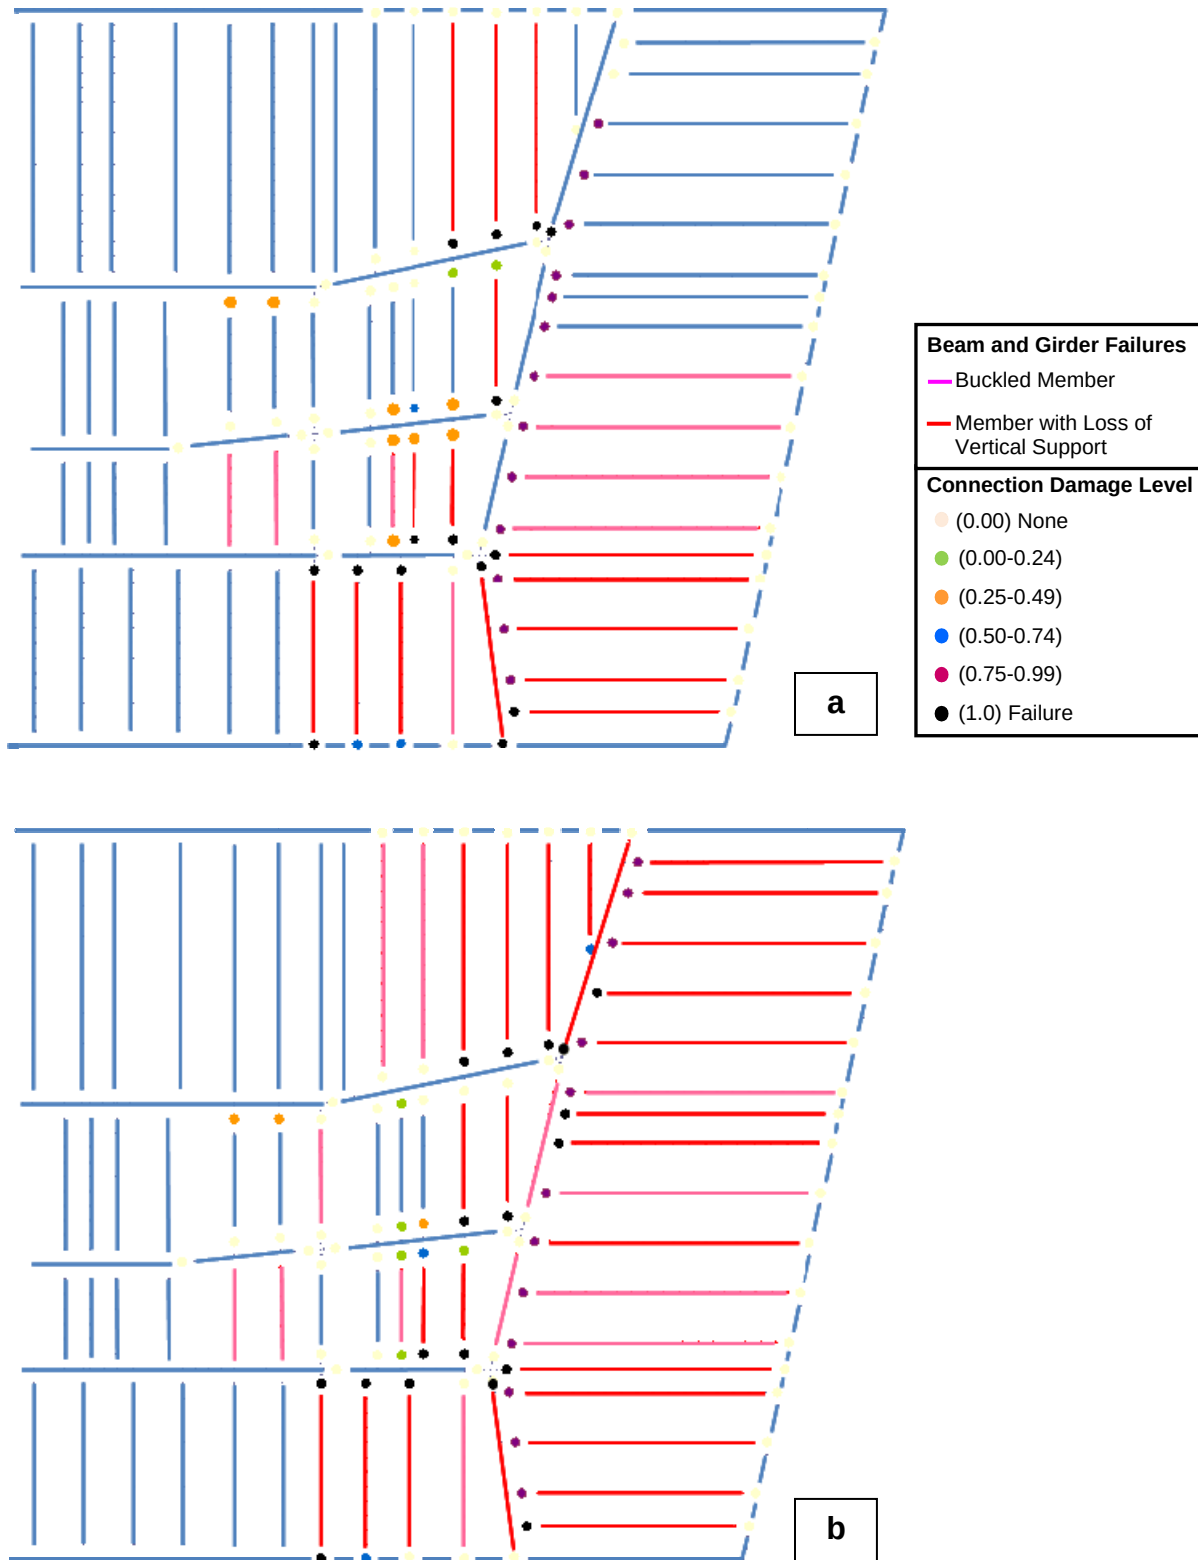
Figure 3-9. Damage state of connections in Floor 13 for Case B temperatures.  
a: at 3.5 h; b: at 4.0 h

The second LS-DYNA analysis (lesser degree of fire-induced damage) did not lead to a collapse-initiating event, despite the extensive damage shown in Figure 3-9a.

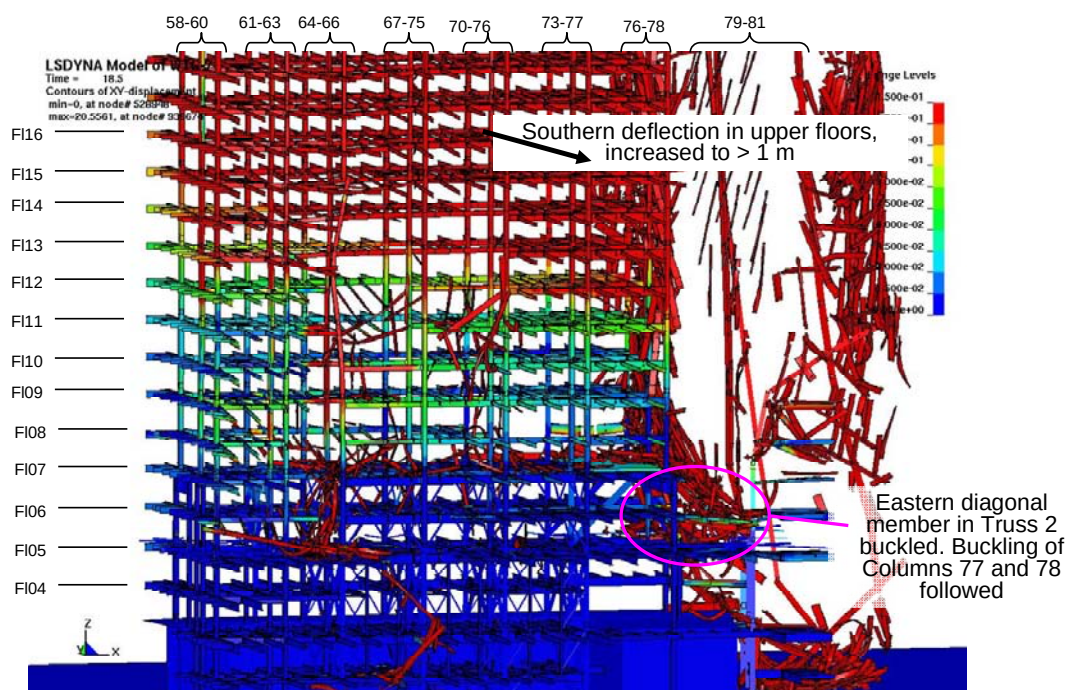
**Figure 3-11. Failure of Columns 77 and 78 due to failure of Truss 2 fails from debris impact at 2.5 s following the initiation of the collapse.**

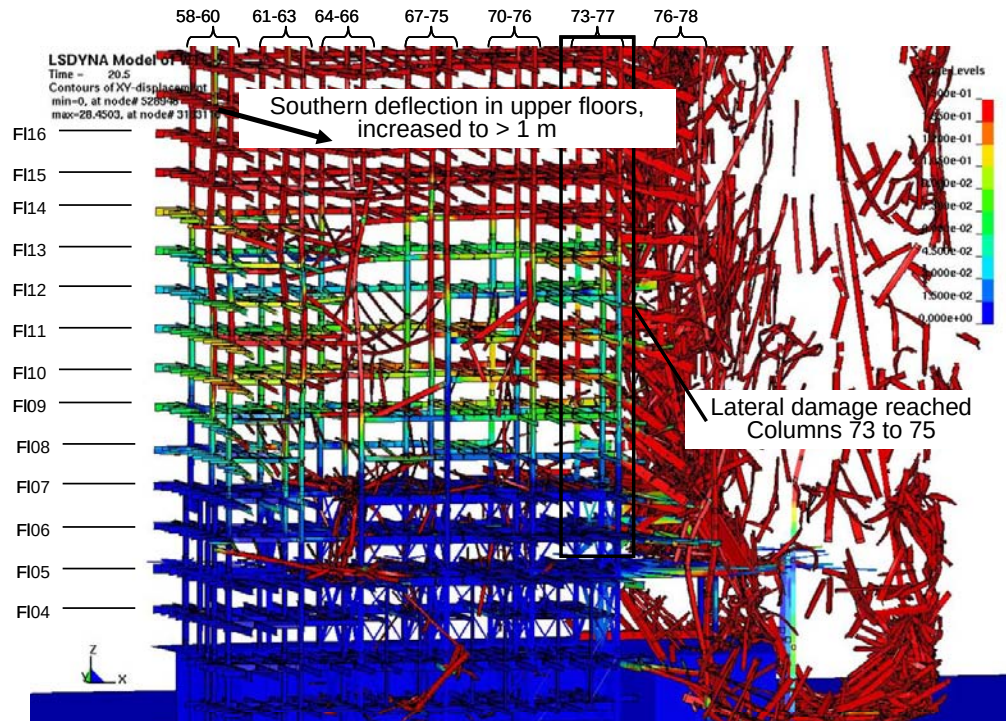
**Figure 3-12. Failure of Columns 73 to 75 from the load redistribution and debris impact at 4.5 s following the initiation of the collapse.**

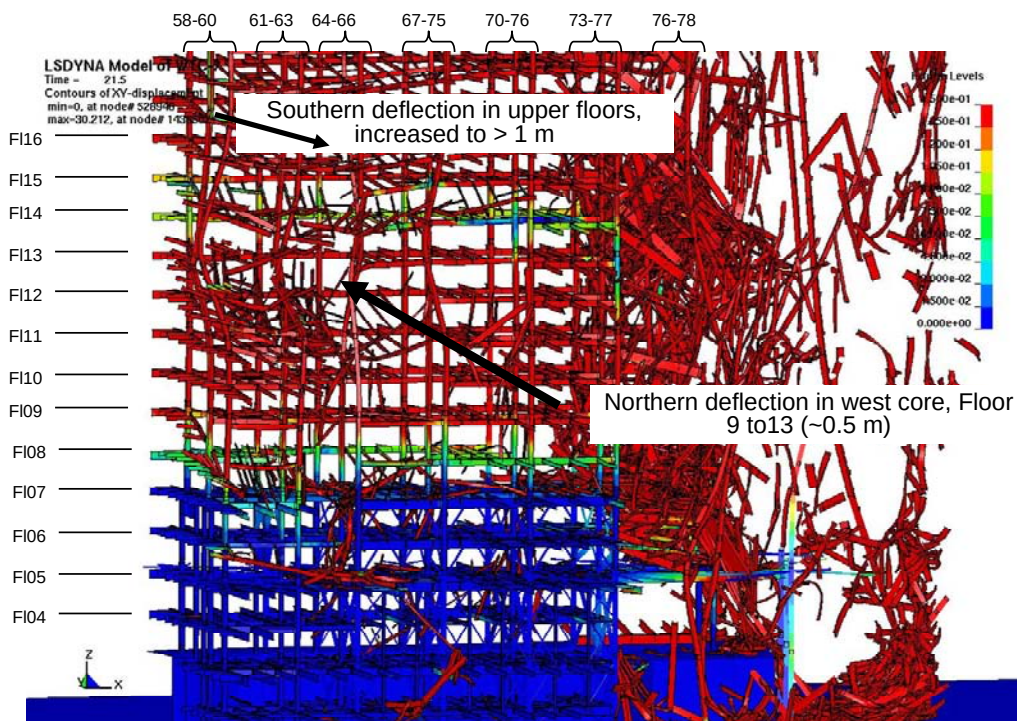
**Figure 3-13. Buckling of all interior columns at 6.5 s following the initiation of the collapse.**
