**Federal Building and Fire Safety Investigation of the
World Trade Center Disaster**

**Structural Fire Response and
Probable Collapse Sequence of
World Trade Center Building 7**

VOLUME 1

National Institute of Standards and Technology

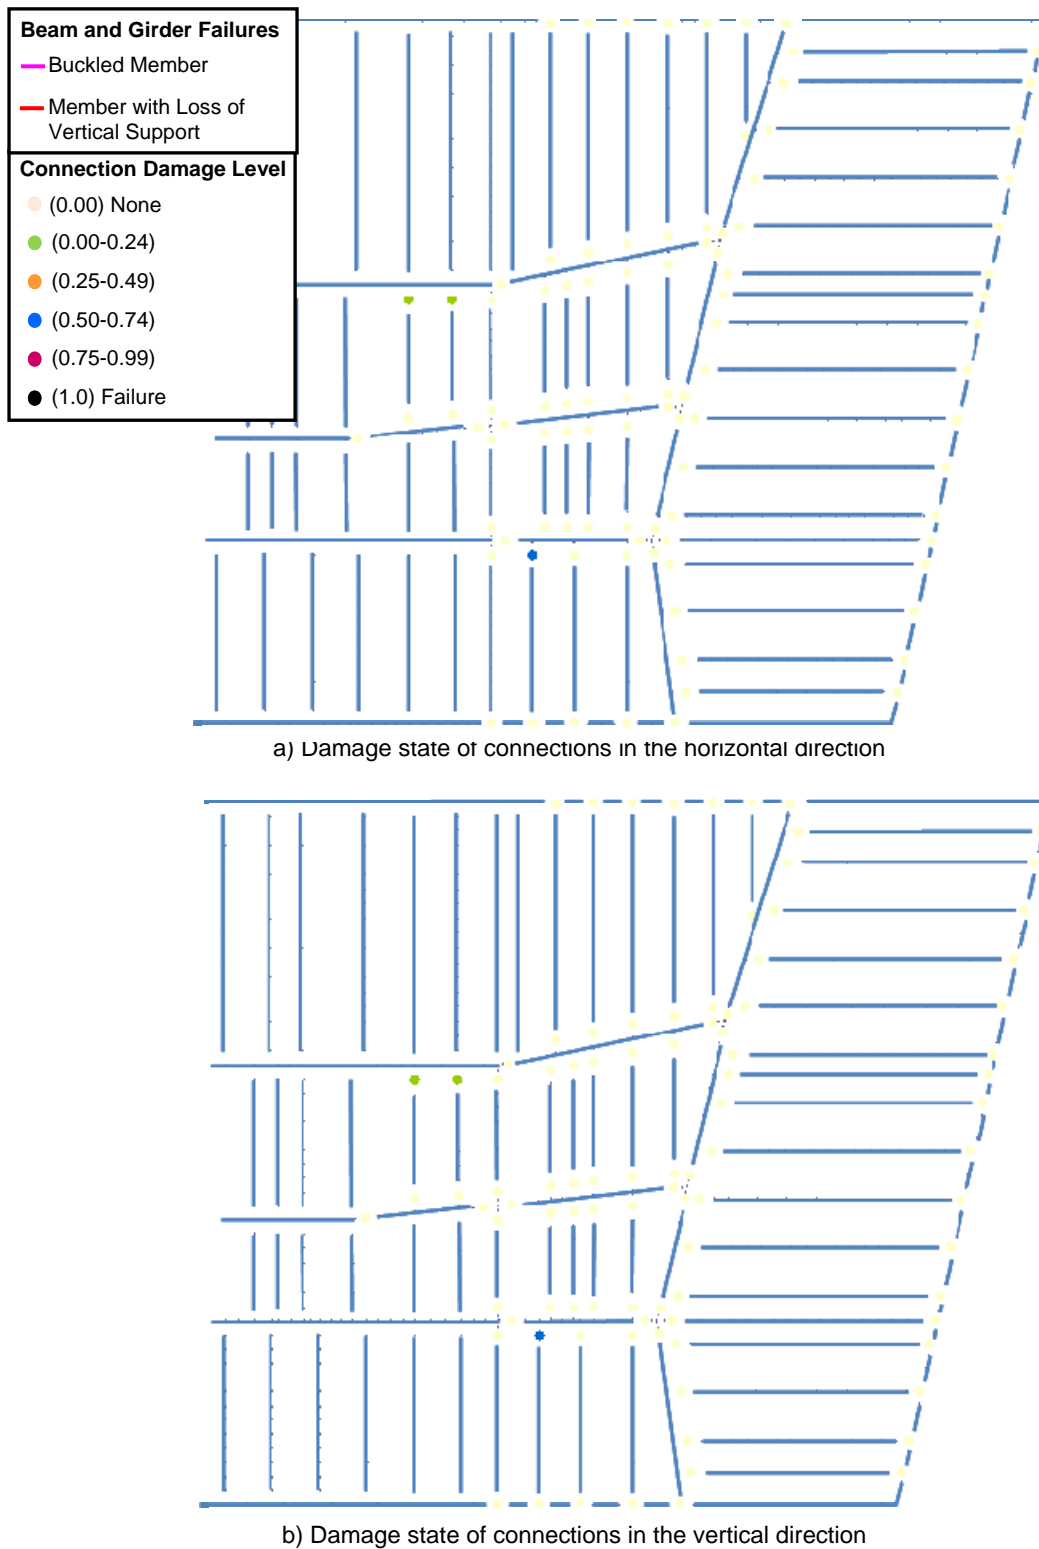
Figure 11–24. Damage state of connections, beams, and girders in Floor 10 at 3.5 h for Case B. temperatures.

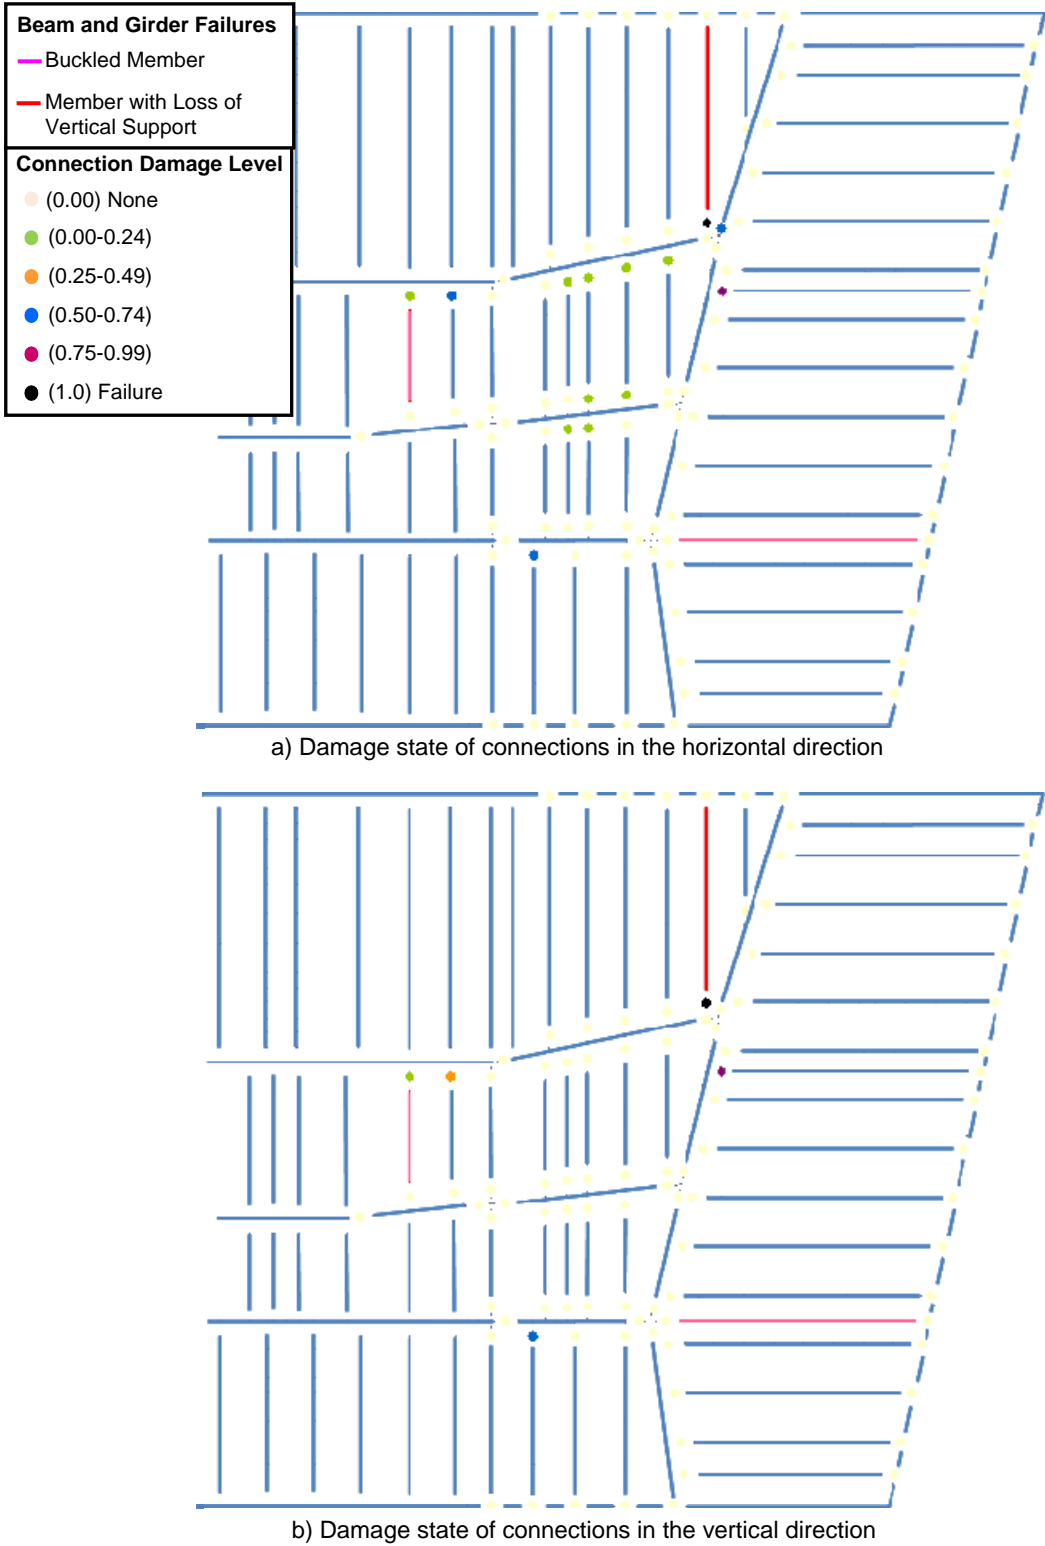
Figure 11–31. Damage state of connections, beams, and girders in Floor 9 at 4.0 h for Case B temperatures.

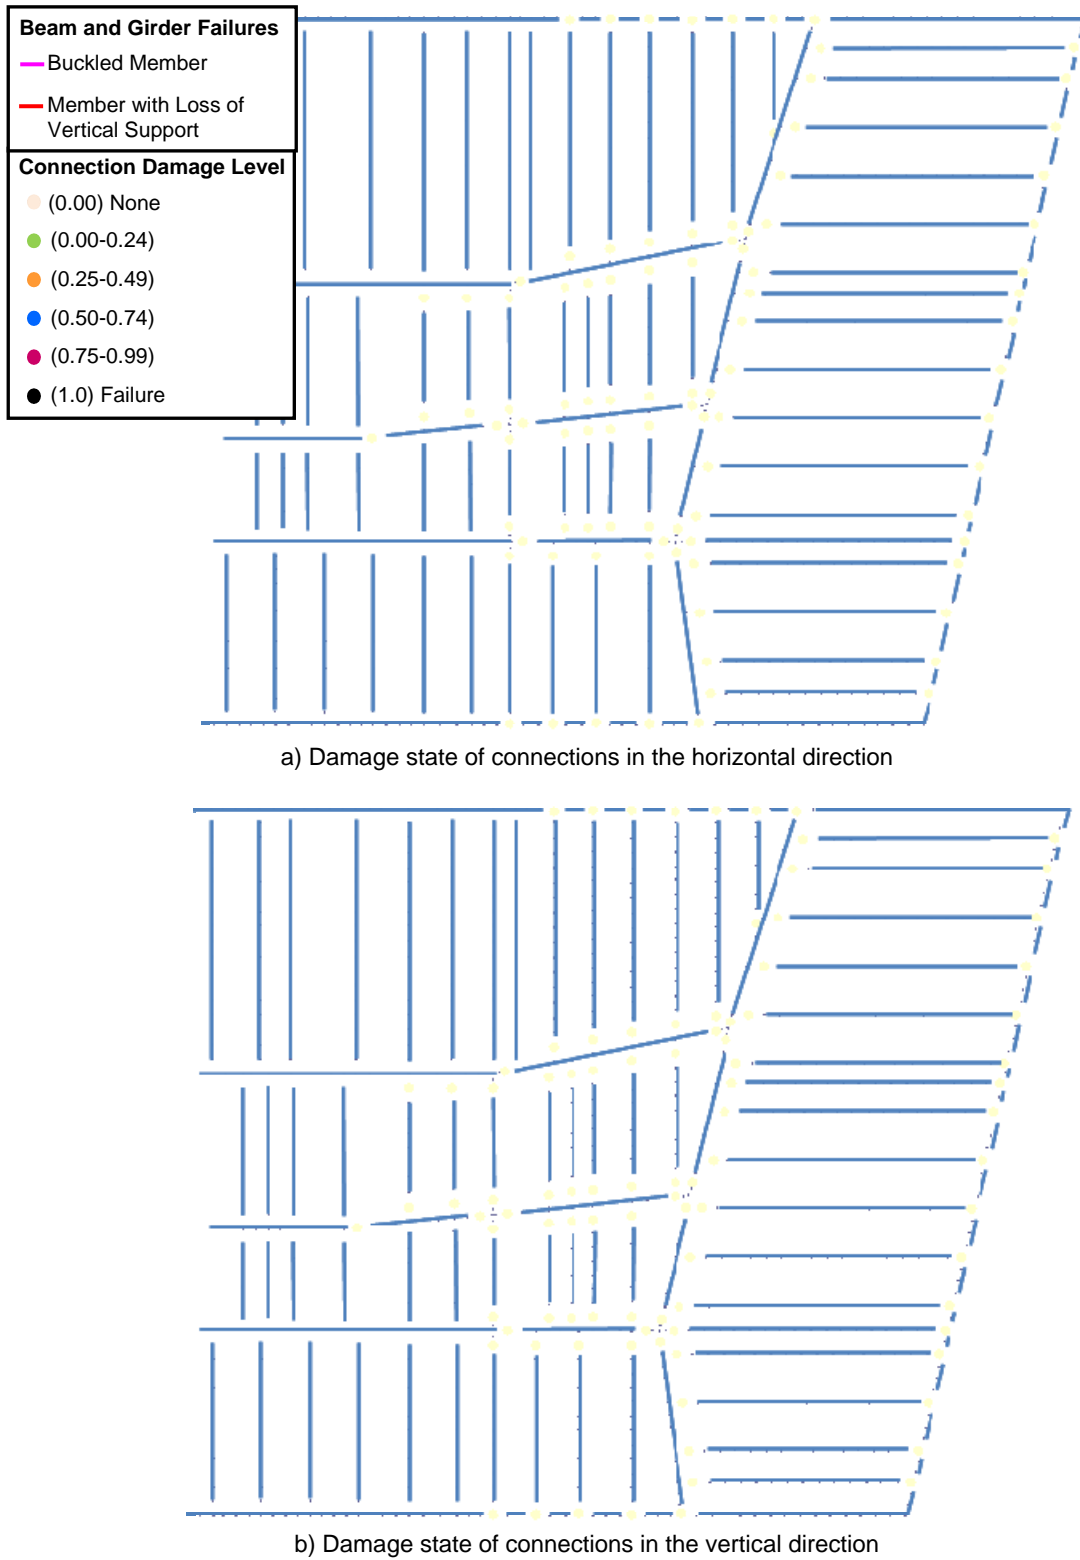
Figure 11–40. Damage state of connections, beams, and girders in Floor 10 at 4.0 h for Case C temperatures.

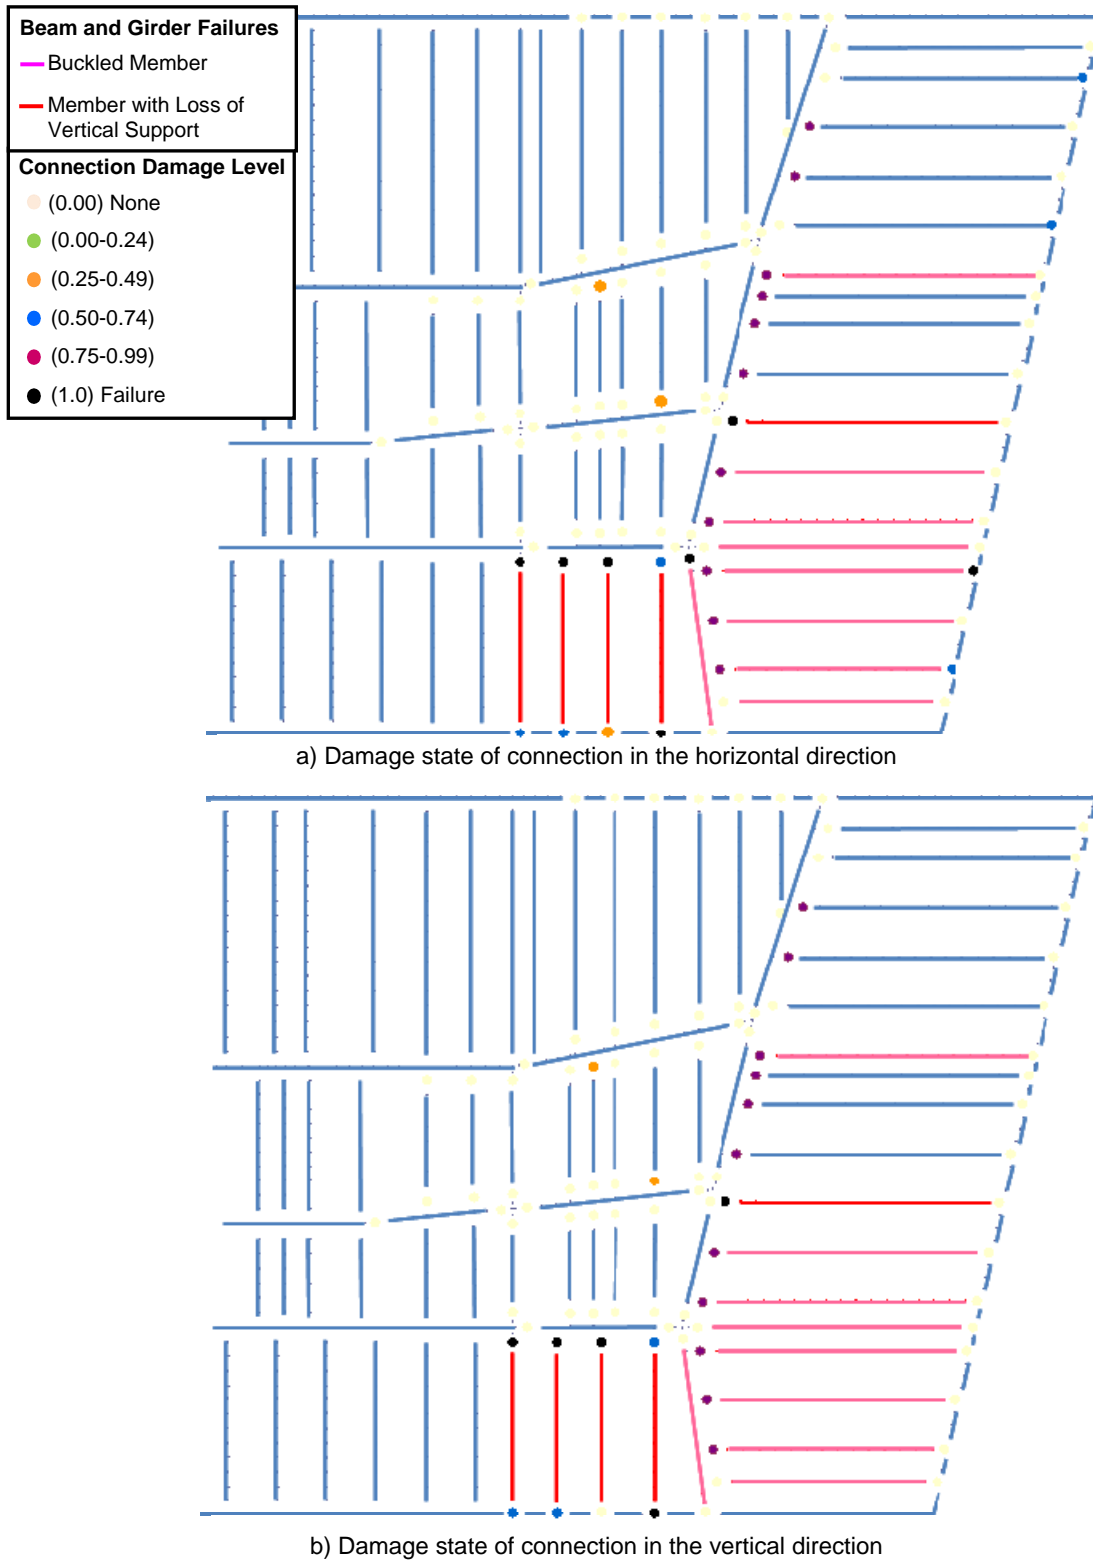
Figure 11–42. Damage state of connections, beams, and girders in Floor 12 at 4.0 h for Case C temperatures.
