NIST Response to the World Trade Center Disaster

Federal Building and Fire Safety Investigation of the World Trade Center Disaster

August 26, 2008

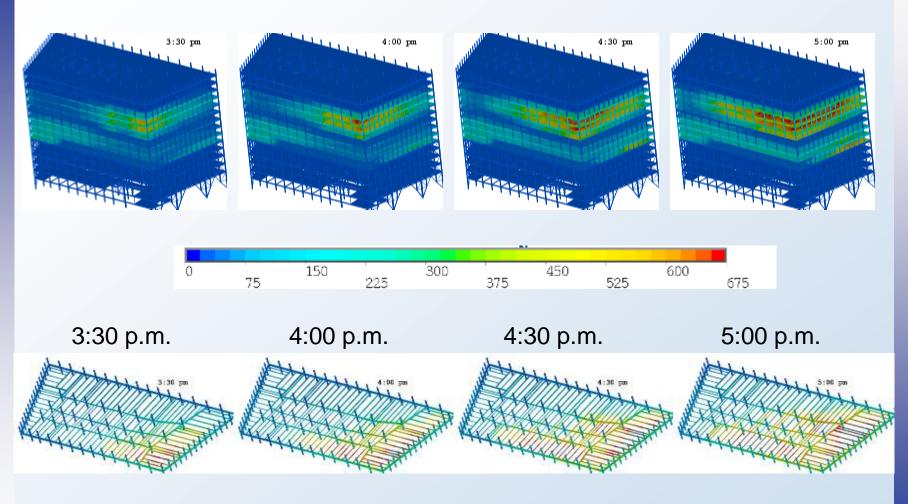
Temperature distribution (°C) on the floor beams of Floor 13.

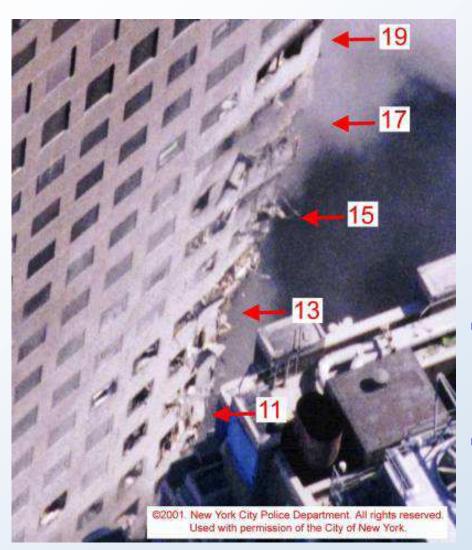
Debris Impact Damage to WTC 7

- Collapse of WTC 2 did not cause any structural damage or start any fires in WTC 7.
- Collapse of WTC 1 damaged seven exterior columns on the lower floors of the south and west faces and initiated fires on 10 floors between Floors 7 and 30.

- Enlargement of a photograph showing part of the west face of WTC 7.
- Arrows and floor numbers have been added for the corresponding rows of windows.

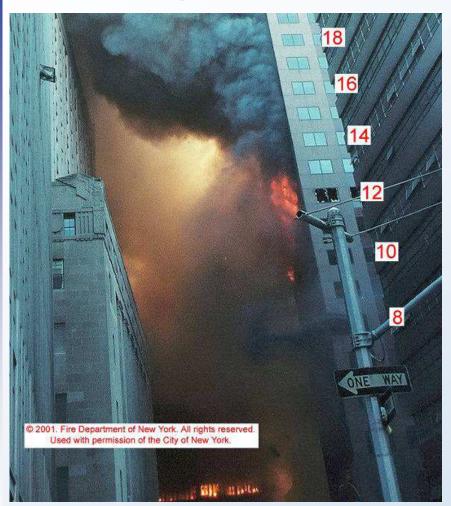
- Photo showing north and east faces.
- Likely taken between 3:20 3:40 p.m.

- Growth and Spread of Fires.
 - Fires on Floors 7 to 9 and 11 to 13 grew and spread since they were not extinguished either by the automatic sprinkler system or by FDNY because water was not available.
 - Fires were generally concentrated on the east and north sides beginning at about 3 p.m. to 4 p.m.
 - The local fires on Floors 19,
 22, 29, and 30 were not observed after ~ 1 p.m.

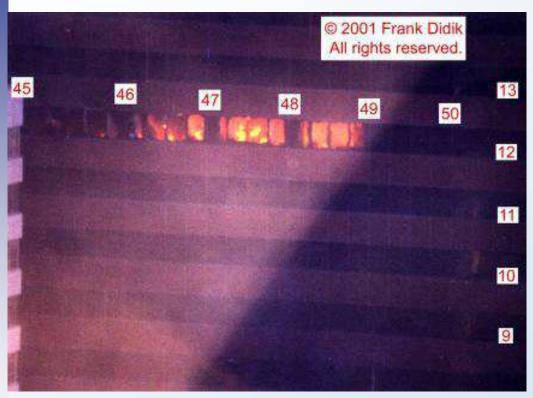
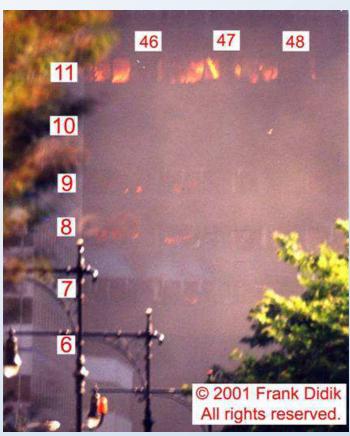
Observed Fires

- Cropped photograph of north face taken between 3:11:15 p.m. and 3:16:51 p.m.
- Cropped photograph showing part of north face at 4:39 p.m. ± 120 s.

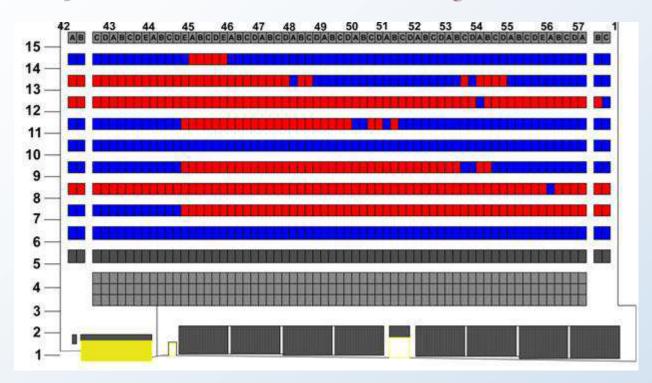
Summary of Fires on North Façade of WTC 7

- Façade map showing where windows were broken and/or fire was observed during the period when fire first appeared shortly before 3:00 p.m. until the building collapsed at 5:20:52 p.m.
- Red represents windows where the glass was broken out and/or fire was observed through the window. Blue indicates that no direct evidence was observed for fires at these locations.

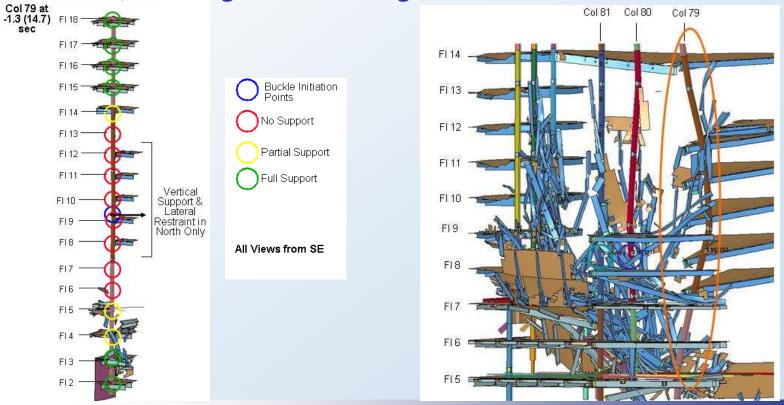
- Initial Local Failure for Collapse Initiation.
 - Fire-induced thermal expansion of the floor system surrounding Column 79 led to the collapse of Floor 13 and triggered a cascade of floor failures.
 - This, in turn, led to loss of lateral support to Column 79 over nine stories, resulting in the buckling failure of Column 79.

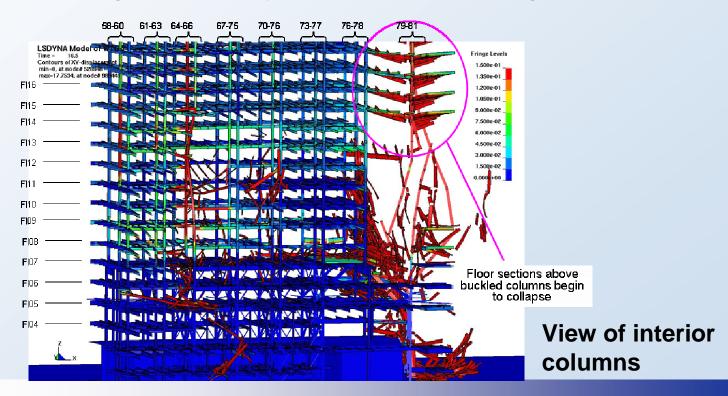
• Buckling of Column 79 triggered a vertical progression of floor system failures to the east penthouse, and subsequent cascading failure of Columns 80 and 81 on the east side of the building, that spread to include the entire east region all the way to the top of the building.

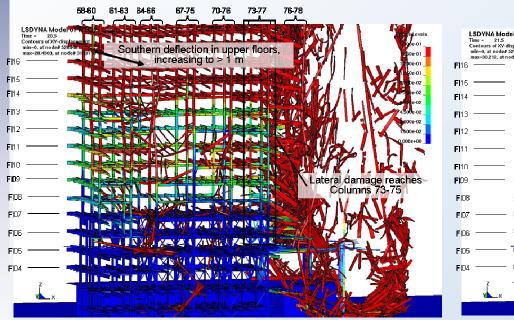
Interior columns buckled from east to west in the lower floors due to
 (1) loss of lateral support from floor system failures, (2) forces exerted by falling debris, and (3) load redistributed from other buckled columns.

Buckling of third line of interior columns at 4.5 s following collapse initiation.

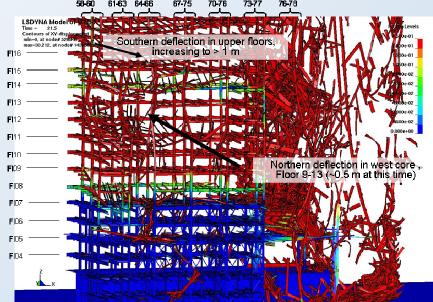
Buckling of all interior columns at 6.5 s following collapse initiation.

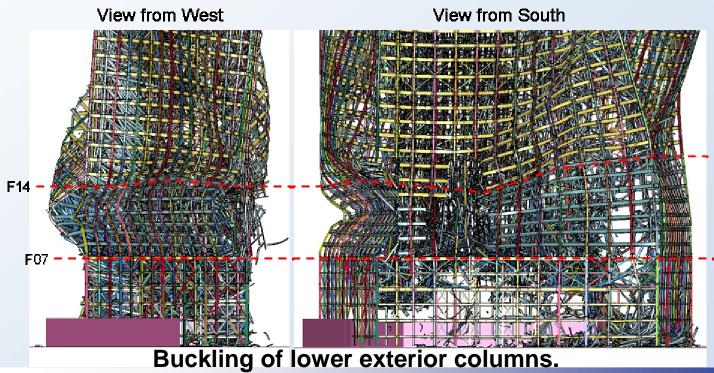
- The exterior columns buckled between Floors 7 and 14 due to load redistribution to these columns as the building core moved downward.
- The entire building above the buckled-column region then moved downward in a single unit, as observed.

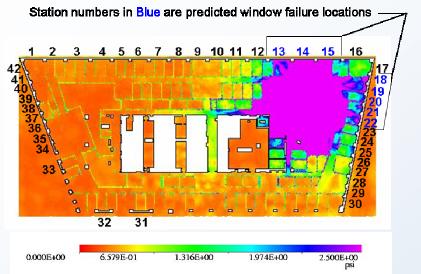
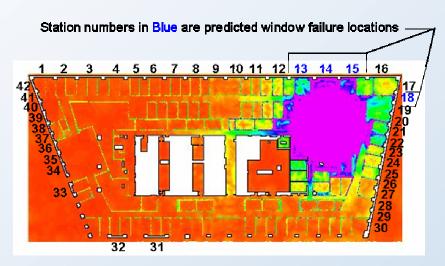
Peak over pressures for 9 lb shaped charge (left) and 2lb charge (right).

- Phase III: Assess the approximate distance from the building that the blast would have been audible in an urban setting.
 - For all four scenarios, windows would have been broken and significant sound levels were predicted from all building faces.
 - The sound level at 1 km (1/2 mile) would have been approximately 130 to 140 dB.
