11-4403-cv

United States Court of Appeals *for the* Second Circuit

JOINT APPENDIX Volume 14 of 16 (Pages JA-3617 to JA-3886)

Volume A - Photographic Timeline
Photographic Analysis Report
World Trade Center 7 Collapse Investigation
16 December 2009

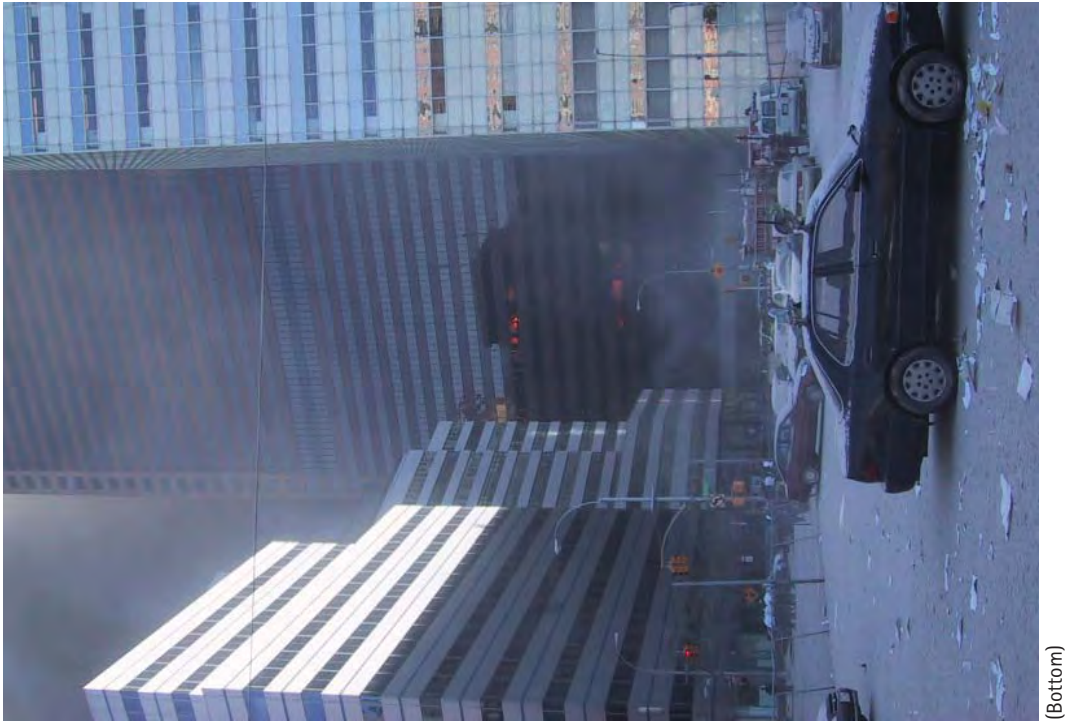
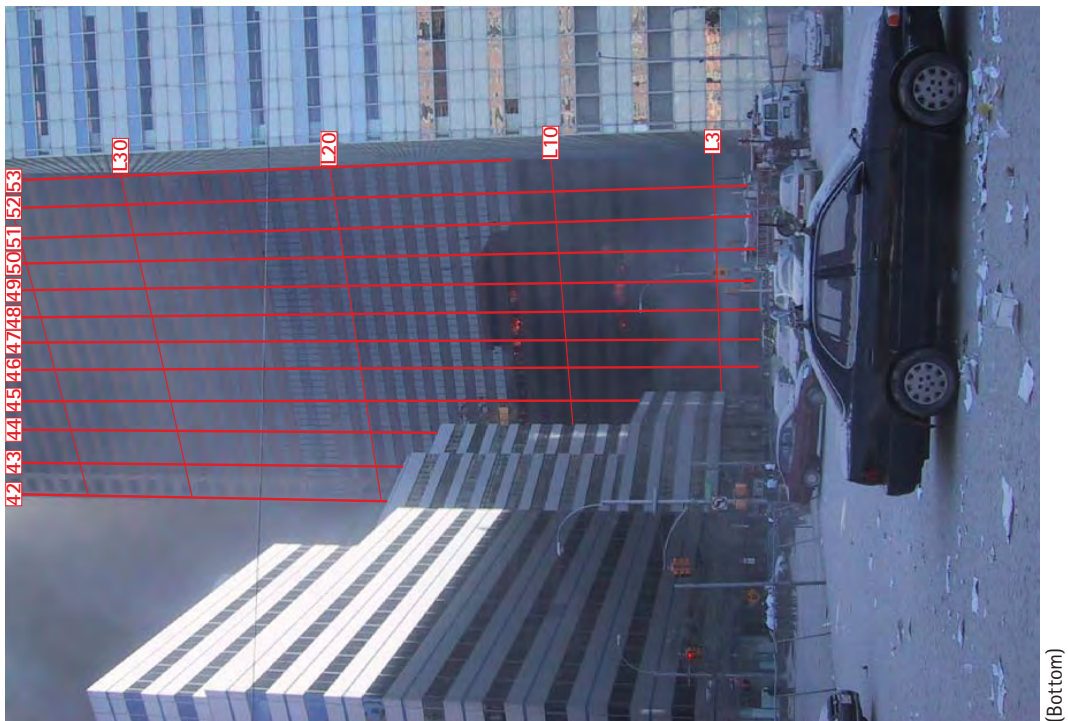
Image 6.N.08 North facade, approximately 3:10PM-3:17PM

Image 6.N.08 with columns and floor levels overlaid

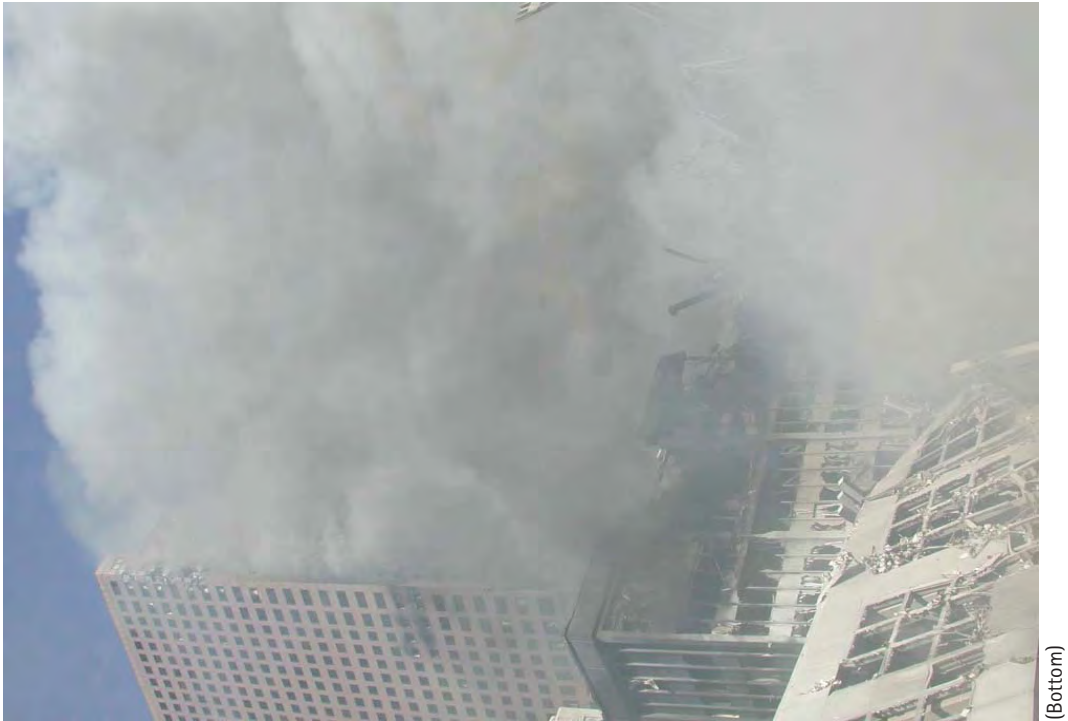
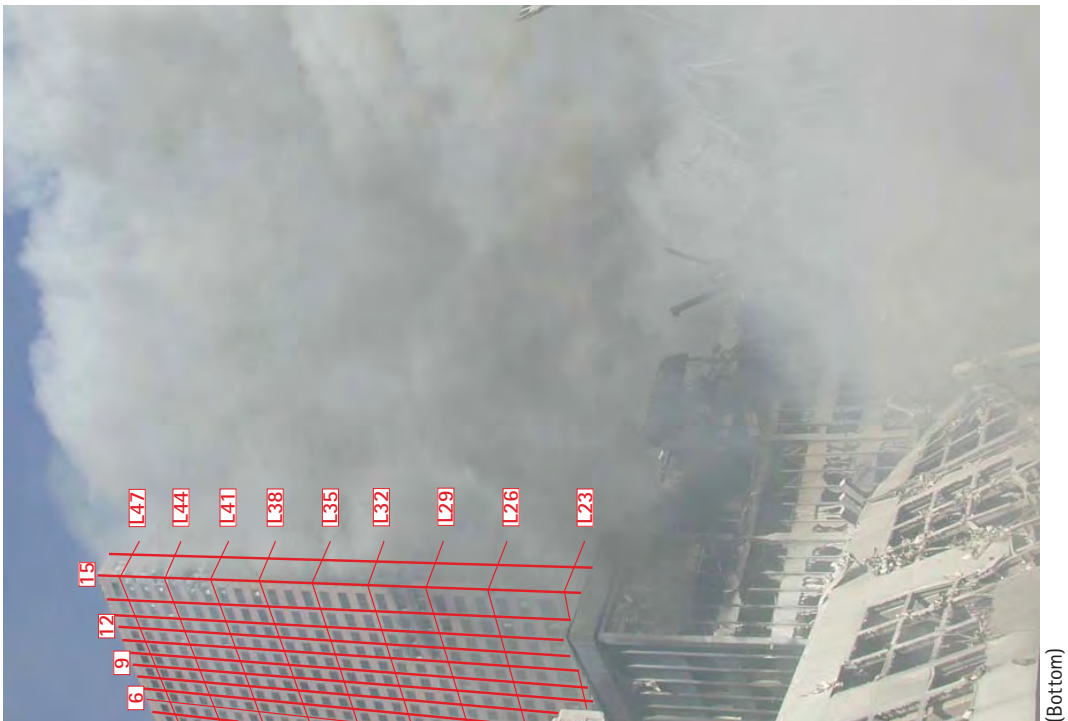
Image 6.W.01 Southwest corner, shortly after 3:00PM

Image 6.W.01 with columns and floor levels overlaid

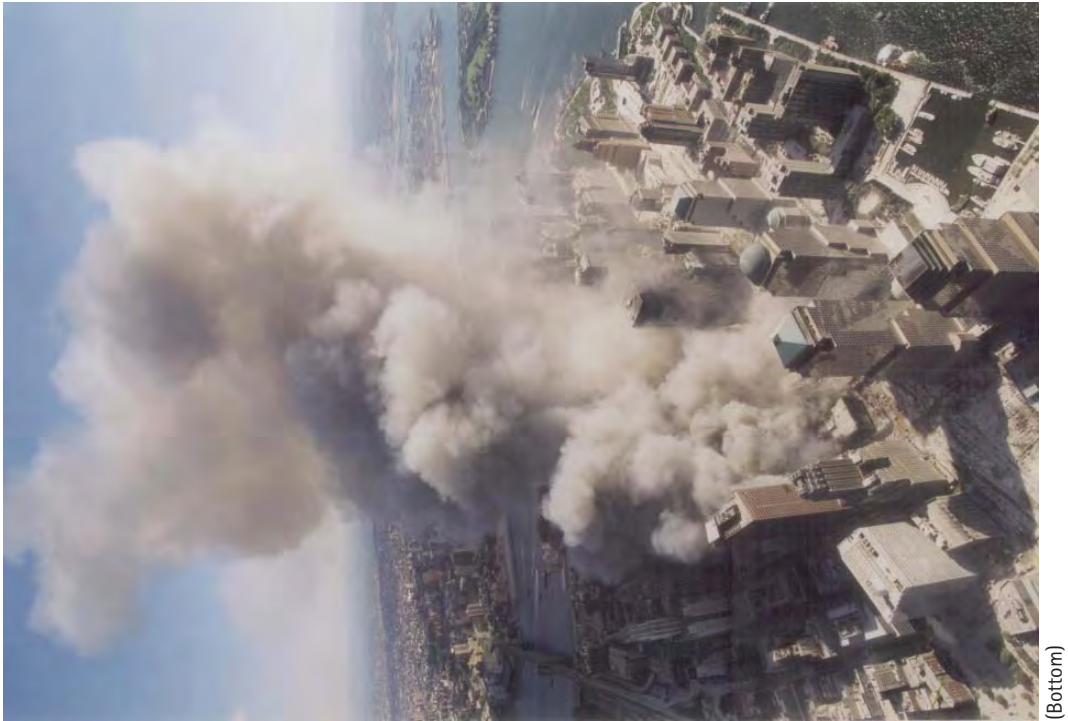
Image 6.W.05 West facade, approximately 3:00PM-4:30PM

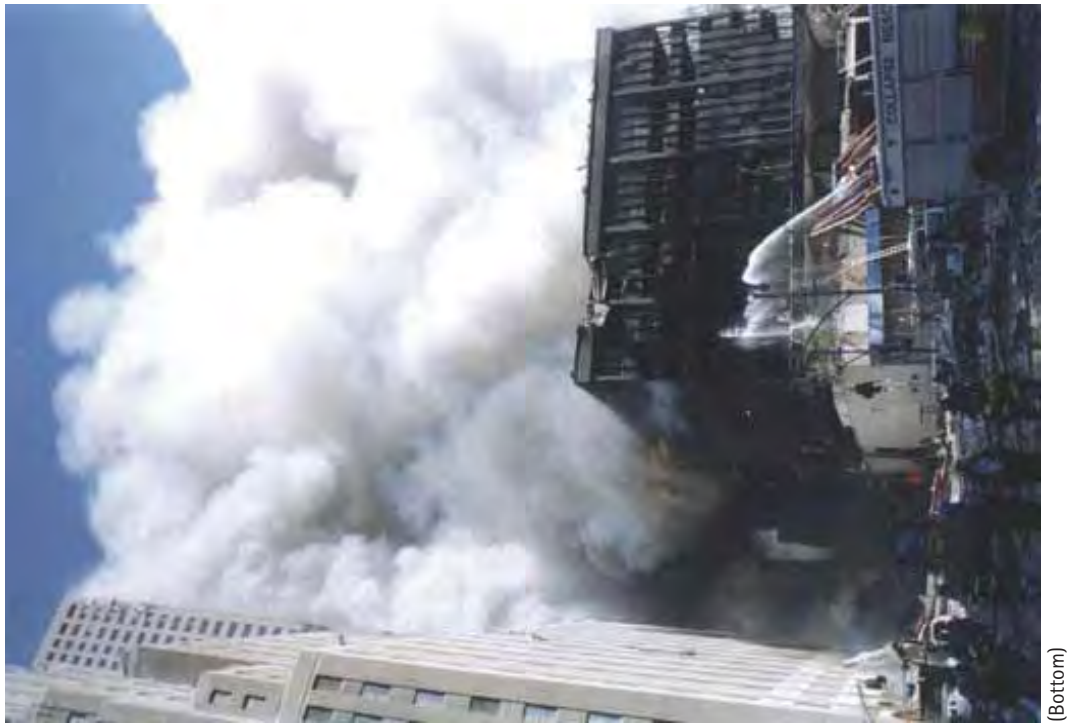
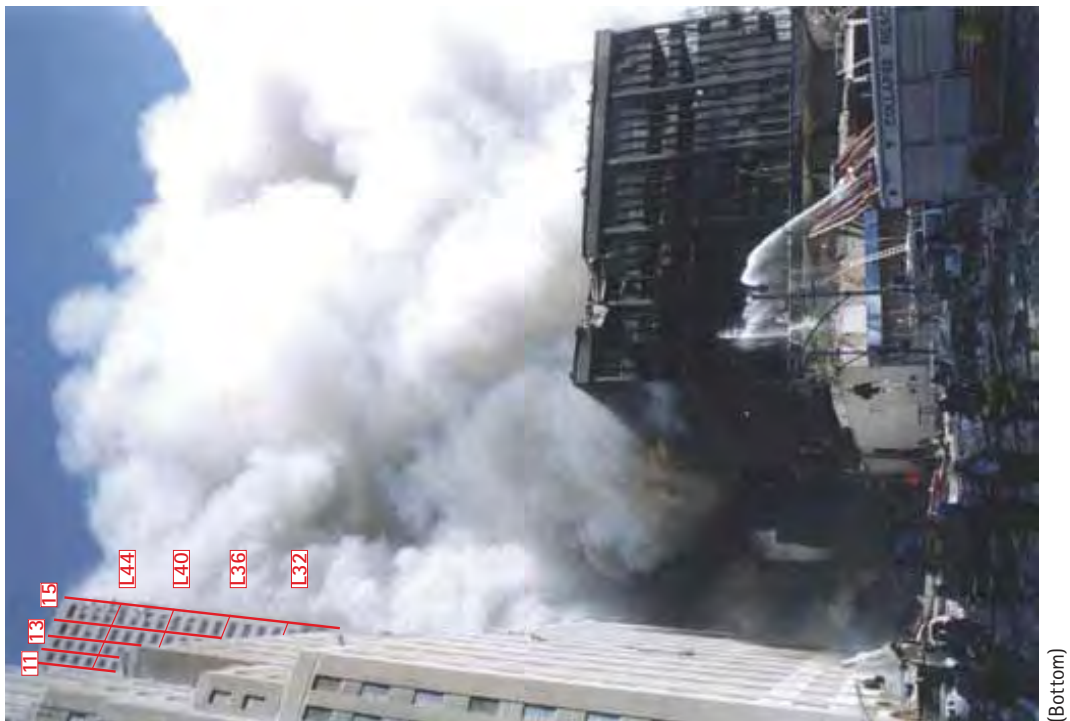
Image 6.W.11 West facade, approximately 3:00PM - 4:30PM

Image 6.W.11 with columns and floor levels overlaid

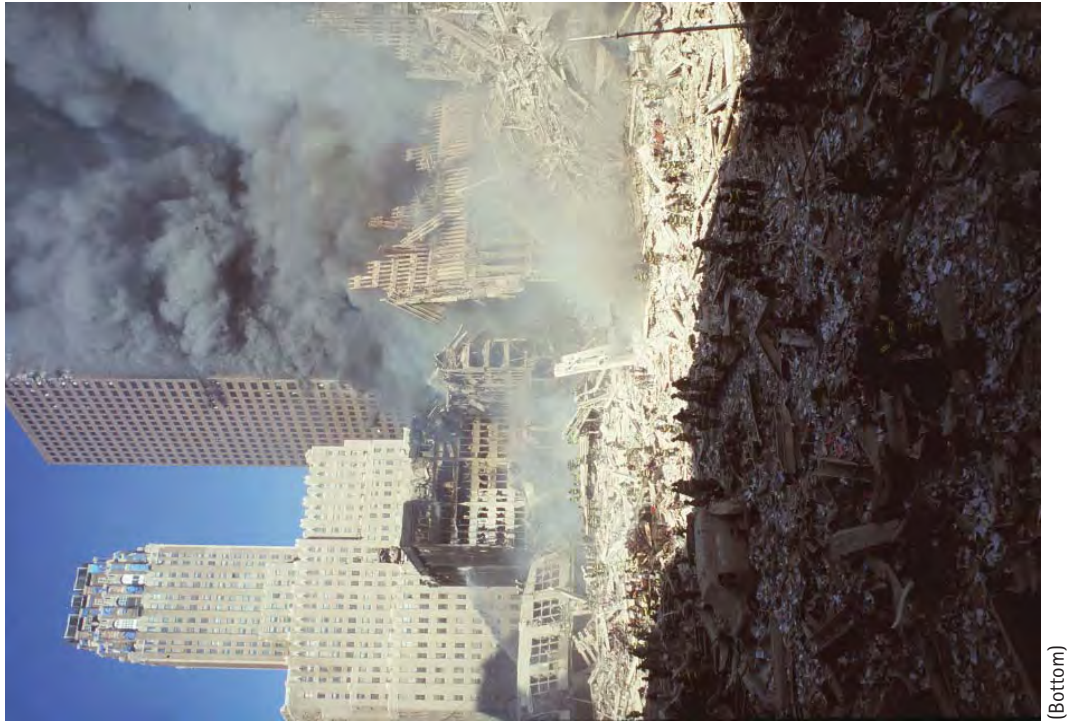
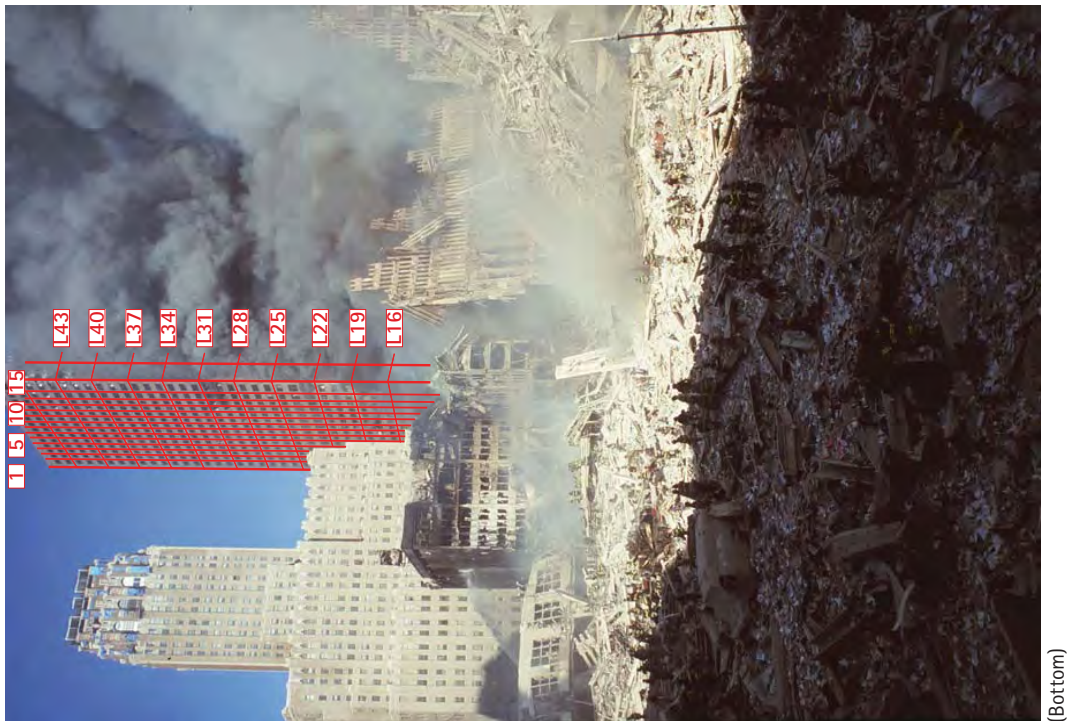
Image 6.W.20 Southwest corner, approximately 3:00PM-4:30PM

Image 6.W.20 with columns and floor levels overlaid

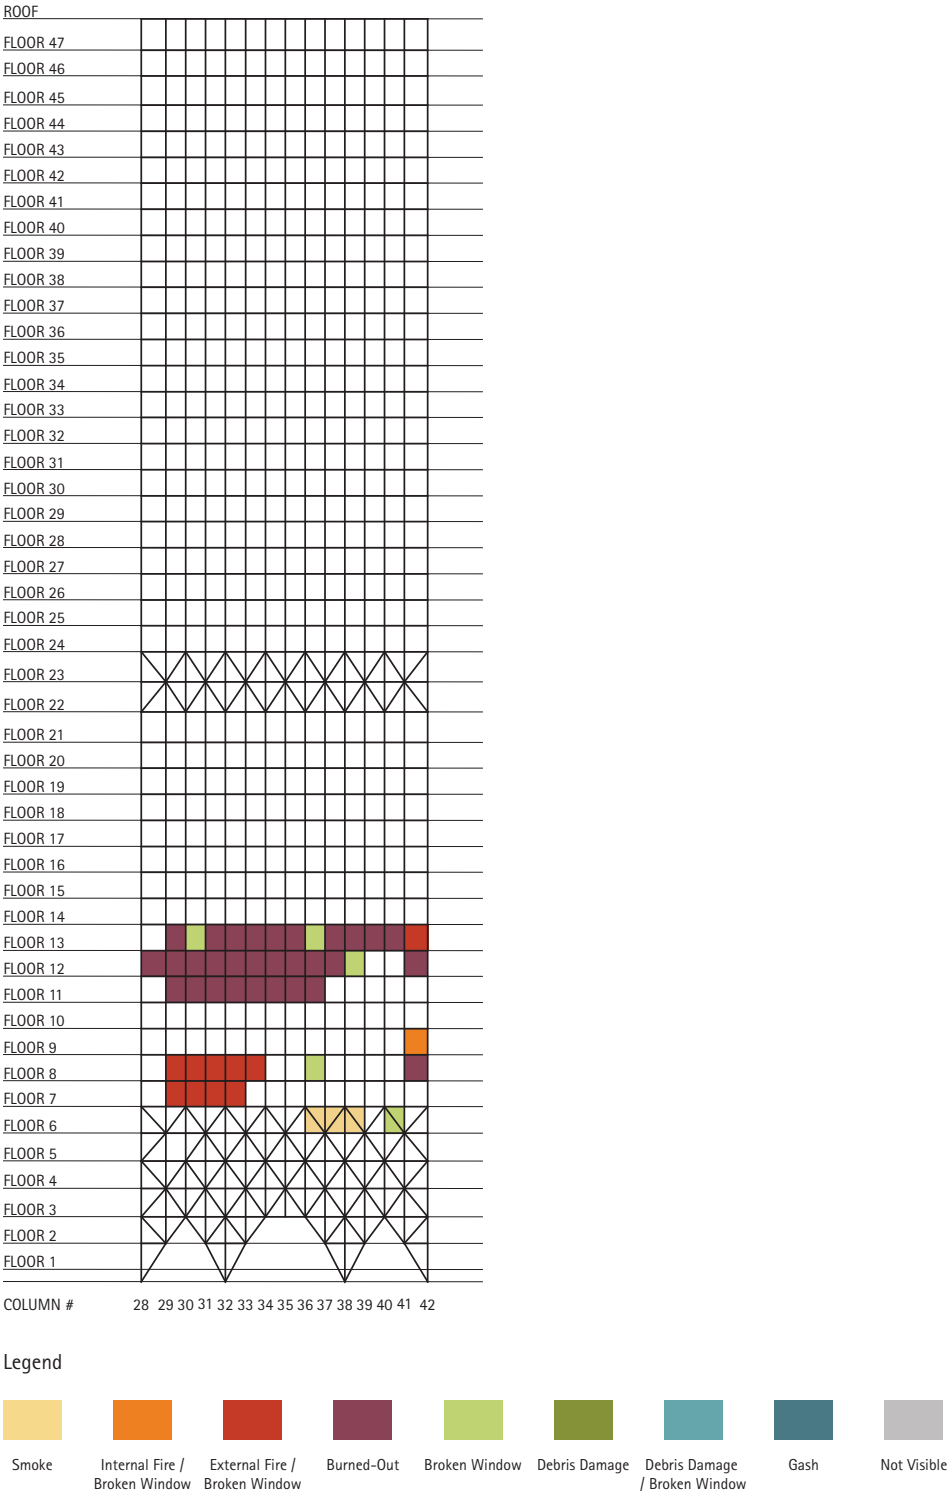
Figures 7.E.01, 7.N.01, 7.W.01, and 7.S.01 on pages 274 to 278 depict the condition of each elevation at the end of this time period as evidenced in the available images. These diagrams are cumulative and contain the fire-related damage timed up until 5:00pm as well as the debris damage from WTC1's collapse. Fire damage types include smoke, broken window with internal fire, broken window with external fire, and burned-out. The fire-related damage on these figures represents a compilation of the last available visual evidence for each area within hour; therefore, these diagrams are only an approximation of what the elevation might have looked like at 5:00pm.

Figure 7.E.01 WTC7 East facade - Debris and Fire Damage at approximately 5PM

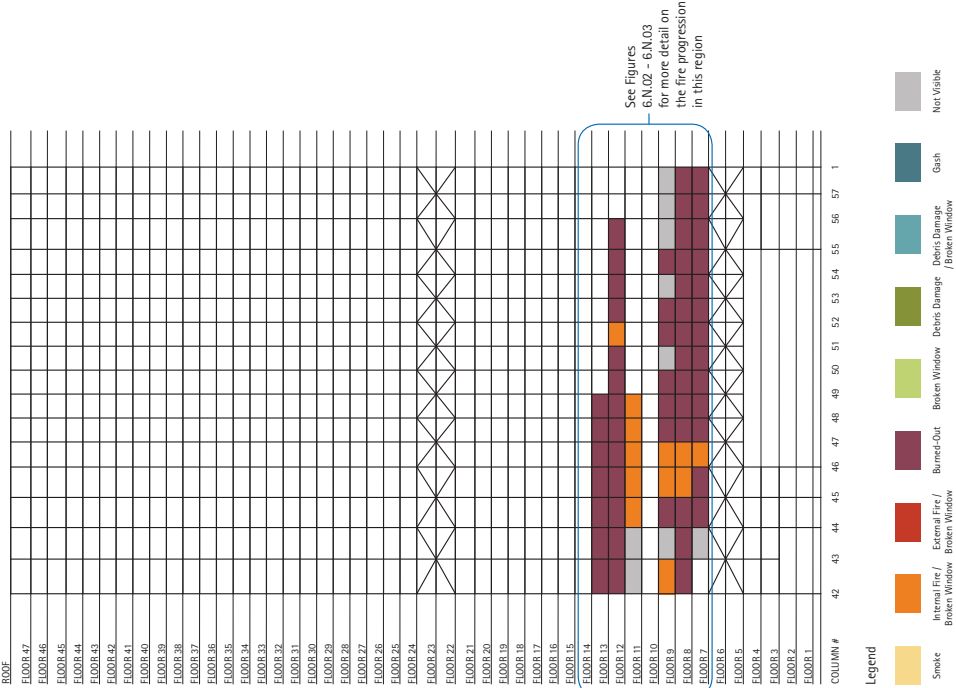
North Facade – The first visual evidence of fire at level 11 on the north facade occurred during the second half of this time period. Level 9 continued to burn for the better portion of the hour. Fires were visible sporadically on levels 7, 8, and 12. There is no visual evidence of fire on level 13 during this time.

Figure 7.N.01 WTC7 North Facade - Debris and Fire Damage at approximately 5PM

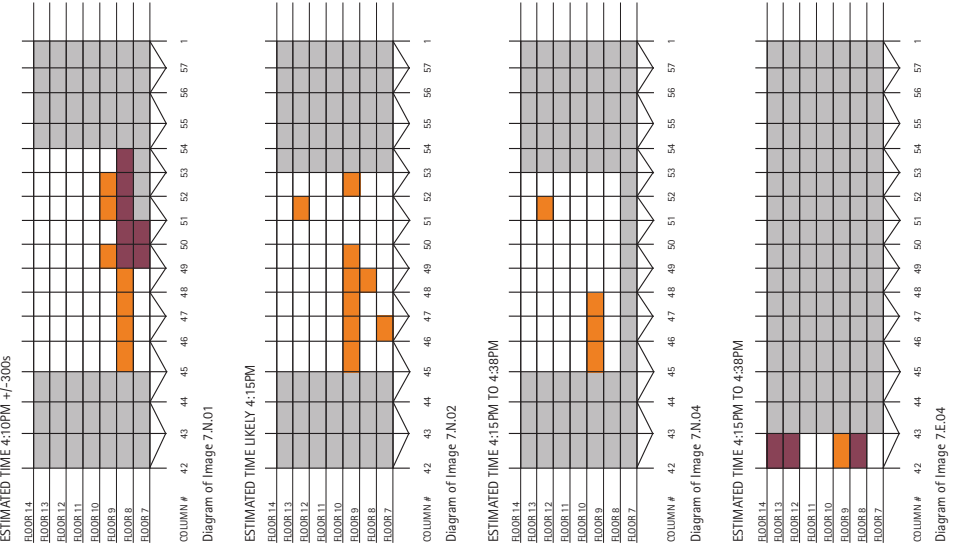
Figures 7.N.02 and 7.N.03 on pages 275 and 276 depicts a series of sequential images showing the progression of fire in a particular area of the north facade during this time increment. While the full elevation diagrams represent the condition of each facade at the end of the time period, the detail elevation mappings illustrate how fire traveled or altered throughout the hour in a specific area. Debris damage has been omitted from these diagrams for clarity.

Figure 7.N.02 WTC7 North Facade - Detailed Fire Progression from 4PM to 5PM

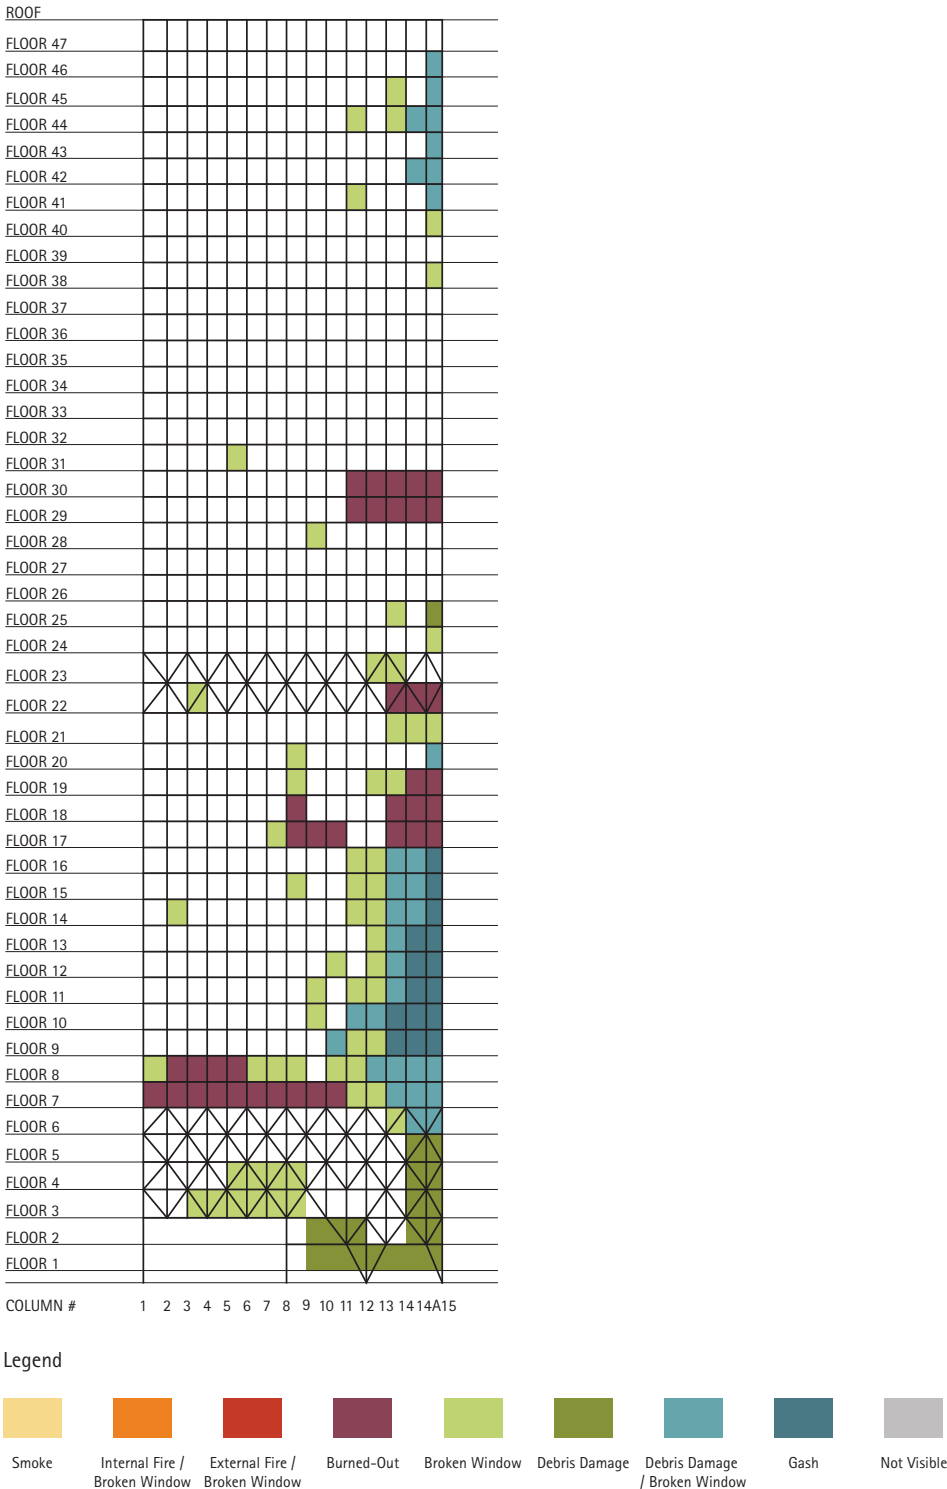
Figure 7.W.01 WTC7 West facade - Debris and Fire Damage at approximately 5PM

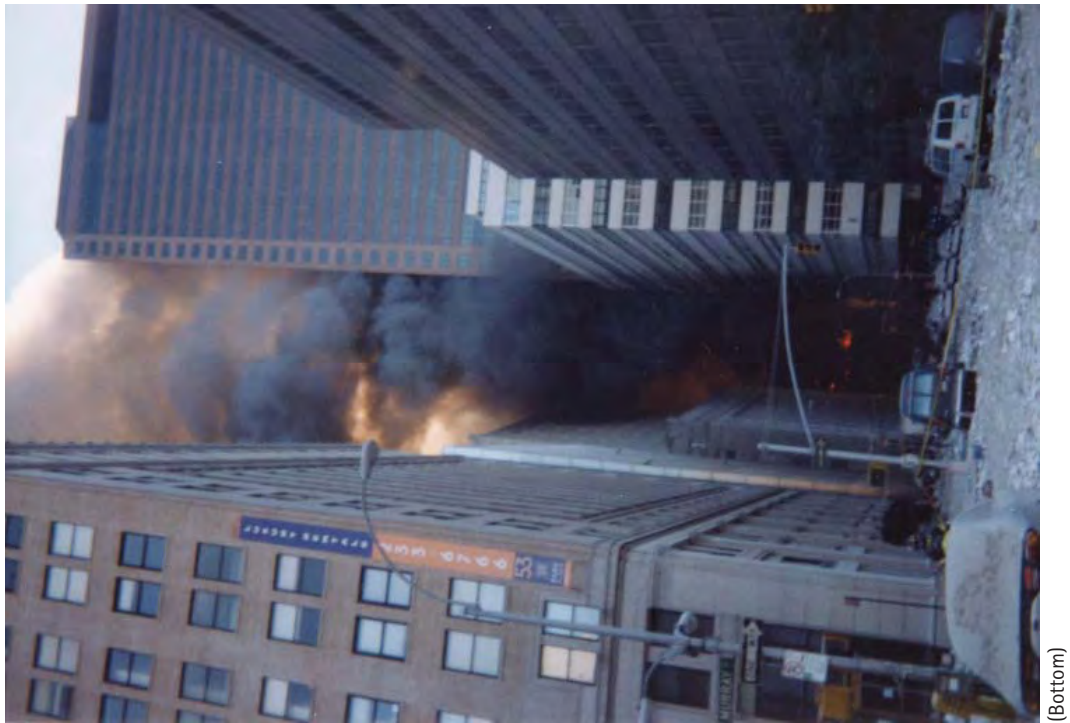
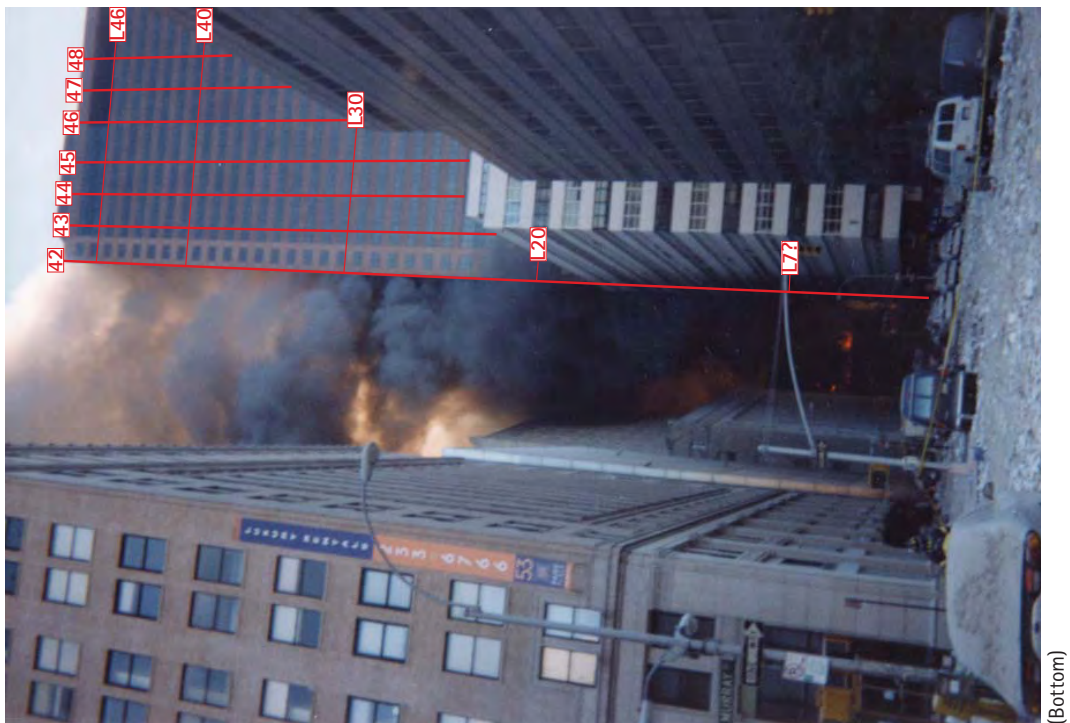
Image 7.E.01 Northeast corner, after 4:00PM

Image 7.E.01 with columns and floor levels overlaid

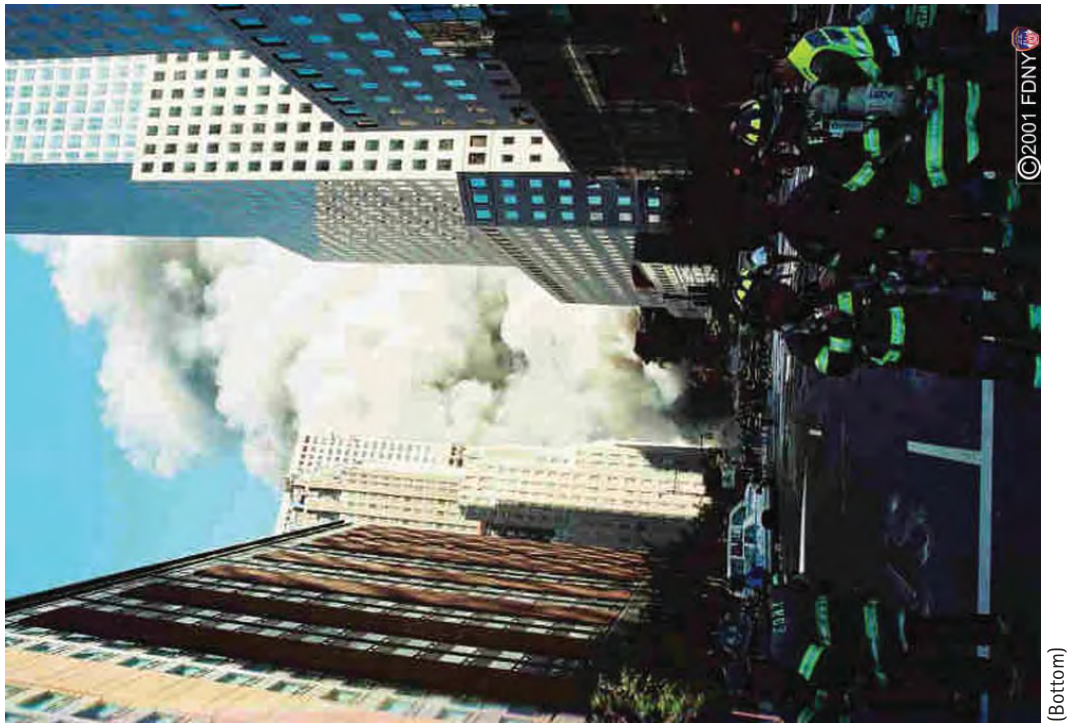
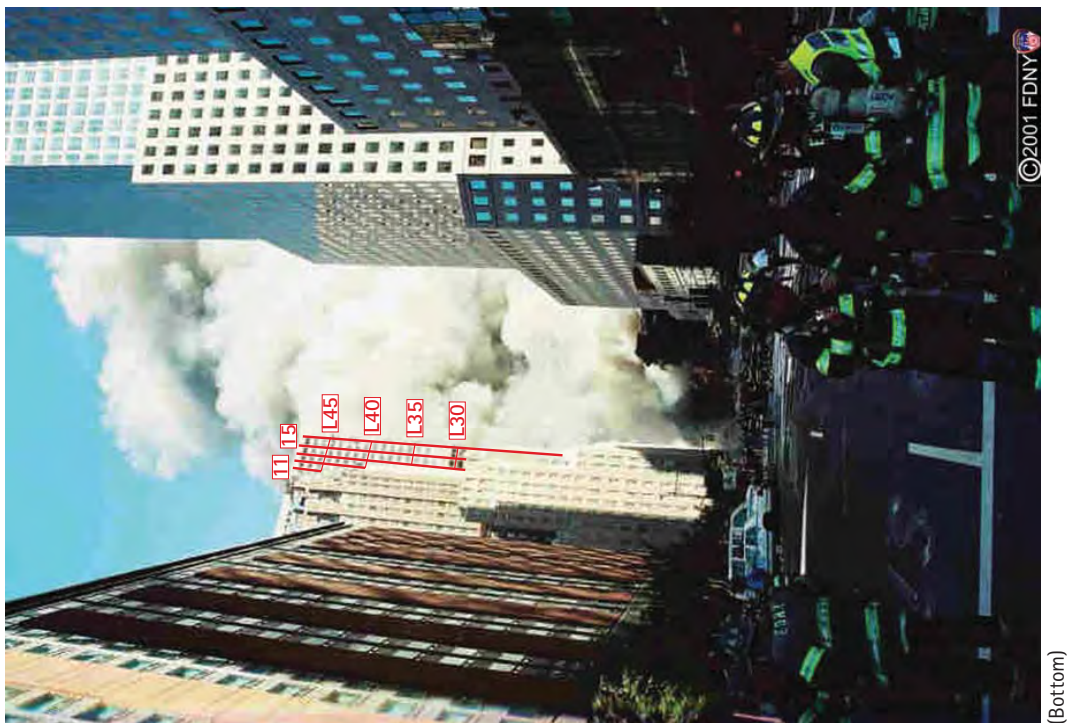
Image 7.W.03 West facade, approximately after 4:00PM

Image 7.W.03 with columns and floor levels overlaid

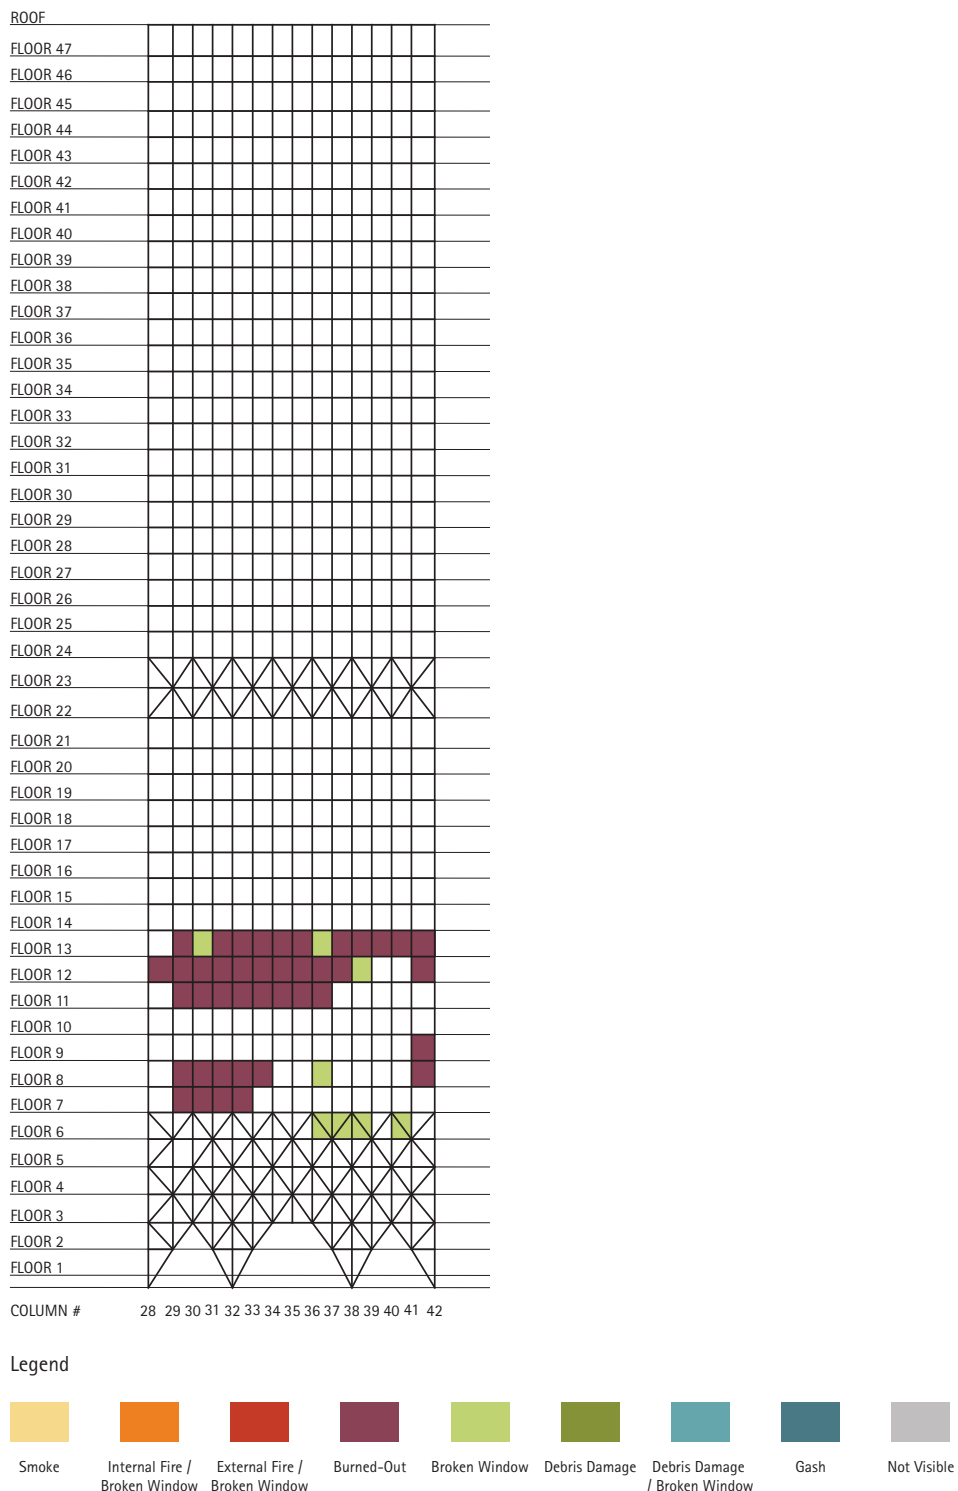
Figures 8.E.01, 8.N.01, 8.W.01, and 8.S.01 on pages 296 to 299 depict the condition of each elevation at the end of this time period as evidenced in the available images. These diagrams are cumulative and contain the fire-related damage timed up until collapse as well as the debris damage from WTC1's collapse. Fire damage types include smoke, broken window with internal fire, broken window with external fire, and burned-out. The fire-related damage on these figures represents a compilation of the last available visual evidence for each area within hour; therefore, these diagrams are only an approximation of what the elevation might have looked like right before the building's collapse.

Figure 8.E.01 WTC7 East facade - Debris and Fire Damage at the approximate time of WTC7 collapse

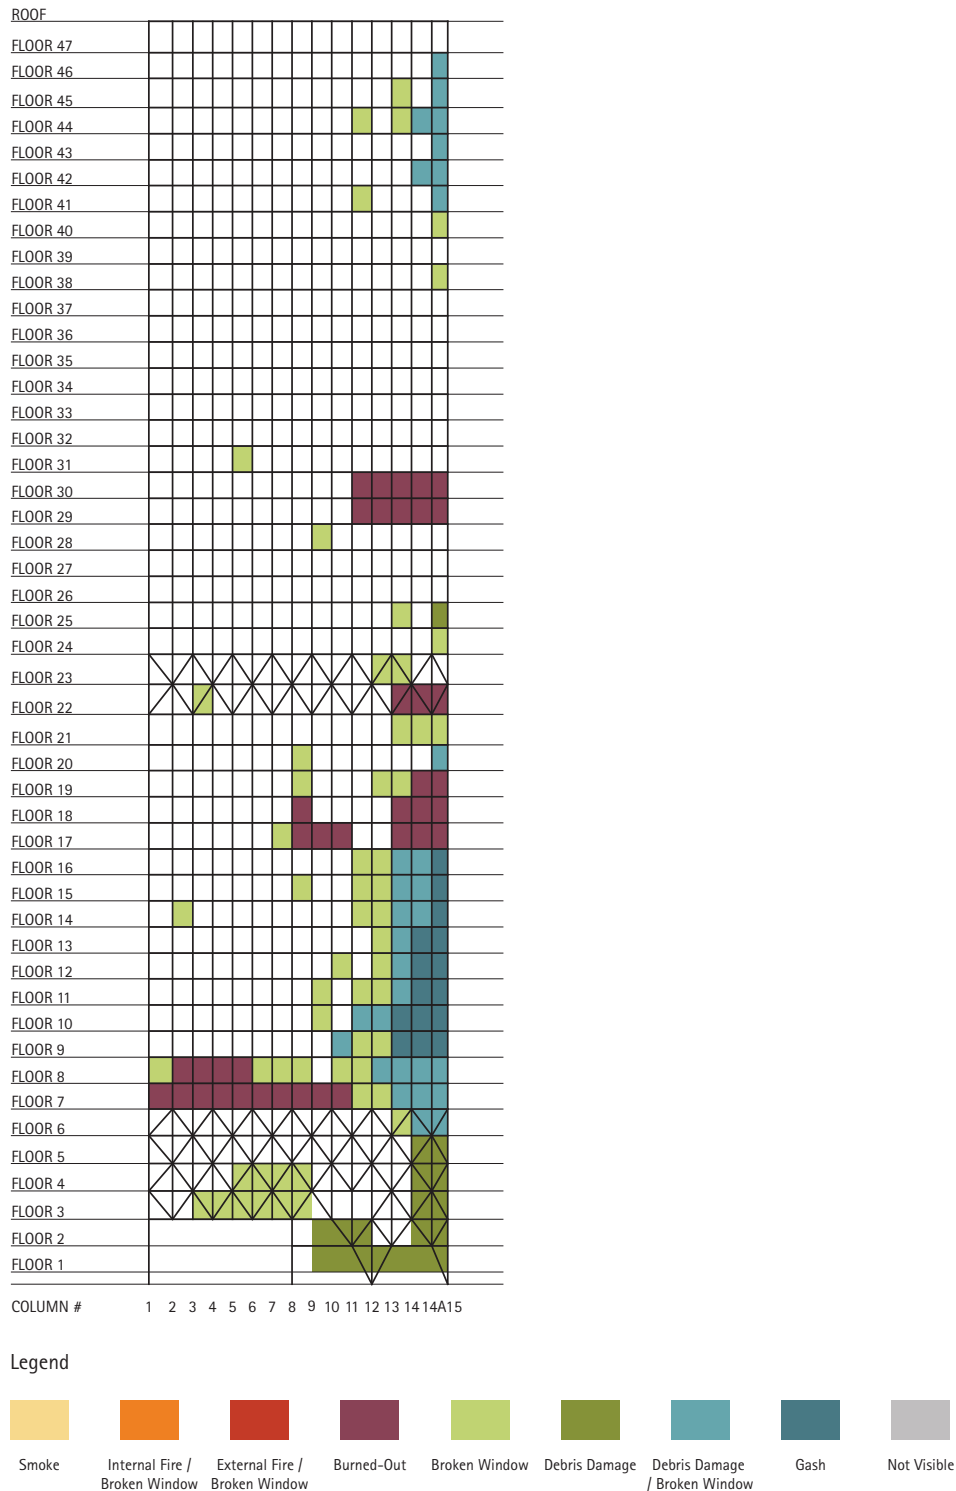
Figure 8.W.01 WTC7 West facade - Debris and Fire Damage at the approximate time of WTC7 collapse

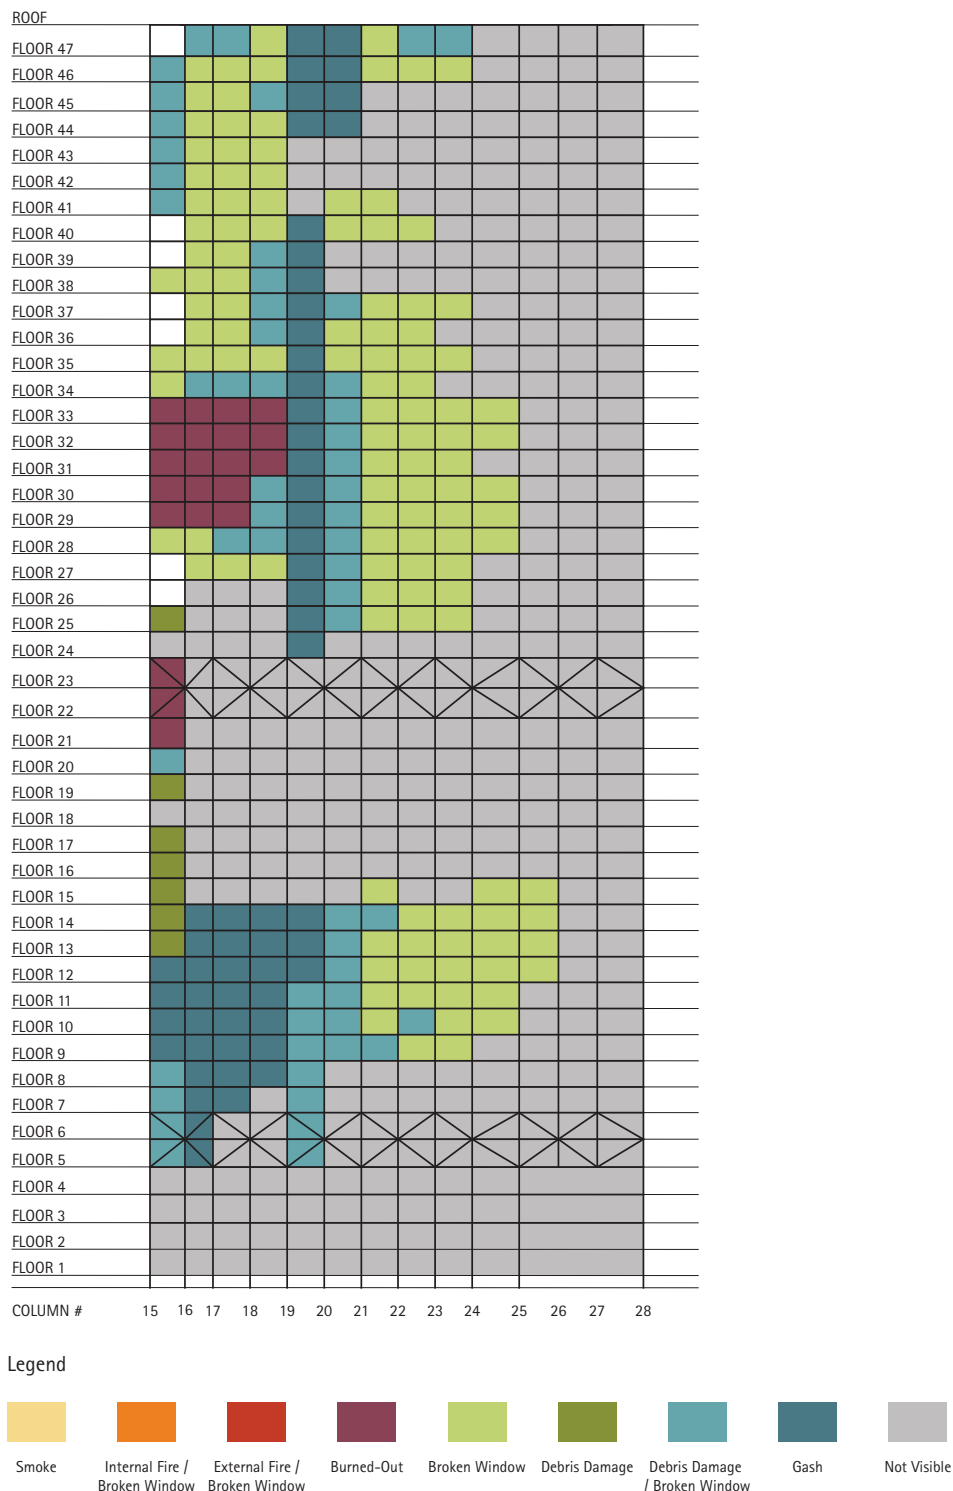
Figure 8.S.01 WTC7 South facade - Debris and Fire Damage at the approximate time of WTC7 collapse

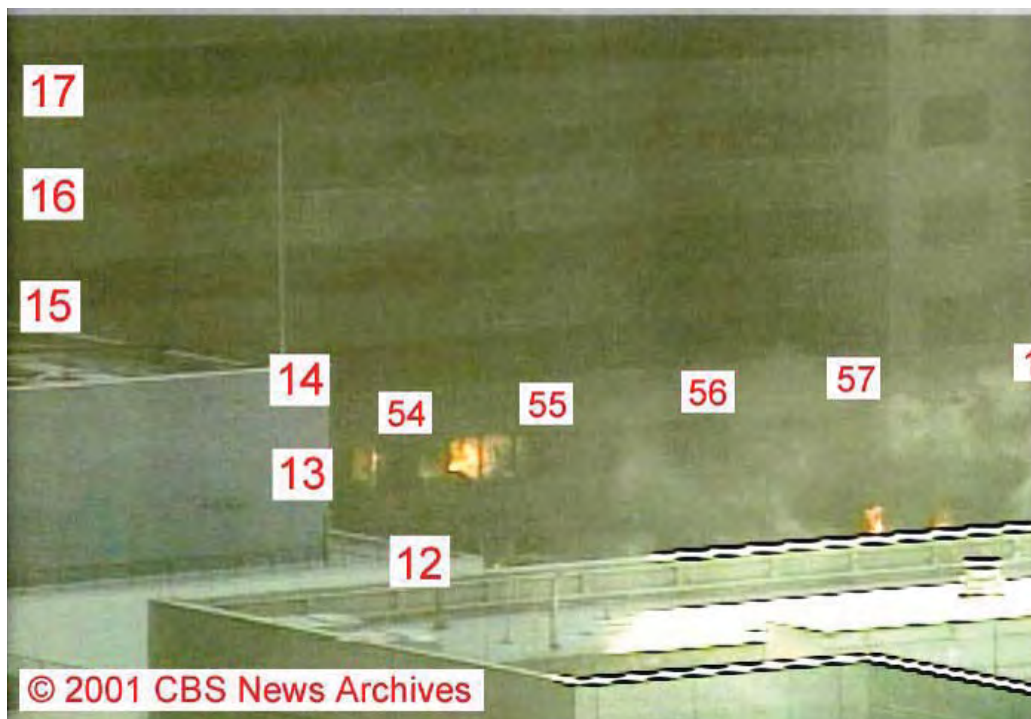
Image 8.N.01 North facade, around 5:00PM +/-600S

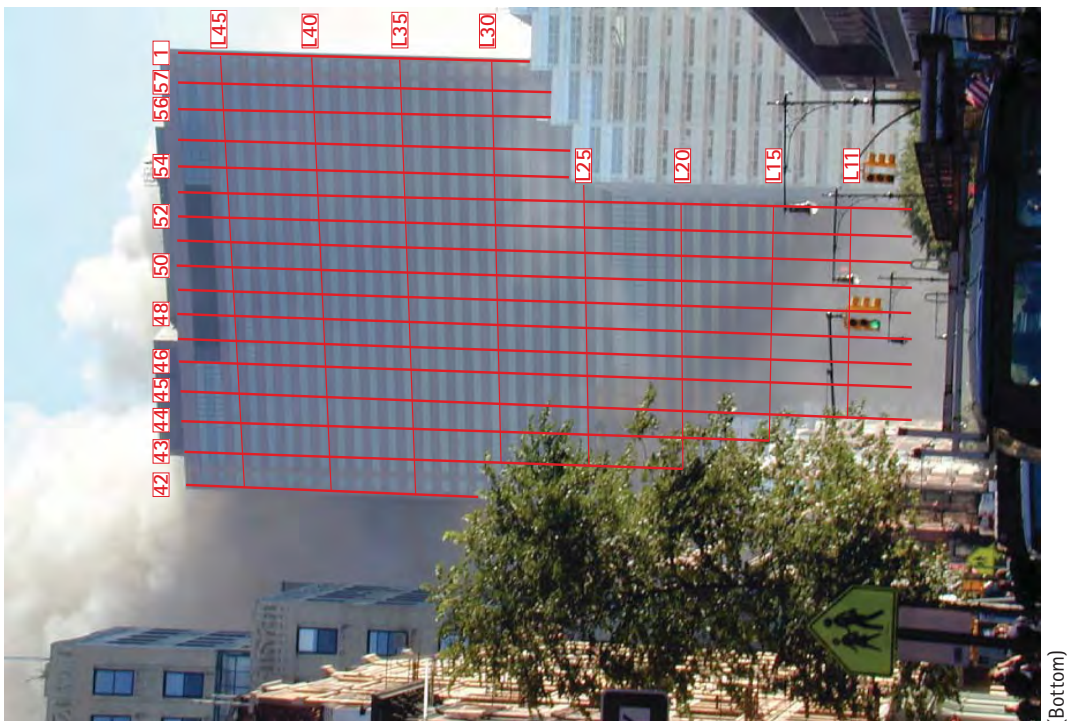
Image 8.N.04 North facade, approximately 5:09PM-5:19PM

Image 8.N.04 with columns and floor levels overlaid

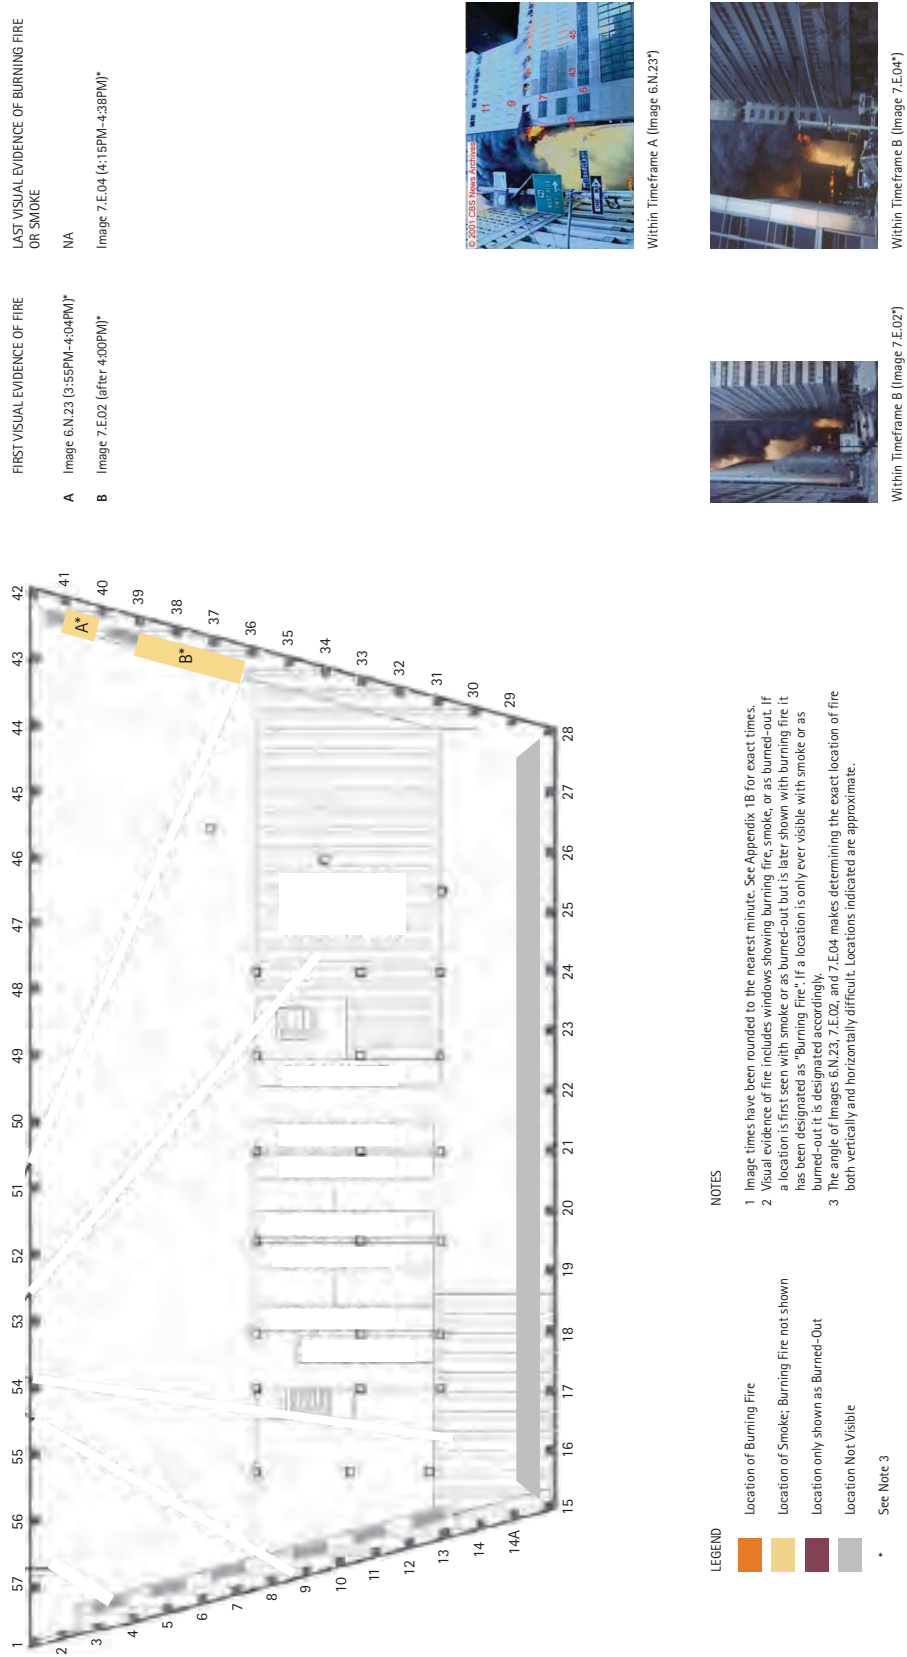
Figure 7.12 WTC7 Level 6 Planometric Fire Progression Diagrams

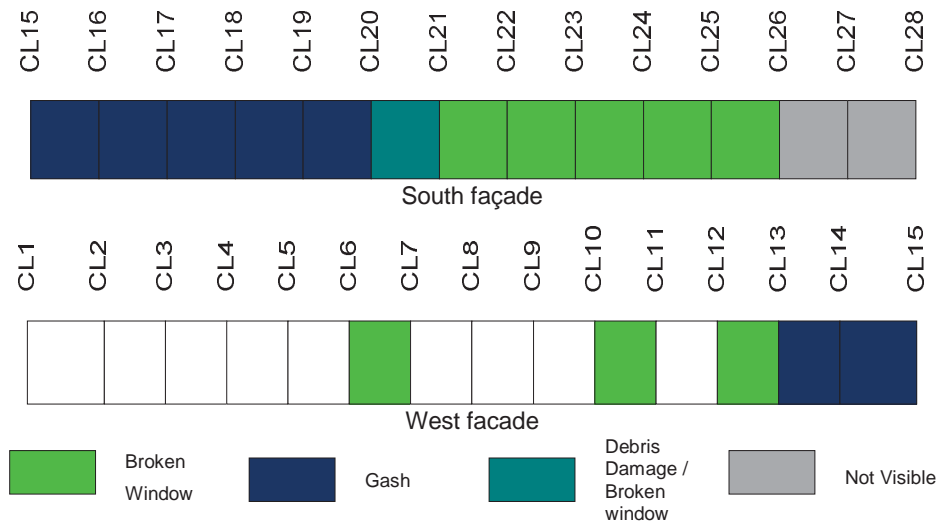
The south and west façades were damaged by the falling debris originating from the collapses of the WTC 1 and 2 Towers. The debris damage was analyzed by Guy Nordenson and Associates (GNA) [2] and are reproduced below in Figure 6.

Figure 6 – South and west façades showing damages due to debris [2]
