11-4403-cv

United States Court of Appeals *for the* Second Circuit

JOINT APPENDIX Volume 14 of 16 (Pages JA-3617 to JA-3886)

Volume A - Photographic Timeline
Photographic Analysis Report
World Trade Center 7 Collapse Investigation
16 December 2009

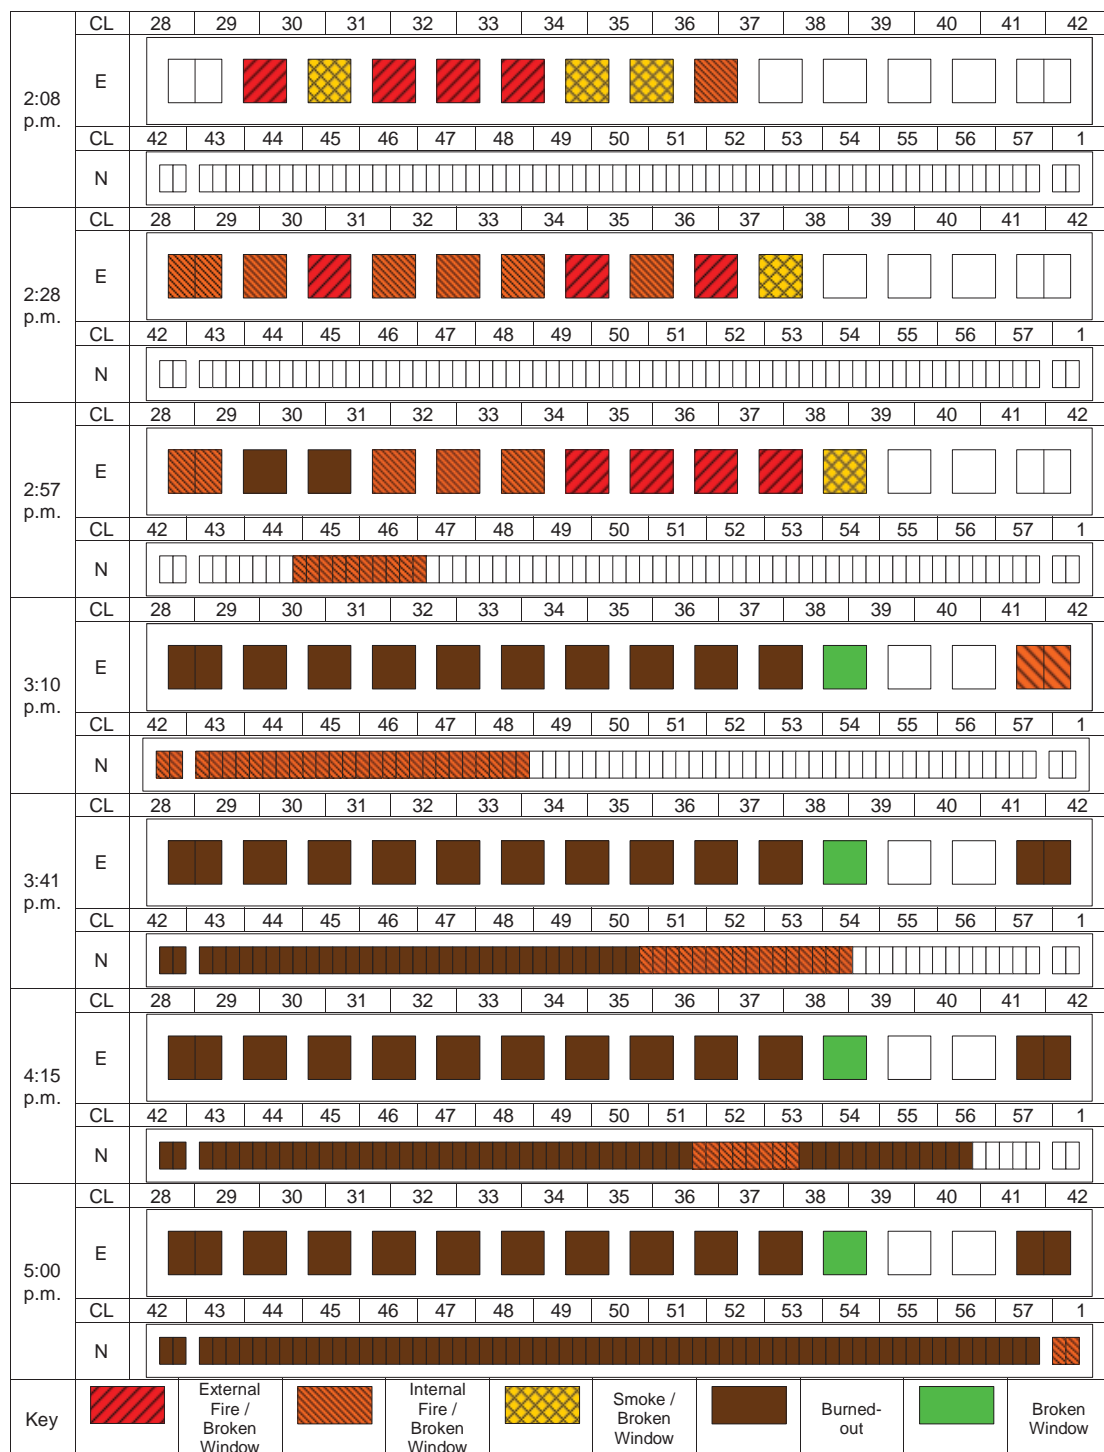
Figure 7 – Visual Evidence along East and North façades from 02:08 p.m. to 05:00 p.m.

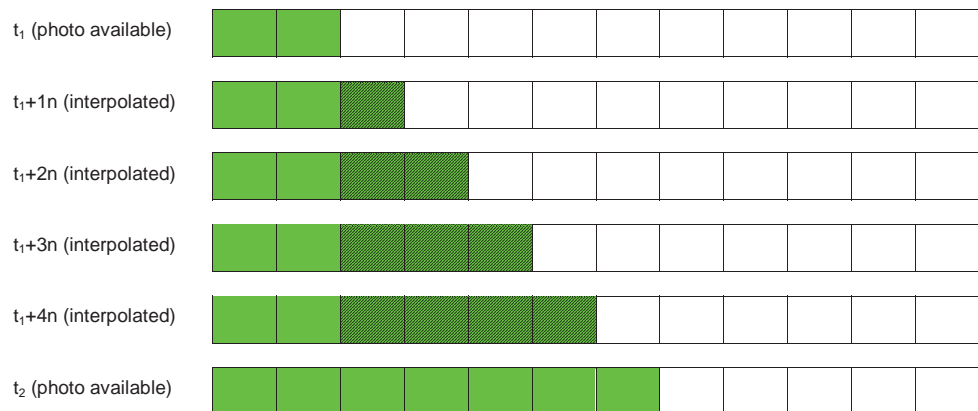
Windows were programmed to “fail” based on the photographic evidence. Thermally induced stresses within the window panes were not predicted. In areas where there were extensive intervals between photographs (e.g., north façade) and extensive changes in the window status, the individual windows were programmed to break at intermediate times estimated via linear interpolation, as illustrated in Figure 9.

Figure 9 – Schematic representation of the interpolation of window failure times; for this example $n = (t_2 - t_1)/5$.

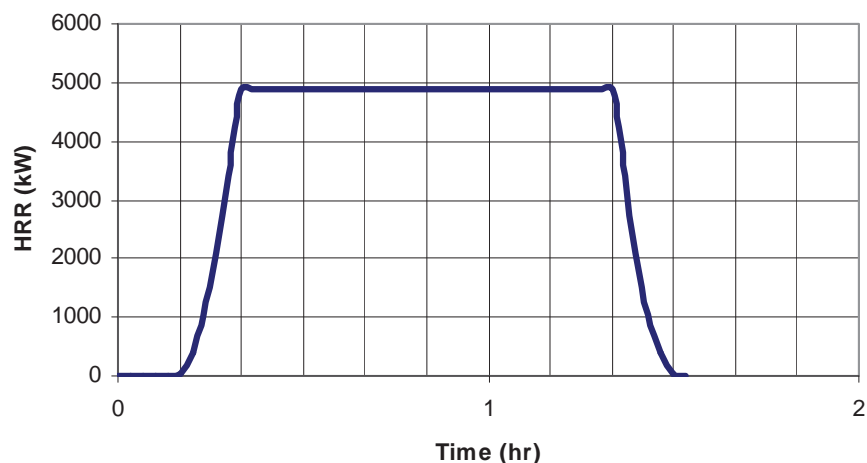
The growth rate and the peak heat release were largely determined to be consistent with a modular office occupancy. For modular offices, a heat release rate density of 270 kW/m² [4] and a nominal medium t-squared fire growth have been observed in experiments [4]. The duration of burning at the peak heat release rate was extended to be consistent with the burning duration of two nominal office spaces. This was done to assure that the fire had spread sufficiently to adjacent spaces prior to removing the dedicated heat source. As the time period of principal interest begins more than three hours subsequent to the end of the initiating fire period as defined, any bias introduced by the assumed initiating fire should be minimal.

Figure 10 – Heat release rate history of the assumed initiating fire

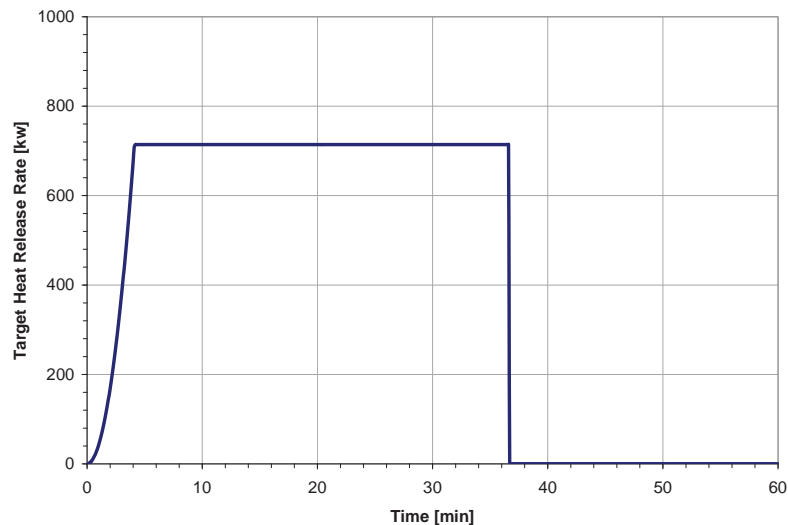
based on the desired overall heat release rate density for the office floor. The heat release rate history for an individual “target” is shown in Figure 11. The burning duration of each individual target is a function of the specified heat release rate per unit area and the specified fuel load. On average, the burning duration within modular type offices is expected to be on the order of 30 to 40 minutes. The assumed fuel load and burning parameters (550 MJ/m² and 270 kW/m², respectively) are consistent with these expectations.

Figure 11 – Idealized heat release rate history of individual “target”

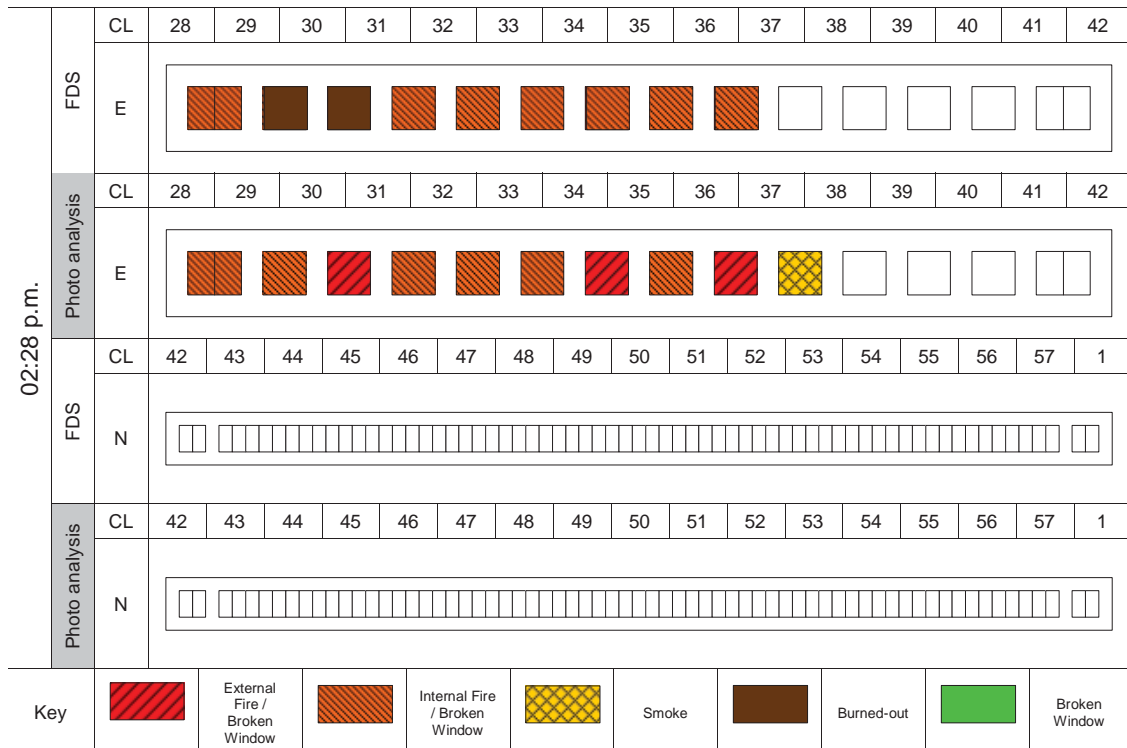
Figure 13 – Visual evidence along east and north façades at 02:28 p.m.

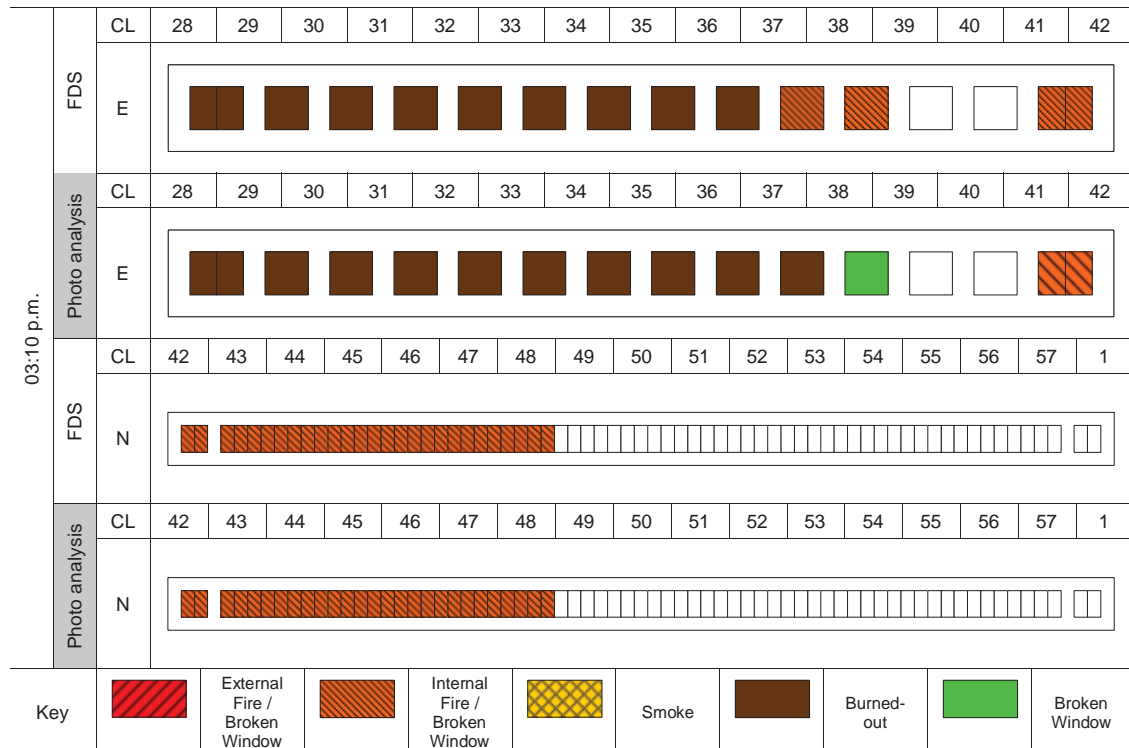
Figure 15 – Visual evidence along east and north façades at 03:10 p.m.

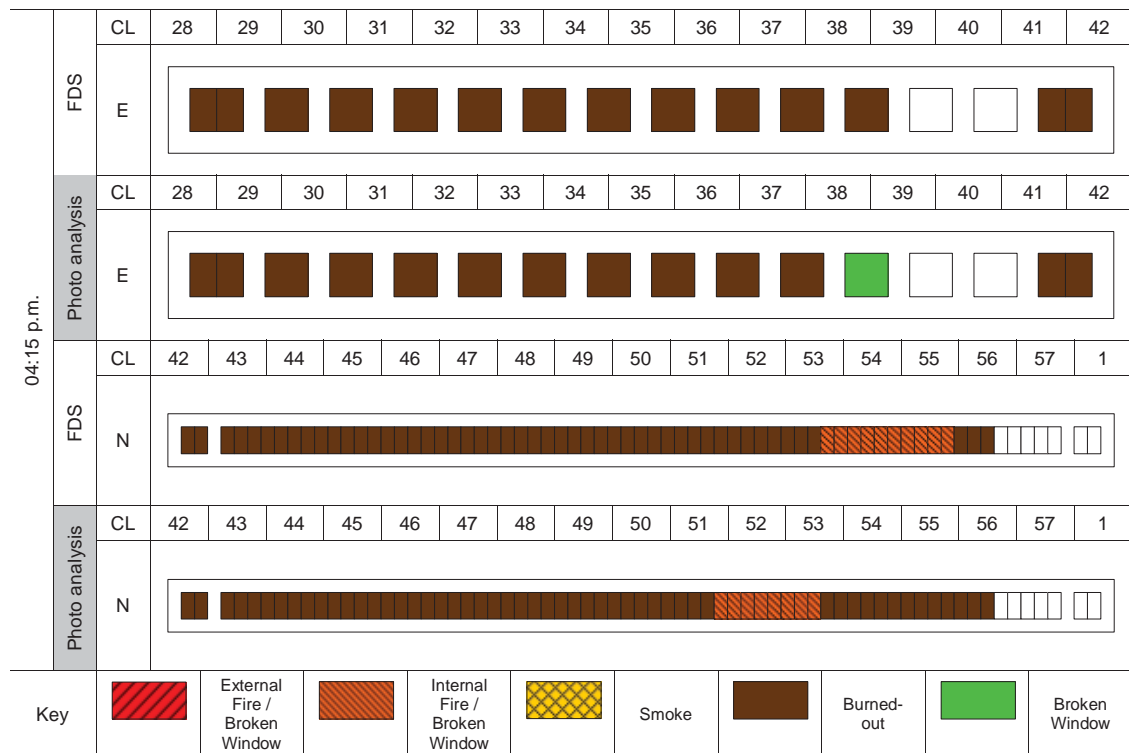
Figure 17 – Visual evidence along east and north façades at 04:15 p.m.

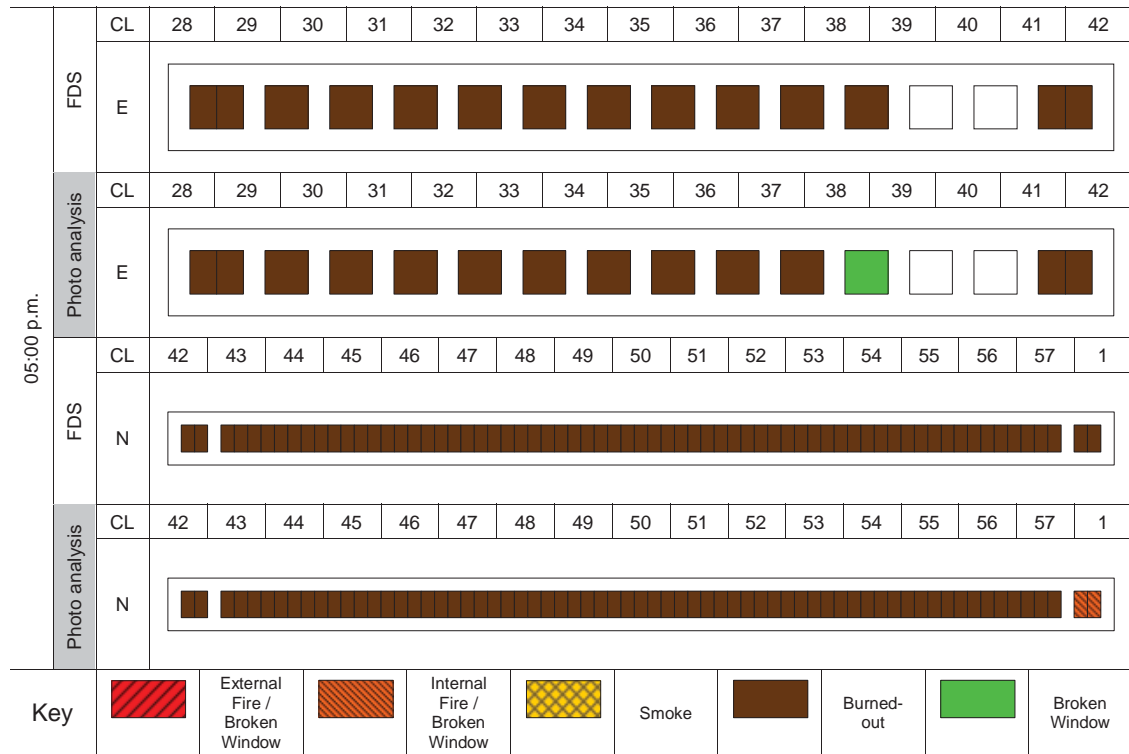
Figure 18 – Visual evidence along east and north façades at 05:00 p.m.

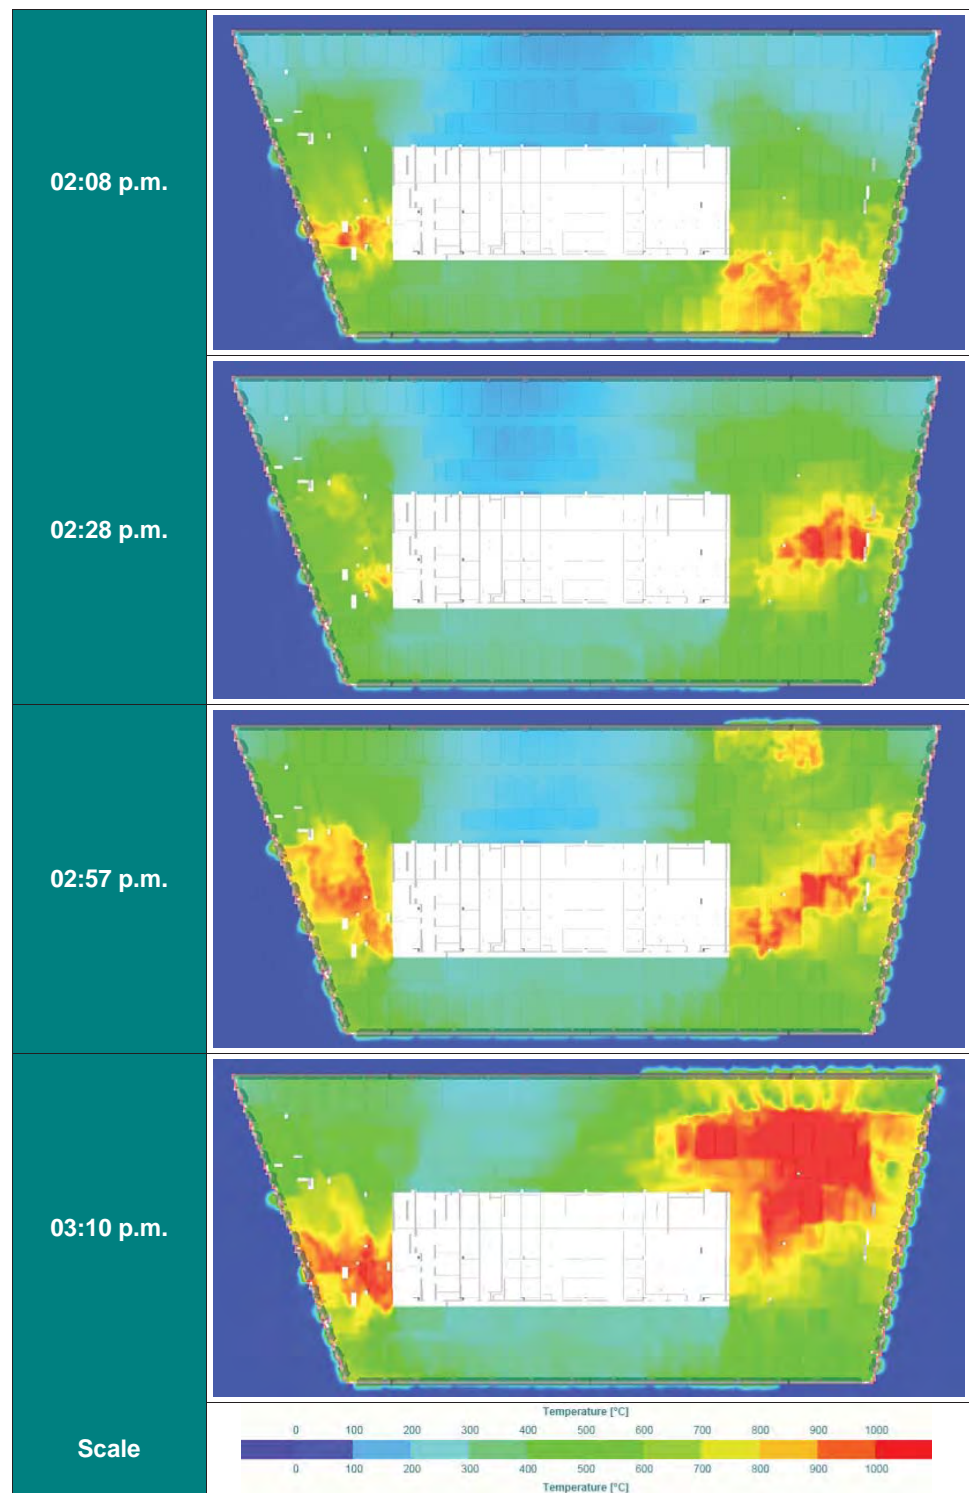
The FDS predictions indicate that a fire starting from the southwest corner reached the southeast area of the building around 2:00 p.m. Subsequently, the fires traveled counterclockwise from the southeast corner to the northwest, which is consistent with the visual observations. Gas temperatures of more than 1000 °C were shown in localized areas where the fire would be considered fully-developed.

Figure 19 – Temperature contour near ceiling from 2:08 p.m. to 3:10 p.m.(2.6 m above Floor)

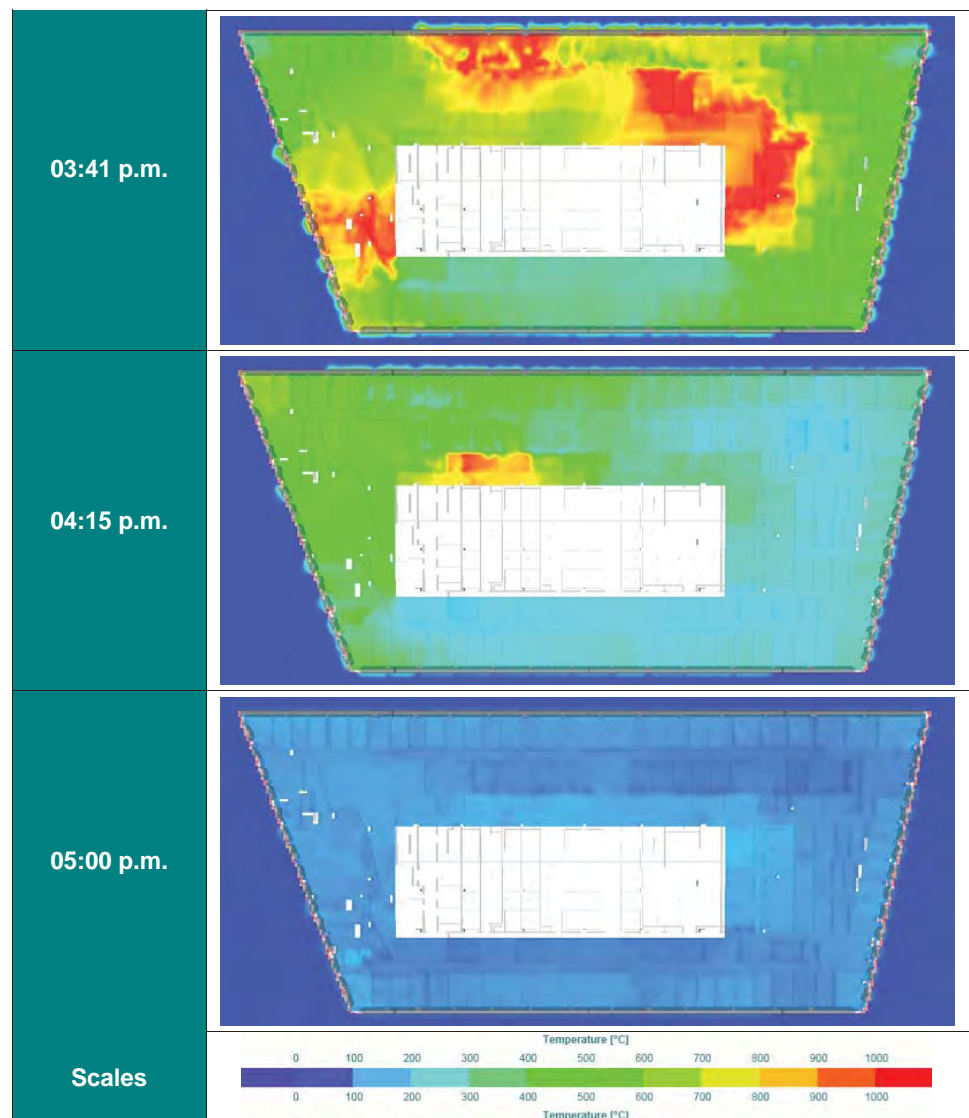
Figure 20 – Temperature contour near ceiling from 3:41 p.m. to 5:00 p.m. (2.6 m above floor)

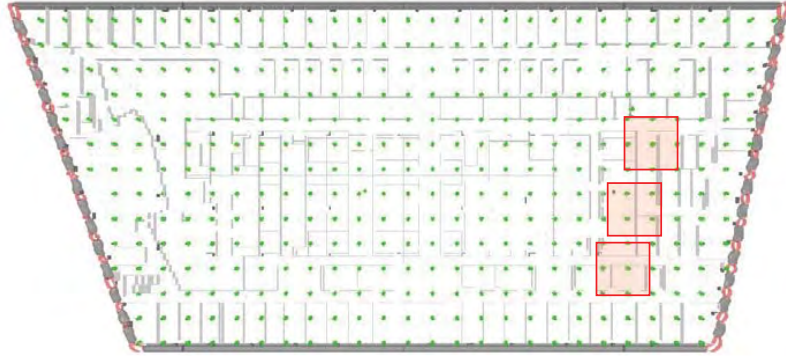
averaged to estimate the exposure conditions for the structure. The results presented here show the average of the measurements at each elevation as well as the overall spatial average (see Figure 24). More comprehensive results are provided in Appendix C.

Figure 21 – Plan view showing the distribution of monitoring points (green dots) throughout the 12th Floor model domain – the regions around Columns 79, 80, and 81 have been highlighted in red

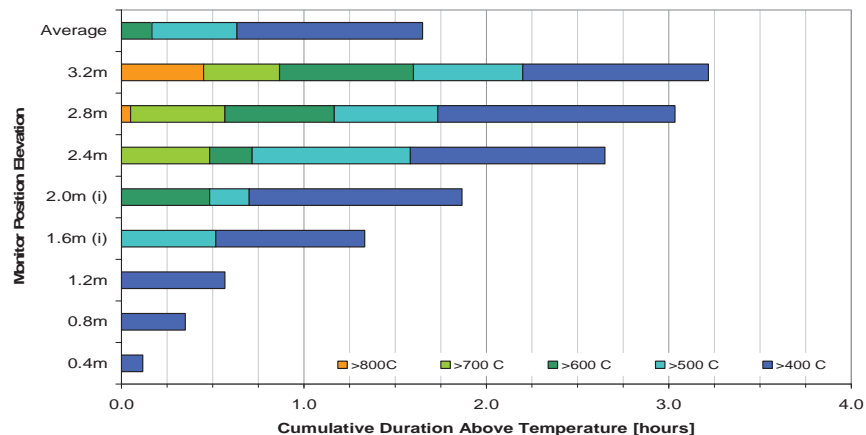
The spatially averaged time temperature profiles at each elevation were evaluated to determine the duration of exposure at certain temperature thresholds. The results are depicted in Figure 25; tabulated results can be found in Appendix C. The uppermost monitoring stations registered an average temperature in excess of 400 °C for approximately 3.25 hours; of that time temperatures were in excess of 600 °C for over 1.5 hours and over 800 °C for just under 0.5 hours.

Figure 25 – Cumulative duration at or above designated temperature thresholds

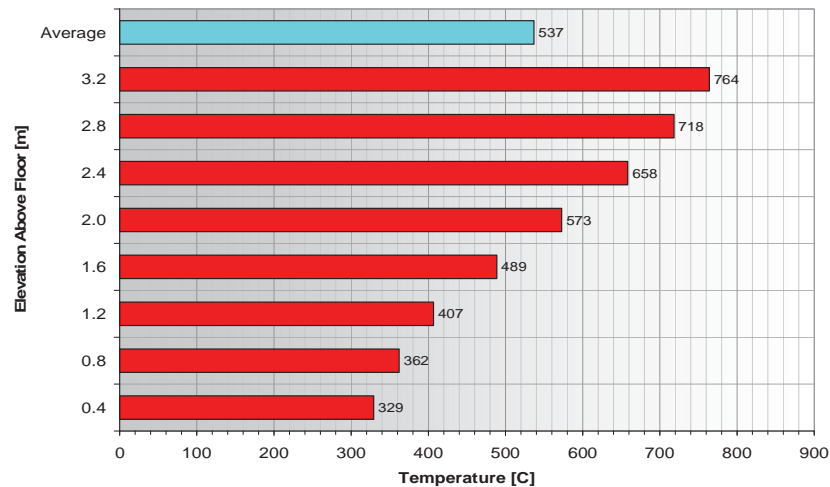
The structural analysis focused on heating periods of approximately 1-hour; therefore, 1-hour rolling averages have been taken of the temperatures measured at each monitor elevation. The maximum 1-hour average for the entire volume is 537 °C; the maximum 1-hour average exposure for the temperature monitoring station nearest the ceiling has been found to be in excess of 750 °C.

Figure 26 – Peak 1-hour rolling average at each monitoring elevation

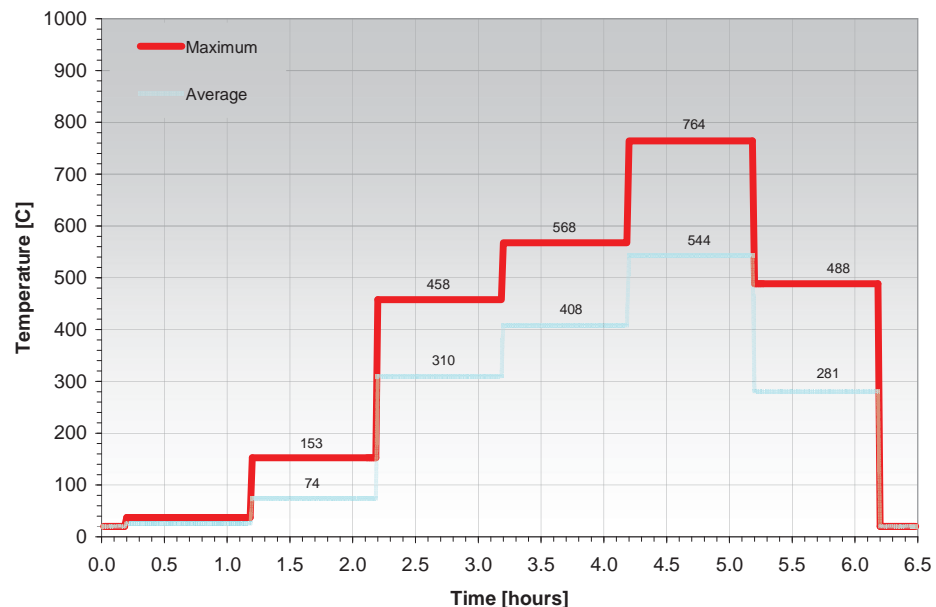
The current section evaluates the CFD modeling results to derive an idealized representation of the temperatures to which the structure may have been exposed. The time temperature histories have been divided into one-hour segments.

Figure 27 – Idealized 1-hour duration exposure conditions

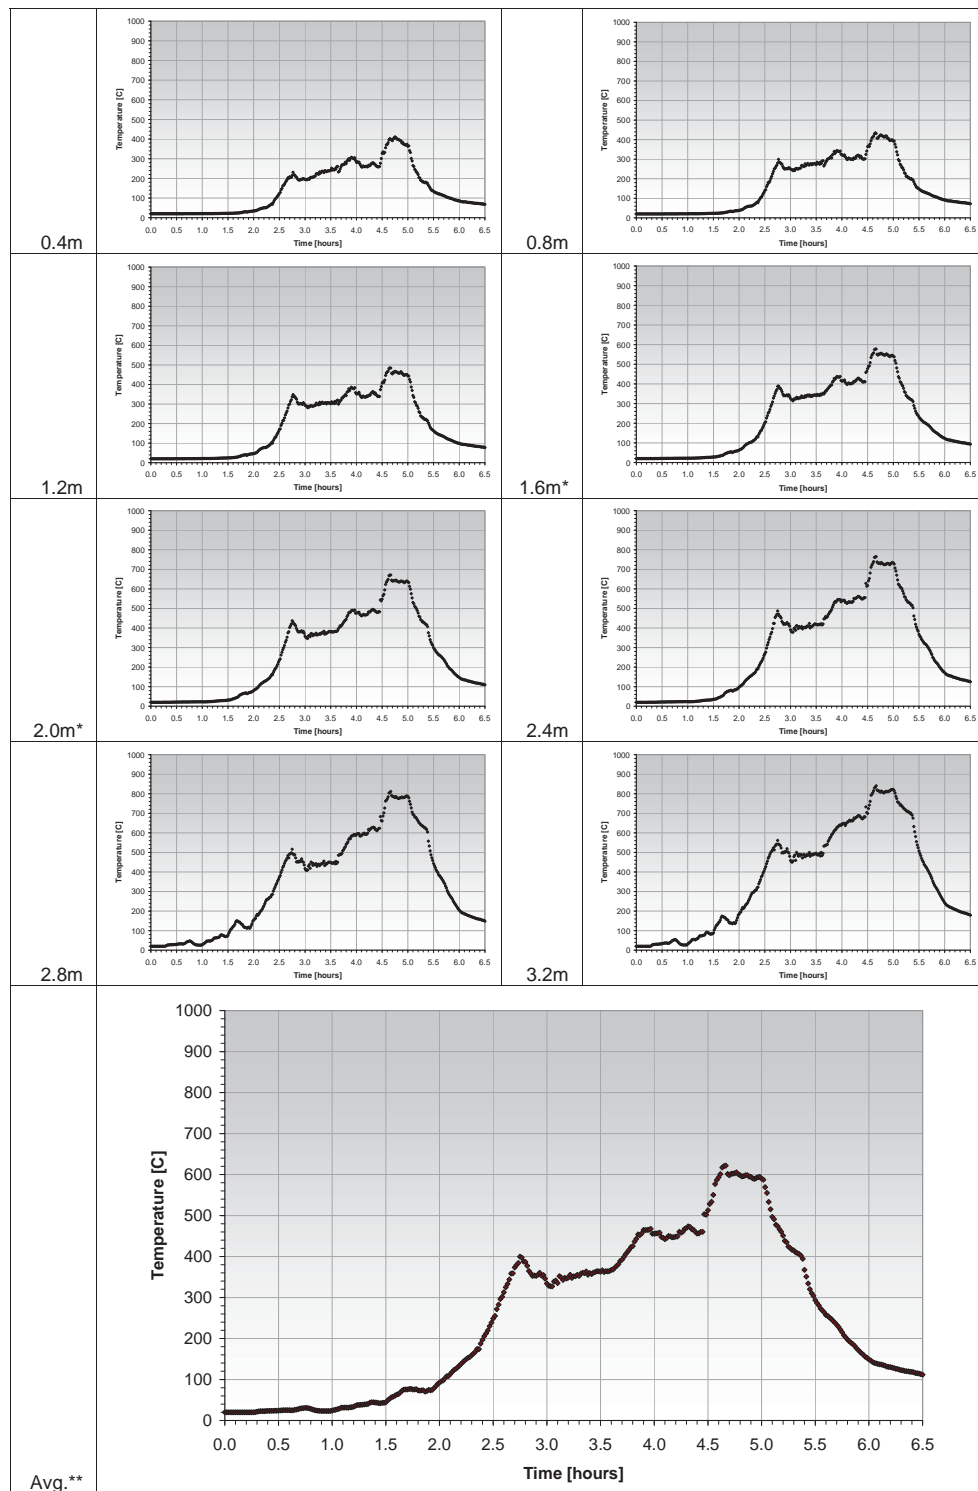
Figure C4 – Time temperature curves for average of each of the monitoring position elevations east of the building core

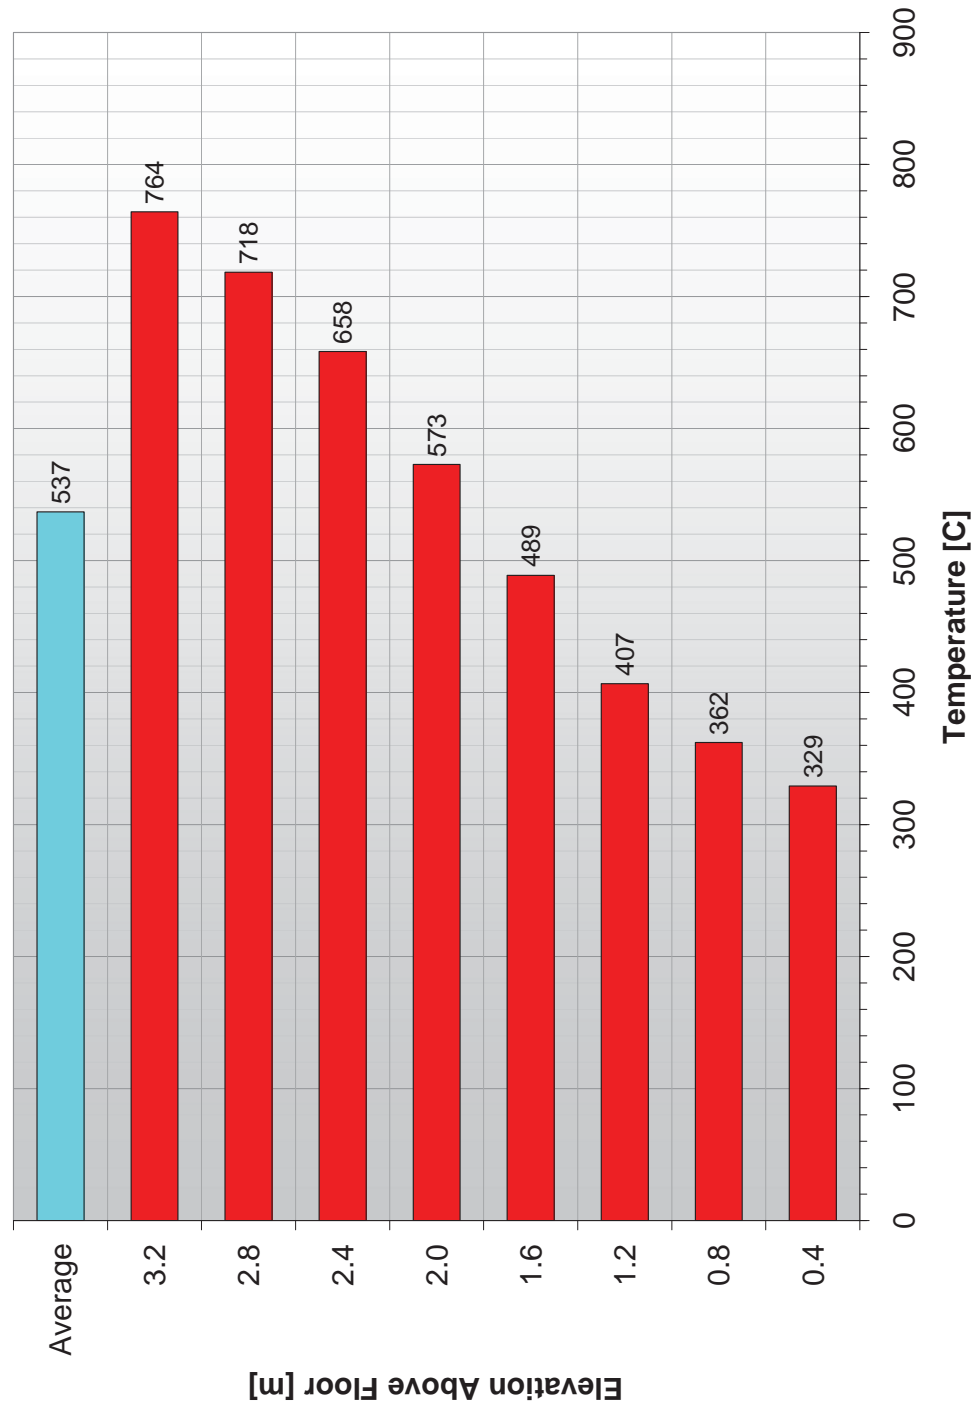
Figure C5 – Peak 1-hour rolling average at each monitoring elevation

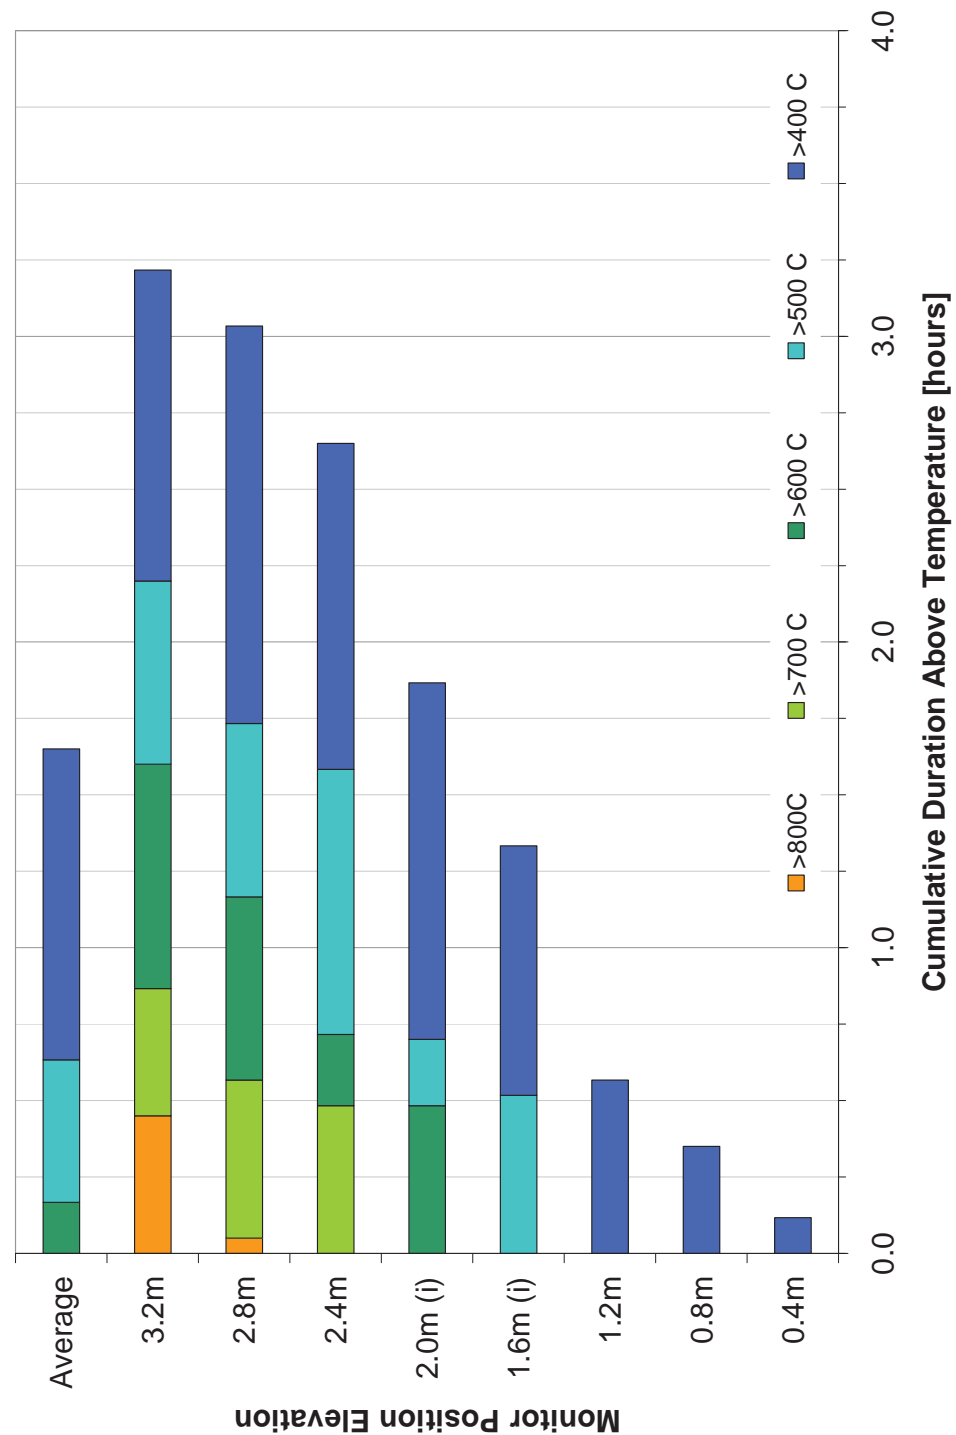
Figure C6 – Cumulative duration above designated temperature thresholds

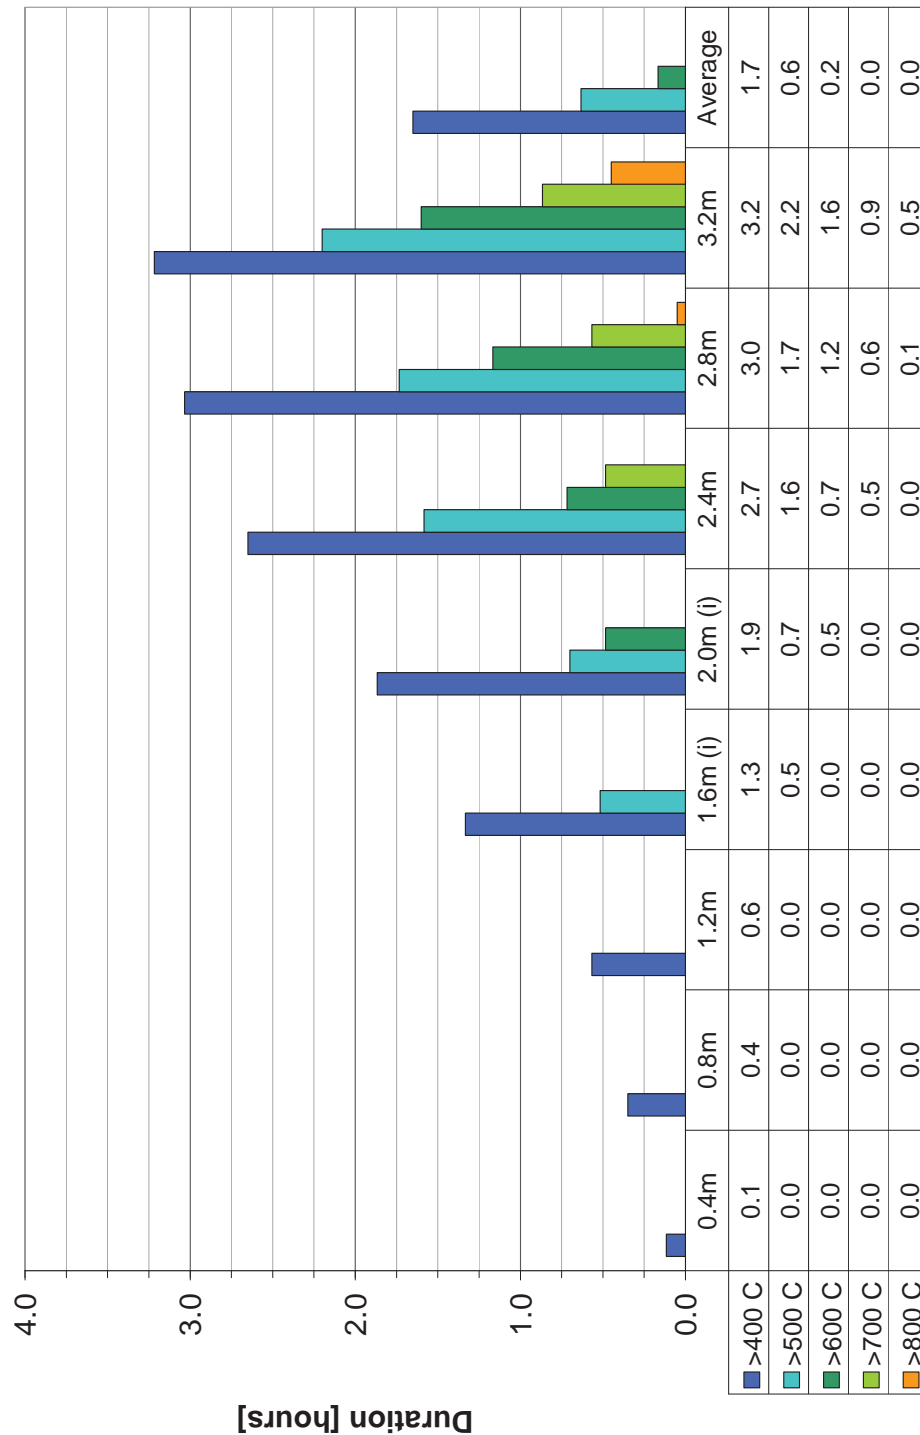
Figure C7 – Duration at or above each designated temperature threshold

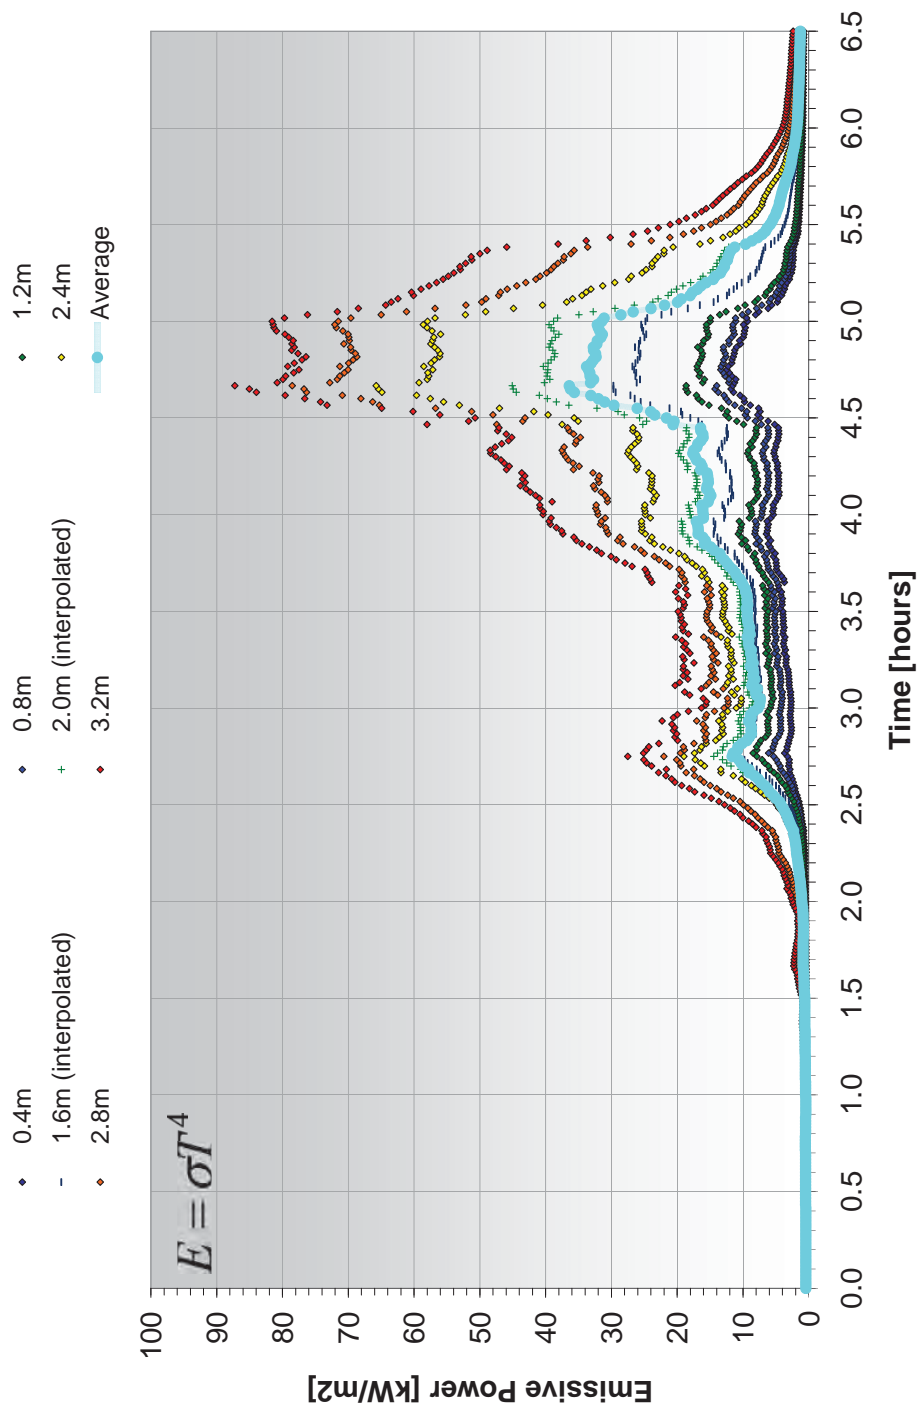
Figure C7 – Equivalent emissive power to measured gas temperature, scaled according to the expression $E = \sigma T^4$.

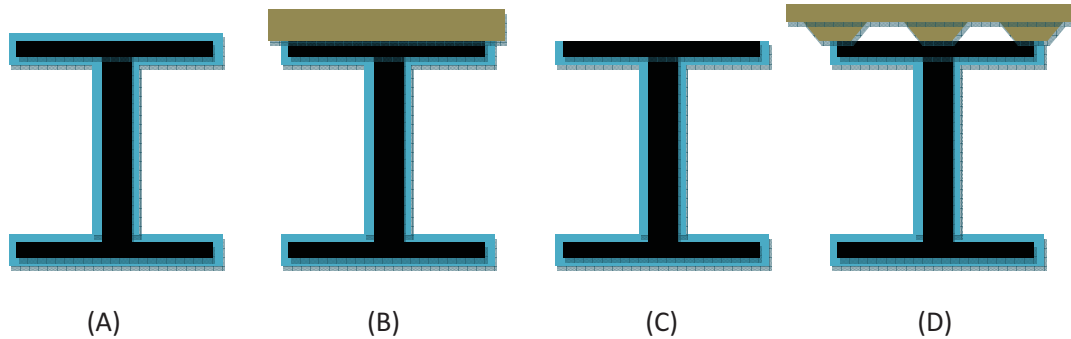
Case A is representative of a column or truss element that is insulated on all four sides and exposed to fire conditions on all four sides. Case B is representative of a beam or girder element with complete contact between the top flange of the element and a concrete floor slab. Case C is representative of a beam or girder element with the top surface of the top flange fully exposed to fire exposure conditions. Case D is representative of a beam or girder element supporting a fluted deck with unfilled cavities; in this case, the contact area between the concrete slab and the top flange covers approximately 35% of the top flange and the unfilled cavity covers approximately 65% of the top flange of the steel element.

Figure D-1. Schematic diagram of boundary conditions used for heat transfer analyses.

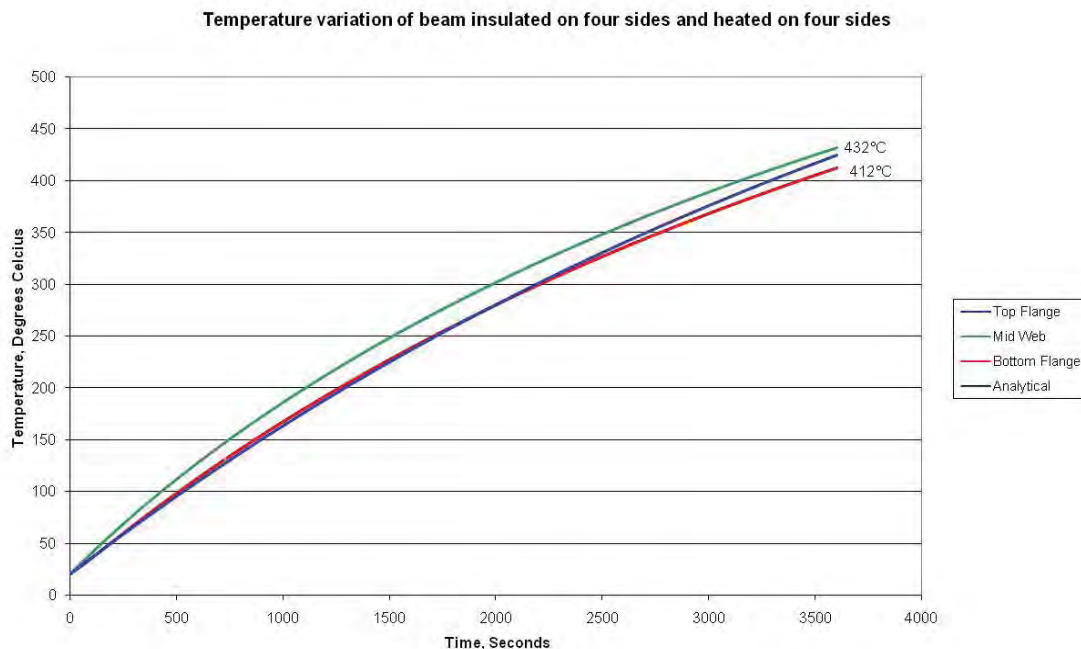
Figure D-2 shows a comparison between the average steel temperature calculated using Equation D-1 and the flange and web temperatures calculated with the ABAQUS 2-D model for a Case (A) scenario. This comparison shows that the temperatures calculated in the ABAQUS 2-D model are relatively uniform and similar to the temperatures calculated using Equation D-1. Based on these results, Equation D-1 was used to calculate the Case (A) results for all the steel elements.

Figure D-2. Comparison between ABAQUS 2D Model and analytical formulation for Case (A).

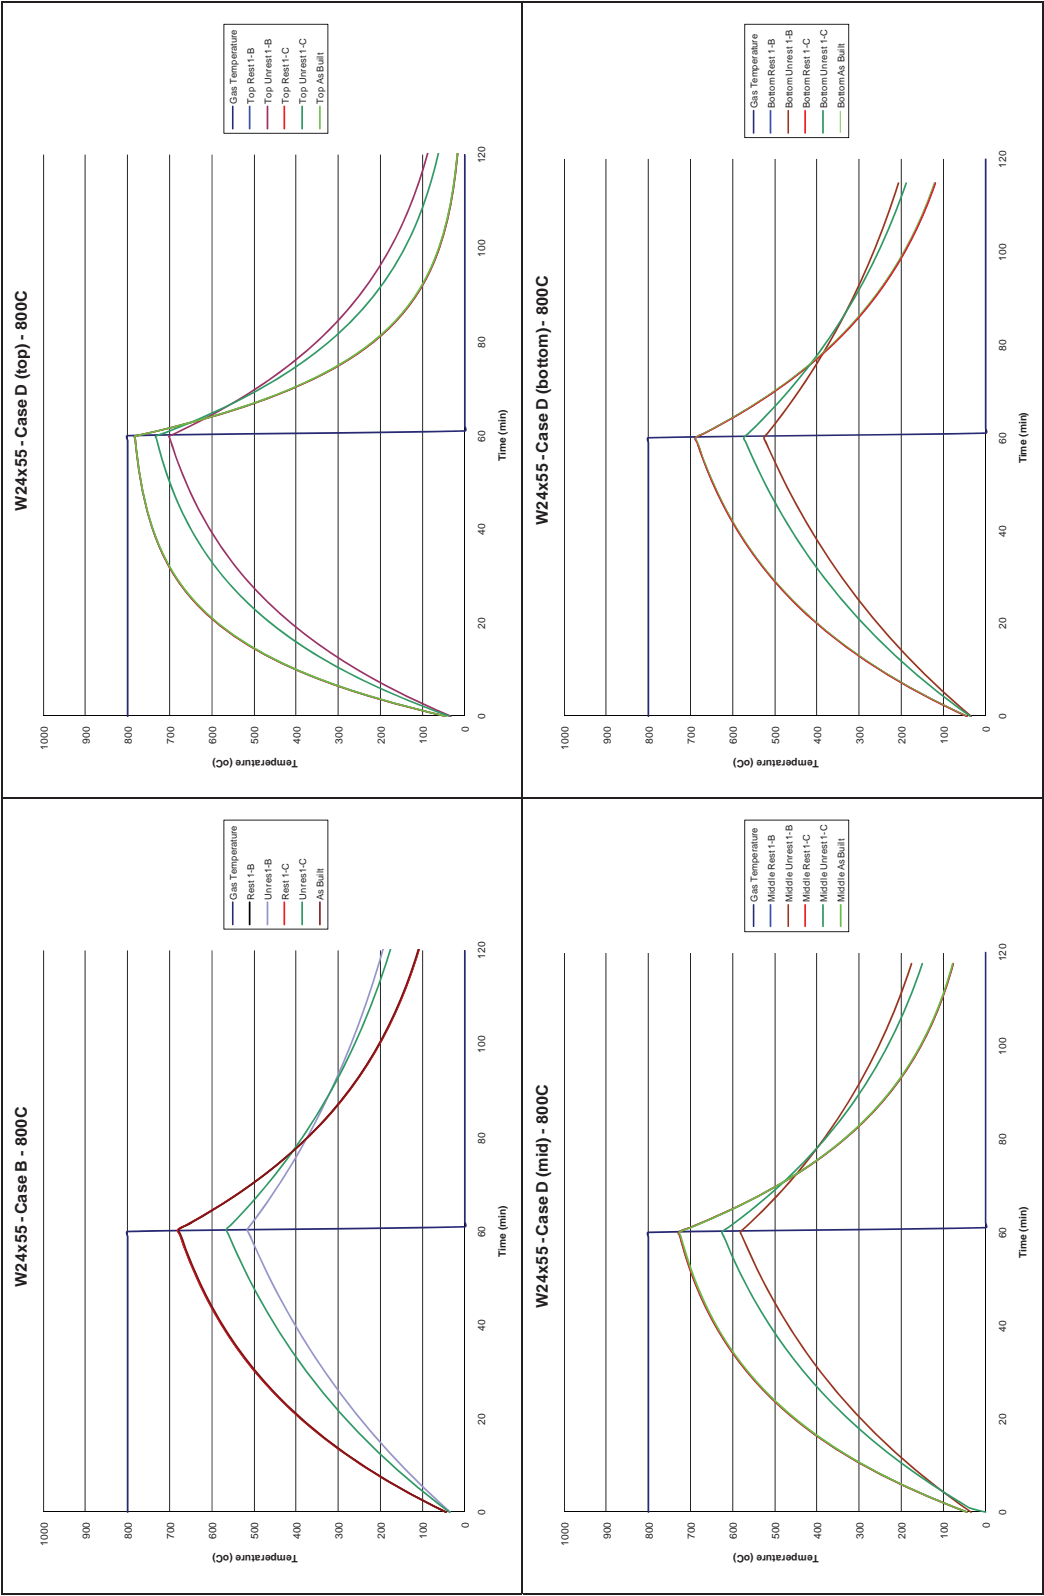
Figure D-3 shows the calculated temperature history for a W24x55 beam under boundary conditions for Cases (B) and (D) for an 800°C exposure for 1 hour. Figure D-4 shows the calculated temperature history for a W33x130 girder under the same boundary and exposure conditions. Figure D-5 shows the calculated temperature for a W14x730 column under boundary condition A for an 800°C exposure for 1 hour. Figure D-6 shows the calculated temperatures in a 4 in. floor slab for an 800°C exposure for 1 hour.

Figure D-3. Temperature histories for a W24x55 beam for Cases (B) and (D) under exposure to a gas temperature of 800°C for 1 hour.
