11-4403-cv

United States Court of Appeals *for the* Second Circuit

JOINT APPENDIX Volume 14 of 16 (Pages JA-3617 to JA-3886)

Volume A - Photographic Timeline
Photographic Analysis Report
World Trade Center 7 Collapse Investigation
16 December 2009

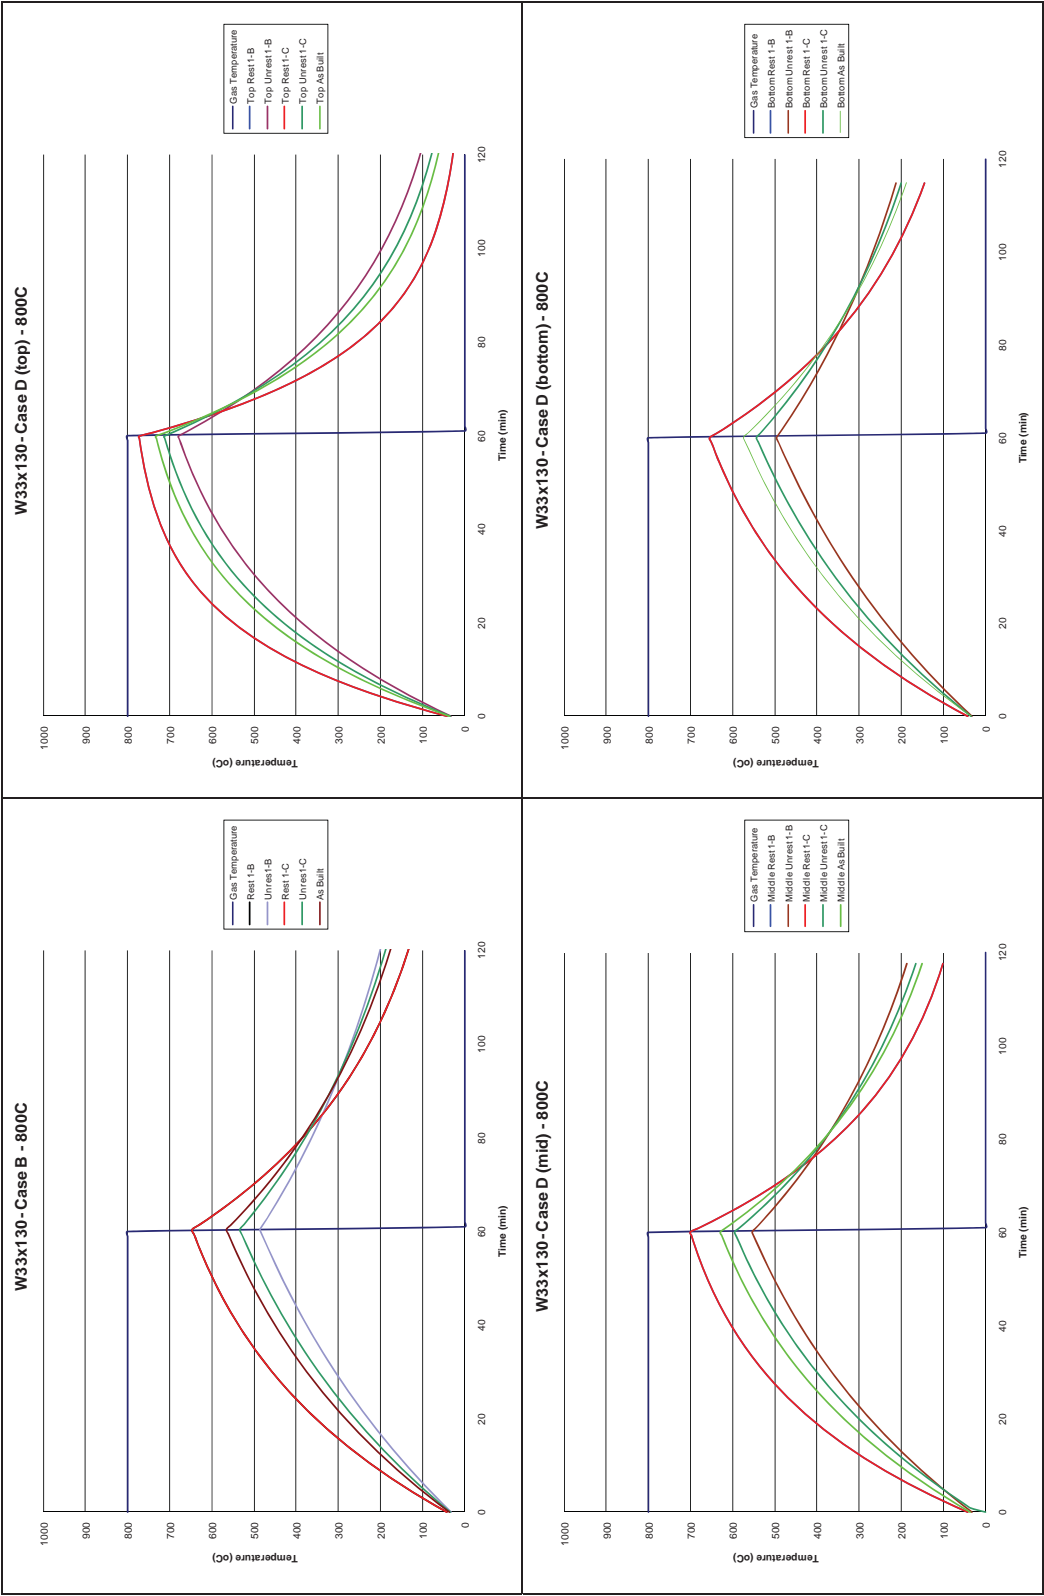
Figure D-4. Temperature histories for a W33x130 girder for Cases (B) and (D) under exposure to a gas temperature of 800°C for 1 hour.

Figure D-3 shows the calculated temperature history for a W24x55 beam under boundary conditions for Cases (B) and (D) for an 800°C exposure for 1 hour. Figure D-4 shows the calculated temperature history for a W33x130 girder under the same boundary and exposure conditions. Figure D-5 shows the calculated temperature for a W14x730 column under boundary condition A for an 800°C exposure for 1 hour. Figure D-6 shows the calculated temperatures in a 4 in. floor slab for an 800°C exposure for 1 hour.
