WORLD TRADE CENTER DEBRIS DISTANCE STUDY

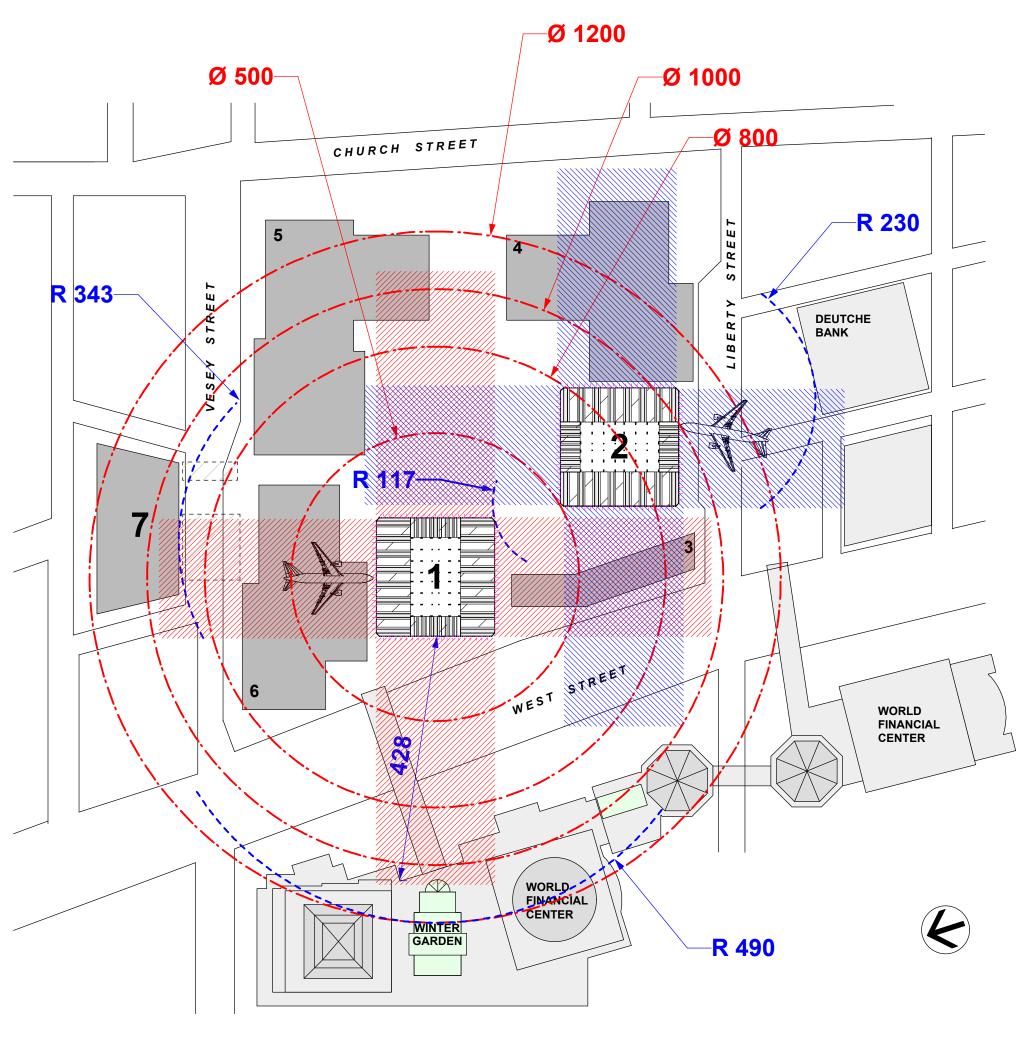
DEBRIS NORTH TOWER

DEBRIS SOUTH TOWER

NORTH TOWER WAS UNDAMAGED BY COLLAPSE OF SOUTH TOWER

DEBRIS RANGED FURTHER FROM NORTH TOWER COLLAPSE THAN SOUTH TOWER

DIAMETERS TAKEN FROM CENTER OF NORTH TOWER
