NIST NCSTAR 1-6B

**Federal Building and Fire Safety Investigation of the
World Trade Center Disaster**

Fire Resistance Tests of Floor Truss Systems

September 2005

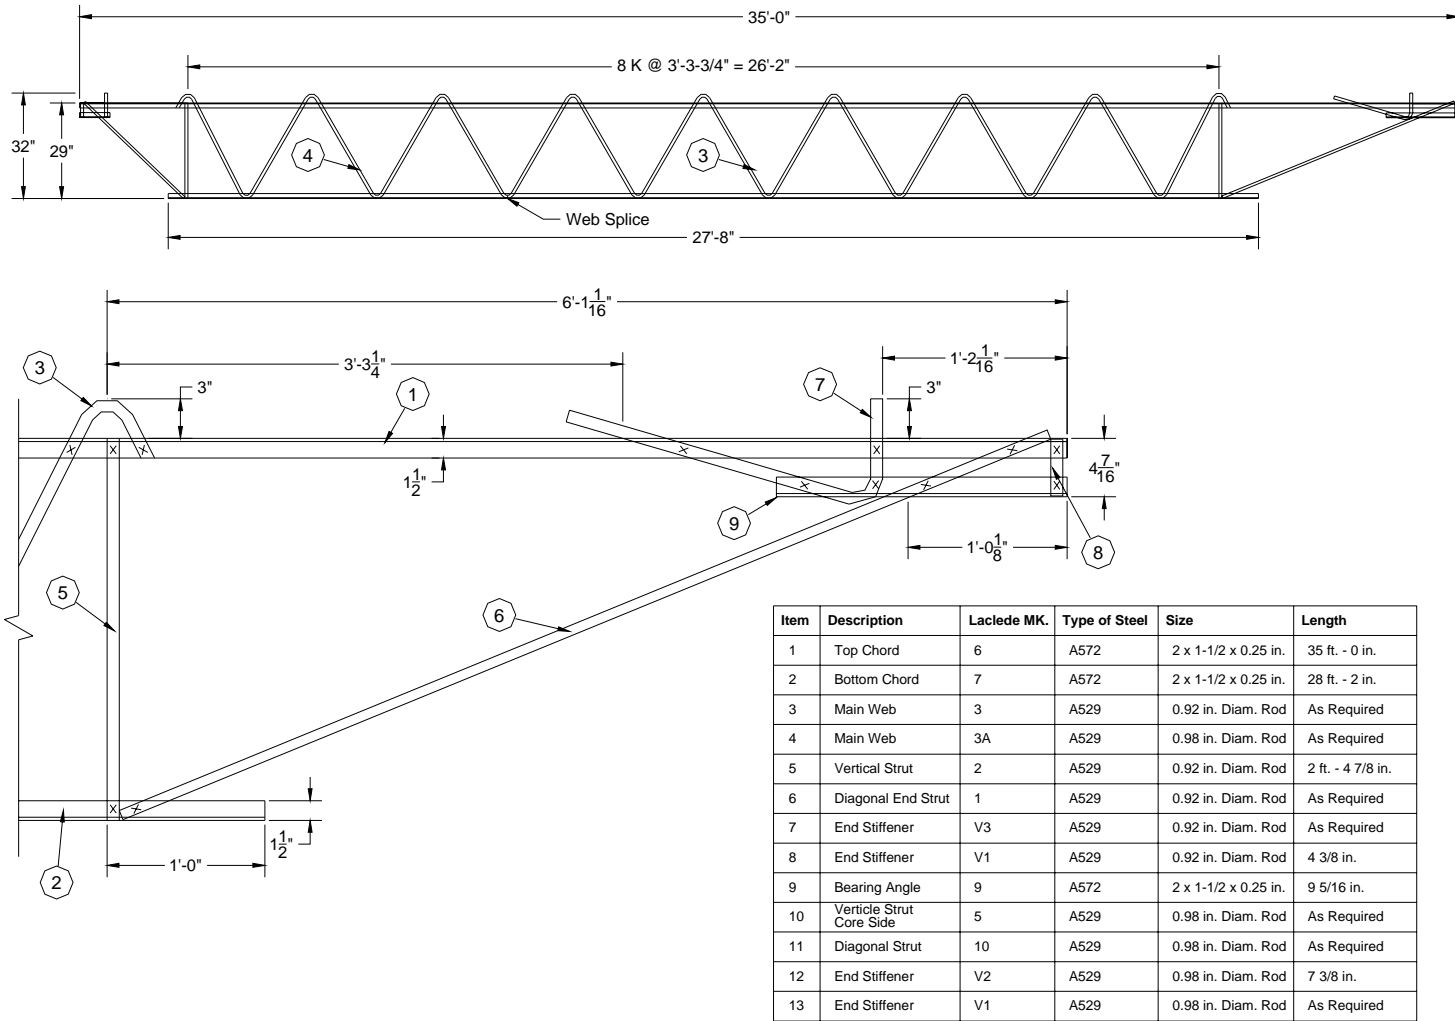
Figure 4-1. 35 ft main truss, column end.

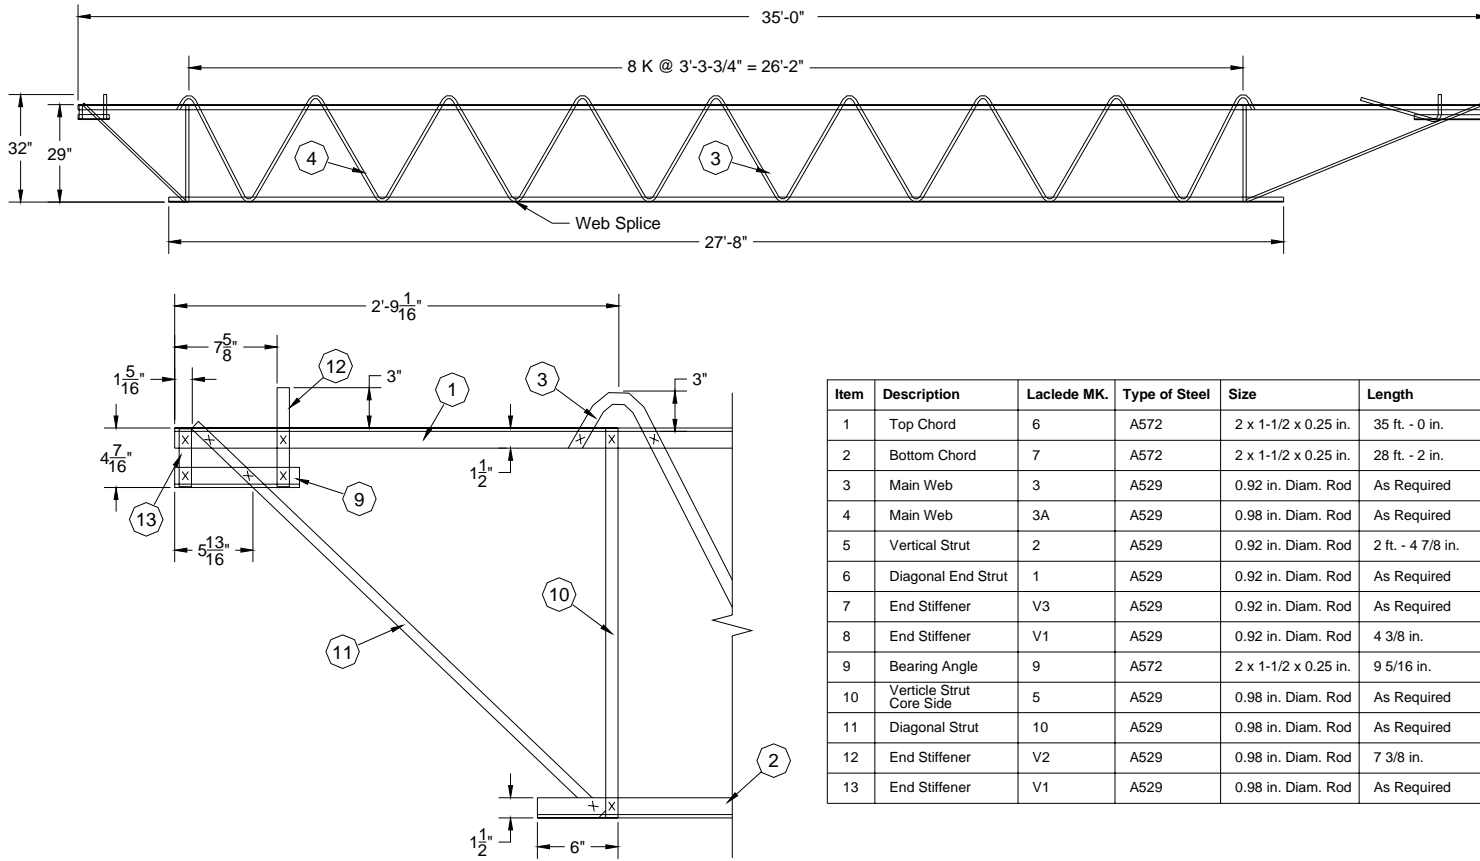
Item	Description	Laclede MK.	Type of Steel	Size	Length
1	Top Chord	6	A572	2 x 1-1/2 x 0.25 in.	35 ft. - 0 in.
2	Bottom Chord	7	A572	2 x 1-1/2 x 0.25 in.	28 ft. - 2 in.
3	Main Web	3	A529	0.92 in. Diam. Rod	As Required
4	Main Web	3A	A529	0.98 in. Diam. Rod	As Required
5	Vertical Strut	2	A529	0.92 in. Diam. Rod	2 ft. - 4 7/8 in.
6	Diagonal End Strut	1	A529	0.92 in. Diam. Rod	As Required
7	End Stiffener	V3	A529	0.92 in. Diam. Rod	As Required
8	End Stiffener	V1	A529	0.92 in. Diam. Rod	4 3/8 in.
9	Bearing Angle	9	A572	2 x 1-1/2 x 0.25 in.	9 5/16 in.
10	Verticle Strut Core Side	5	A529	0.98 in. Diam. Rod	As Required
11	Diagonal Strut	10	A529	0.98 in. Diam. Rod	As Required
12	End Stiffener	V2	A529	0.98 in. Diam. Rod	7 3/8 in.
13	End Stiffener	V1	A529	0.98 in. Diam. Rod	As Required

Figure 4-2. 35 ft main truss, core end.

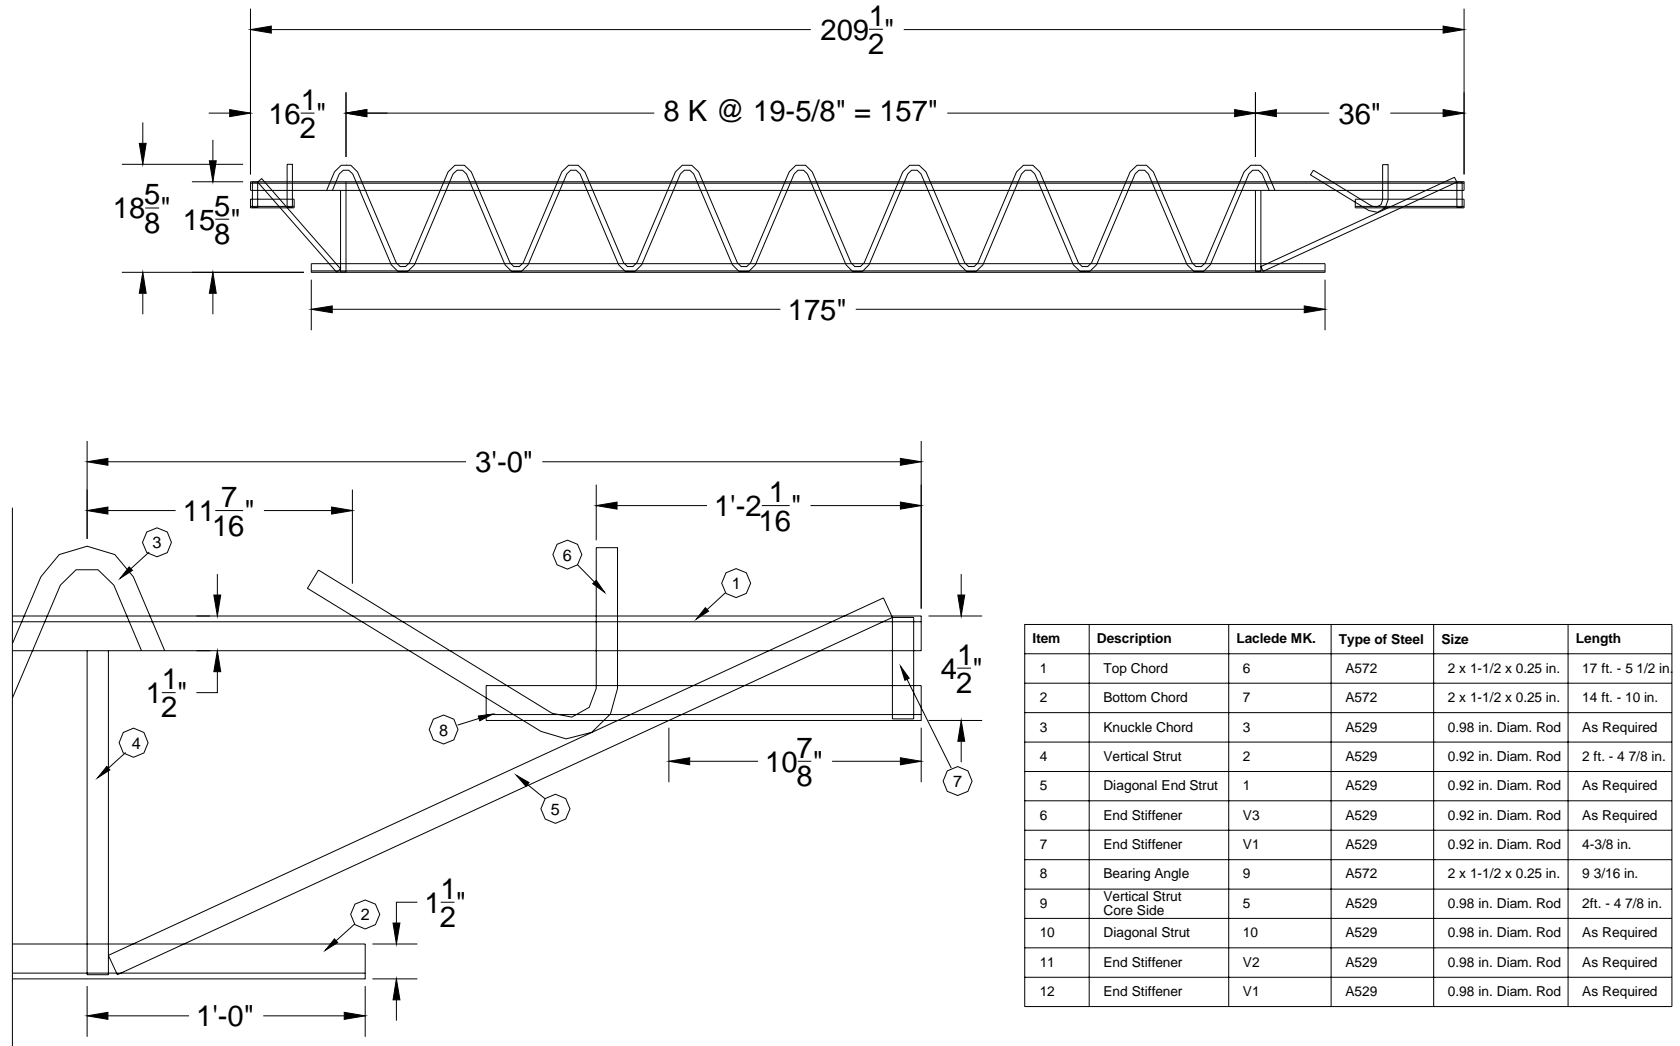
Figure 4-3. 17 ft main truss, column end.

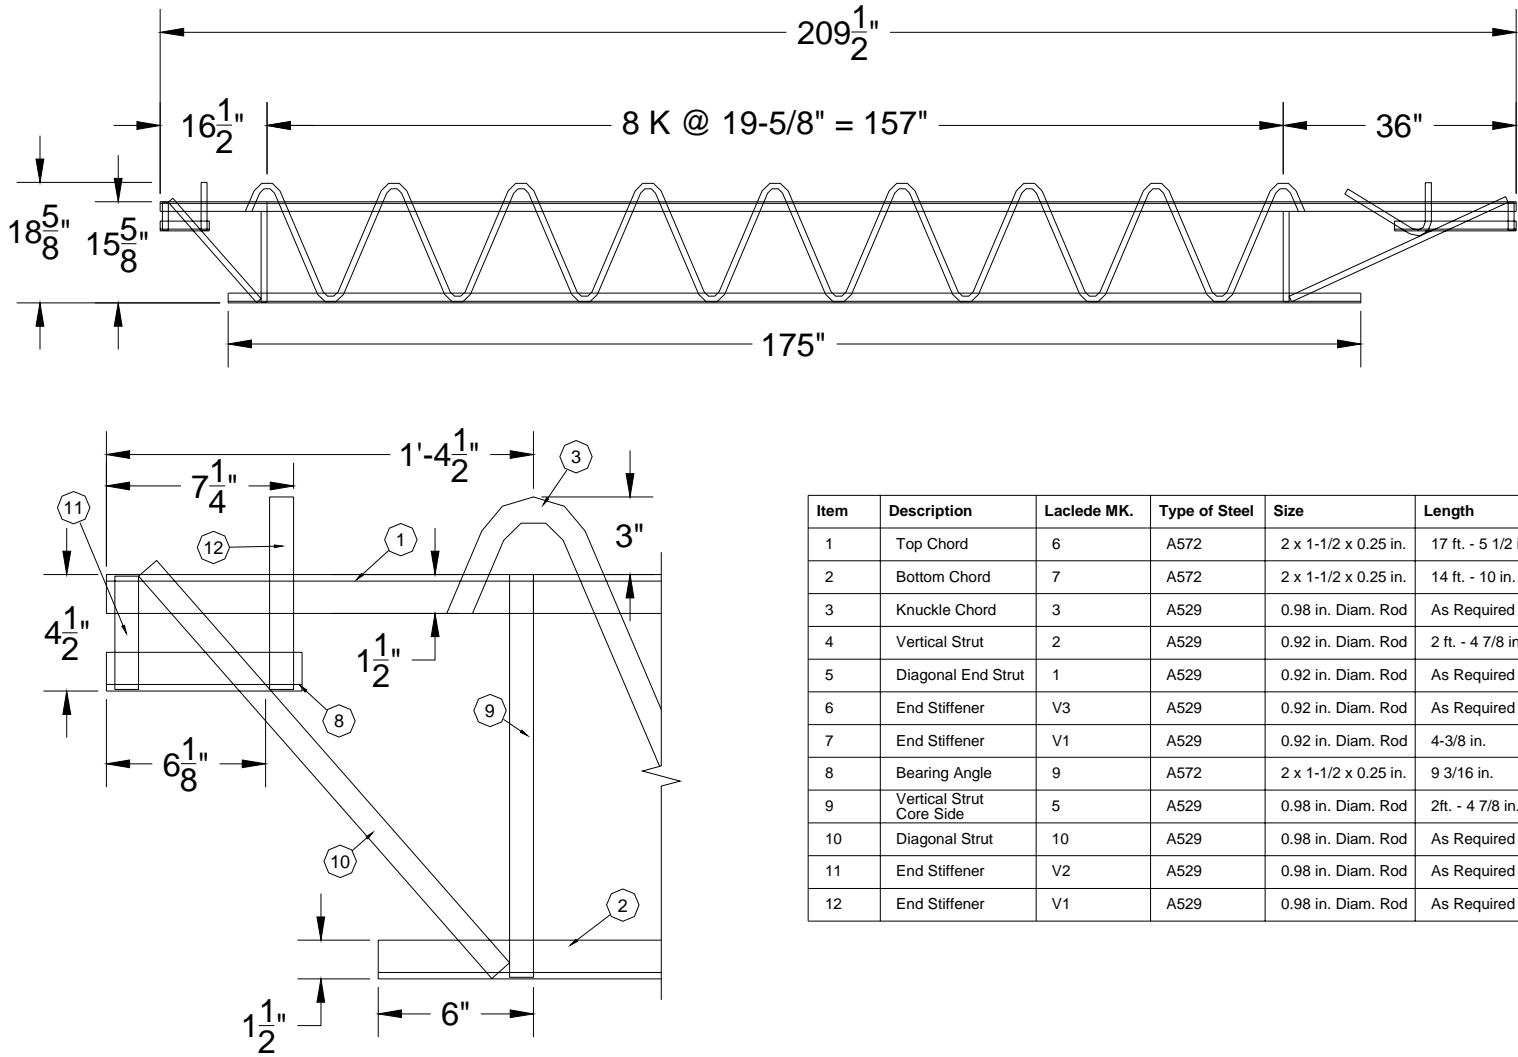
Figure 4-4. 17 ft main truss, core end.

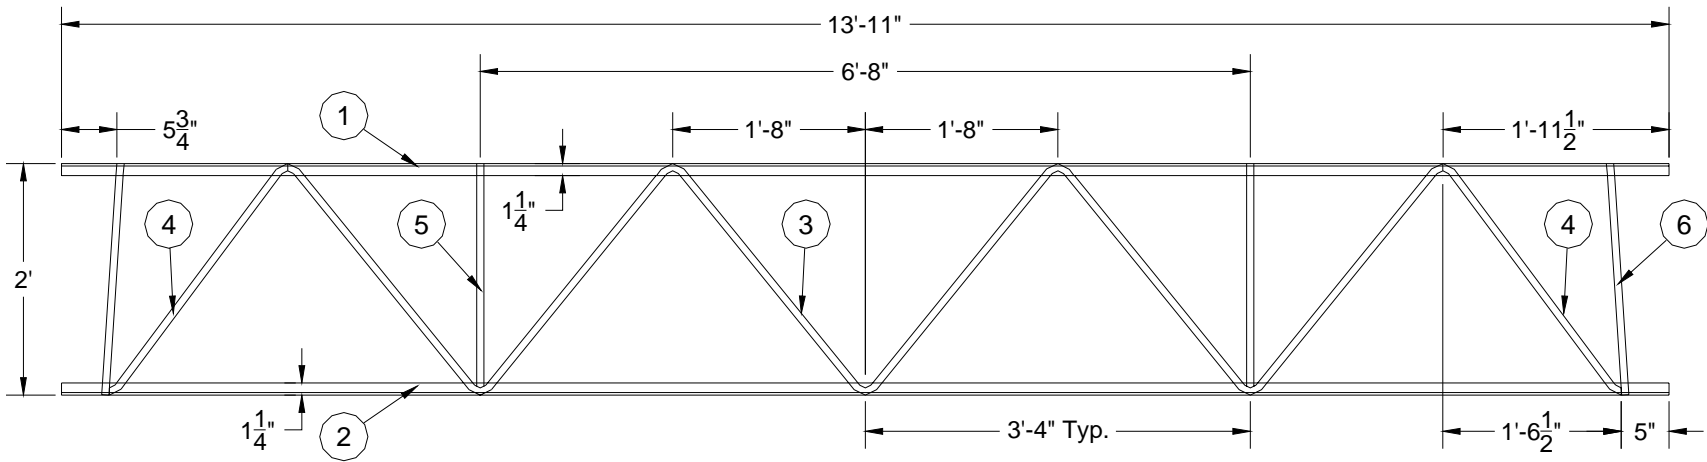
Item	Description	Laclede MK.	Type of Steel	Size	Length
1	Top Chord	6	A572	1-1/2 x 1-1/4 x 0.230 in.	13 ft. - 8 in.
2	Bottom Chord	7	A572	1-1/2 x 1-1/4 x 0.230 in.	13 ft. - 8 in.
3	Main Web	3	A572	0.75 in. Diam. Rod	As Required
4	Web Chord	4	A572	0.75 in. Diam. Rod	As Required
5	Vertical Strut	12	A572	0.75 in. Diam. Rod	1 ft. - 10-7/8 in.
6	Inclined End Strut	2	A572	0.75 in. Diam. Rod	1 ft. - 11-3/4 in.

Figure 4-5. Bridging truss for Assemblies Nos. 1 and 2.

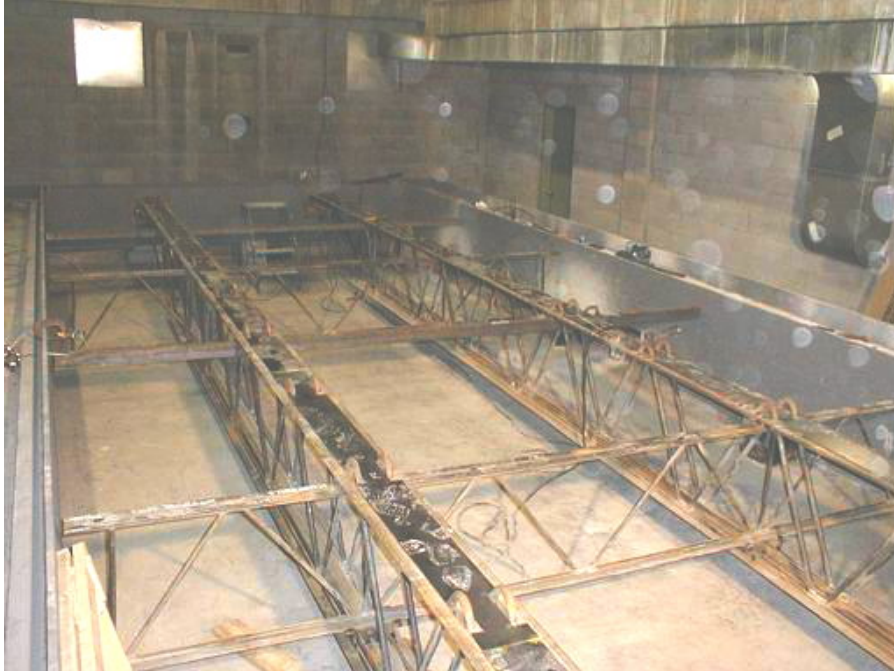
Figure 4–7. Structural steel frame of Assembly No. 1.

The ends of the main trusses in Test Assembly No. 1 were supported by L6×4×1 structural angles 12 in. long welded to the test frame. The bearing length for each main truss was 3¹/₂ in. The ends of the main trusses were welded with a 1/2 in. fillet along the entire bearing length on each side of the trusses (see Fig. 4-8). Steel plates were placed between the ends of the main trusses and the test frame, filling the gap and, thus, preventing thermal expansion.

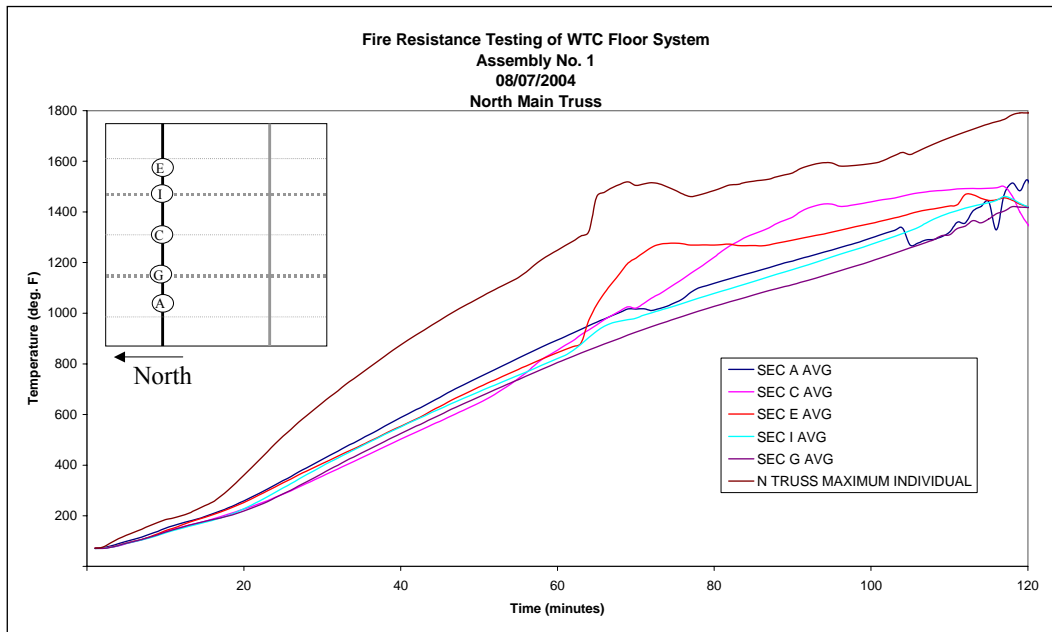
Figure 5–1. Assembly No. 1 – average and maximum individual temperatures on north main truss.

All data shown in the following figures (Figures 5–1 through 5–12) are unedited for the entire duration of the test. However, not all data shown is reliable due to the limitations of the instrumentation, i.e. thermocouples, radiometers, and calorimeters. Data may become unreliable past the rating period when structural events occur that can dislodge the instrumentation. Also, protective insulation of the thermocouple wire may burn away, and the individual wires can make contact with themselves and/or neighboring wires rendering the data unreliable. Appendix H gives a listing of the times that various instrumentation failed to give reliable data, as determined by UL.

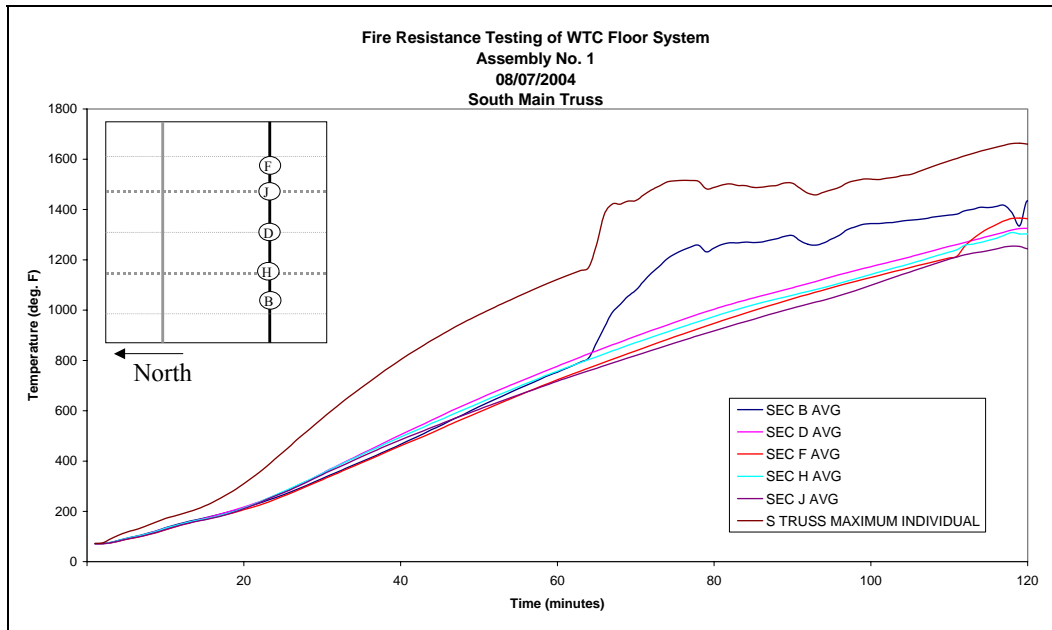
Figure 5–2. Assembly No. 1 – average and maximum individual temperatures on south main truss.

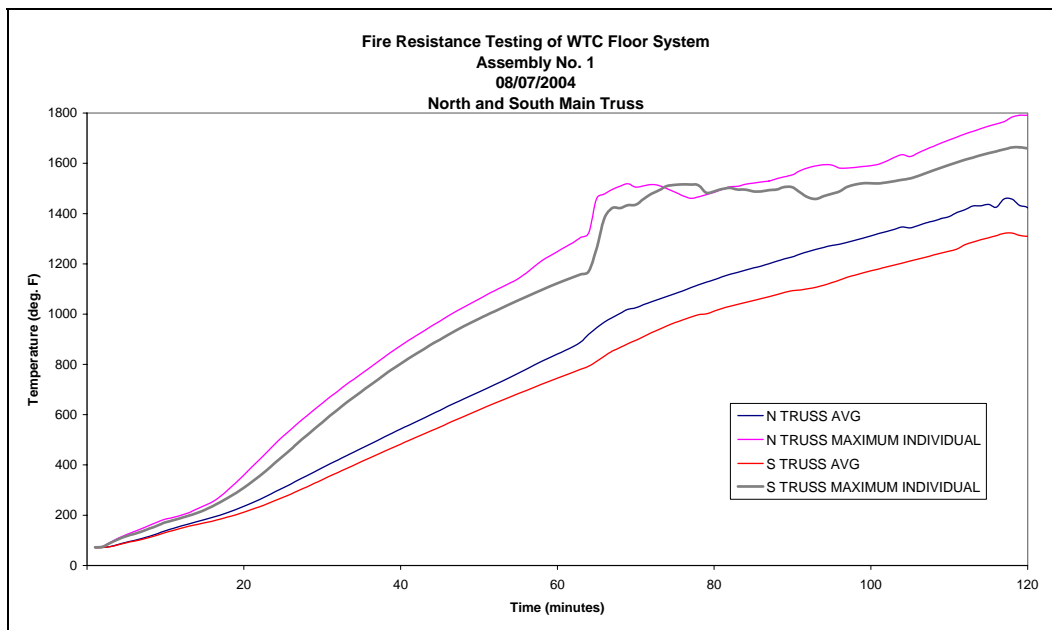
Figure 5–3. Assembly No. 1 – overall average and maximum individual temperatures on north and south main trusses.

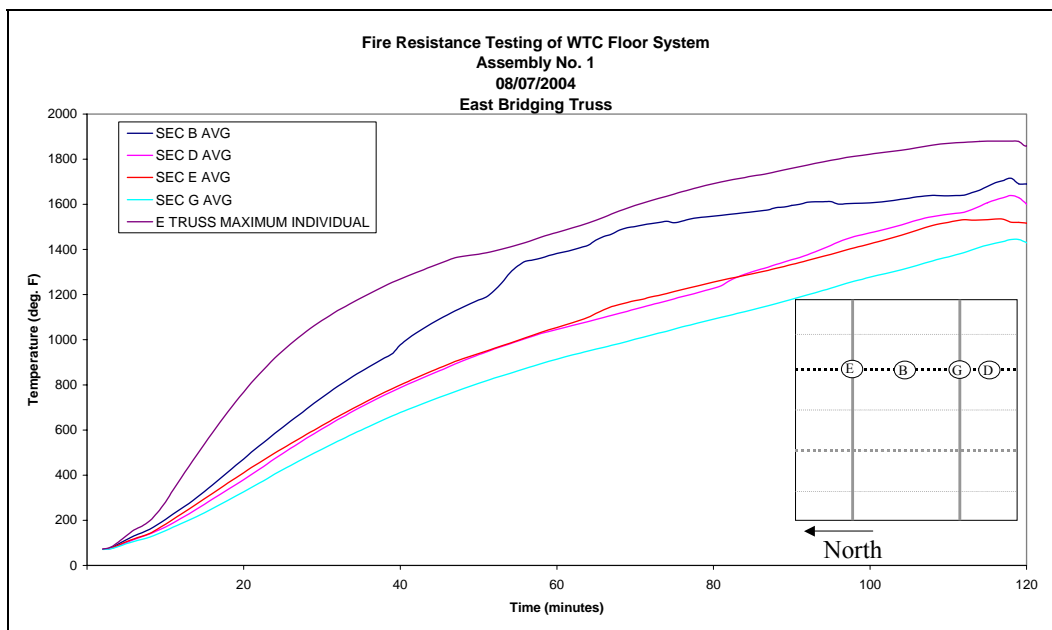
Figure 5-5. Assembly No. 1 – average and maximum individual temperatures on east bridging truss.

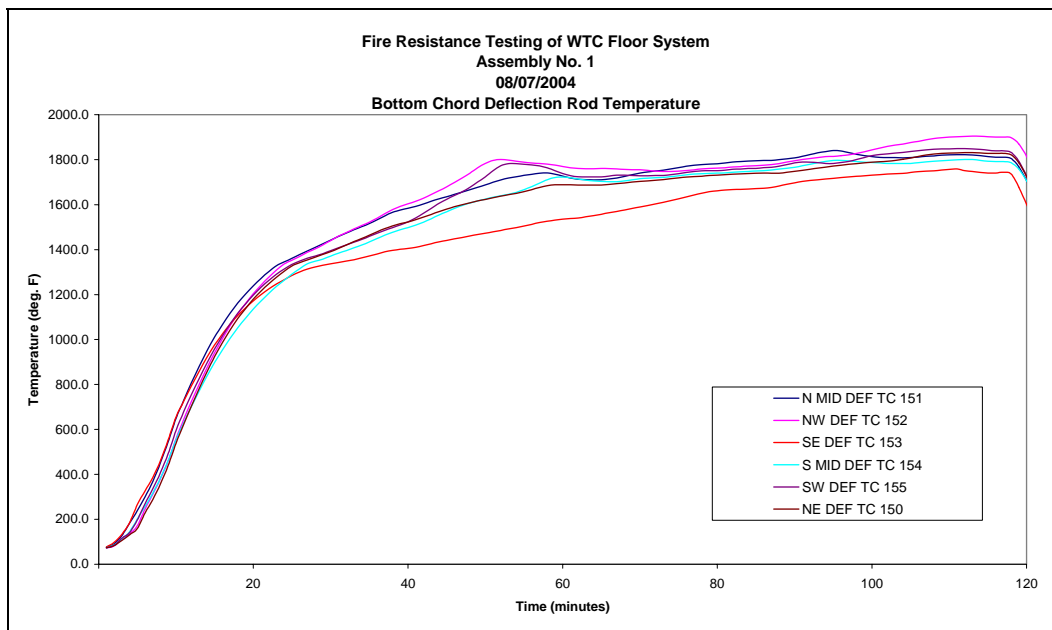
Figure 5–9. Assembly No. 1 – temperatures of bottom chord deflection rods.

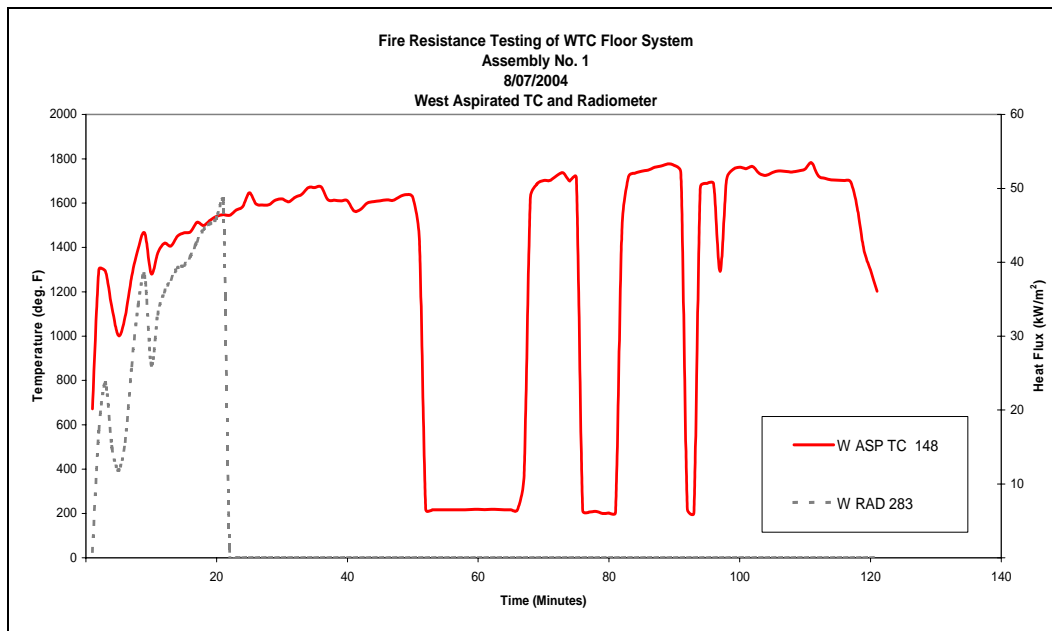
Figure 5–11. Assembly No. 1 – additional instrumentation through west opening.

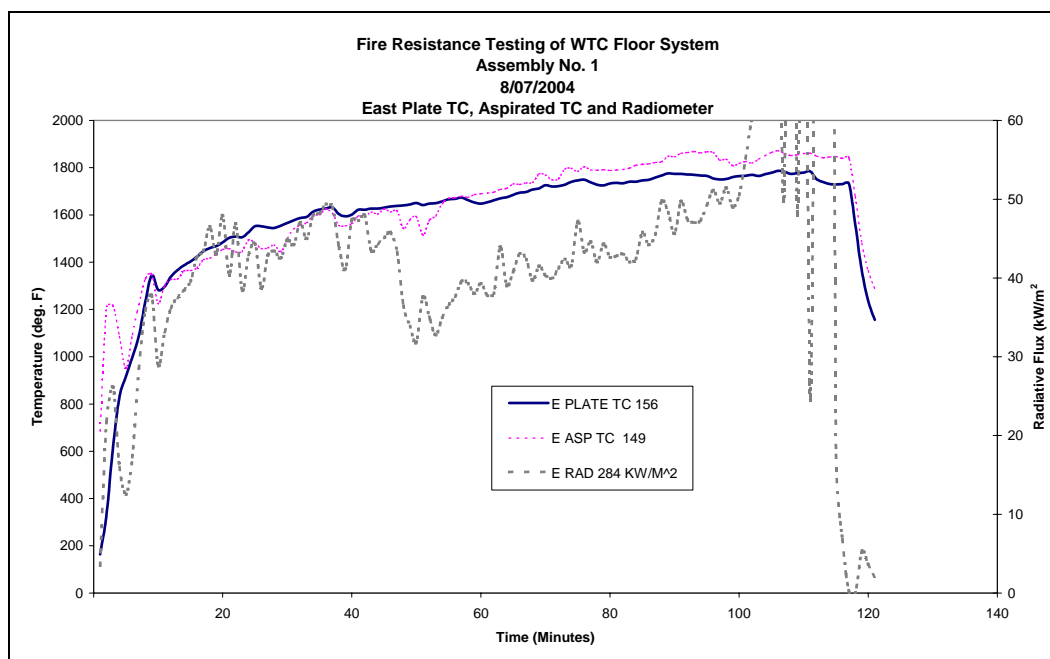
Figure 5–12. Assembly No. 1 – additional instrumentation through east opening.

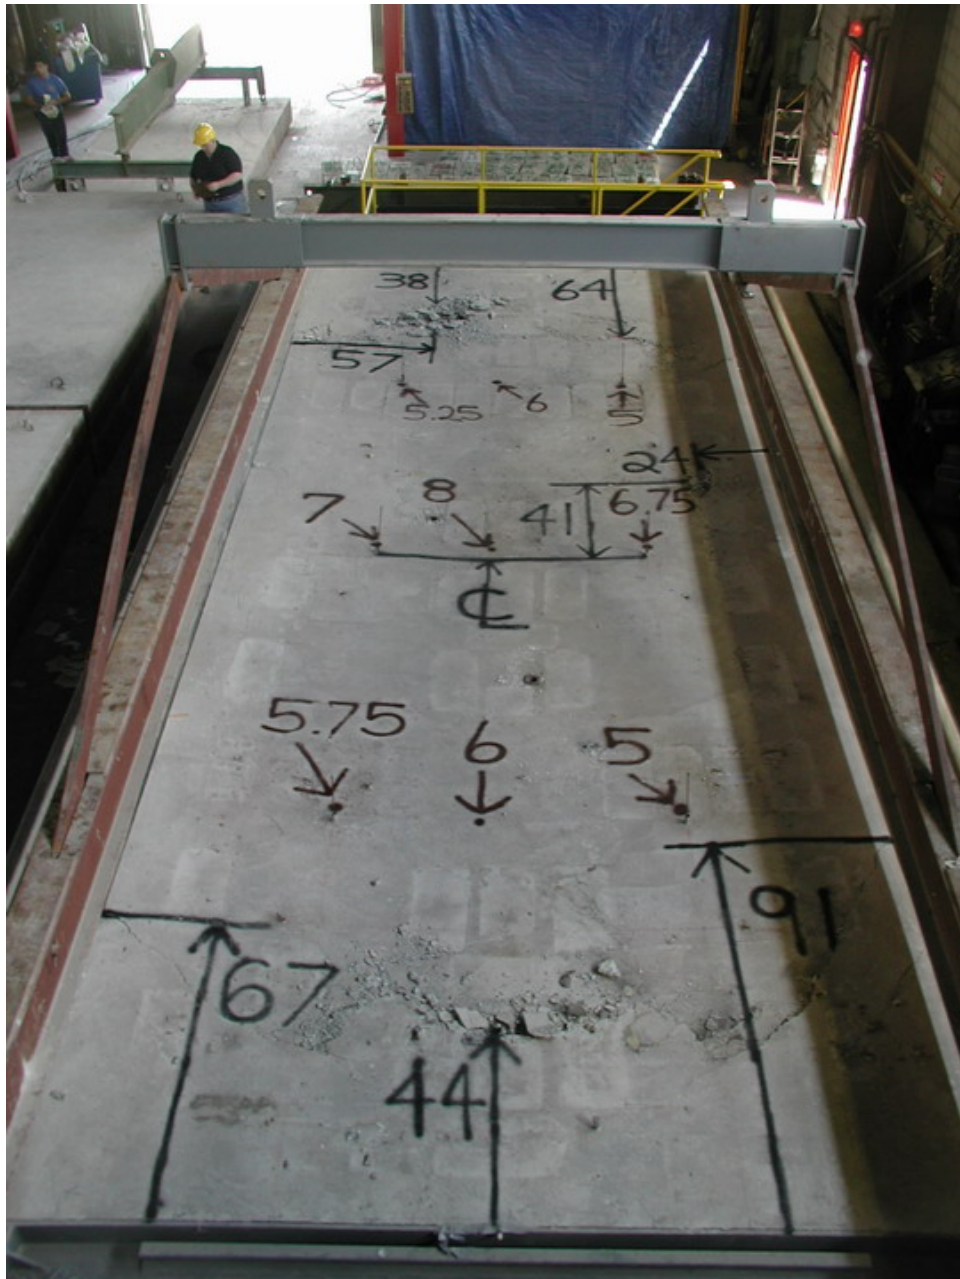
Figure 5–13. Unexposed surface of Assembly No. 1 after loading equipment was removed.

Figures 5–14 through 5–19 are additional views of the top of the specimen, showing the cracked and spalled concrete, and of the underside, showing bulging of the metal deck and deformations of the steel trusses after the test specimen had cooled and had been removed from the furnace. To confirm the spalling of the bottom side of the concrete slab and to quantify the depth of spalling, sections of the slab were cut using a diamond concrete wet saw (see Fig. 5–20). The depth of the delamination spalling varied but was on the order of 2 in. as seen in Fig. 5–21.

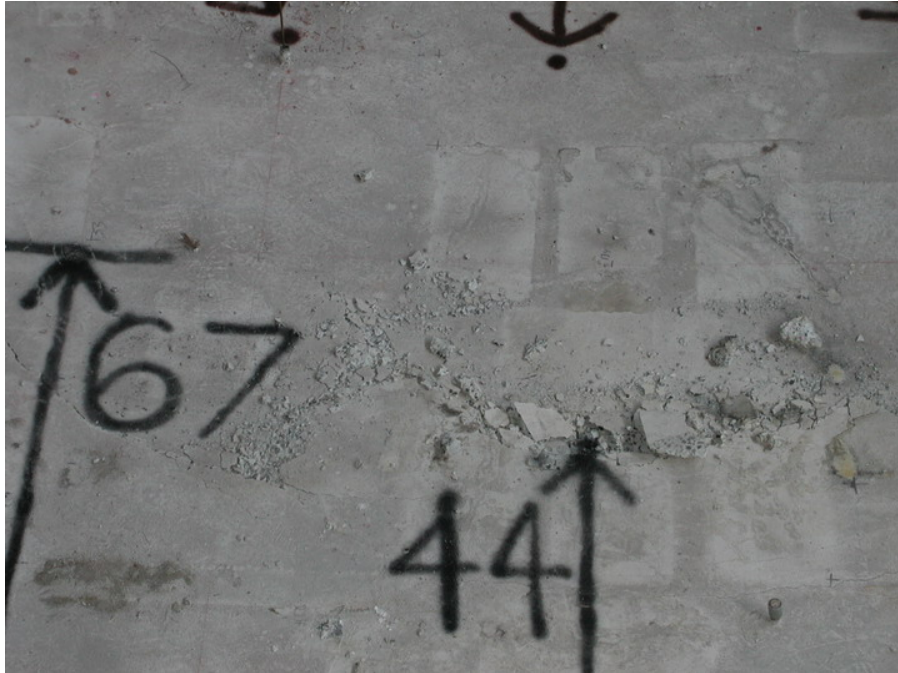
Figure 5–14. Detail of spalling concrete at west end of Assembly No. 1.

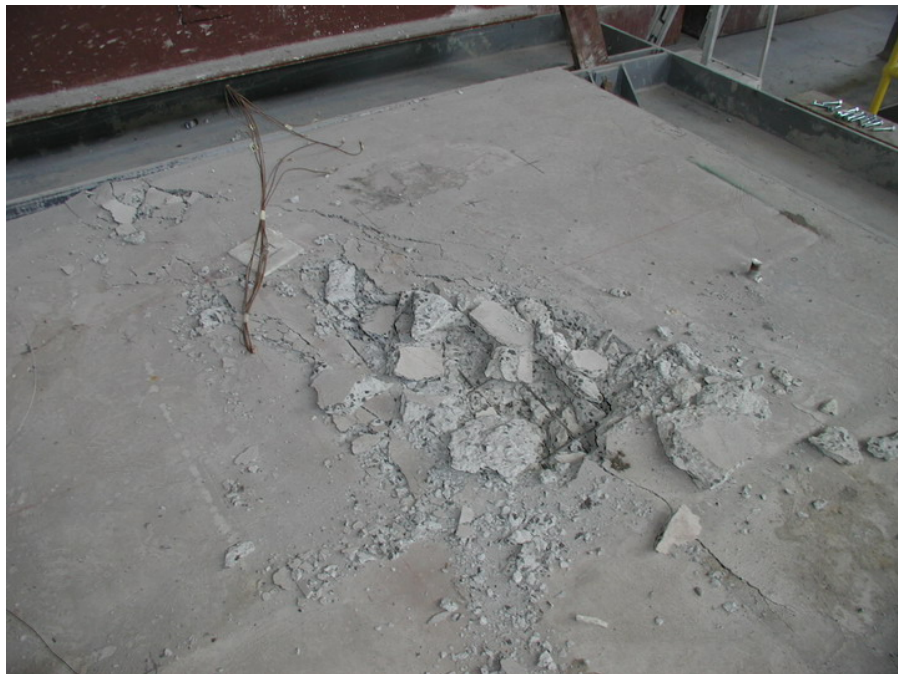
Figure 5–15. Detail of spalling concrete at east end of Assembly No. 1.

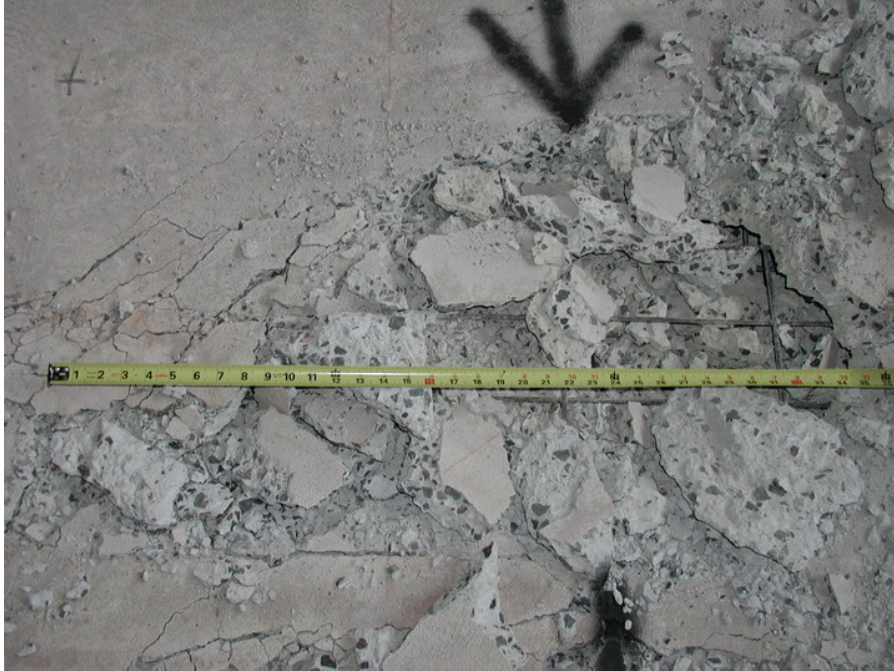
Figure 5–16. Close-up of spalling concrete at east end of Assembly No. 1.

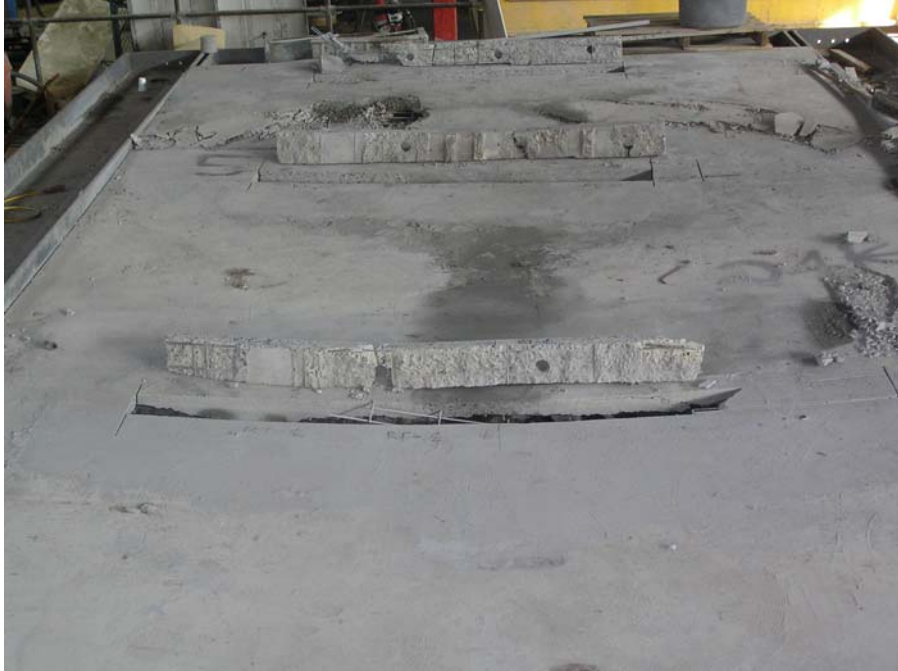
Figure 5–20. Sections cut through concrete slab to confirm delamination spalling.

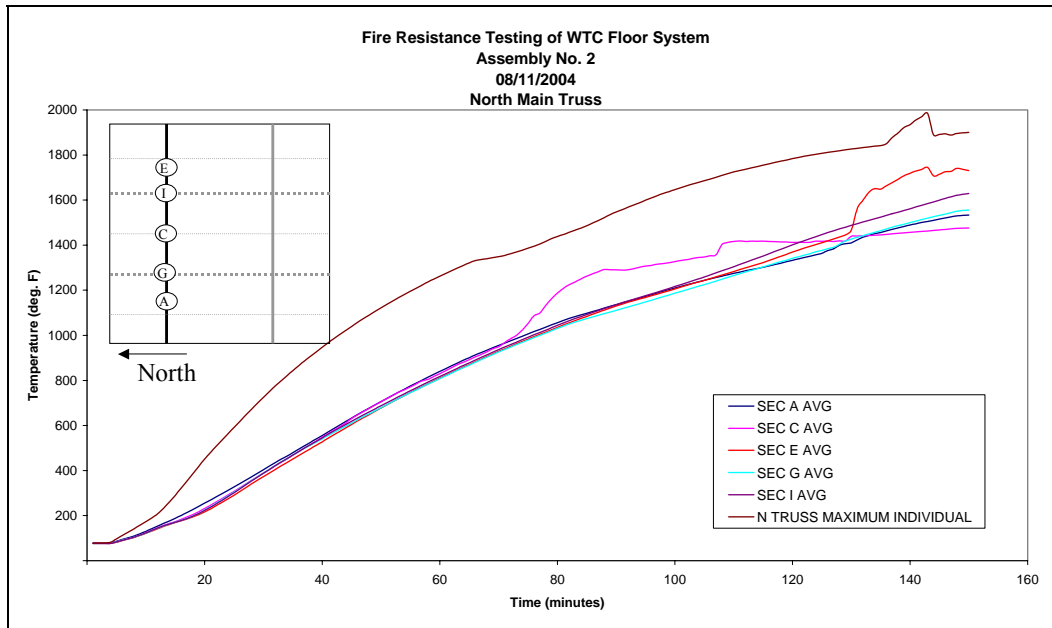
Figure 5-22. Assembly No. 2 – average and maximum individual temperatures on north main truss.

All data shown in the following figures (Figures 5–22 through 5–33) are unedited for the entire duration of the test. However, not all of the data shown is reliable due to the limitations of the instrumentation, i.e. thermocouples, radiometers, and calorimeters. Data may become unreliable past the rating period when structural events occur that can dislodge the instrumentation. Also, protective insulation of the thermocouple wire may burn away, and the individual wires make contact with themselves and/or neighboring wires rendering the data unreliable. Appendix H gives a listing of the times that instrumentation failed to give reliable data, as determined by UL.

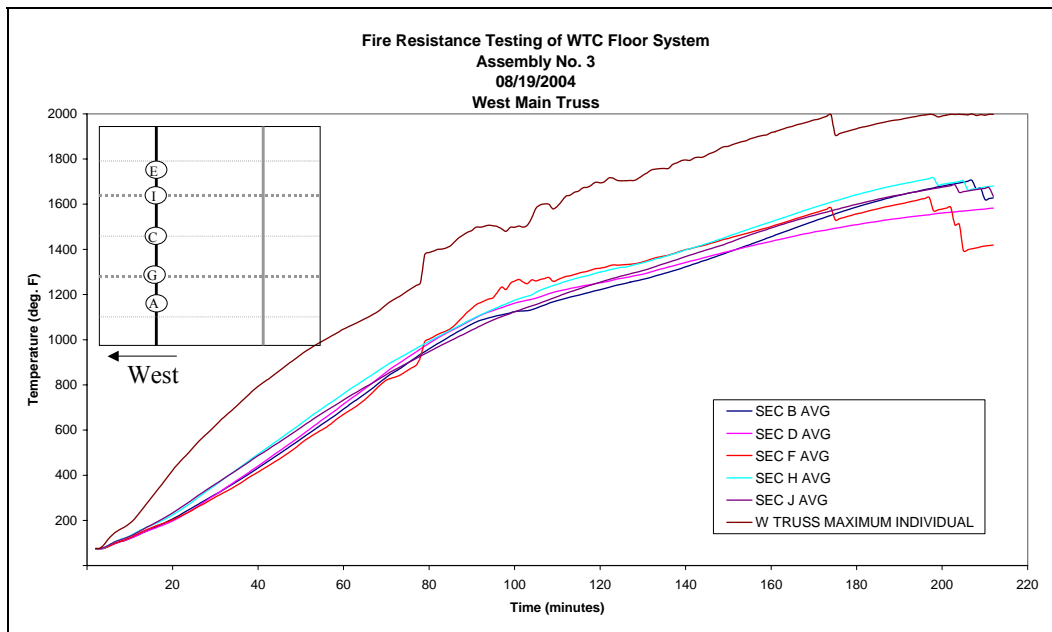
Figure 5–38. Assembly No. 3 – average and maximum individual temperatures on west main truss.

All data shown in the following figures (Figures 5–38 through 5–49) are unedited for the entire duration of the test. However, not all data shown is reliable due to the limitations of the instrumentation, i.e. thermocouples, radiometers, and calorimeters. Data may become unreliable past the rating period when structural events occur that can dislodge the instrumentation. Also, protective insulation of the thermocouple wire may burn away, and the individual wires make contact with themselves and/or neighboring wires rendering the data unreliable. Appendix H gives a listing of the times that instrumentation failed to give reliable data, as determined by UL.

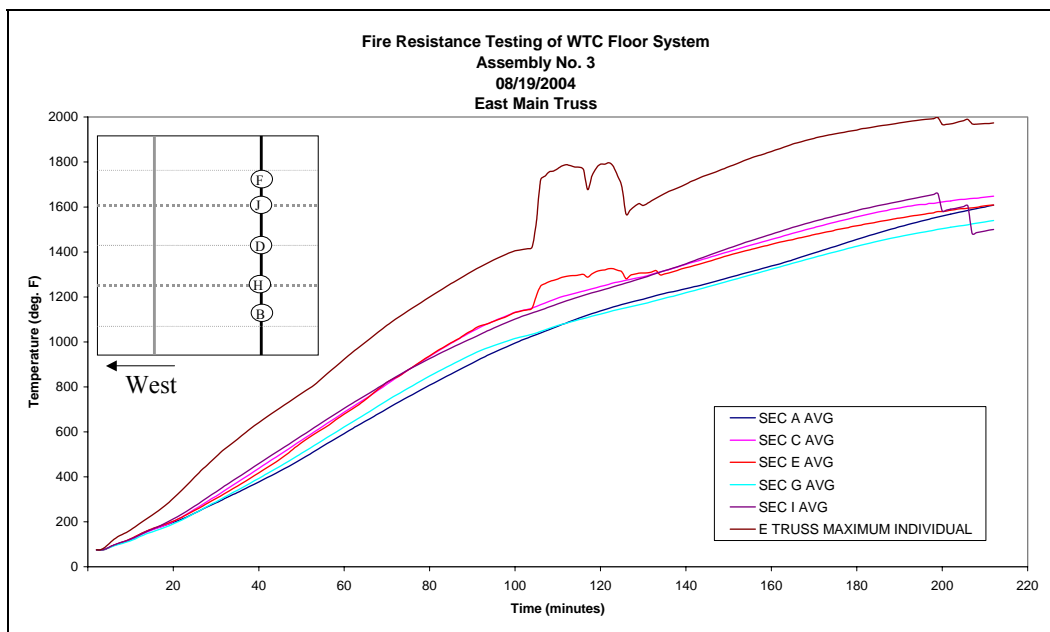
Figure 5–39. Assembly No. 3 – average and maximum individual temperatures on east main truss.

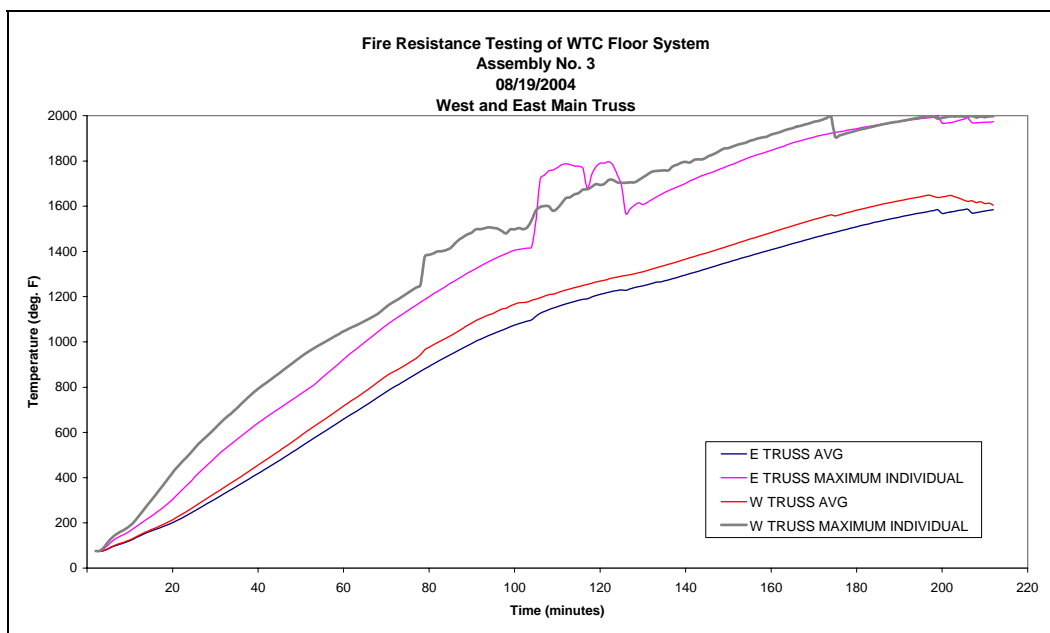
Figure 5–40. Assembly No. 3 – overall average and maximum individual temperatures on west and east main trusses.

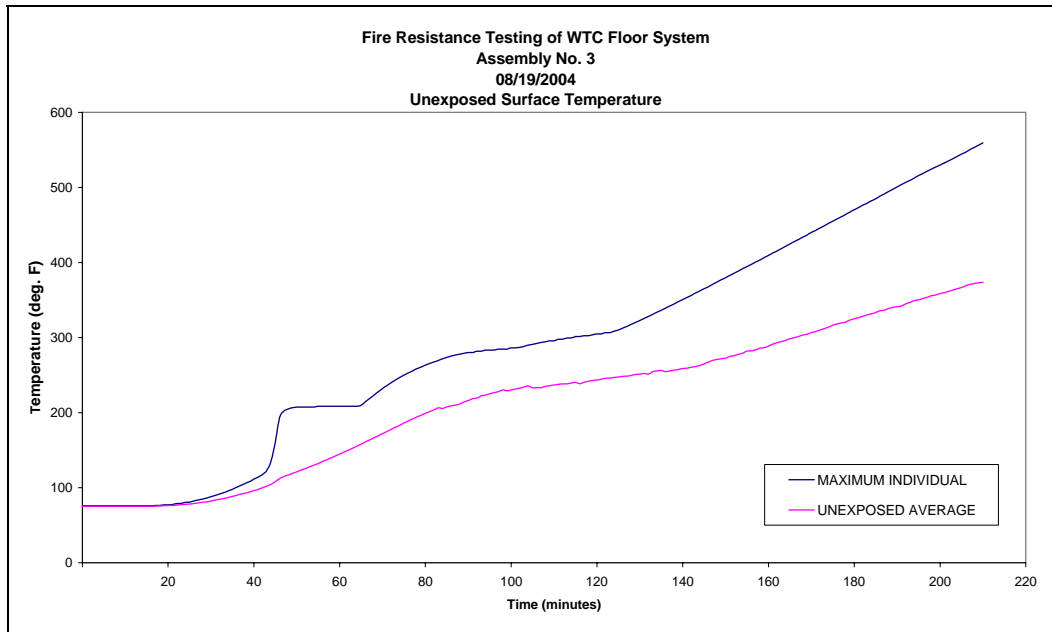
Figure 5-43. Assembly No. 3 – average and maximum individual temperatures on unexposed surface.

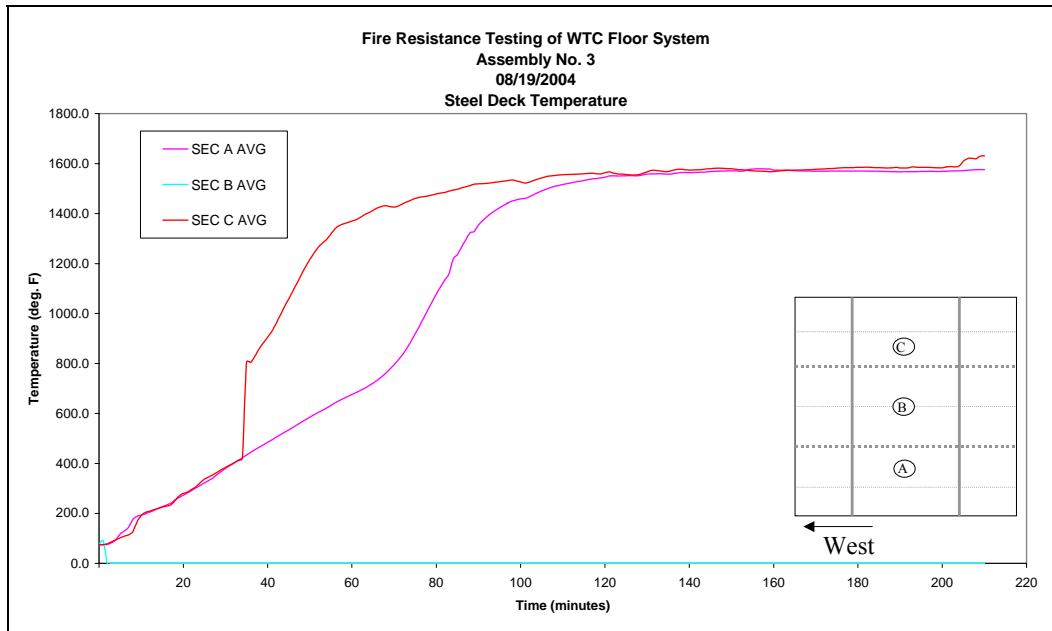
Figure 5-44. Assembly No. 3 – average temperatures on steel deck.

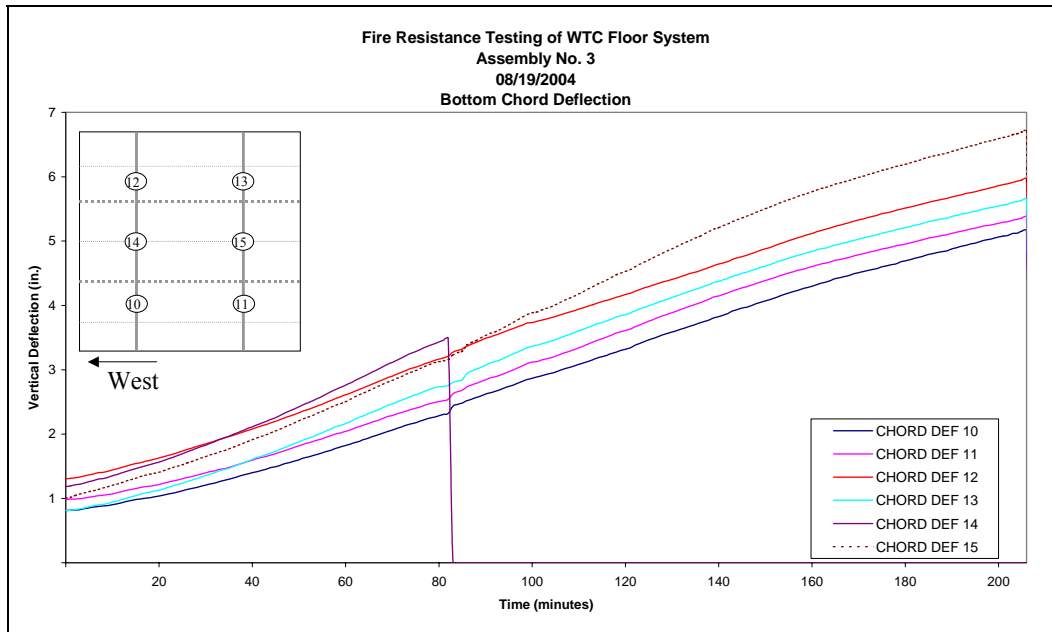
Figure 5–45. Assembly No. 3 – bottom chord deflection measurements.

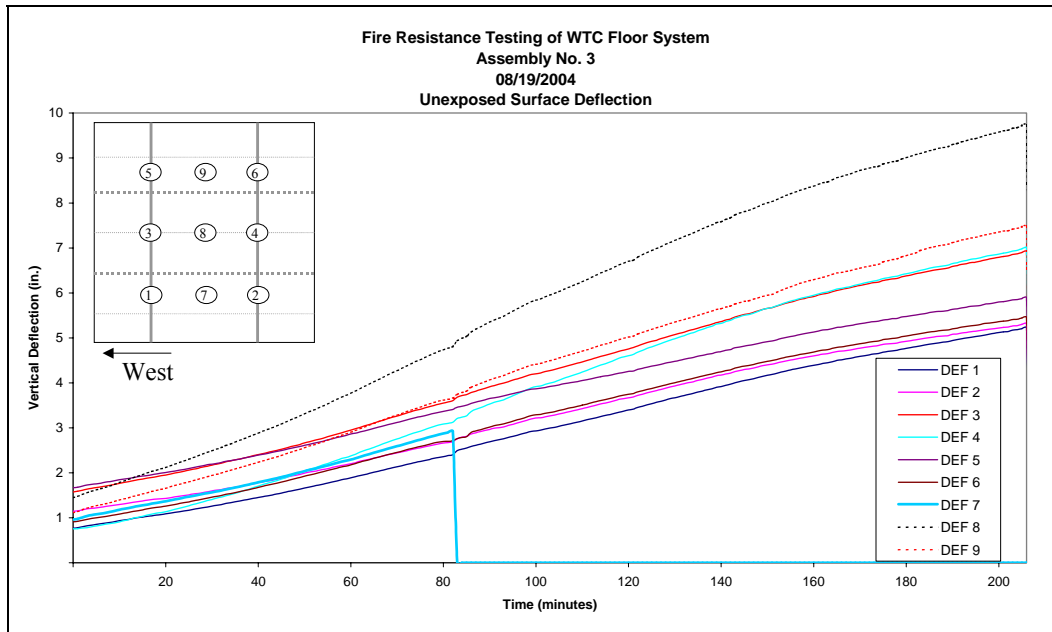
Figure 5-47. Assembly No. 3 – unexposed surface deflection measurements.
