NIST NCSTAR 1-6B

**Federal Building and Fire Safety Investigation of the
World Trade Center Disaster**

Fire Resistance Tests of Floor Truss Systems

September 2005

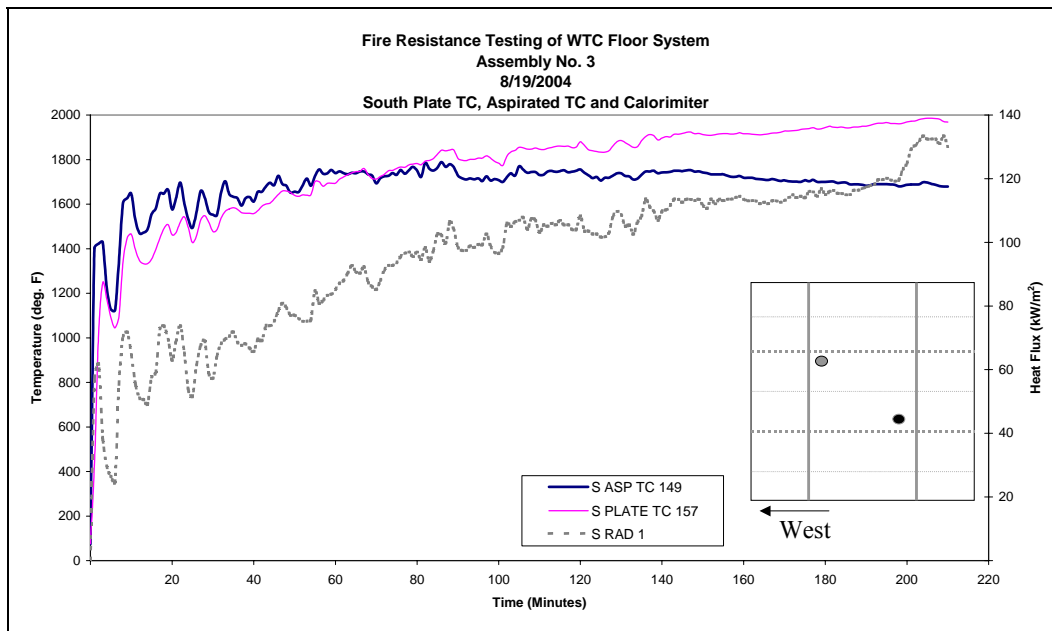
Figure 5-48. Assembly No. 3 – additional instrumentation through south opening.

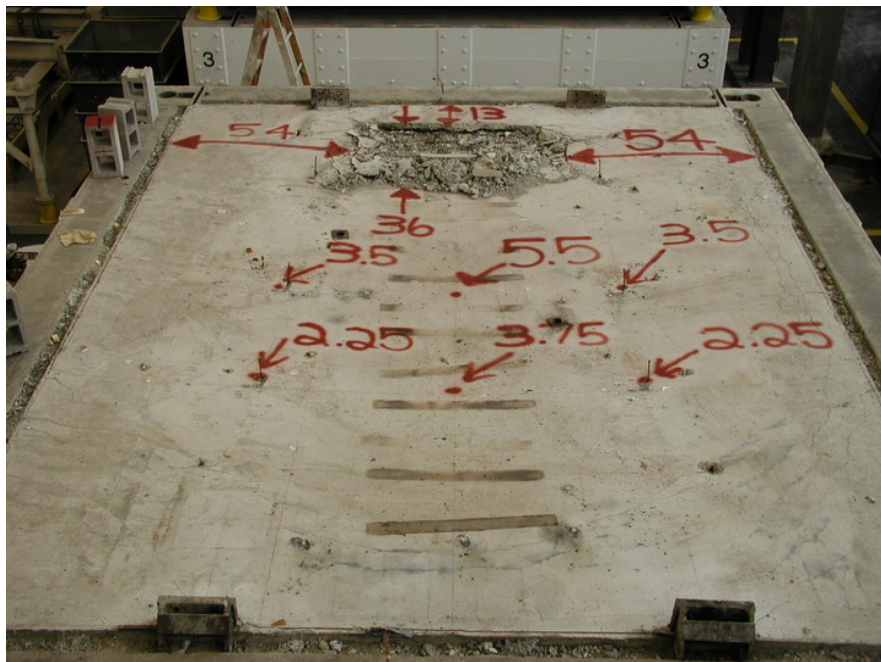
Figure 5–50. Unexposed surface of Assembly No. 3 after loading equipment was removed.

Figure 5–50 shows the unexposed side of floor assembly No. 3 after all loading equipment had been removed (view looking north). Numbers shown at the centerline and quarter points are vertical deflections after cooling. All other numbers are reference dimensions as measured from the edge of the slab. Figures 5–51 through 5–53 are additional views of the post-test condition of the test specimen.

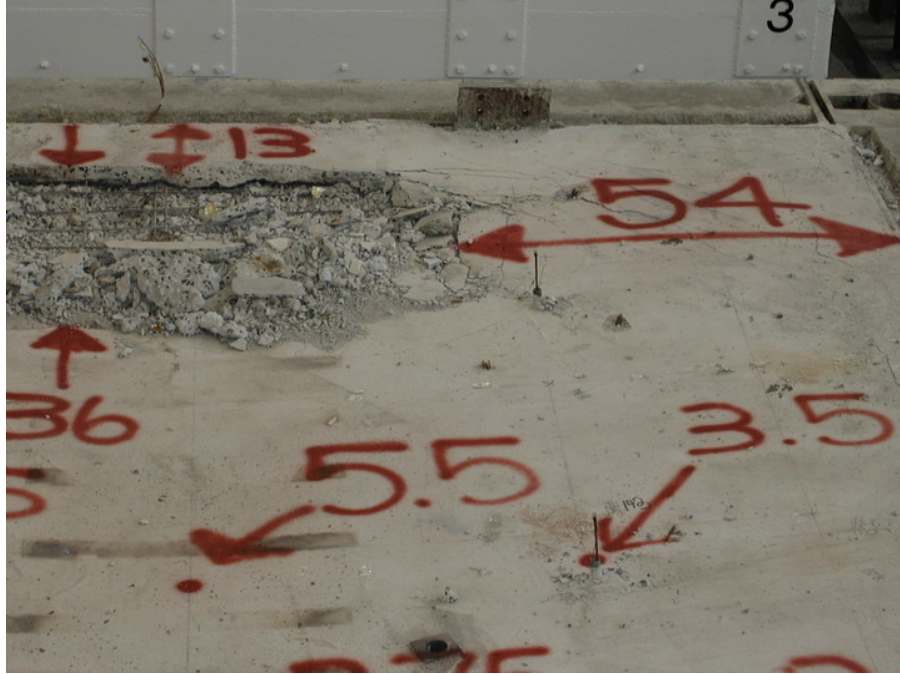
Figure 5–51. Detail of spalling concrete at north end of Assembly No. 3.

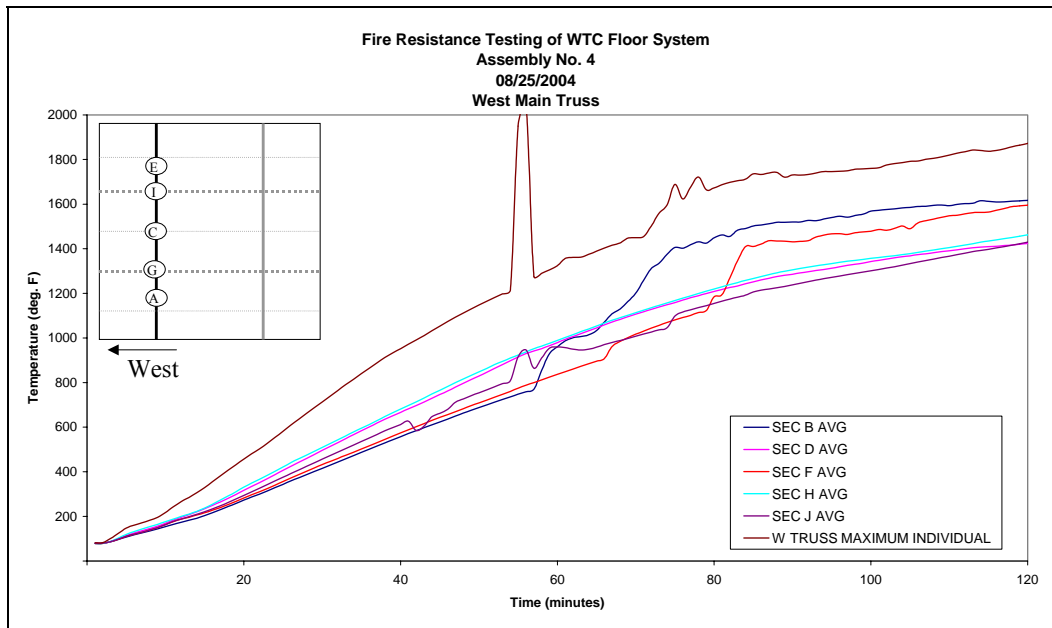
Figure 5–54. Assembly No. 4 – average and maximum individual temperatures on west main truss.

All data shown in the following figures (Figures 5–54 through 5–65) are unedited for the entire duration of the test. However, not all data shown is reliable due to the limitations of the instrumentation, i.e. thermocouples, radiometers, and calorimeters. Data may become unreliable past the rating period when structural events occur that can dislodge the instrumentation. Also, protective insulation of the thermocouple wire may burn away, and the individual wires make contact with themselves and/or neighboring wires rendering the data unreliable. Appendix H gives a listing of the times that instrumentation failed to give reliable data, as determined by UL.

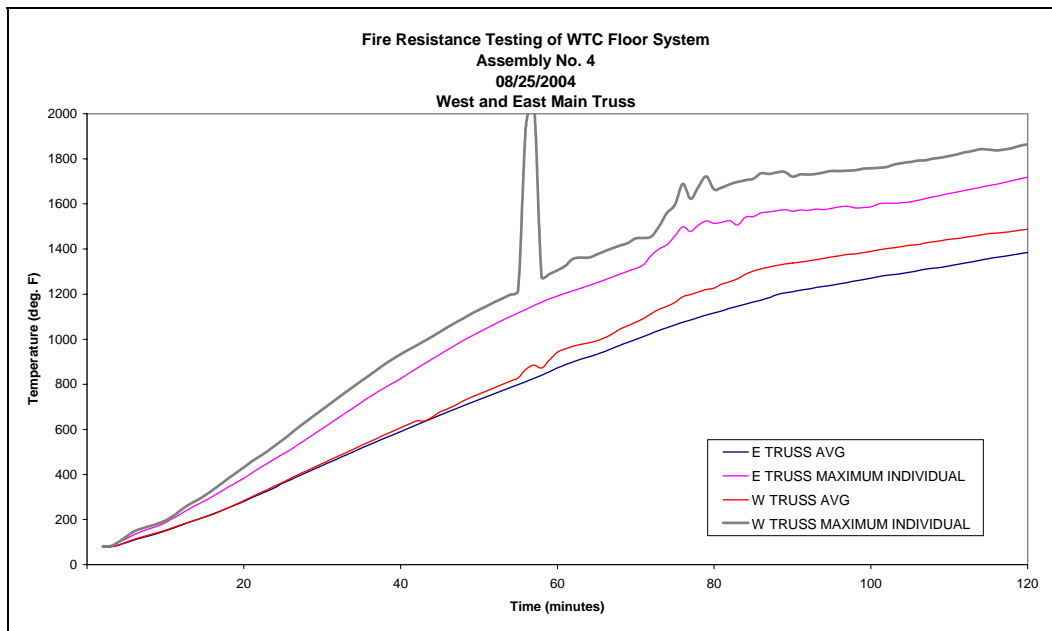
Figure 5–56. Assembly No. 4 – overall average and maximum individual temperatures on west and east main trusses.

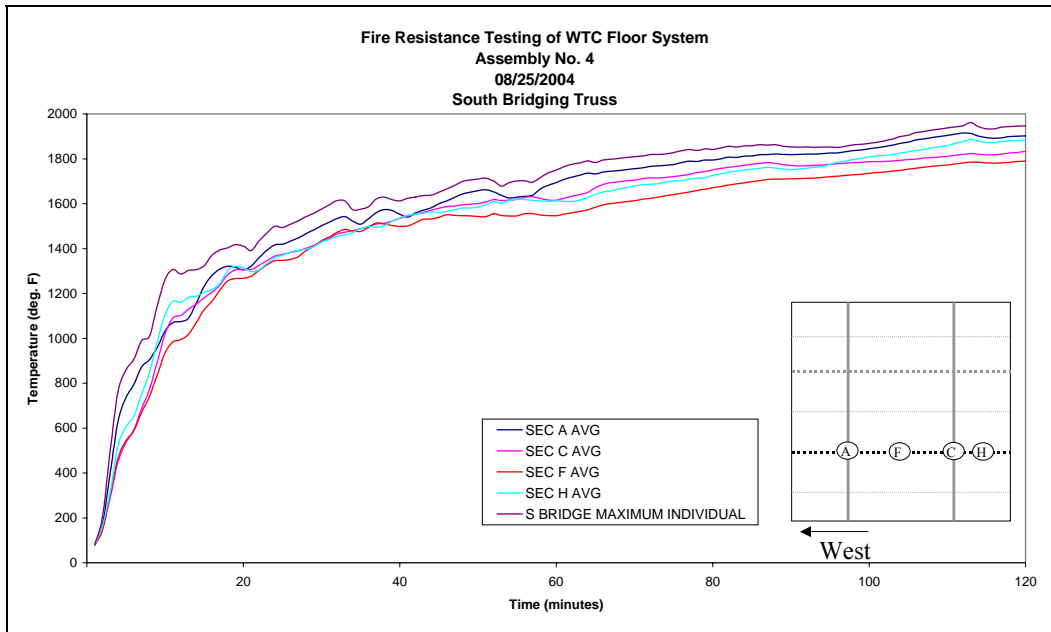
Figure 5–57. Assembly No. 4 – average and maximum individual temperatures on south bridging truss.

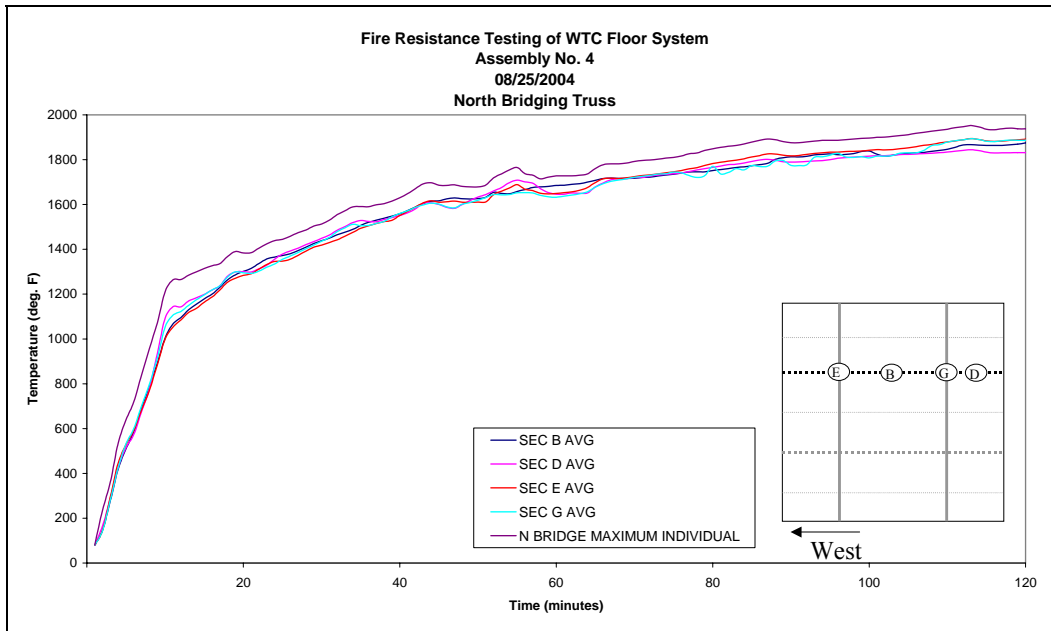
Figure 5–58. Assembly No. 4 – average and maximum individual temperatures on north bridging truss.

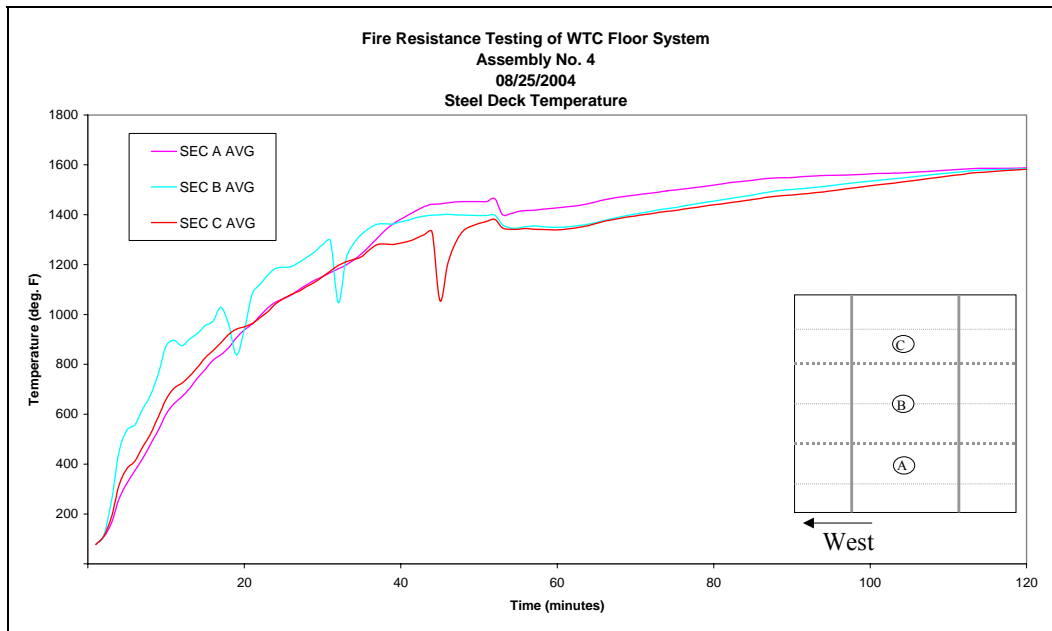
Figure 5–60. Assembly No. 4 – average temperatures on steel deck.

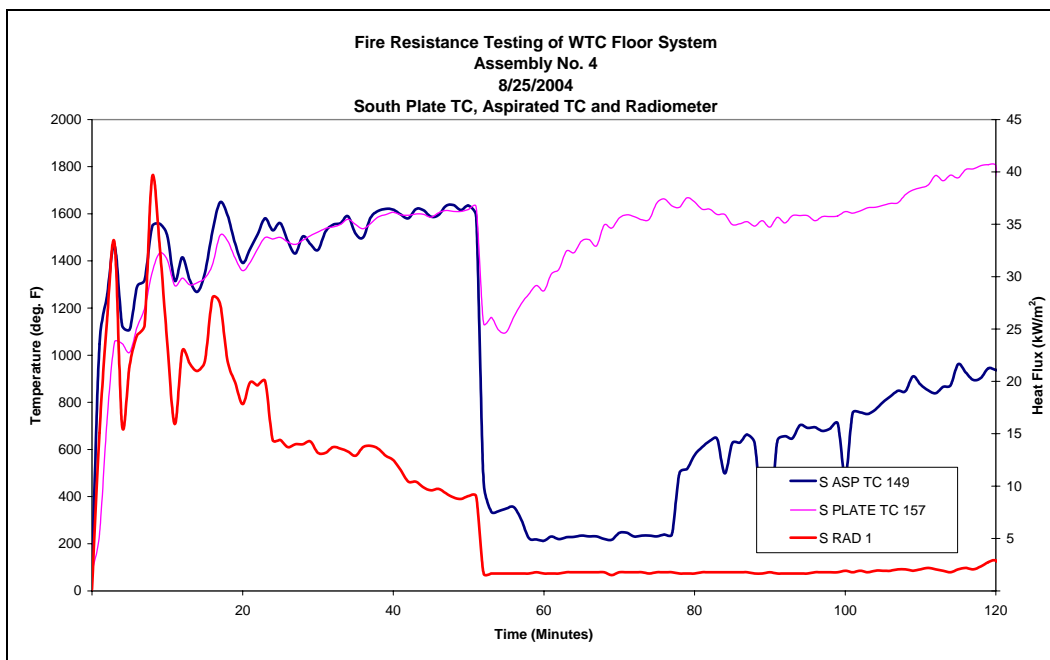
Figure 5–64. Assembly No. 4 – additional instrumentation through south opening.

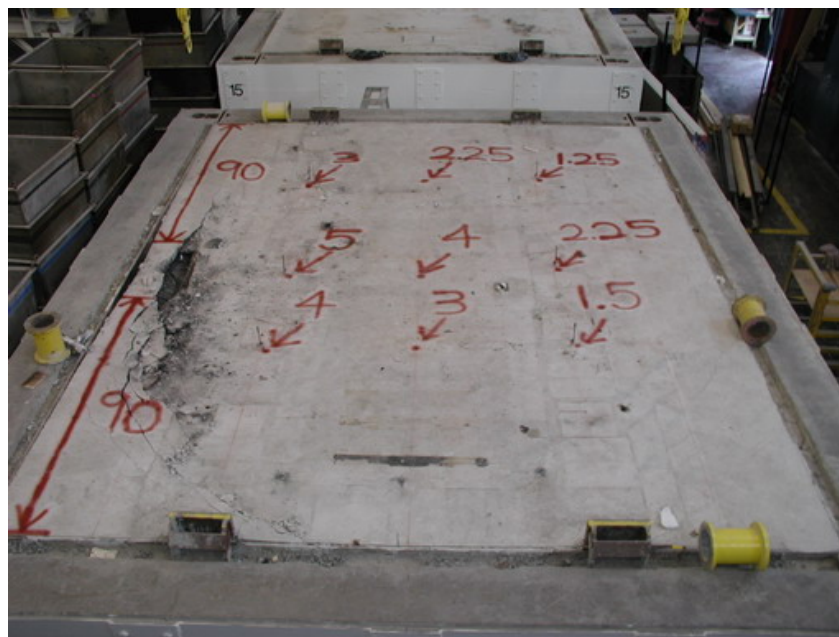
Figure 5–66. Unexposed surface of Assembly No. 4 after loading equipment was removed.

Figure 5–66 shows the unexposed side of the assembly after all loading equipment was removed (view looking north). Numbers shown at the centerline and quarter points are vertical deflections after cooling. All other numbers are reference dimensions as measured from the edge of the slab. Figures 5–67 through 5–70 are additional views of the post-test condition of the test specimen.

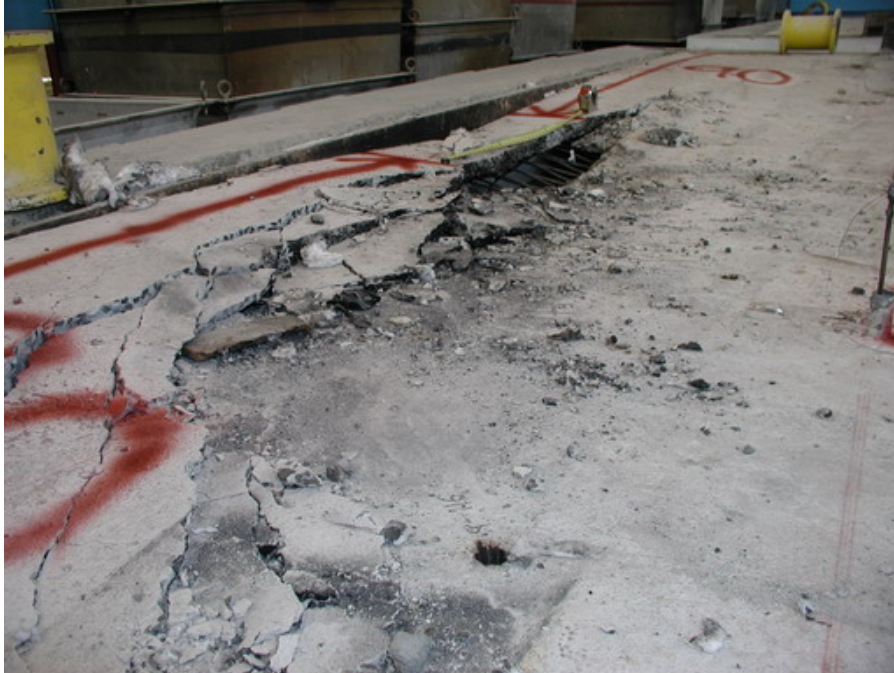
Figure 5–67. Unexposed surface of Assembly No. 4, view of concrete spalling on west side of assembly.

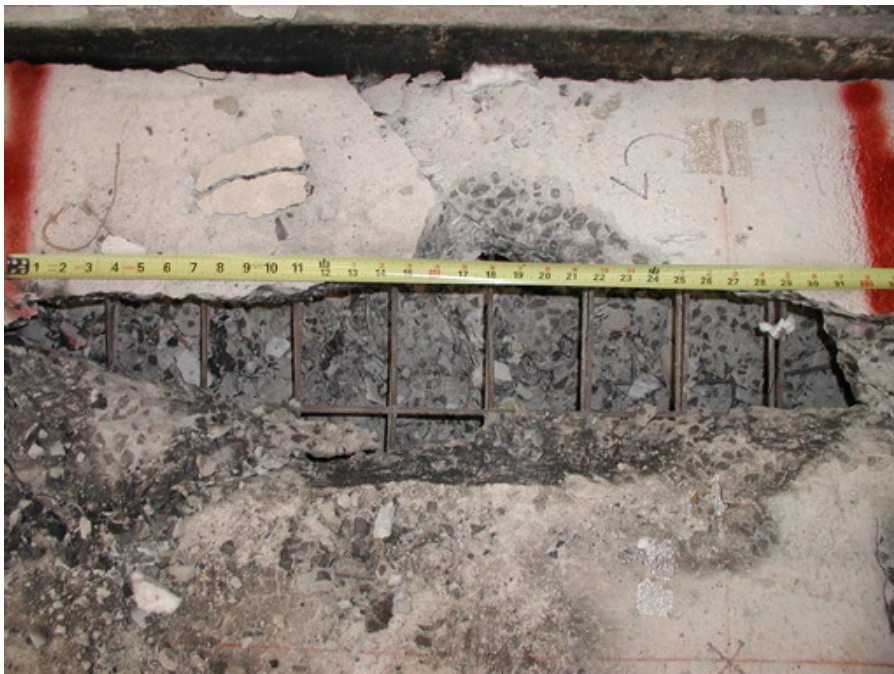
Figure 5–68. Unexposed surface of Assembly No. 4, close-up of concrete spalling on west side of assembly.

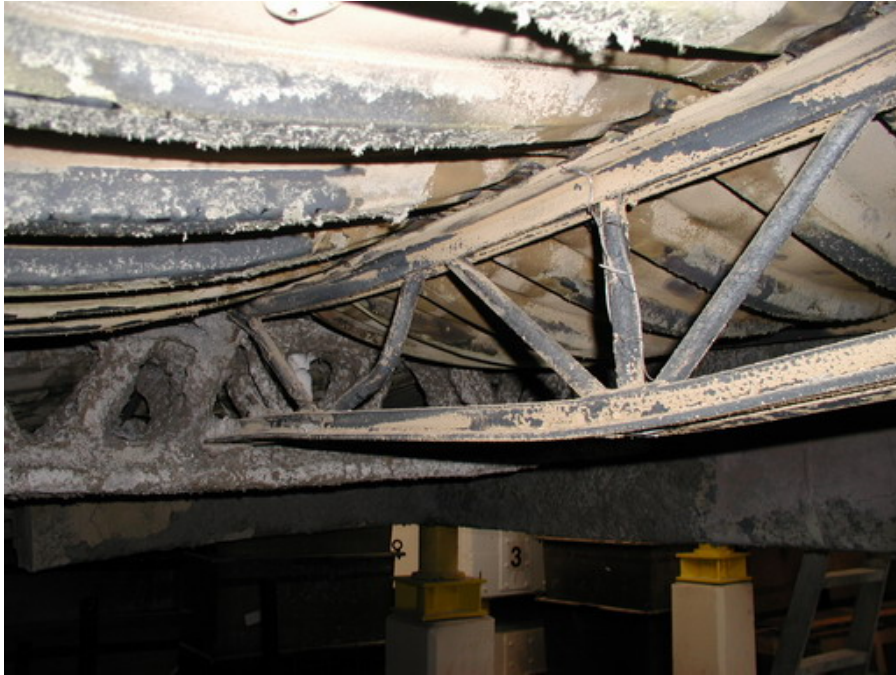
Figure 5–69. Intersection of north bridging and west main truss on Assembly 4.

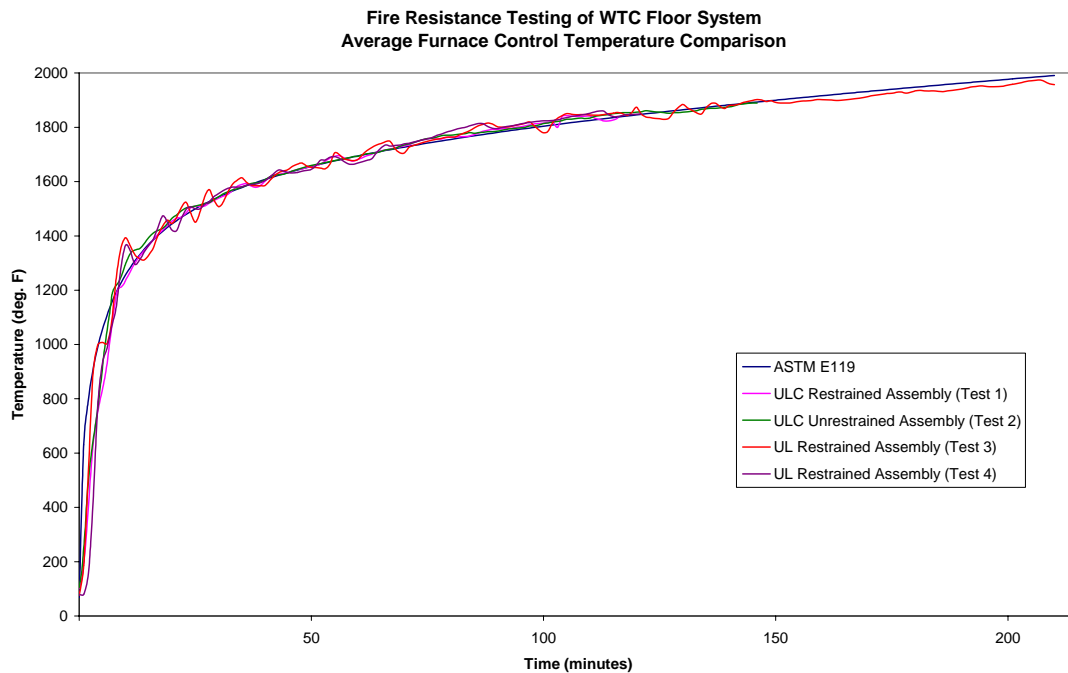
The average furnace temperatures during all four tests and the target time-temperature relationship prescribed by ASTM E 119 are shown in Fig. 6–1. It is seen that the average furnace control temperatures were very similar and indeed met the requirements of ASTM E 119.

Figure 6–1. Comparison of average furnace control temperatures.

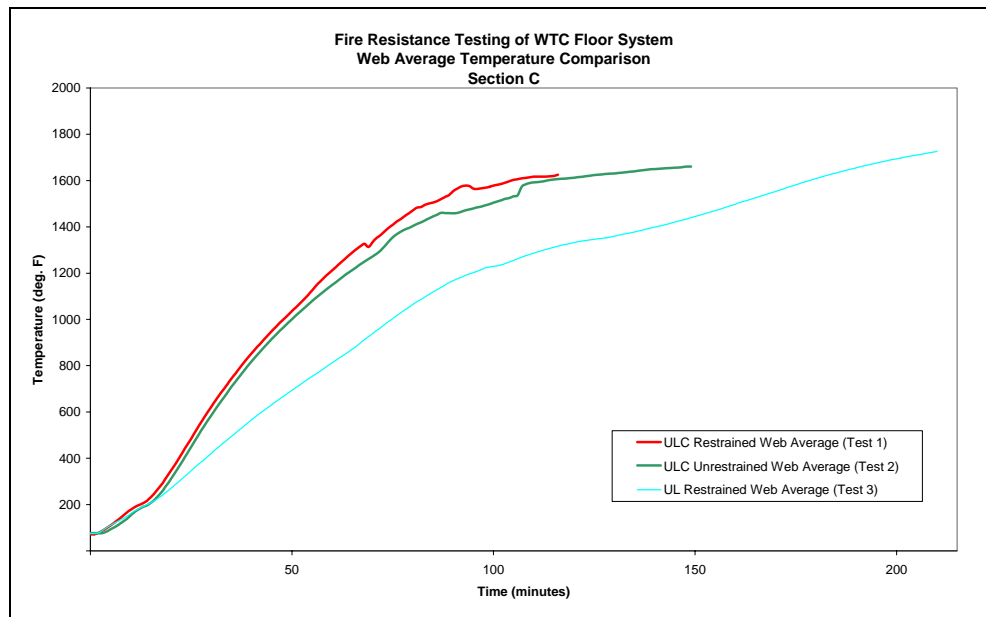
Figure 6–5 presents a comparison of temperatures of the truss web diagonals for the three tests in which the thickness of the SFRM was $\frac{3}{4}$ in. The web temperatures for the two full-scale tests (35 ft span assemblies) were greater than those for the reduced-scale test (17 ft span assembly) after about 15 min. The reason for this difference is not clear but is possibly due to the relationship between the SFRM thickness and scale of the steel trusses. Comparison of Figs. 5–35 and 5–53 illustrates the difference in the buildup of SFRM at the intersections of the webs and chord members between the full- and reduced-scale test specimens, which may affect the rate of heating of the truss web diagonals. These results illustrate that thermal scaling is an issue that needs to be addressed.

Figure 6–5. Average temperature of web diagonals for Test Nos. 1, 2, and 3 (3/4 in. thick SFRM).

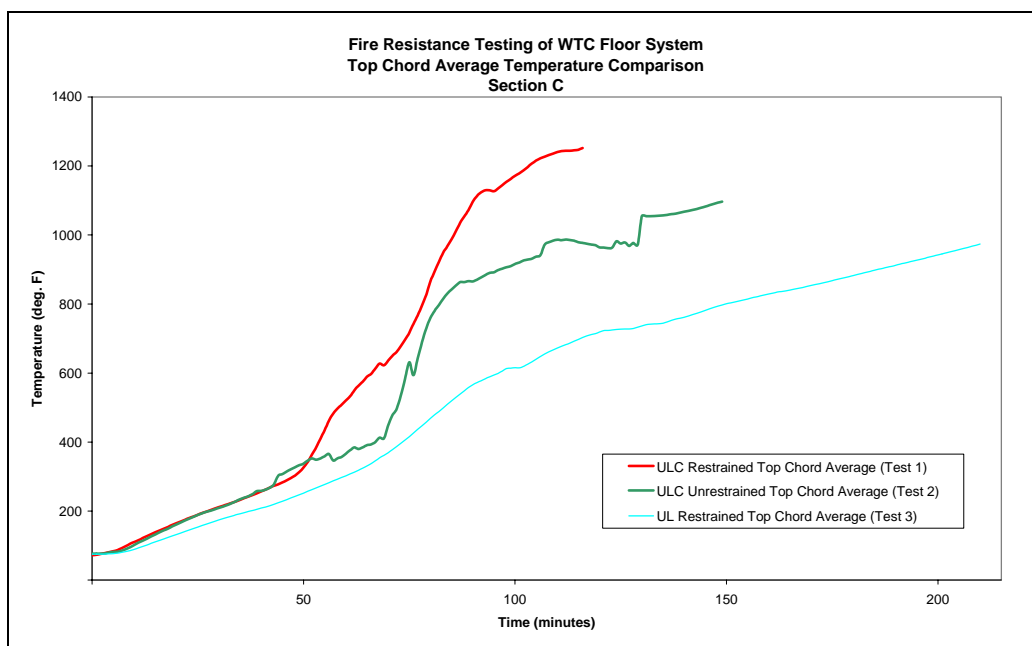
The average temperature of the top chord is plotted in Figure 6–6 for the three test assemblies with $\frac{3}{4}$ in. of SFRM. The average top chord temperature for the two full-scale tests (35 ft span test assemblies) was greater than the average temperature recorded for the reduced-scale test (17 ft span assembly) after about 50 min. Because of the comparatively abrupt changes in average temperature beginning around 50 min, the difference may be explained by sudden changes such as the onset of spalling of concrete and attendant loss of fire protection. However, since the steel temperatures in the reduced-scale test generally tend to be lower than in the full-scale test, this trend may be explained by a scale-related factor such as the difference in the buildup of SFRM affecting the rate of heating of the steel as noted above. Further, it is possible that the overspray on the metal deck was greater for test Specimen No. 3 than for the other two tests since the lower chord is closer to the metal deck. This, too, would be a geometrical scaling effect.

Figure 6–6. Average temperature of the top chord for Test Nos. 1, 2, and 3 (3/4 in. thick SFRM).

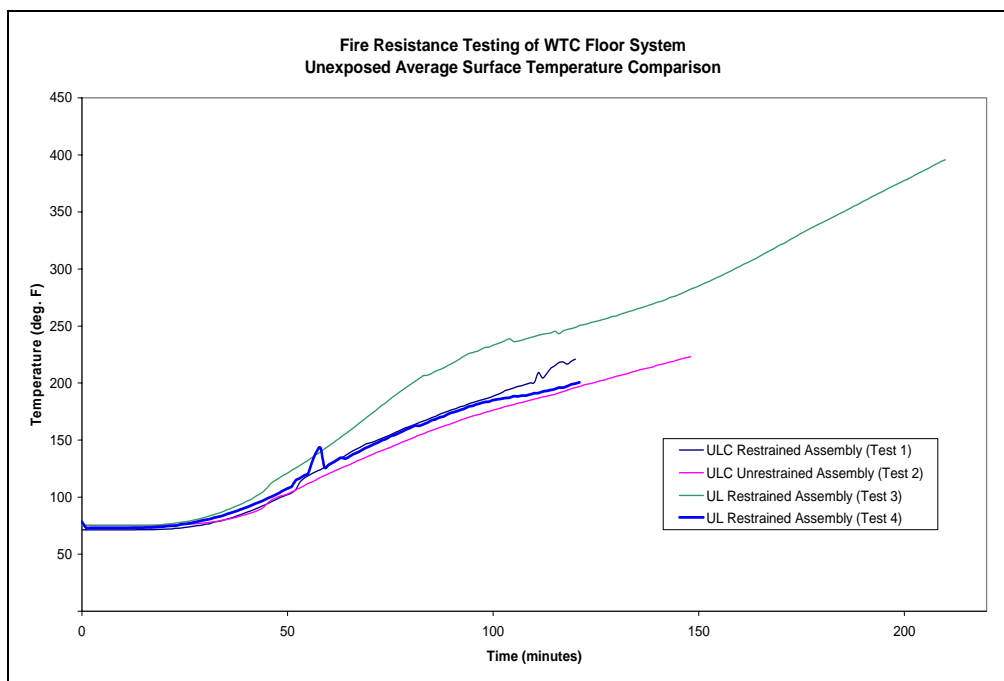
The temperature of the unexposed surface of the floor assemblies is plotted in Fig 6–8. It is observed that the unexposed surface temperatures of all four test assemblies were similar prior to the onset of significant concrete spalling at around 50 min. In Test 4, the surface-mounted TC on the west edge near the center of the span was affected by the explosive failure of the slab and recorded hot gas temperatures.

Figure 6–8. Average temperature of the unexposed surface for all four tests.

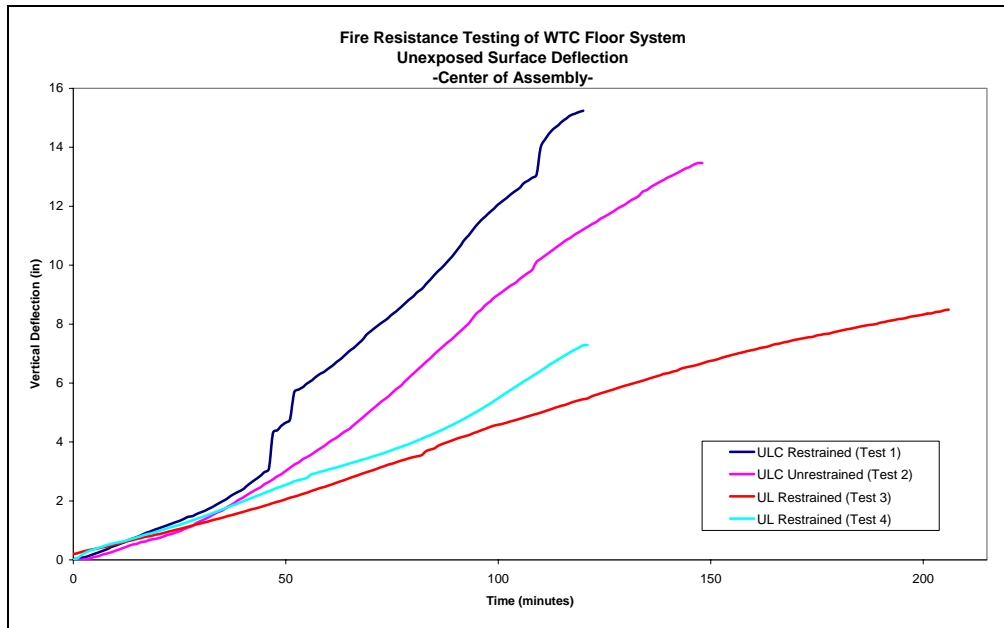
The following plots show the vertical deflection measured at the center of each assembly. Figure 6–9 shows the deflection, while Fig. 6–10 shows a plot of the deflection normalized by the span. It is seen that test Assembly No. 1 experienced a significant increase in vertical deflection at 49 min, which corresponds directly to a loud report and visible deflection noted in the test observations. Figure 5–13 shows the damage to the top side of the concrete slab that occurred with the sudden increases in deflection. The normalized curves show good agreement throughout the duration of the tests.

Figure 6–9. Deflection measured at the center of each assembly.
