NIST NCSTAR 1-5A

Federal Building and Fire Safety Investigation of the World Trade Center Disaster

Visual Evidence, Damage Estimates, and Timeline Analysis

William M. Pitts
Kathryn M. Butler
Valentine Junker

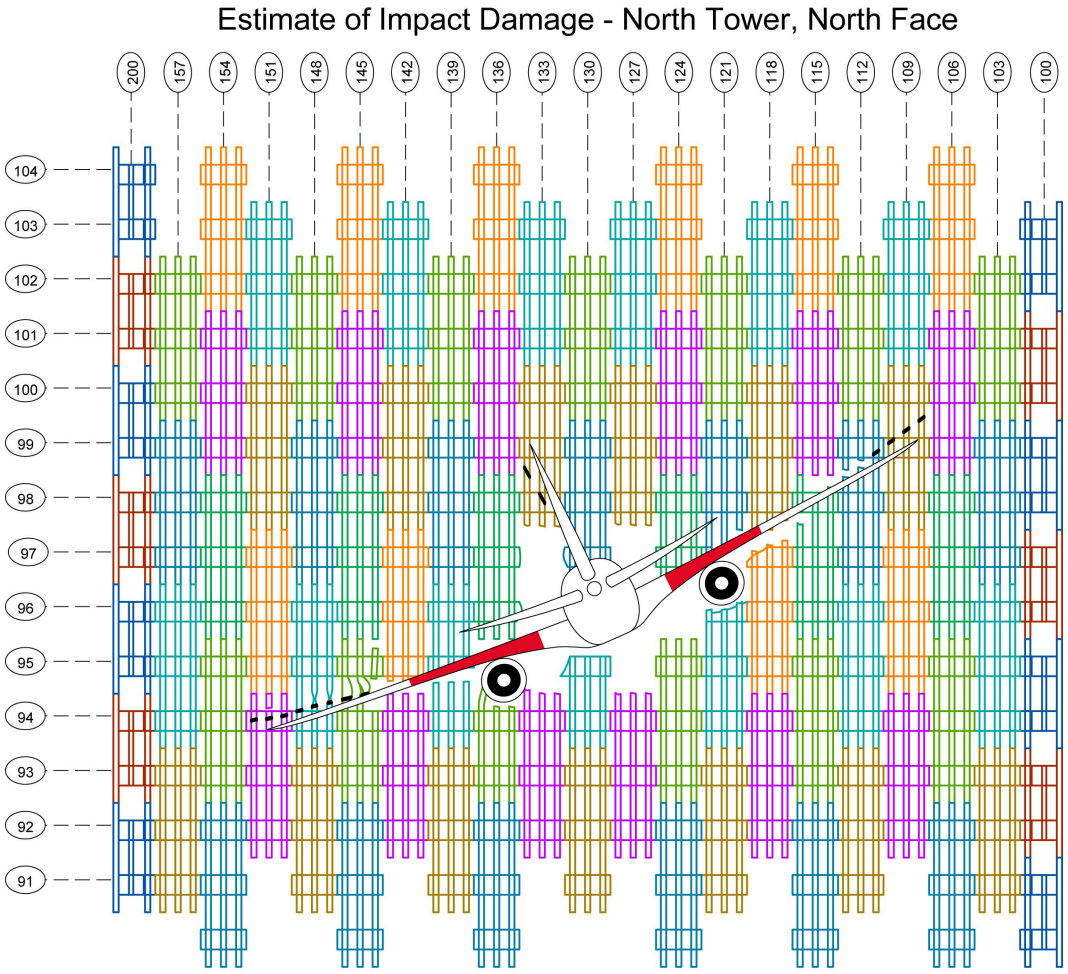
Figure E–1. A scaled outline of a Boeing 767-200ER is superimposed on the damage diagram for the north face of WTC 1. The position of the aircraft has been adjusted to best match the damage pattern and marks showing where the wing tips and vertical stabilizer struck. The red areas correspond to the approximate locations of fuel on the aircraft based on an analysis reported elsewhere (NIST NCSTAR 1-2B).

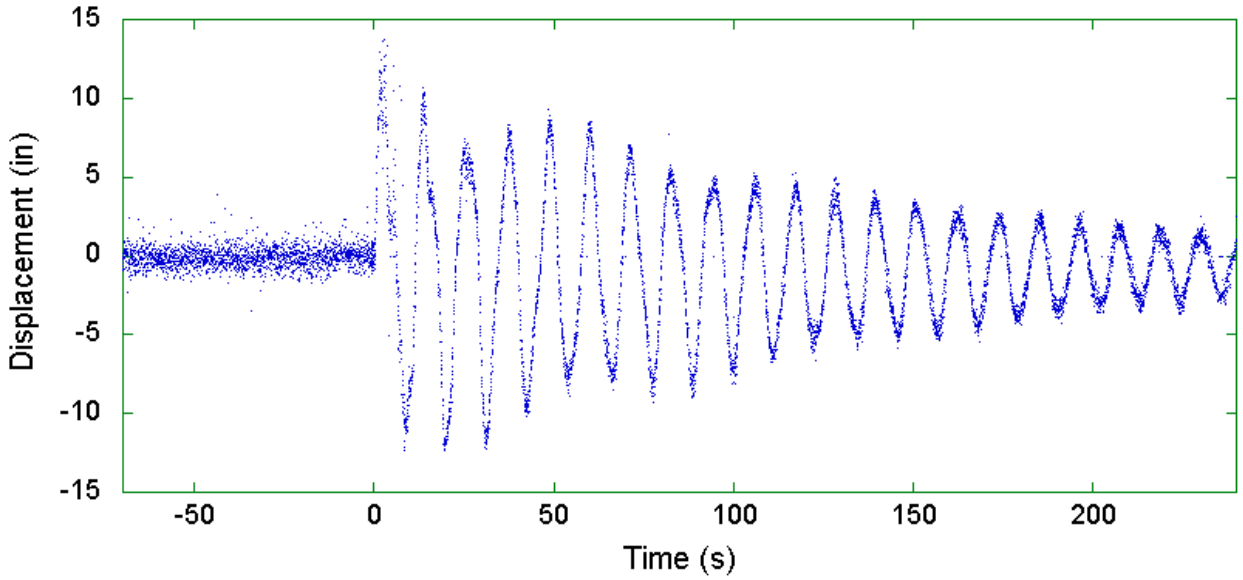
Close examination of this video revealed a perceptible north-south movement of WTC 2 after it was struck by the aircraft. Image analysis of the video allowed the movement of the tower at the 70th floor to be determined as shown in Figure E-2. The maximum deflection was determined to be 12 in. ± 1 in. at this height, which extrapolates to a value of 22 in. ± 5 in. at the roofline. The primary period for the motion was 11.4 s ± 0.1 s, consistent with the fundamental natural mode of the building. Similar measurements using a brief video shot from the north yielded an amplitude near the roof line of 6 in. ± 1 in. for the east-west direction with a period of 5.3 s ± 0.1 s. This period and motion are consistent with the first torsional (twisting) mode of the tower.

Figure E–2. The displacement of the first (left-most) window line on the 70th floor of WTC 2 determined using moiré analysis is shown as a function of time.

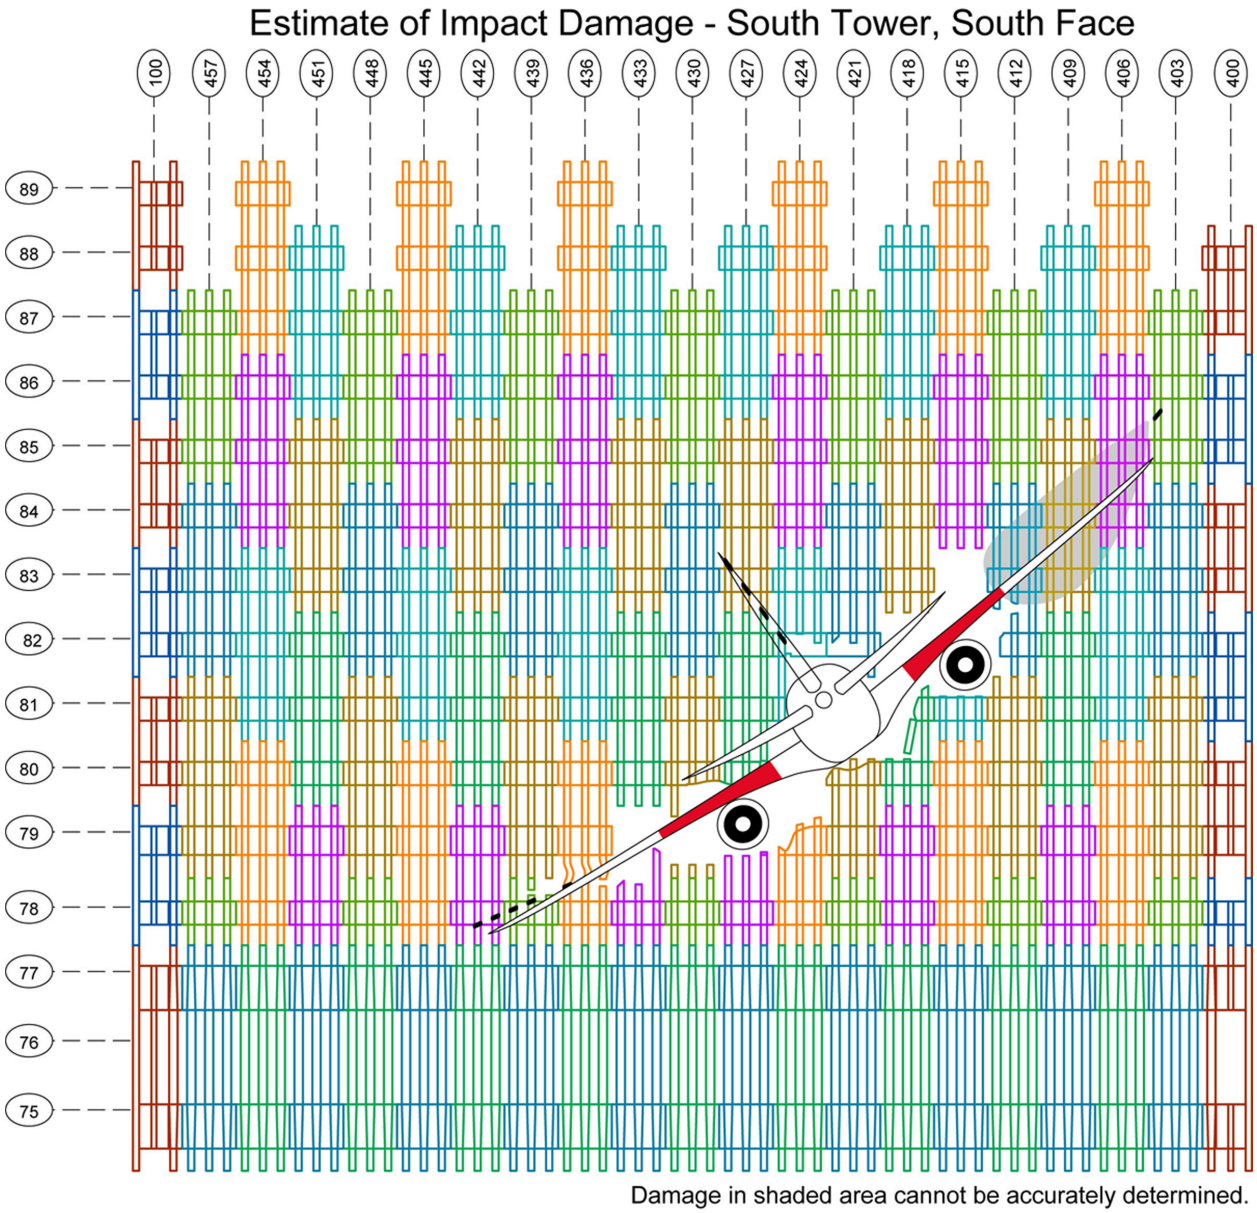
Figure E–3. A scaled outline of a Boeing 767-200ER is superimposed on the damage diagram for the south face of WTC 2. The position of the aircraft has been adjusted to best match the damage pattern and marks showing where the wing tips and vertical stabilizer struck. The red areas correspond to the approximate locations of fuel on the aircraft based on an analysis reported elsewhere (NCSTAR 1-2B).

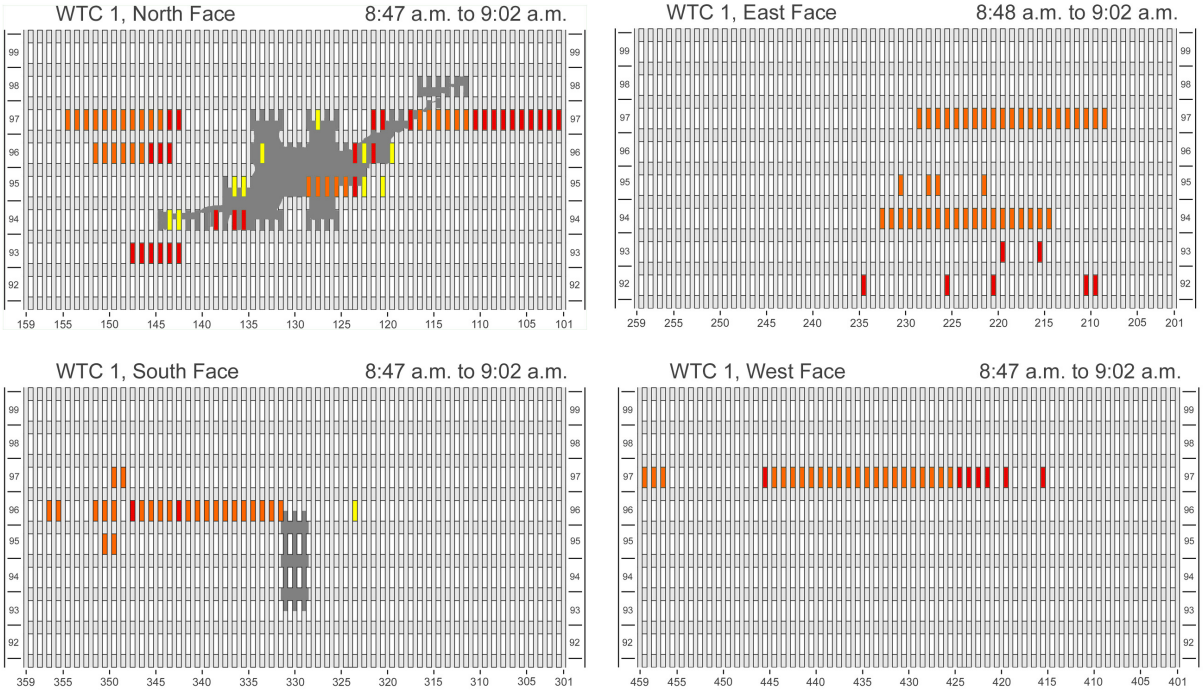
Fire observations for the period are summarized by the façade maps in Figure E-4, which show fire locations integrated over the period. The color coding indicates the highest fire intensity recorded during the period, with yellow representing a spot fire, red a more extensive fire burning inside the tower, and orange a fire with flames extending out of the window.

Figure E–4. Maps of integrated fire observations between 8:47 a.m. and 9:03 a.m. are shown for the four faces of WTC 1.

The most extensive fire growth took place on the 97th floor. The apparent rapid development of these fires, particularly on the west face, may be an indication that the fire growth and spread was accelerated by the presence of initially unburned aviation fuel that may have been dispersed over this floor during the aircraft impact.

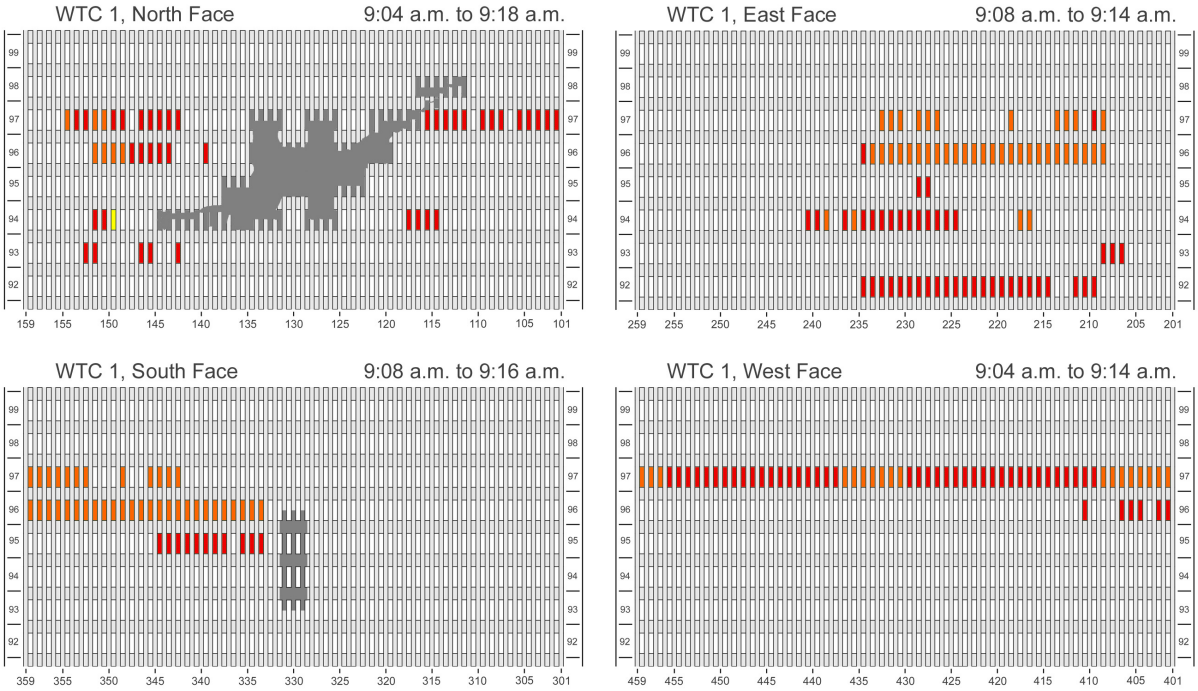
Figure E–5 shows integrated fire maps for the four faces of WTC 1 covering the period. Comparison with Figure E–4 reveals the changes in fire distributions between the two time periods. The most prominent feature in Figure E-5 is the extent of the fires on the 97th floor, with flames visible in a nearly continuous band running clockwise from just west of the center of the south face, along the western and northern faces, and reaching just past the center of the east face. Another feature which stands out is the general lack of visible fire in the southwest quadrant of the tower.

Figure E–5. Maps of integrated fire observations between 9:03 a.m. and 9:18 a.m. are shown for the four faces of WTC 1.

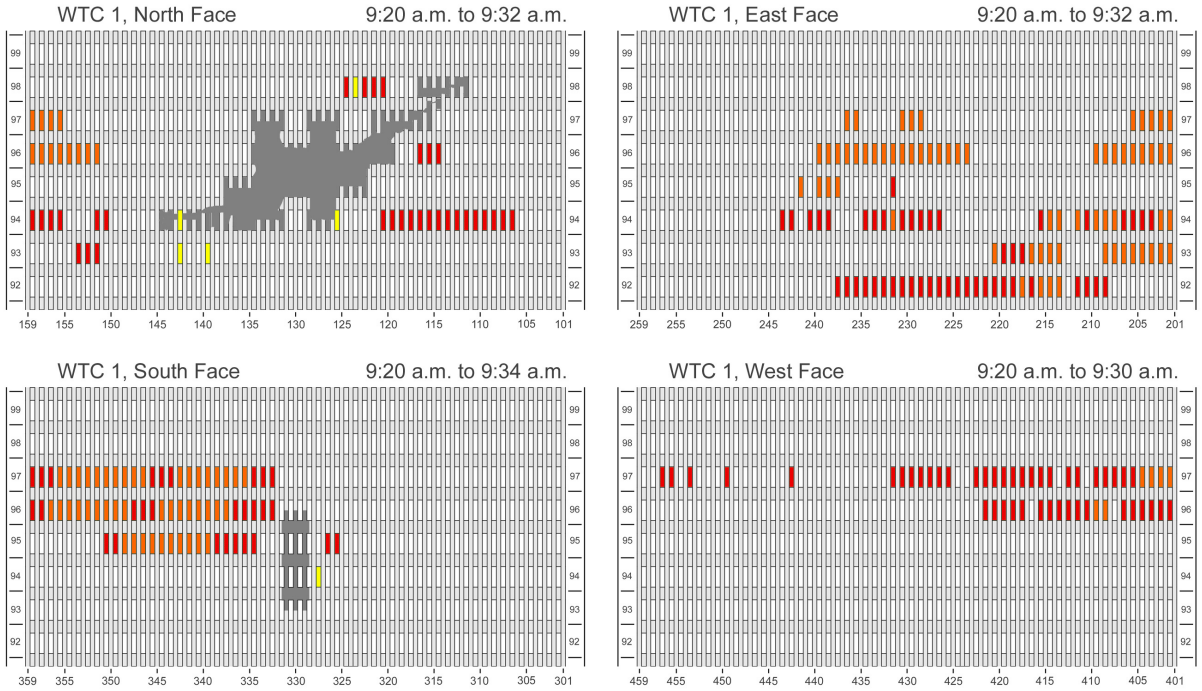
Integrated façade maps for the fires observed during the period are shown in Figure E-6. In general, fire spread during this period was reduced compared to the first two periods. While intensely burning fires with extended flames developed in northeast corner rooms on several floors, most of the new fire growth involved less intense flames that did not extend from windows. Such fires included those on the west side of the 94th floor and the central section of the 98th floor on the north face and the south side of the 96th floor on the west face.

Figure E–6. Maps of integrated fire observations between 9:19 a.m. and 9:35 a.m. are shown for the four faces of WTC 1.

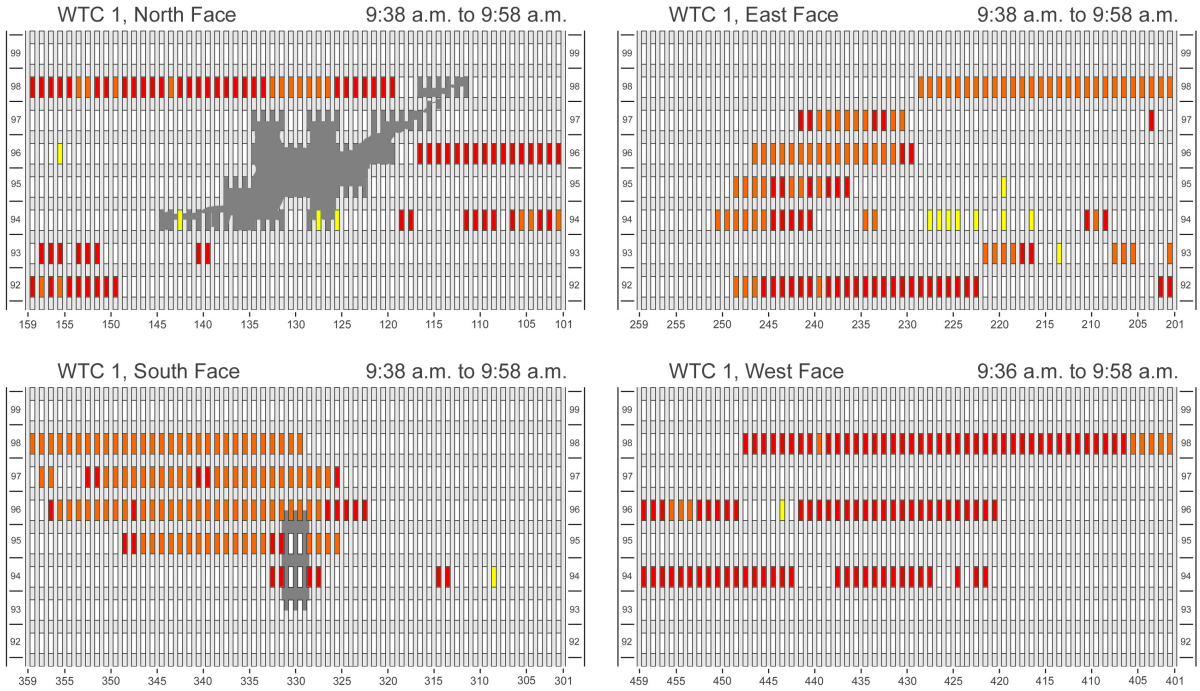
Figure E–7. Maps of integrated fire observations between 9:36 a.m. and 9:59 a.m. are shown for the four faces of WTC 1.

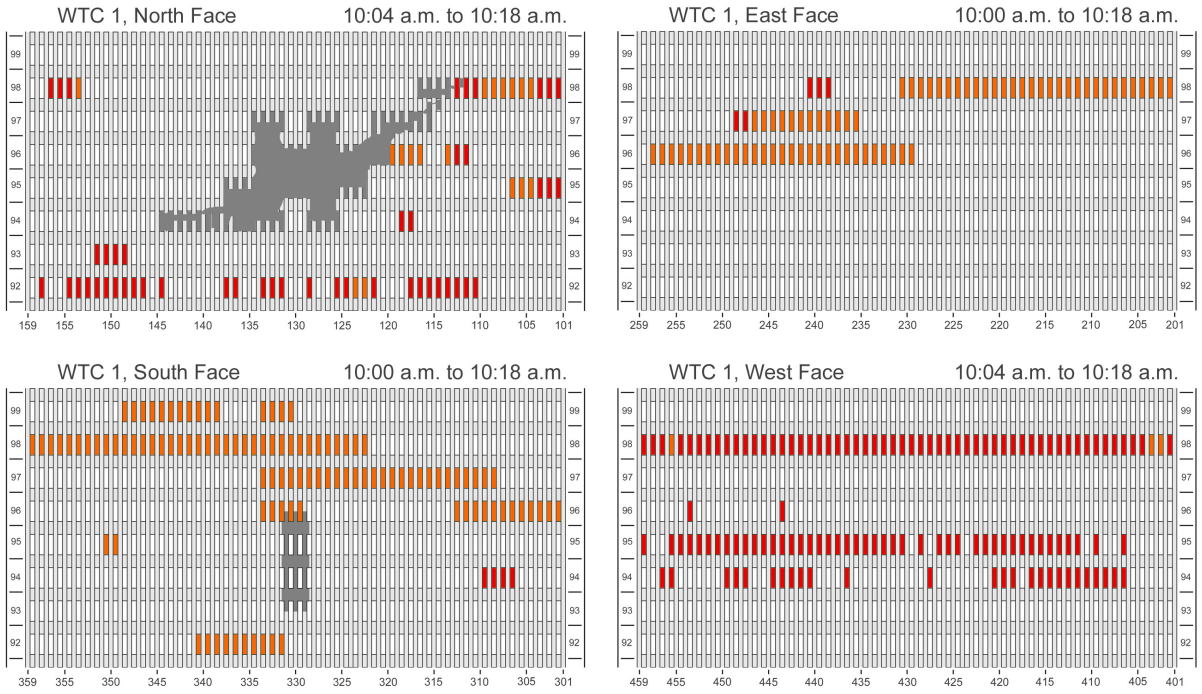
Integrated fire maps of the four faces for the period are included in Figure E–8. These maps likely underestimate the actual extent of the fires due to the limited visibility on the east and south faces. The extensive fires on the 98th floor are a dominant feature. Keep in mind that the much of the fire on the north side of this floor had already died down. The intense fires that developed rapidly along the periphery of the southeast quadrant also stand out. The broad extent of the low intensity fires on the west

sides of the 94th and 95th floors is also evident. Note that the intense fire that grew on the south side of the west face of the 104th floor is not displayed in the façade map.

Figure E–8. Maps of integrated fire observations between 10:00 a.m. and 10:18 a.m. are shown for the four faces of WTC 1.

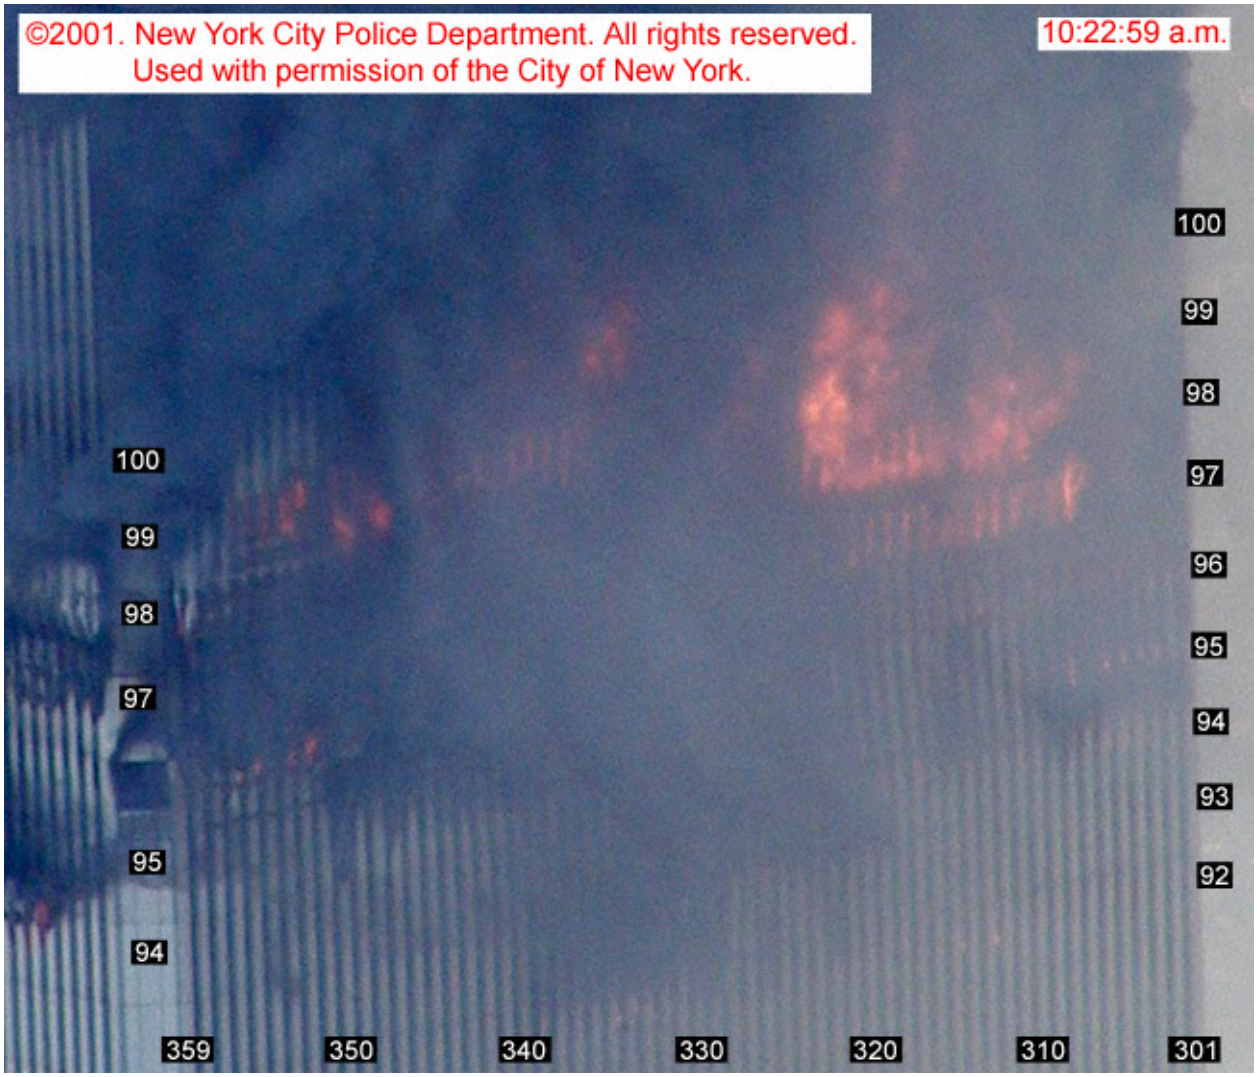
Views of the south face of WTC 1 were also limited for this time period, but several photographs taken from a helicopter flying relatively close to the tower provided a good indication of conditions on this face roughly half way through the period. Figure E–9 shows a cropped view of one of these photographs shot from the southwest at 10:22:59 a.m. Fires are visible on the east side of the face on the 92nd through 98th floors. A long distance video showed that the particularly intense fire on the 98th floor moved into the area around 10:19 a.m. Closer inspection reveals that many of the columns on the south face in the vicinity of 95th floor to the 98th floors were bowed inward at this time. Somewhat smaller flames are visible on the west side of the face on the 92nd, 96th, 98th, 99th, and 100th floors. Around 10:25 a.m. heavy smoke and fire appeared from windows in a room located in the southwest corner of the 94th floor. Long distance videos show that during the period leading up to the tower collapse the line of fire on the 98th floor continued to burn vigorously. The fire on the 99th floor appeared to intensify and move toward the east, eventually reaching a location more than half way between the center of the face and the east edge. When WTC 1 began to collapse, a large amount of flame was pushed from openings on the south face, with flames appearing to come from three separate locations. The first was from the vicinity of the intense fire burning on the east sides of the 98th and 99th floors, the second was from the fire burning on the western edge of the 94th floor, and the third came from around the center of the face near the 94th floor.

Figure E–9. This photograph showing the south face of WTC 1 is a cropped version of a photograph shot from a helicopter at 10:22:59 a.m. It has been enhanced by adjusting the intensity levels, and column and floor numbers have been added.

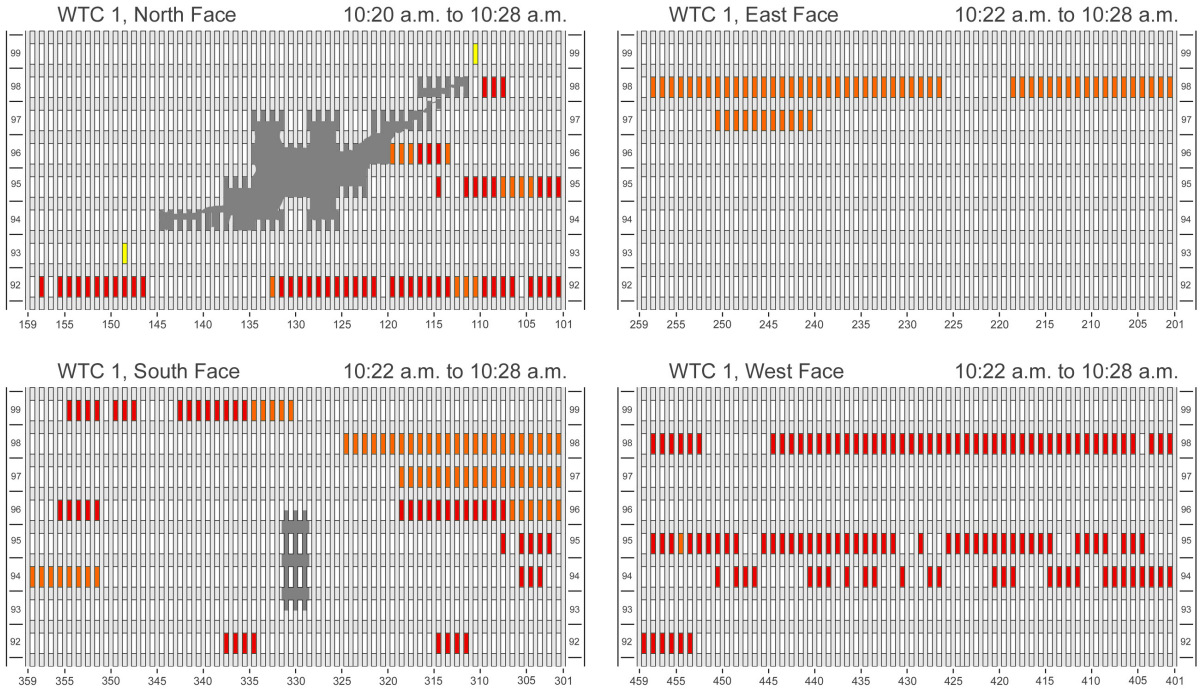
The integrated fire data for the period are shown in Figure E–10. A notable feature is the widespread presence of intense fire in the southeast quadrant of the tower following a long period when the area seemed to be isolated from fires burning elsewhere.

Figure E–10. Maps of integrated fire observations between 10:20 a.m. and 10:28 a.m. are shown for the four faces of WTC 1.

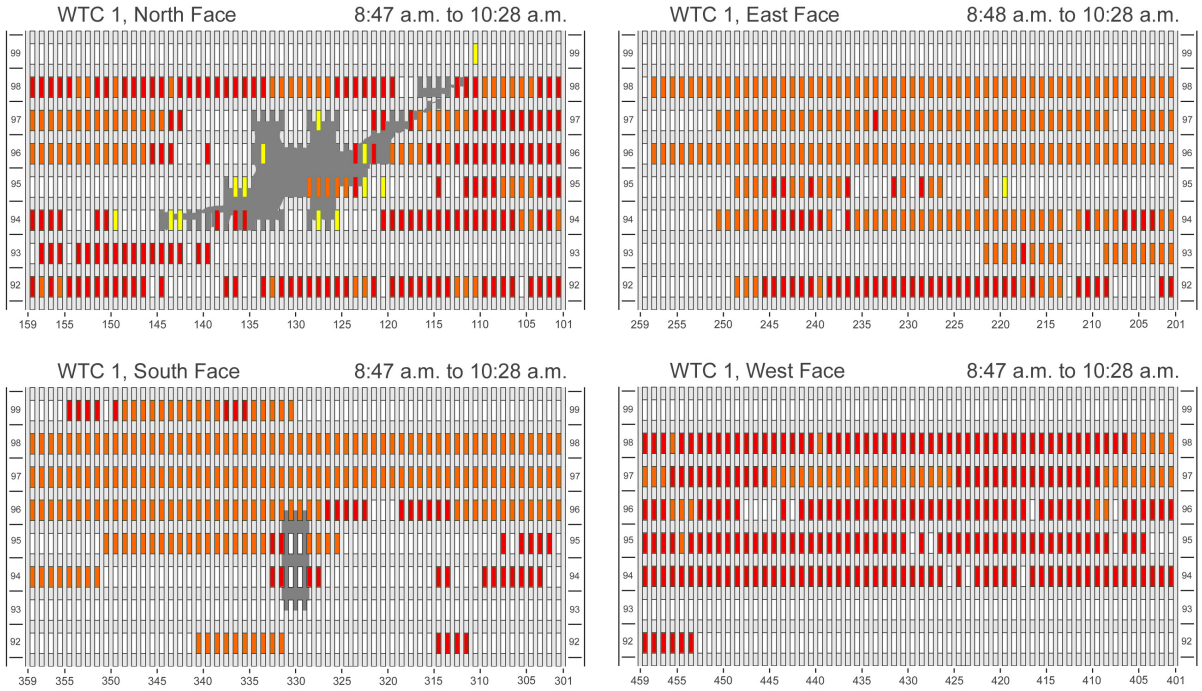
An interesting aspect of the fire behavior in WTC 1 was the variation in burning behavior observed on the different faces. Fires at most locations on the west and north faces of the towers burned without flame extension or release of large amounts of smoke from nearby windows. In many cases the fires appeared to burn as relatively low intensity distributed flames. The preponderance of red in the north and west face maps in Figure E-11 reflects this type of burning. In contrast, the fires burning on the east and south faces

most often generated external flames and heavy smoke flows at nearby windows as indicated by the extensive areas of orange on the façade fire maps. Various explanations for the different burning behaviors were considered. The most plausible is the effect of the prevailing wind. On September 11, the wind was striking WTC 1 from the northwest and then flowing down the north and west faces. This wind created positive pressures at the windows on these faces that tended to resist gas flows out of the tower. On the east and south faces the effect of the wind was the opposite, creating low pressure areas at the windows that tended to draw gases out of the building. The net effect of these pressure forces was a tendency for gases to flow internally on a floor, if a pathway was available, from the west and north faces to the east and south faces.

Figure E–11. Maps of integrated fire observations between 8:47 a.m. and 10:28 a.m. are shown for the four faces of WTC 1.

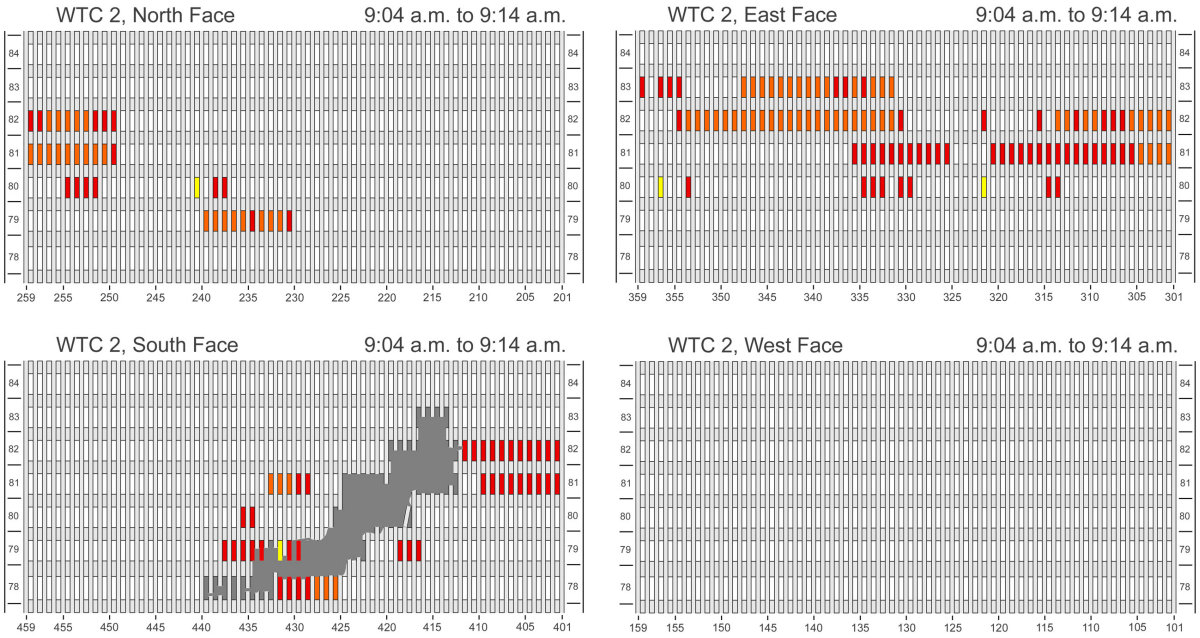
The fire data sheets for the period were integrated as a means for summarizing the fire distributions. The results are shown in Figure E-12. From these maps it is clear that the major visible fires were burning on the east and north faces of the tower. The most intense fires were on the 81st through 83rd floors, i.e., the upper portion of the floors impacted by the aircraft.

Figure E–12. Maps of integrated fire observations between 9:04 a.m. and 9:14 a.m. are shown for the four faces of WTC 2.

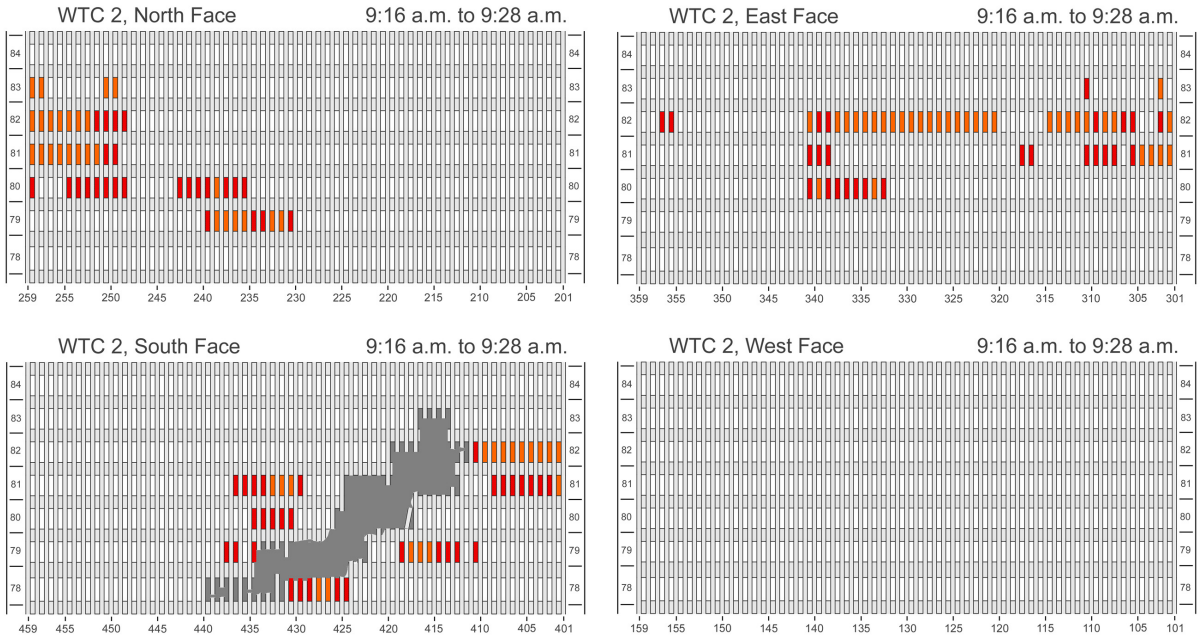
Maps of integrated fire intensities over the period for the four faces are shown in Figure E–13. Comparison with Figure E–12 confirms that minimal fire spread was taking place during the period. The fire distributions on the east face for the two periods appear quite different due to the rapid changes in the fires observed near the beginning of the first period and the continued northward spread of the fire on the 81st floor, which initially developed on the south side of the face, while going through a cycle of growth, intense burning, and decay. As during the initial time period, the largest fires were in the northeast corners of the tower on the 81st and 82nd floors and near the center of the north face on the 79th and 80th floors. These fires had been burning since the aircraft impact and were slowly dying down.

Figure E–13. Maps of integrated fire observations between 9:15 a.m. and 9:29 a.m. are shown for the four faces of WTC 2.

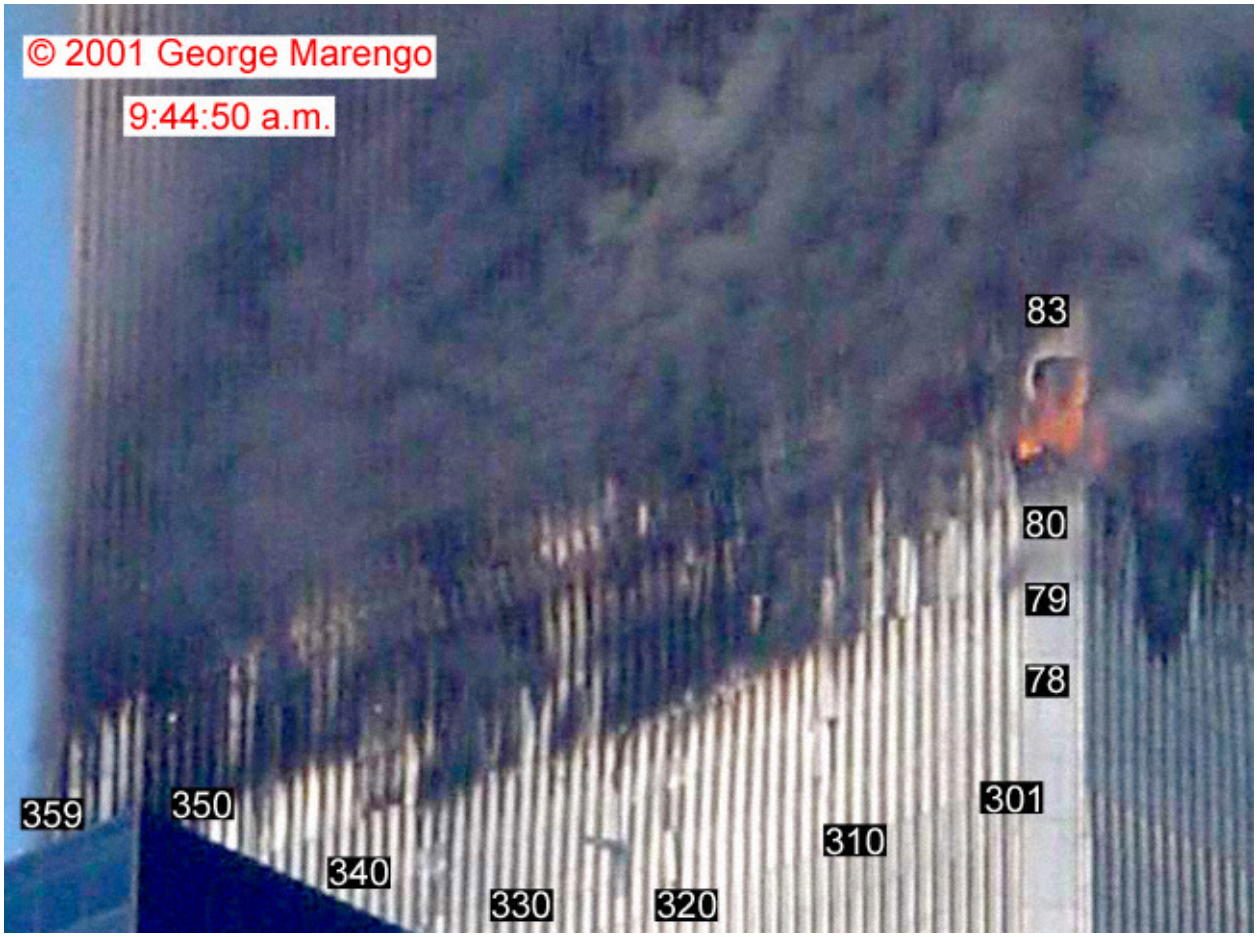
Figure E–14. This cropped photograph was shot from the northeast and shows the east face of WTC 2 at 9:44:50 a.m. The original intensity levels have been adjusted, and column and floor numbers have been added.

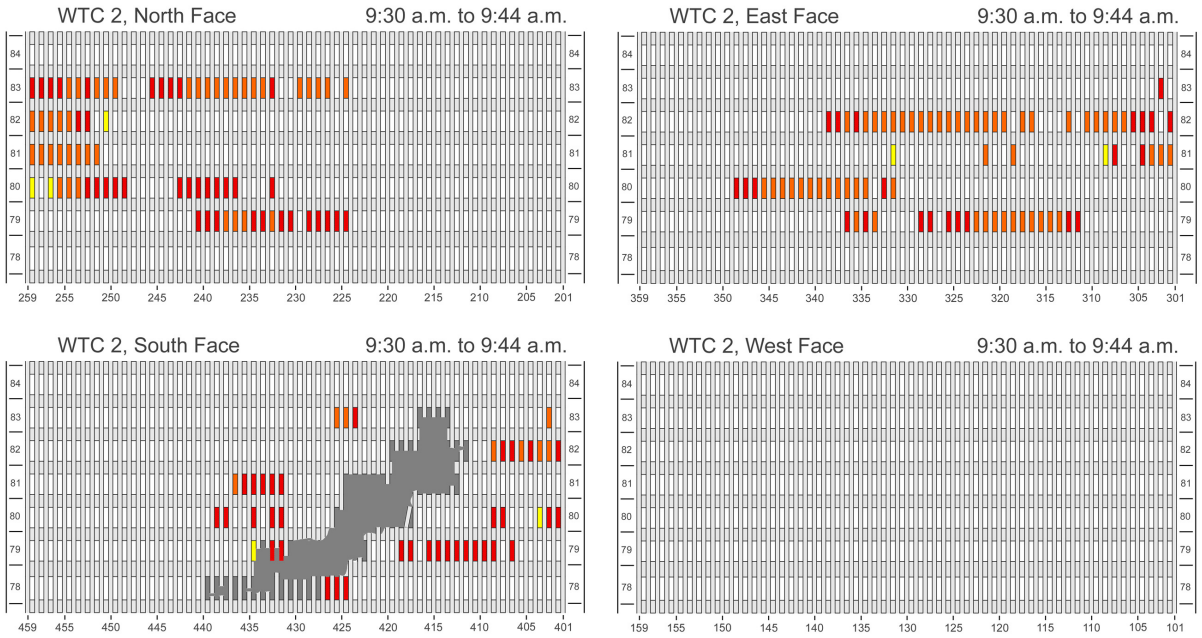
Figure E-15 shows integrated fire maps for the period. The new areas of fire that appeared on the 79th and 83rd floors of the north face are evident. Extensive new areas of fire were also present on the 79th and 80th floors of the east face. It should be remembered that a fraction of the observed fire indicated on the maps for these floors was associated with the three roughly one-minute-duration periods during which heavy smoke flows and fires were present.

Figure E–15. Maps of integrated fire observations between 9:30 a.m. and 9:45 a.m. are shown for the four faces of WTC 2.

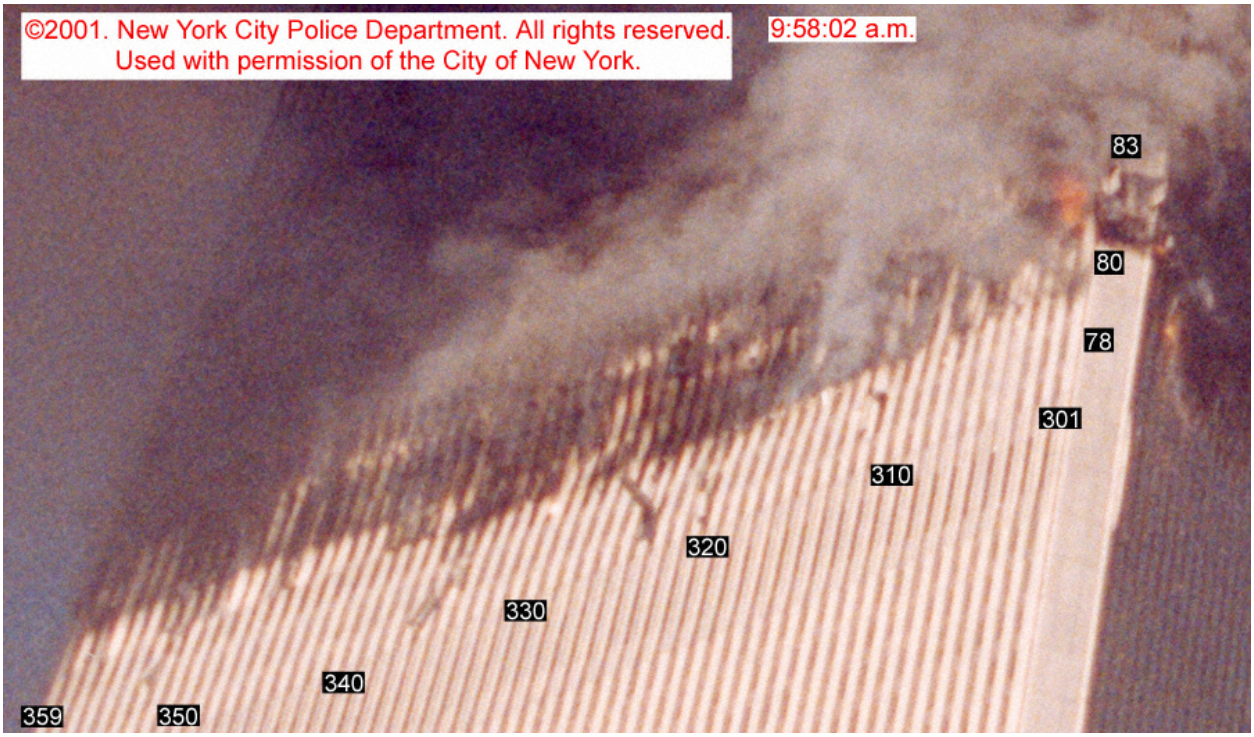
through windows on the 82nd floor changed again, with the northernmost window where the object could first be seen located slightly to the north. A prominent feature on the east face during the period was the inward bowing of the outer wall. This can be seen clearly over the 79th to 82nd floors in Figure E-16, which was taken less than a minute before the collapse started. During the 20 s prior to the collapse, a large number of pieces of debris fell from the northern sides of the 80th and 81st floors. The falling debris coincided with a heavy flow of molten metal from the north face. When WTC 2 collapsed, very little flame was expelled from the east face windows. Based on observations elsewhere on the two towers, regions of intense burning would have been expected to generate short-lived jets of flames. Their absence suggests that large fires were not burning near the east face at the time of collapse.

Figure E–16. This cropped image shows the east face of WTC 2 at 9:58:02 a.m. The intensity levels have been adjusted, and column and floor numbers have been added.

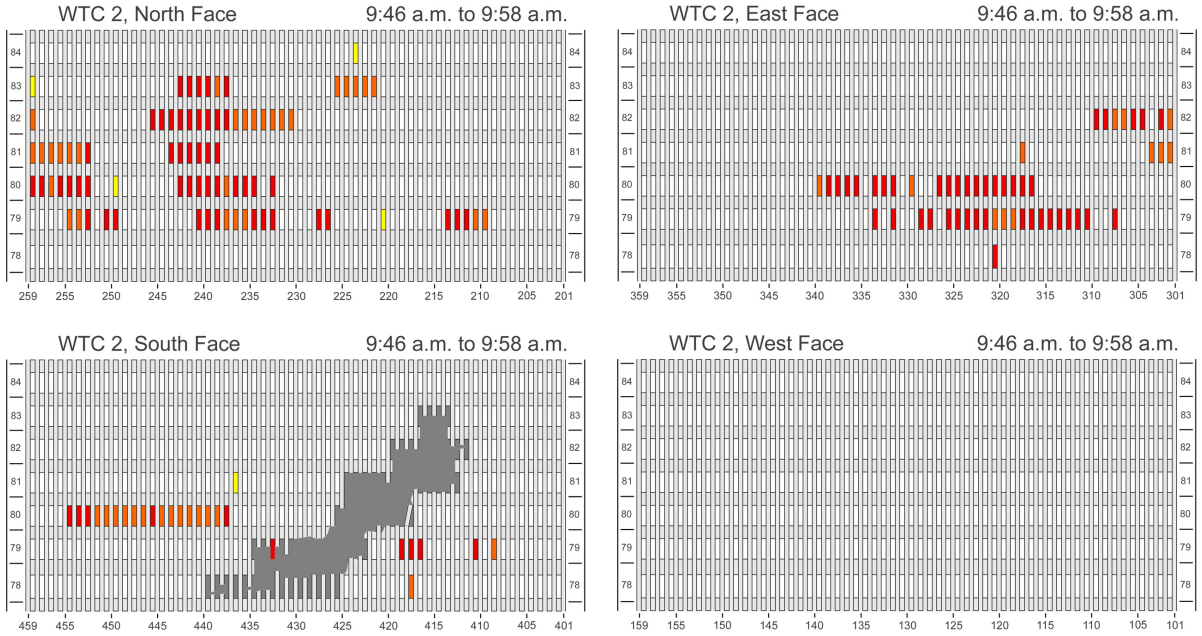
Façade maps of integrated fire intensities for the period are shown in Figure E–17. Many of the fires present during earlier periods were either no longer visible or were dying down during the final interval prior to the tower collapse. Some fire spread to the west had taken place on several floors on the north face. Areas with substantial fires included those on the north sides of the east face on the 79th and 80th floors (recall that the observed fires are combinations of sustained fires and short-lived flame releases) and the intense fire that grew on the west side of the south face on the 80th floor.

Figure E–17. Maps of integrated fire observations between 9:45 a.m. and 9:59 a.m. are shown for the four faces of WTC 2.

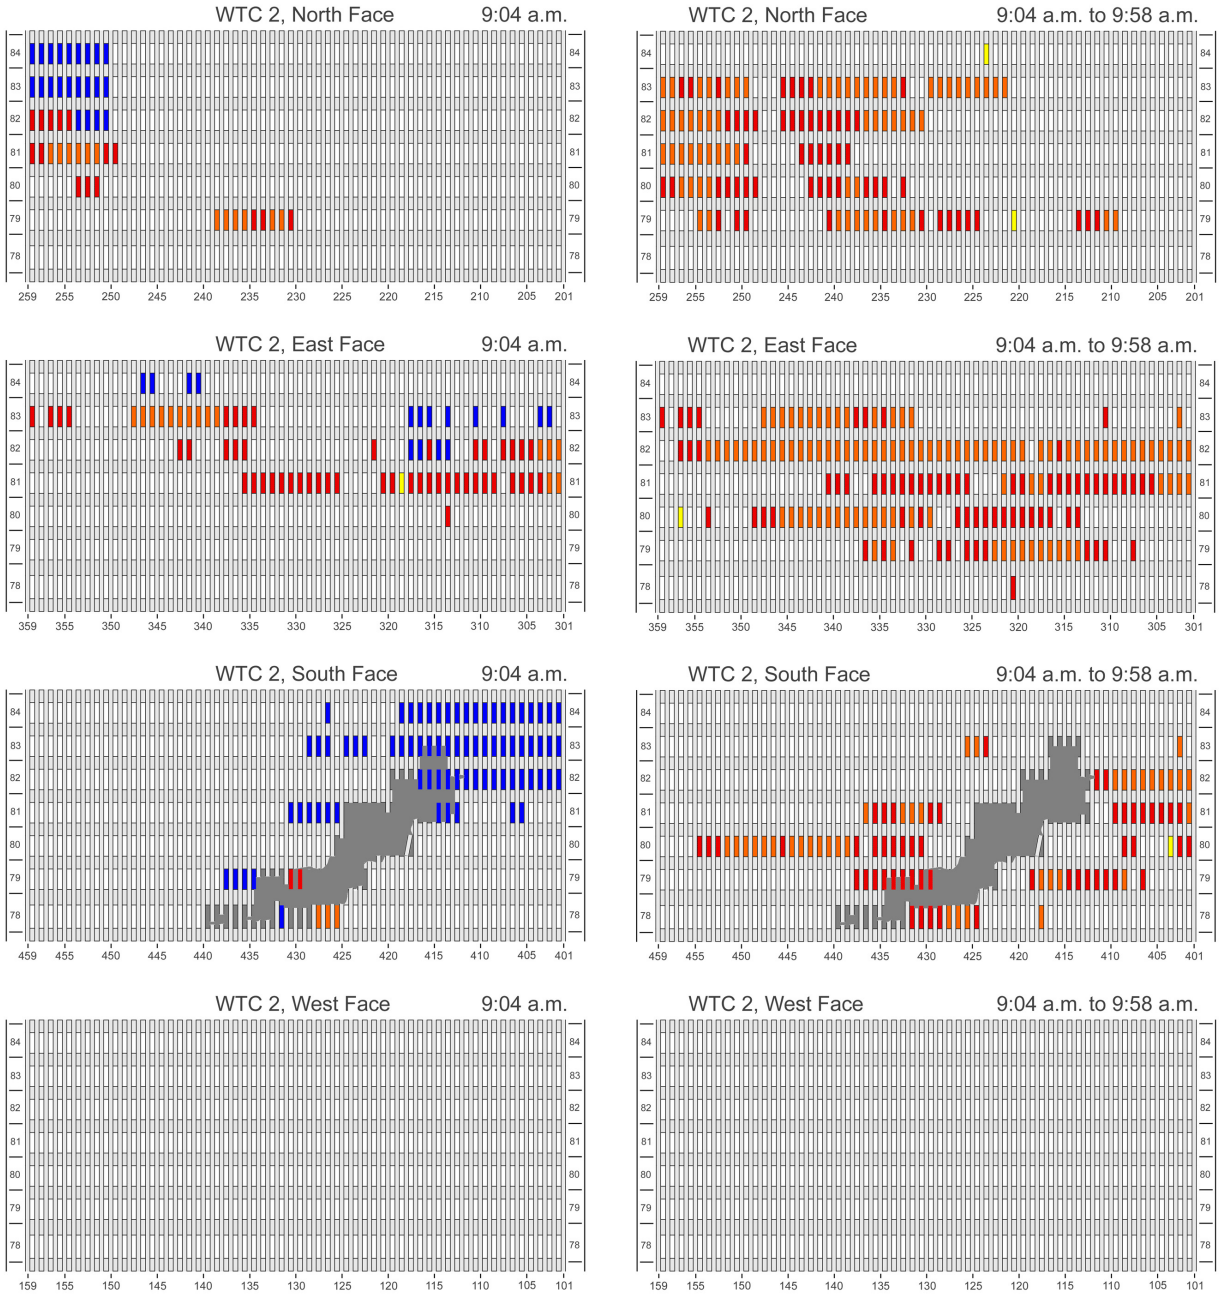
Compared to WTC 1, there was less observed fire spread in WTC 2, even when the difference in available time (102 min for WTC 1 and 56 min for WTC 2) is taken into account. Figure E-18 compares WTC 2 integrated façade maps of fire observations for the entire 56 min period with fire distributions present shortly after the aircraft impact. Primary areas of fire growth and spread include the east side of the 83rd floor and locations to the west of the cold spot on several additional floors of the north face, much of the 81st floor and extensive areas toward the centers of the 79th and 80th floors on the east face, and areas on either side of the aircraft impact cavity on the south face, particularly to the west side of the 80th floor and to the east on the 81st and 82nd floors. The absence of visible fire indicates that substantial fires did not reach the west face of the tower during the available time.

Figure E–18. Maps of observed fire distributions on the four faces of WTC 2 shortly after the aircraft impact (near 9:04 a.m.) are compared with the corresponding integrated fire observations for the entire period between 9:03 a.m. and 9:59 a.m. Blue represents windows where observations were not possible.
