NIST NCSTAR 1-5A

Federal Building and Fire Safety Investigation of the World Trade Center Disaster

Visual Evidence, Damage Estimates, and Timeline Analysis

William M. Pitts
Kathryn M. Butler
Valentine Junker

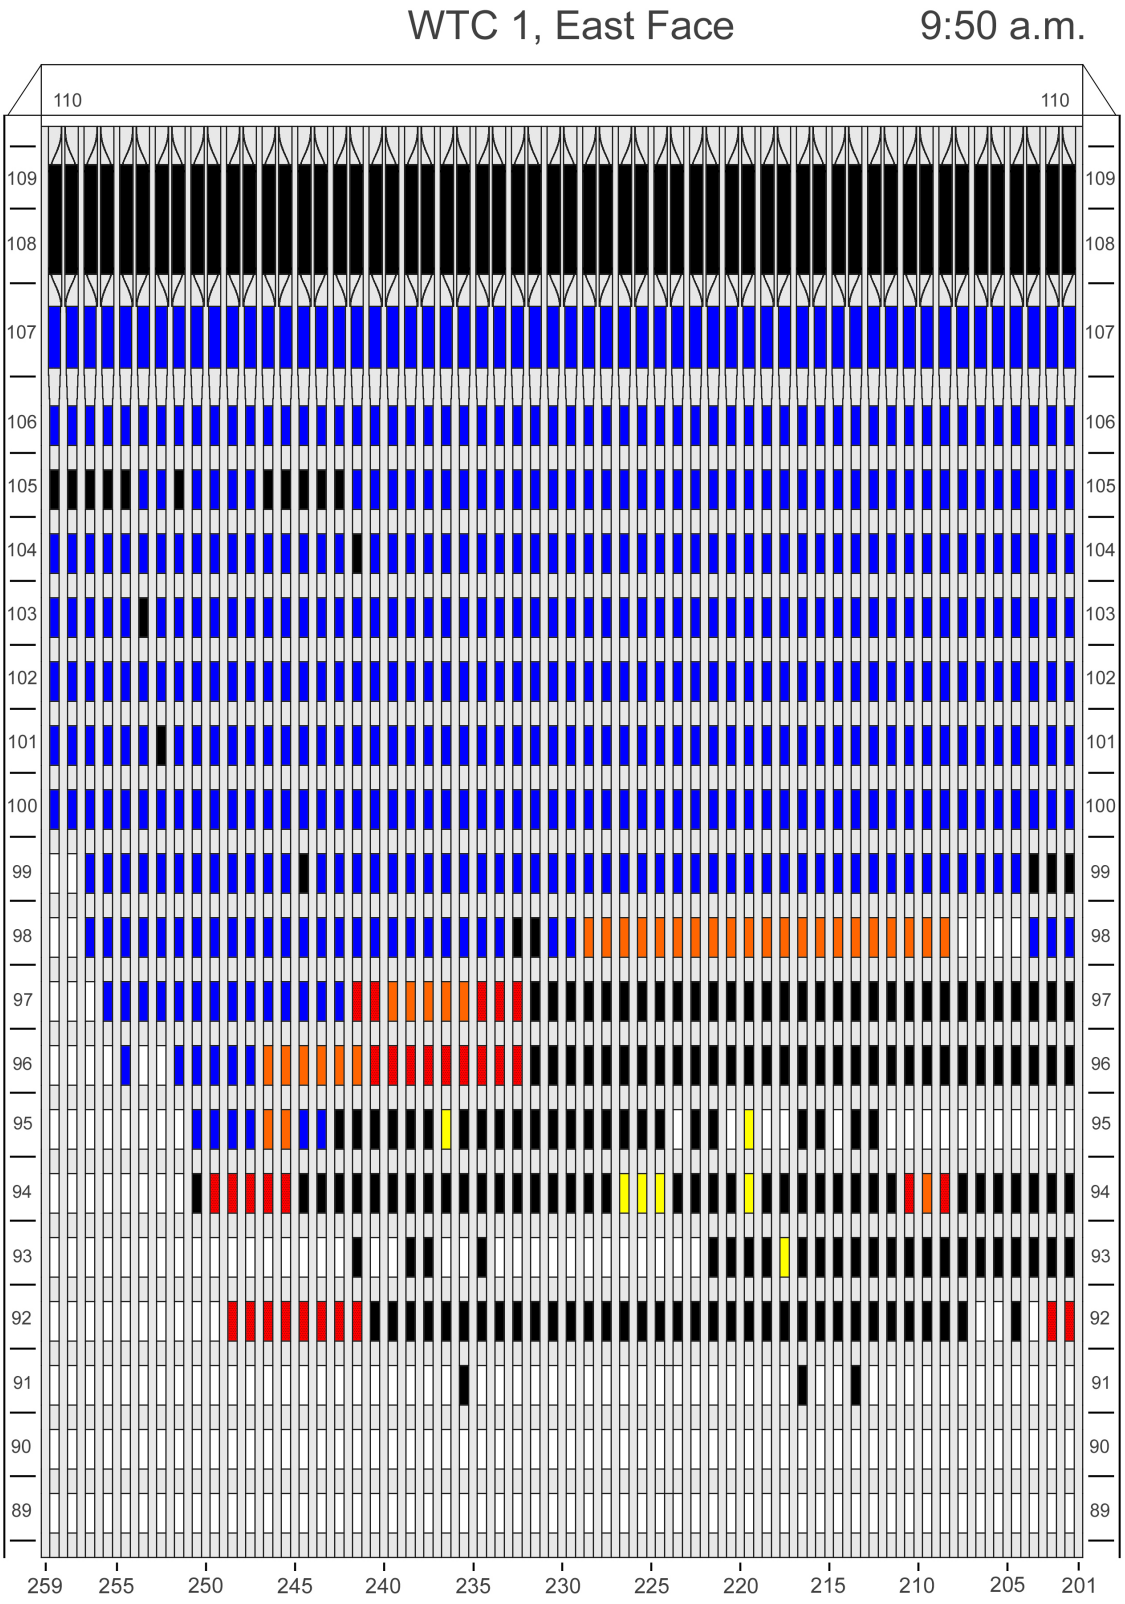
Color coding has been used to map the data included in the data sheets onto the façade. Figure 5–1 includes the key used for mapping the different types of data. Figure 5–6 shows an example of a map that combines datasheet results for windows and fires. Individual windows are coded such that if a fire is present or if a value cannot be assigned its color code is displayed. Otherwise, the window code is displayed. For the vast majority of time, this is equivalent to displaying the window data since fires were typically observed only when the window glass had been removed. Very seldom was fire observed through window glass that was still in place.

Figure 5-6. An example of a façade drawing combining data for window condition and fires is shown. The data is for the east face of WTC 1 around 9:50 a.m.

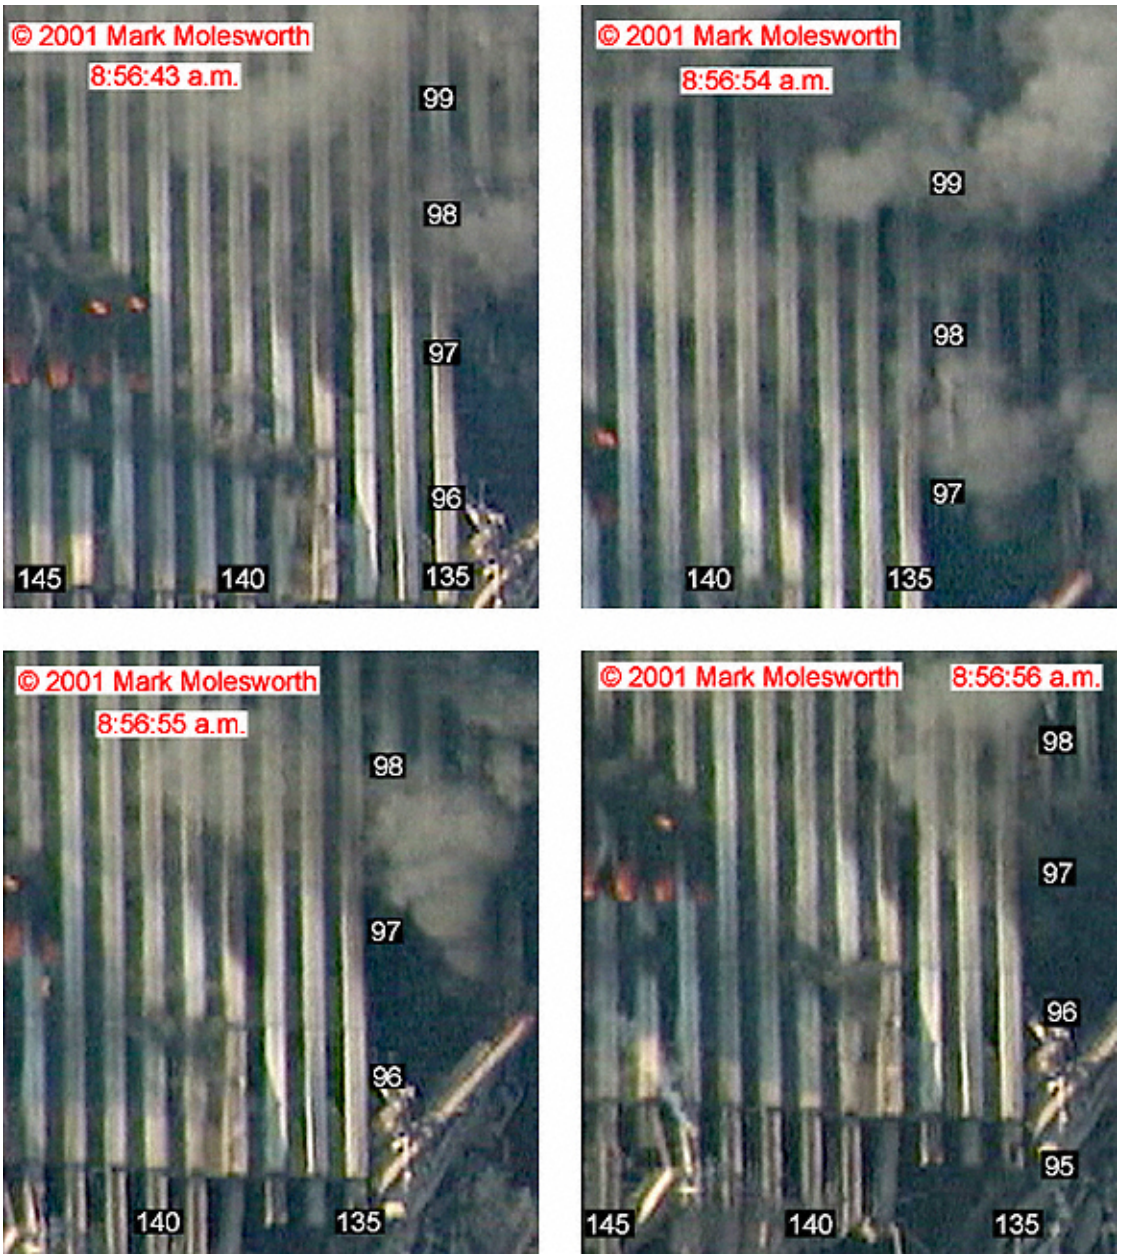
Figure 5–8 shows a series of four frames taken from a video that recorded the formation of a streamer on the north face of WTC 1. At 8:56:43 a.m. two small areas of flame are visible at the tops of windows 97-142 and 97-143. At 8:56:54 a.m. the flame at the top of window 97-142 was still in place (note that window 97-143 was out of the frame at this point). Very shortly afterward, the flame at the top of window 97-142 began to fall. The frame at 8:56:55 a.m. was taken 1.2 s later. The flaming object can now be seen near the base of window 97-142. This object extinguished very rapidly and formed the streamer that is visible curving downward at 8:56:56 a.m. near the base of the 96th floor. Note that the area of fire at the top of window 97-143 is still in place.

Relatively small fires at the tops of windows, such as those in Figure 5–8, were a common feature when active burning was present near the outer walls and the aluminum façade was intact. Such fires were often the only flames visible in a given window. Figure 5–9 shows a frame taken from a video in which a number of such fires burning on the 96th and 98th floors of the west face of WTC 1 are visible. As discussed in Section 8.5, the fires on this floor appeared to burn with low intensity. Nevertheless, the material at the tops of the window was exposed and ignited.

In Section 4.2.2, it was noted that polyurethane was used to thermally insulate the areas above the aluminum head casings located just inside and above the windows. Polyurethane is a flammable polymeric material that is easily ignited. It is likely that the high-temperature gases generated by nearby fires either first ignited the polyurethane above the head casing, which, in turn, resulted in the head casing dropping down to expose the burning material, or first caused the head casing to drop down, exposing the polyurethane, which was then ignited. For either scenario the result is the same, a substantial area of flaming polyurethane becomes exposed near the top of the window. In Figure 5–9, a number of what appear to be thin lines are visible near the top of windows on the 96th and 98th floor. In some cases

flames are visible on top of these lines, while in others only the lines are apparent. A likely explanation for these observations is that the thin lines are the edges of aluminum head casings that have dropped down from above the windows and that the fires seen above the lines are burning on the polyurethane located above the head casing. The large number of isolated fires seen at the tops of windows suggests that the polymer burned for a period of time before falling and forming streamers.

Figure 5-8. A series of four cropped frames from a video were recorded during the period when an isolated area of fire at the top of window 97-142 on the 97th floor dropped and formed a streamer. The intensity levels have been adjusted. Column and floor numbers have been added.

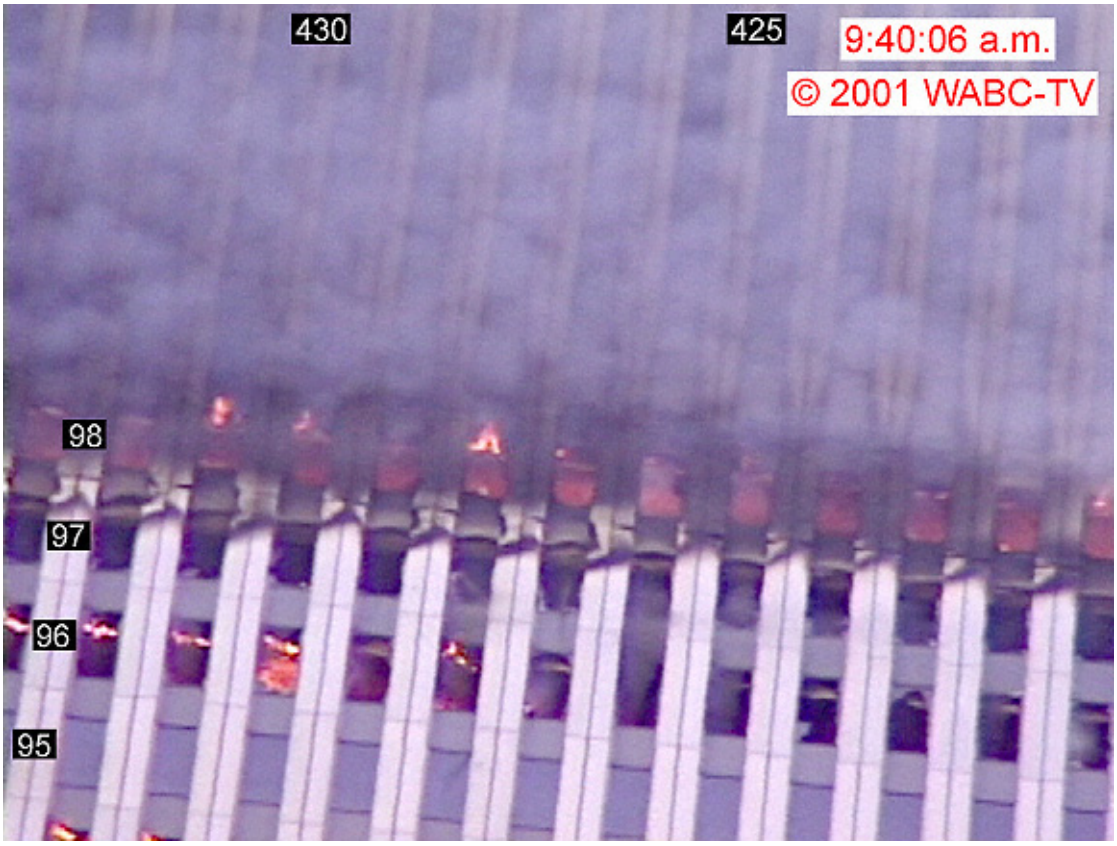
Figure 5-9. This close up view of the west face of WTC 1 was captured from a video recorded at 9:40:06 a.m. It has been enhanced by adjusting the intensity levels. Column and floors numbers have been added.

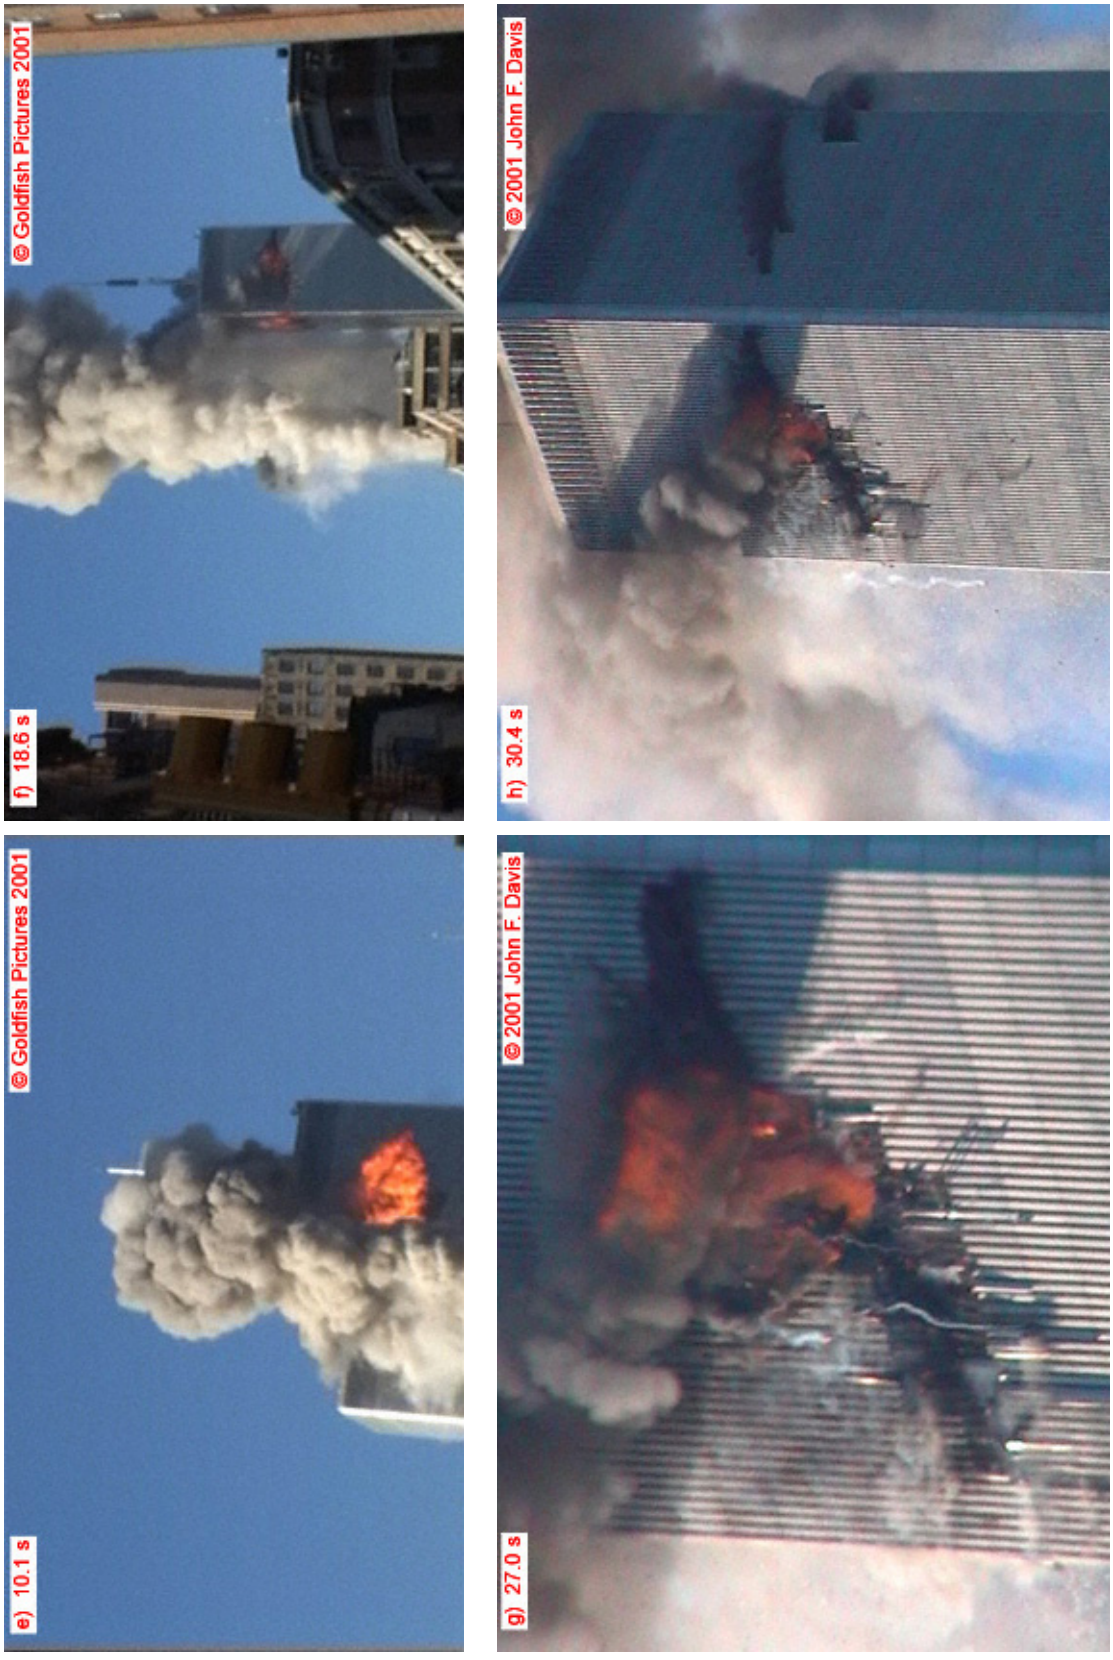
Figure 6–1. A series of frames from videos shows American Airlines Flight 11 striking WTC 1 and the immediate aftermath. Times relative to the aircraft impact time are shown in the upper left-hand corner (continued).

The next frame, (f), was recorded roughly 8.5 s later. At this time the dust-filled cloud sinking below the impact area and the rising thermal created on the north face have been blown further by the wind and are now more than a building width to the east of the northeast corner of the tower. The tube-like cloud of debris extends downward many stories and has developed the appearance of a concentrated vortex. The wind has also blown the debris away from the east face, and this face can now be observed. Substantial fires are now evident on the north and east faces in areas where the dust plumes were initially observed. Even though frame (f) is more zoomed out than frame (e), it is evident that the fire on the north face is much smaller than it was just 8.5 s earlier, suggesting that fires due to the aviation fuel released by the aircraft impact are already beginning to burn out. A thermal can be seen rising behind WTC 1, which provides additional evidence that the south face was damaged by debris passing through the tower.

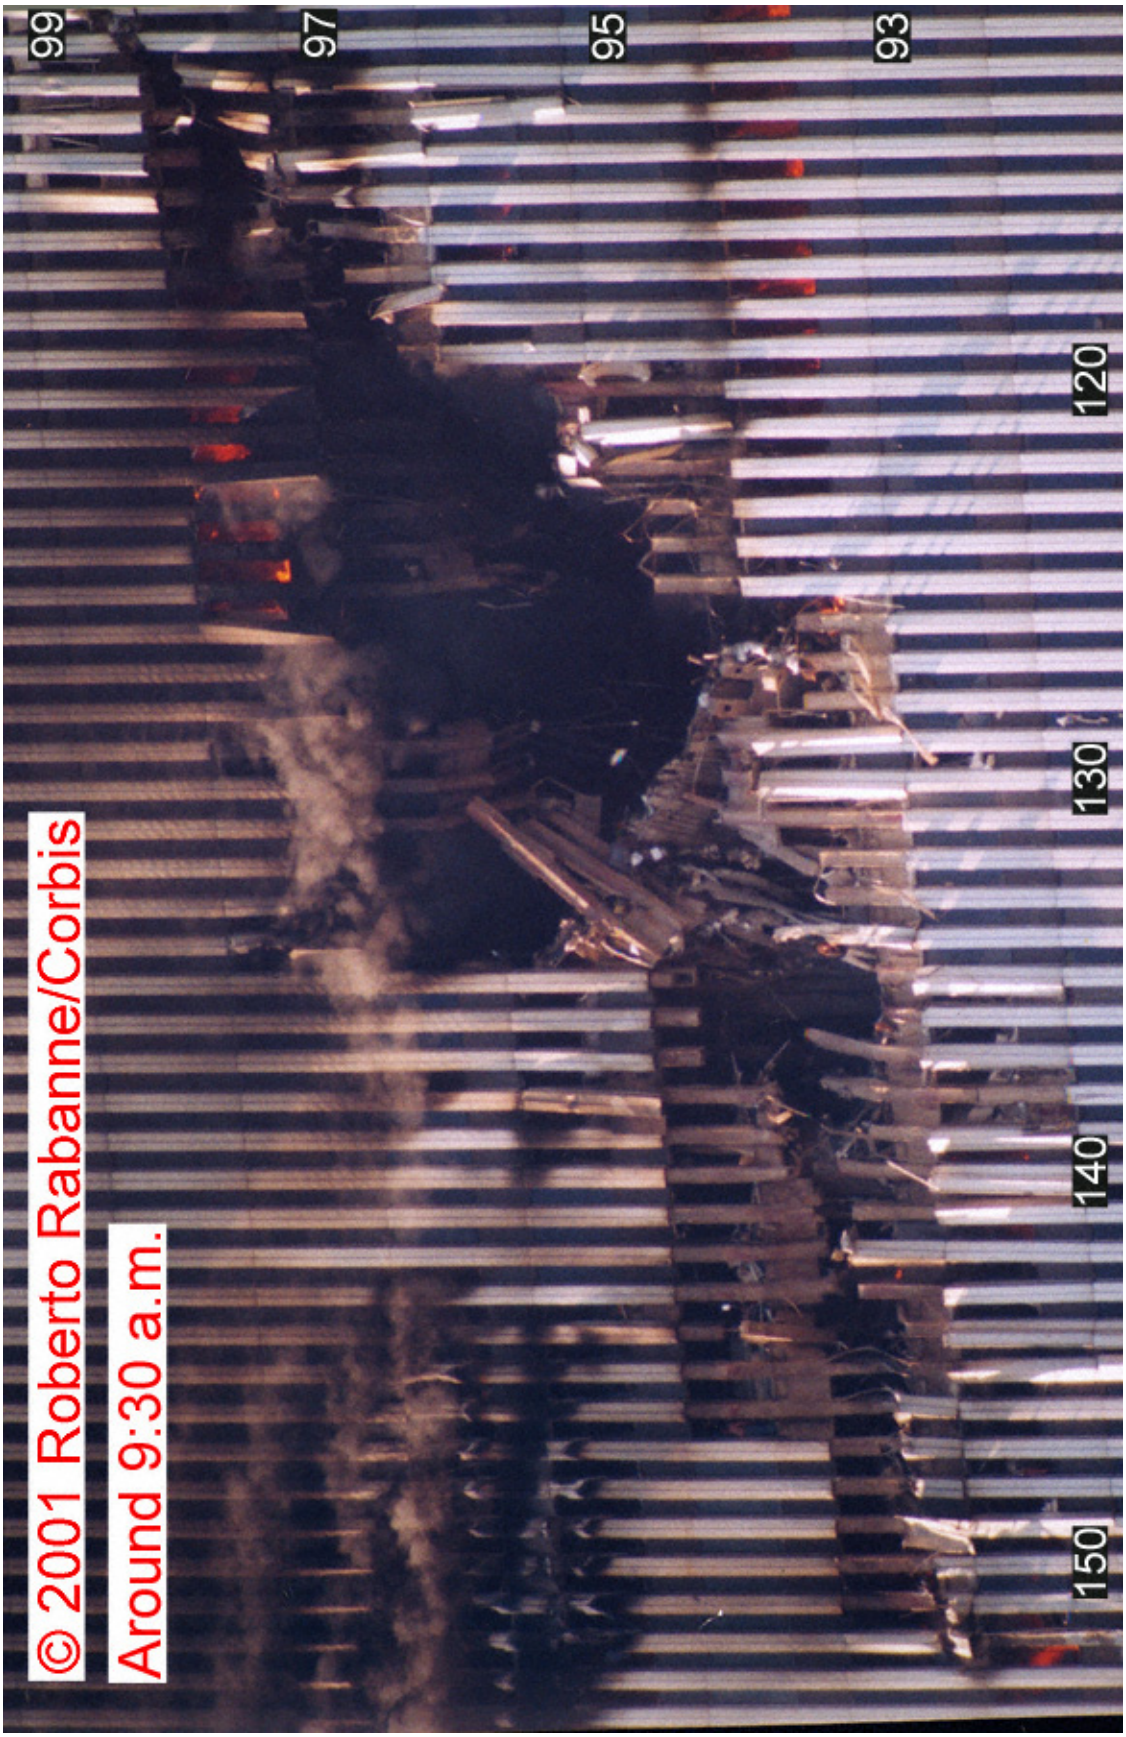
Figure 6-5. A close-up image of the north face of WTC 1 recorded around 9:30 a.m. shows the area of WTC 1 where the aircraft impacted. Column and floor numbers have been added.

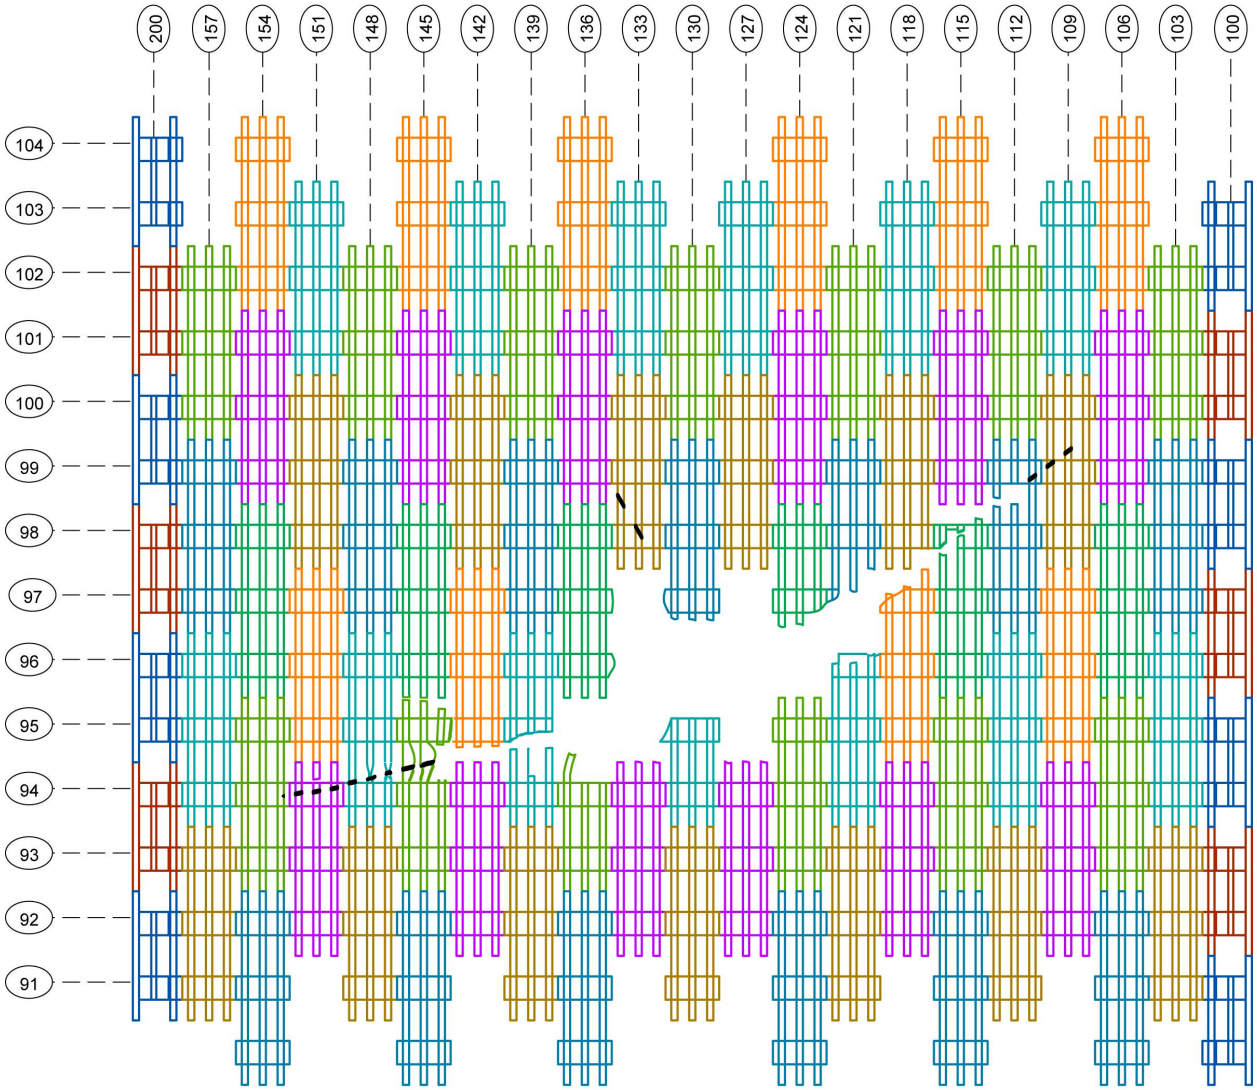
Figure 6-6. A drawing shows the aircraft impact damage to the steel façade of WTC 1. The dark dotted lines indicate locations where the wings and vertical stabilizer of the aircraft marked the aluminum cladding on columns.

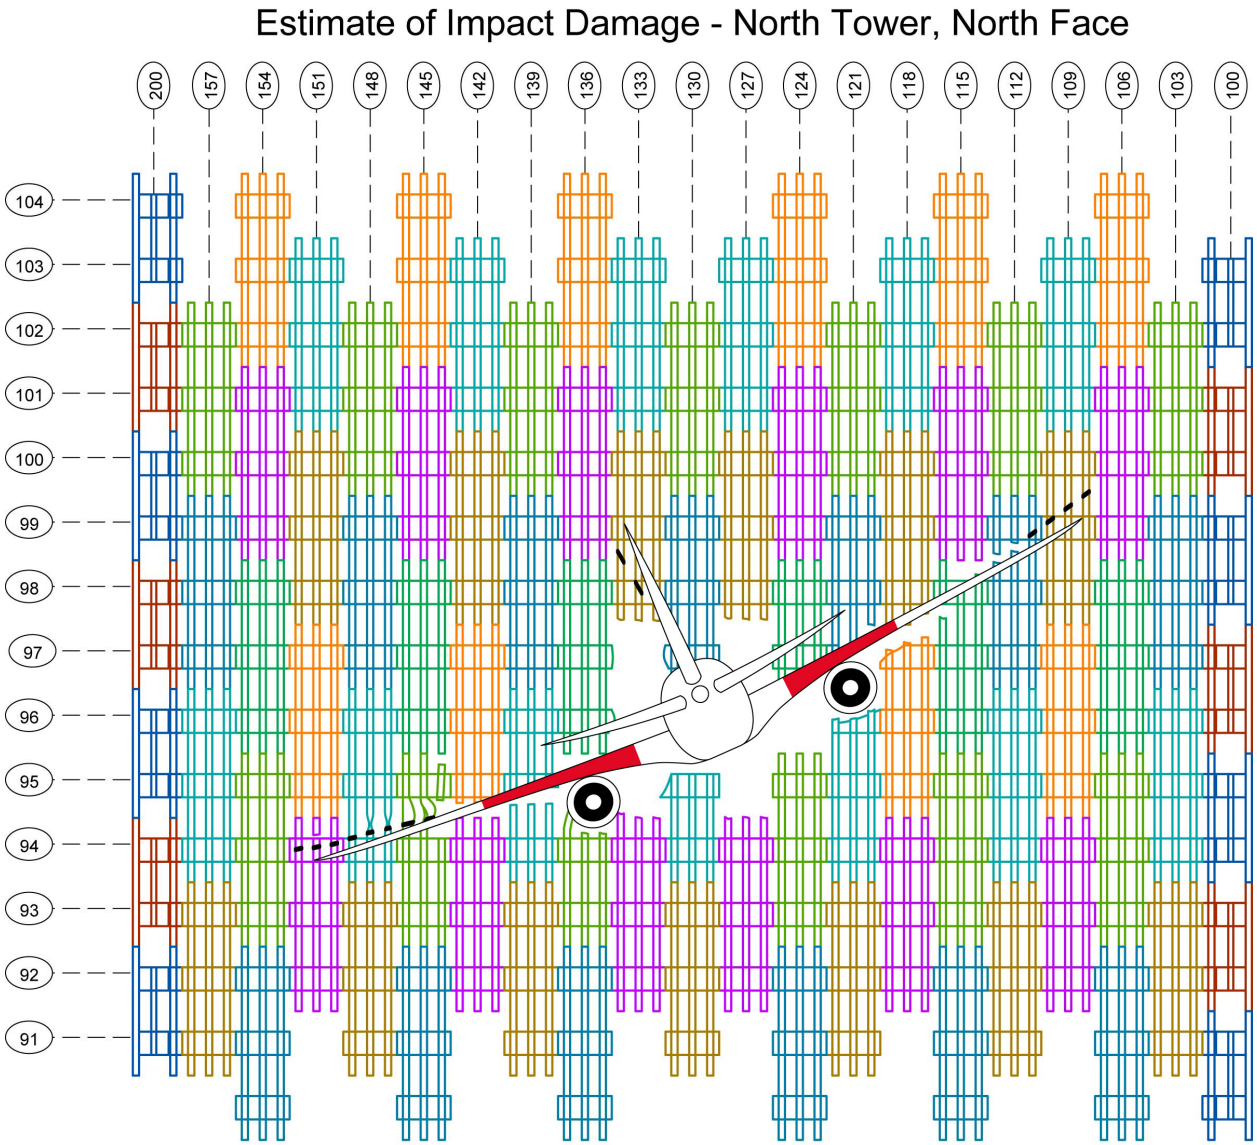
Figure 6-7. A scaled outline of a Boeing 767-200ER is superimposed on the damage diagram shown in Figure 6–6. The position of the aircraft has been adjusted to give the best match with the damage pattern and marks showing where the wing tips and vertical stabilizer struck. The red areas correspond to the approximate locations of fuel on the aircraft based on an analysis reported elsewhere (NIST NCSTAR 1-2B).

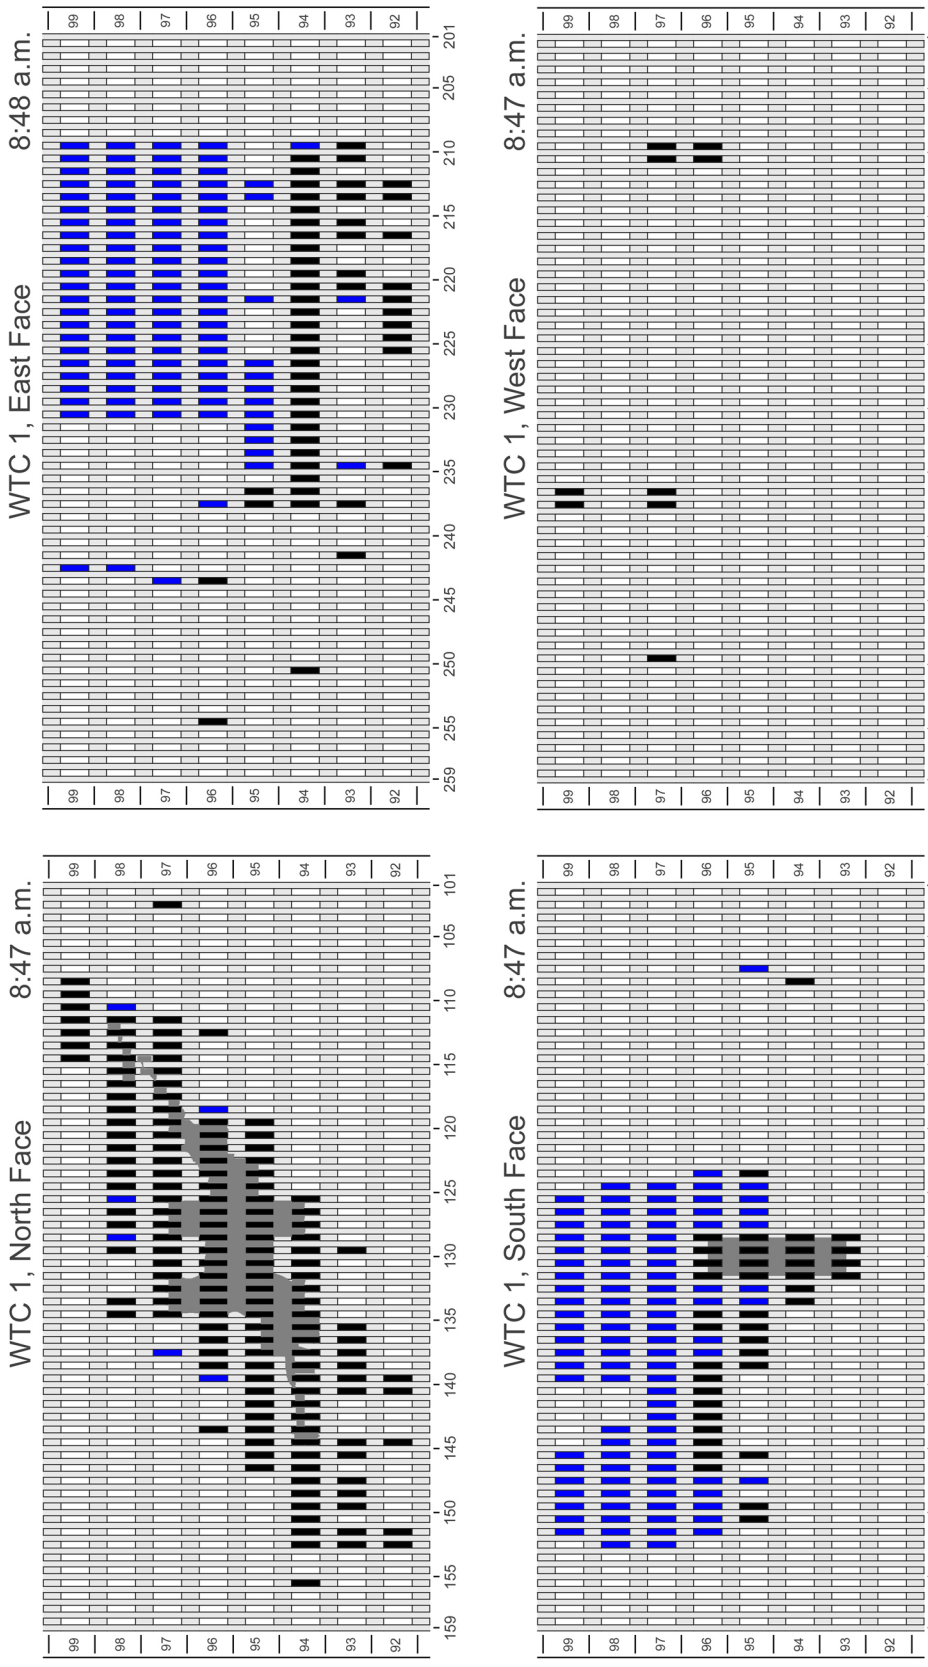
Figure 6-9. The condition of windows is shown for the four faces of WTC 1 around 8:47 a.m. shortly after it was struck by American Airlines Flight 11. The colors represent ▌- window broken open, ▯ - glass in place, and ▌- not visible.

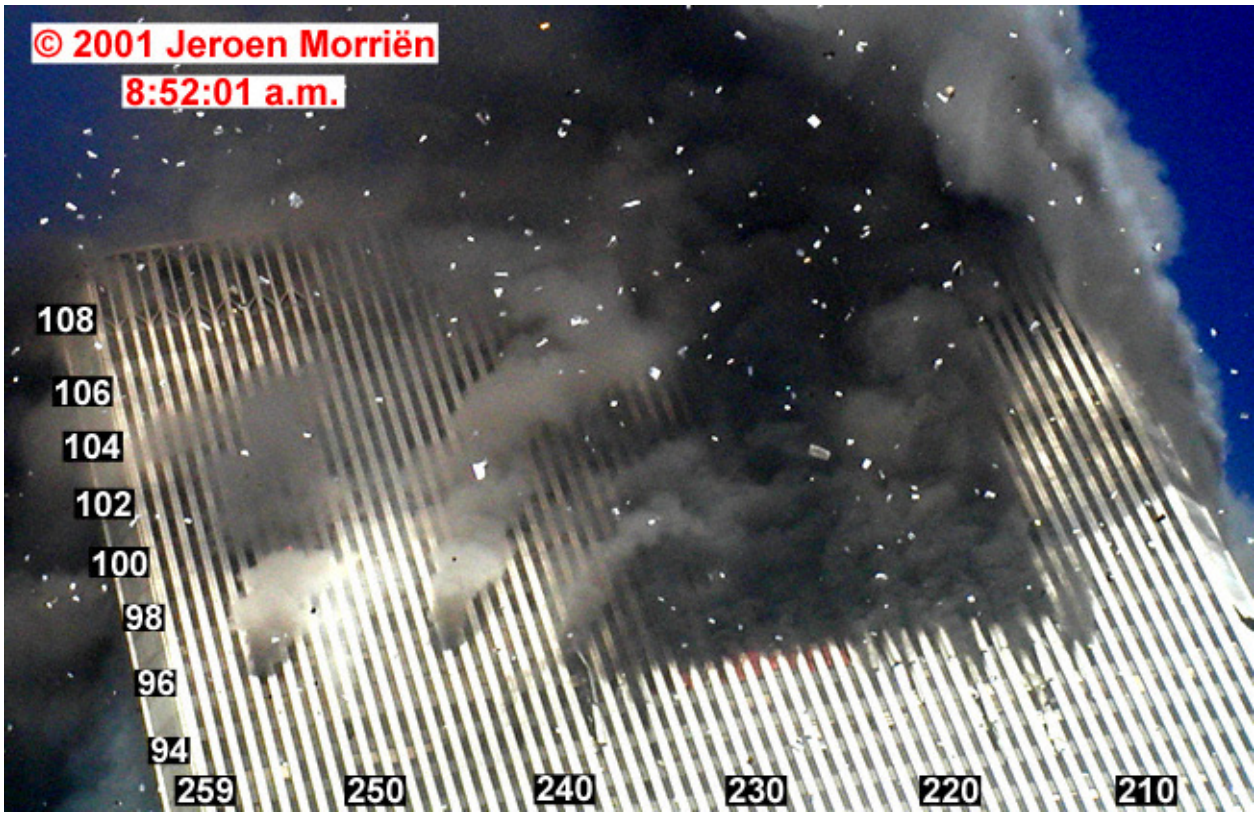
The most prominent feature in Figure 6–11 is a long line of smoke on the 94th floor extending from roughly window 94-210 to window 94-237, or a distance of nearly 90 feet. Clearly, all of the glass in the windows over this length has been broken out. Closer inspection shows that several of the aluminum covers on these columns have been partially dislodged as well. Most are near the right edge of the region, but the cover for column 94-237 has been nearly removed. Two covers, for columns 94-213 and 94-216, are missing completely. The aluminum cover on the northeast corner for this floor has also been partially

displaced. This proved to be an easily recognized marker for the floor. Isolated windows at 94-241 and 94-250 are also missing.

Figure 6-11. Photograph of the east face of WTC 1 taken at 8:52:01 a.m. The photograph has been enhanced and cropped. Floor numbers are indicated along the left edge of the building and column numbers along the bottom of the photo.

Some damage and missing window glass are present on lower floors that were not directly impacted by the aircraft. Window glass has been broken out and some column covers have been displaced or removed completely on the 93rd floor from columns 93-209 to 93-216 as well as columns 93-219 and 93-220. The glass for window 93-237 is missing, and the aluminum cover for column 93-237 has been displaced. Damage is also apparent on the 92nd floor, where windows 92-212 and 92-213 have been broken out. A chair is stuck in window 92-212, and the aluminum cover on column 92-212 has been removed. Covers on columns 92-216 and 92-217 have been displaced, and the window glass between these two columns is missing. On the 91st floor, the covers on columns 91-213, 91-214, and 91-216 have been displaced, and windows 91-213 and 91-216 are open. There is no apparent damage lower than the 91st floor.

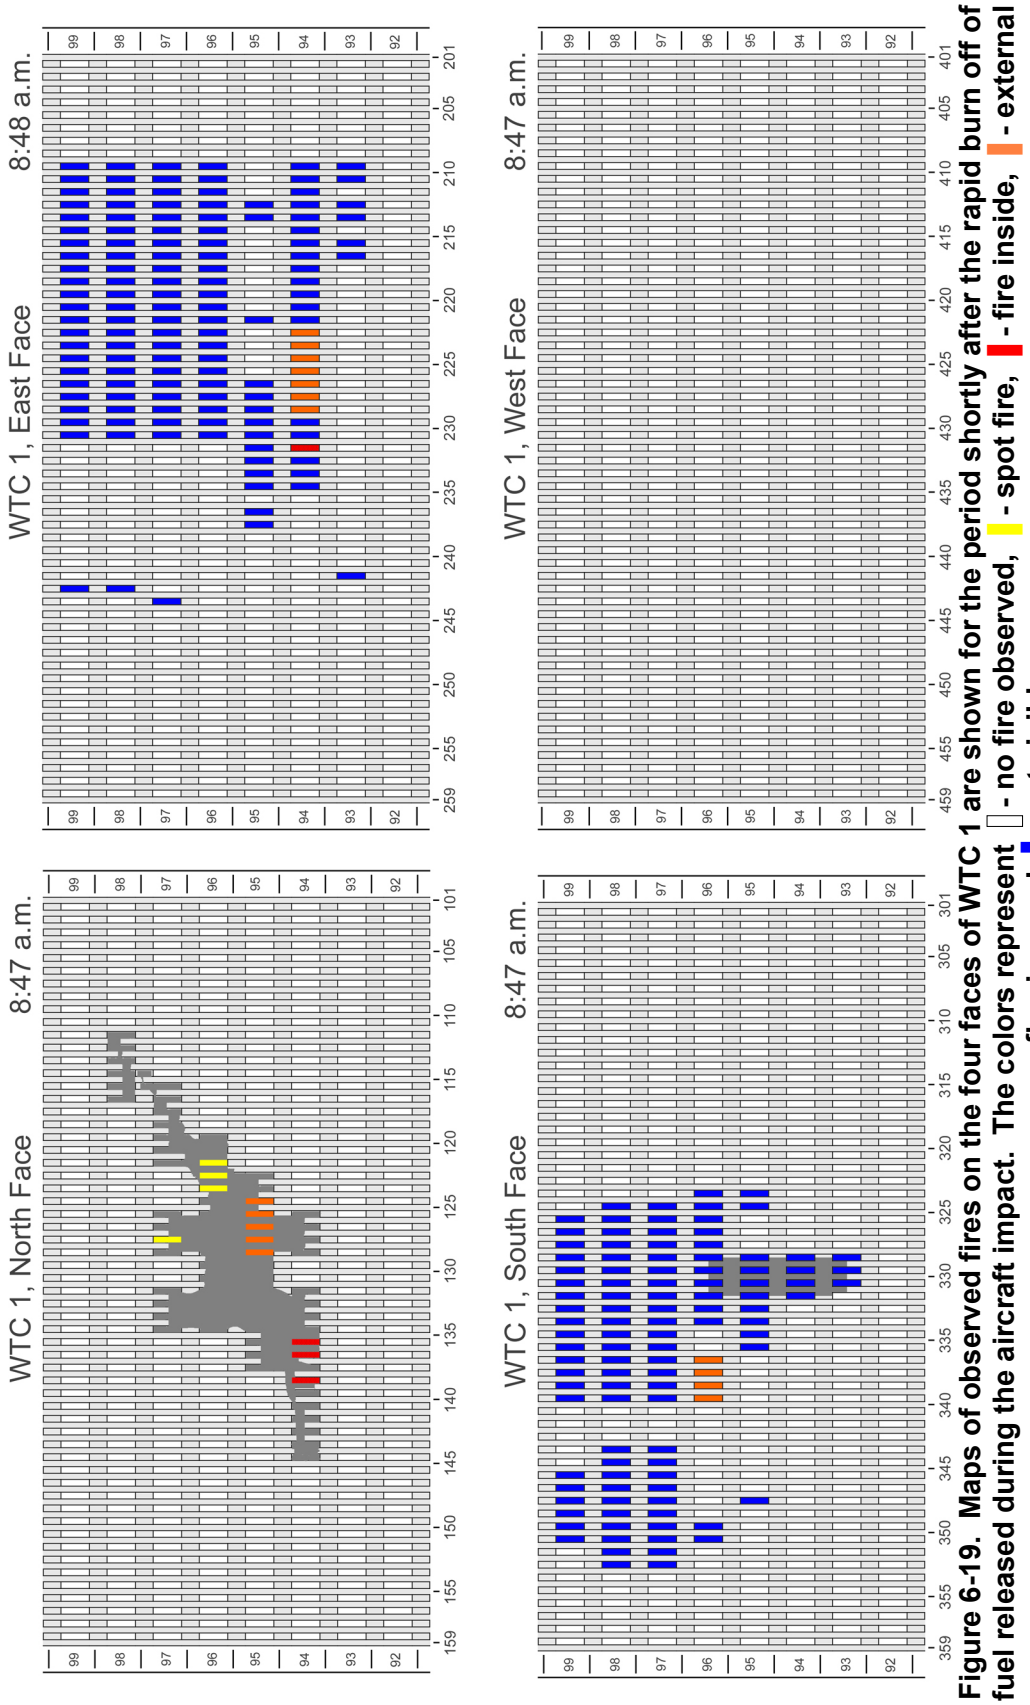
Figure 6-19. Maps of observed fires on the four faces of WTC 1 are shown for the period shortly after the rapid burn off of fuel released during the aircraft impact. The colors represent ☐ - no fire observed, ■ - spot fire, ■ - fire inside, ■ - external flaming, and ■ - not visible.

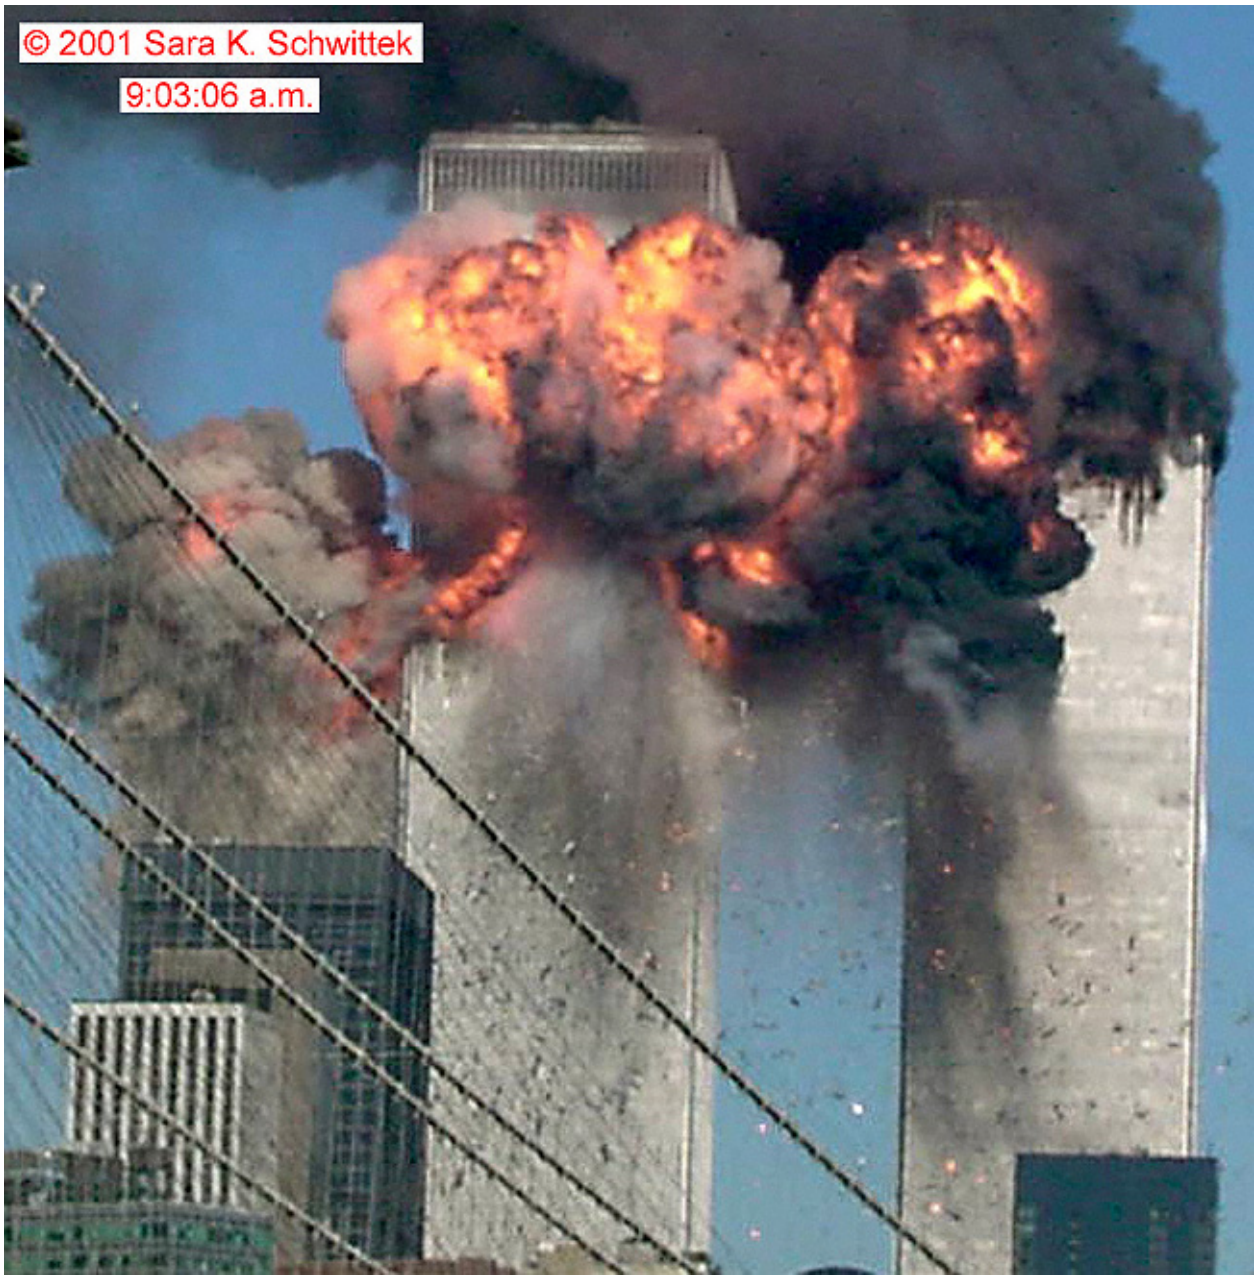
Figure 7-6. This cropped image of the towers recorded 6.5 s after the aircraft impact on WTC 2 was shot from the east on the opposite side of the East River in Brooklyn.

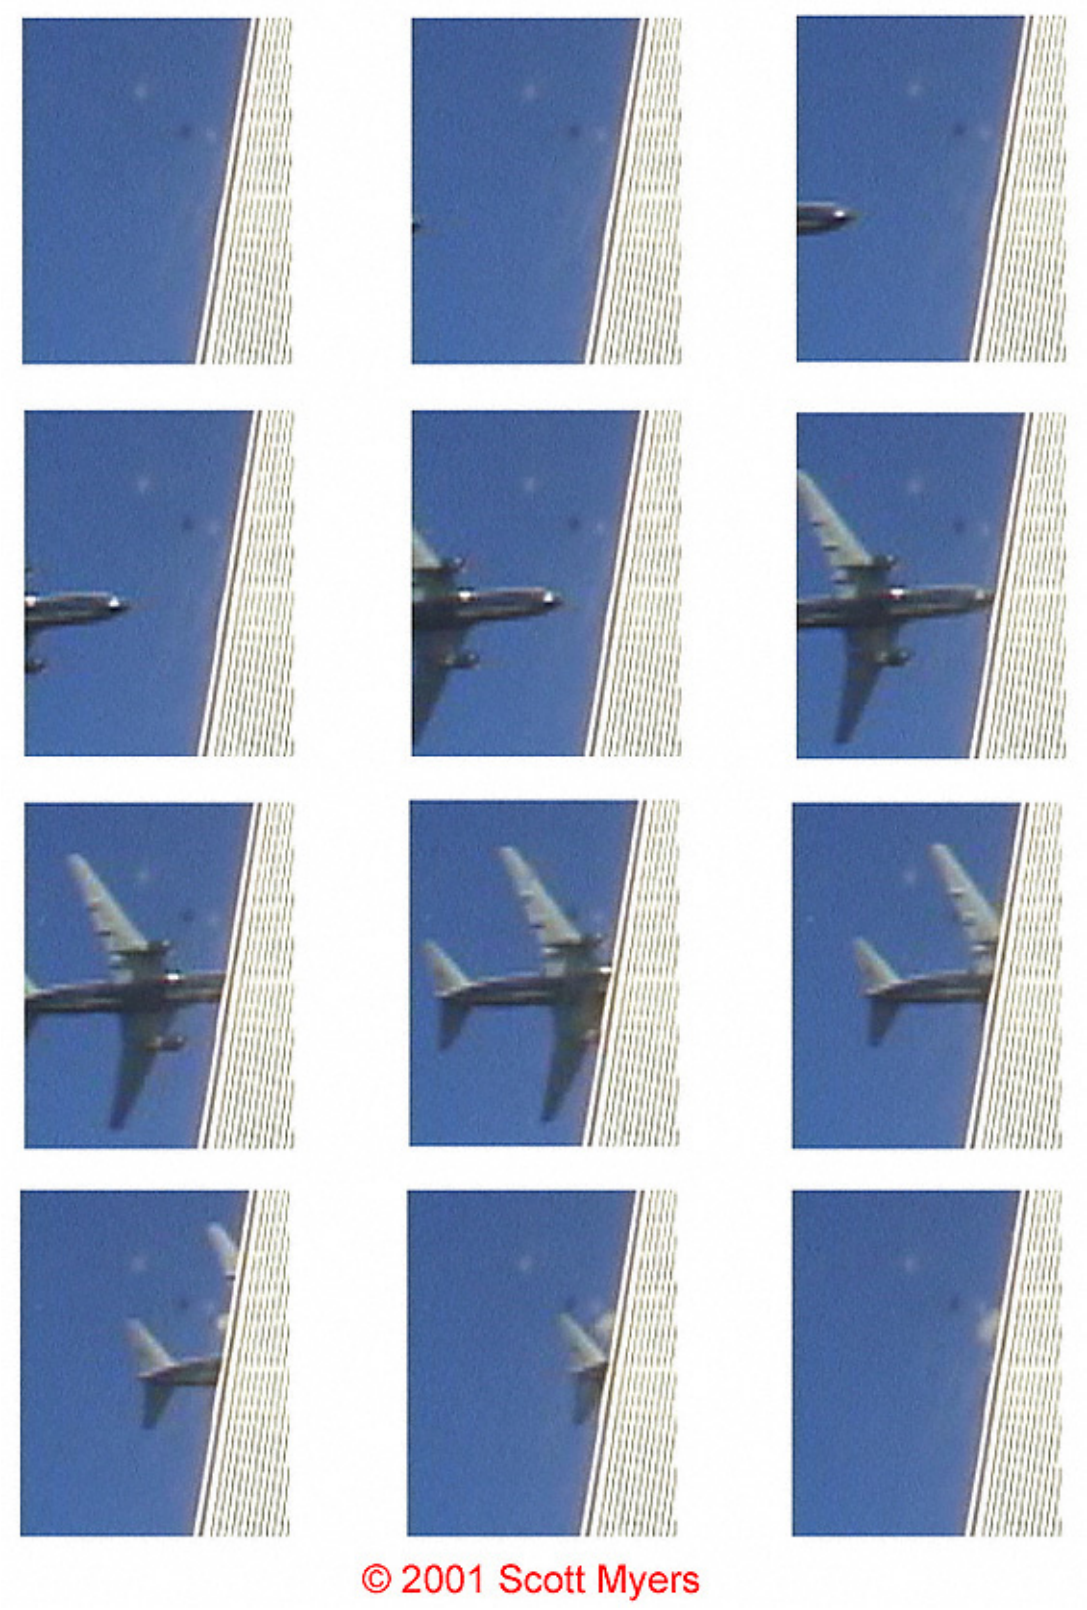
Figure 7–12 shows a series of cropped frames captured from the video shot from the east that shows the aircraft approaching WTC 2 and disappearing inside. These images have been used to determine the speed of the aircraft as it approached the tower. This was done by identifying the locations of the nose and tail of the aircraft relative to a fixed point defined to be the location on the frames where the aircraft passes out of sight behind the corner of the building. The aircraft was very nearly level relative to this point, so it is appropriate to simply count the number of picture elements, pixels, between this location and the two measurement points on the aircraft.

Figure 7-12. Series of sequential cropped frames taken from a video shot on September 11th showing the aircraft approaching WTC 2. The frames, ordered from left to right and top to bottom, are separated by 33.3 ms.

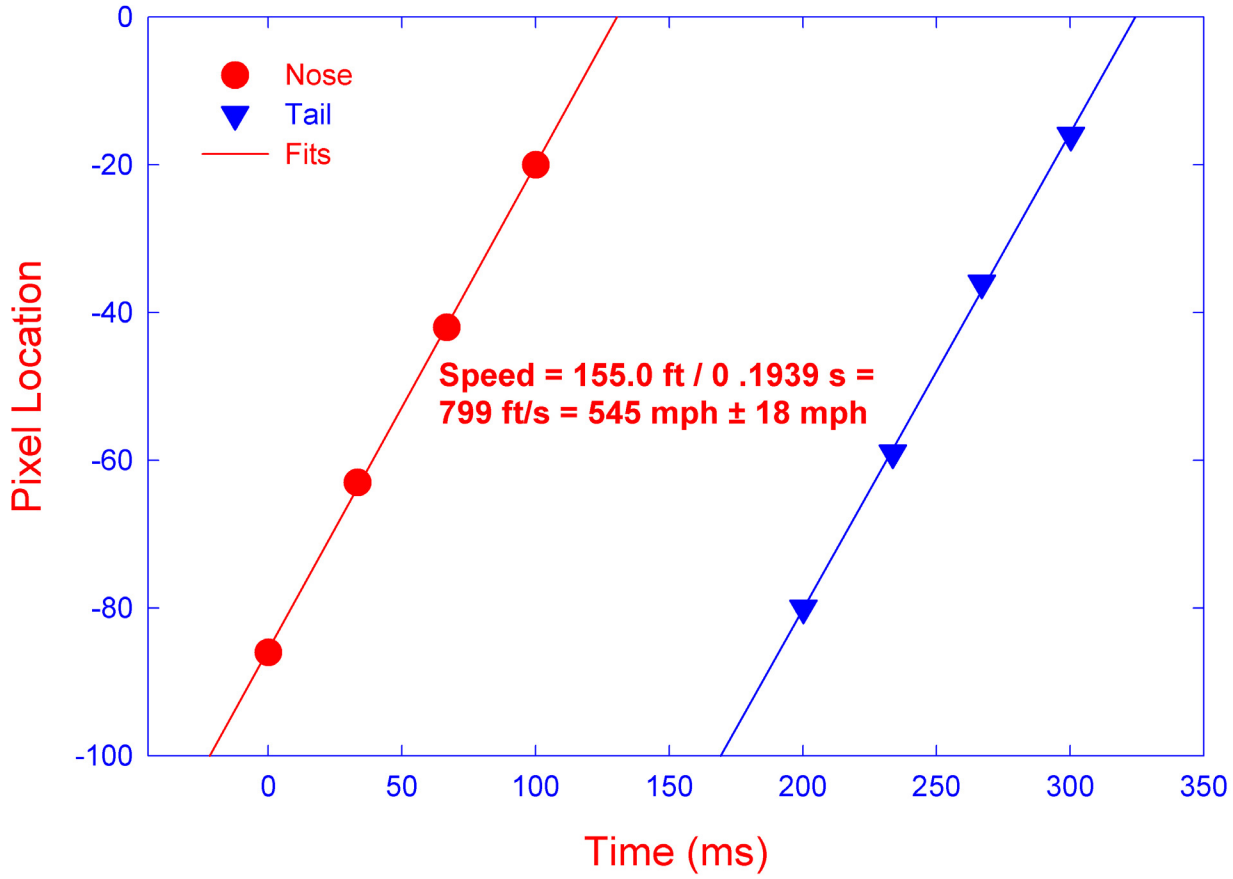
Figure 7–13 shows the pixel locations of the two points as a function of time. Using linear least squares curve fits, it was possible to estimate the exact relative times when the nose and tail pass the reference location. The difference between these two times is the period required for the entire length of the aircraft to pass the reference location. The result is 0.1939 seconds. Since the distance between these two locations on the aircraft is known to be 155.0 ft, the average speed can be estimated by simply dividing this length by the passage time to give 155.0 ft/0.1939 s = 799 ft/s = 545 mph. An uncertainty estimate based solely on the uncertainty in the determined time difference yields a value of ± 18 mph, with 95 % confidence.

Figure 7-13. Plots of pixel locations for the nose and tail of the aircraft that struck WTC 2 as a function of time taken from the images shown in Figure 7–12. Straight lines are the results of linear least squares curve fits to the data. Extrapolation of the lines to pixel 0 allows the time for the passage of the aircraft to be calculated.
