NIST NCSTAR 1-5A

Federal Building and Fire Safety Investigation of the World Trade Center Disaster

Visual Evidence, Damage Estimates, and Timeline Analysis

William M. Pitts
Kathryn M. Butler
Valentine Junker

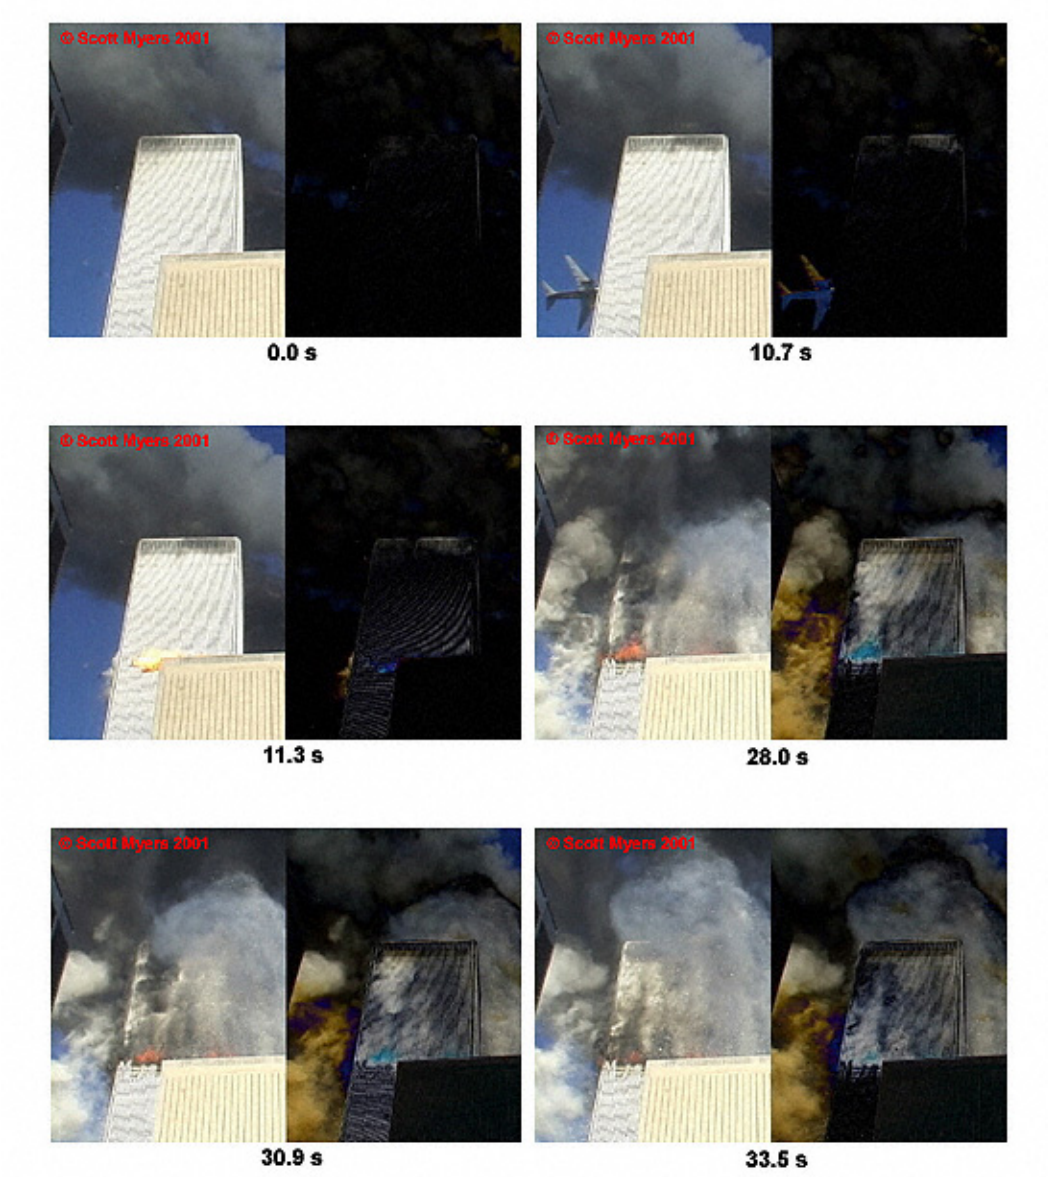
When this approach was applied to the video, a region of windows was observed on the building that seemed to appear and disappear. Figure 7–14 shows several frames of a composite video formed by overlaying half frames of the original video and the difference video. In the initial frame (time = 0.0 s) the aircraft has not yet appeared, and the difference frame is black. In the next frame (time = 10.7 s) the aircraft is approaching the building. The aircraft is evident in the difference frame since it represents a change in the frame. WTC 2 is still dark except near the top where changes due to smoke movement are apparent. In the third frame (time = 11.3 s) the aircraft has struck the building and dramatic changes in the appearance of the building façade in the difference frame are evident. Close inspection shows what appear to be curved lines running across the face of WTC 2. These curves result from an interaction between the straight lines formed by the windows and columns on the tower and the straight lines of picture elements (pixels) that make up the detector in the digital video camera. This well known behavior is called the moiré effect. As discussed in the following section, the moiré effect provides a sensitive approach for determining the displacement of the building as a function of time and allows a detailed analysis of the various oscillation frequencies of the tower following the aircraft impact.

Figure 7-14. Frames from a composite video are shown. The half frames on the left are taken from a video showing the aircraft impact on WTC 2, while the half frames on the right are generated by subtracting a frame recorded prior to the aircraft impact from all subsequent frames in the original video. Times refer to the period since the start of the difference video.

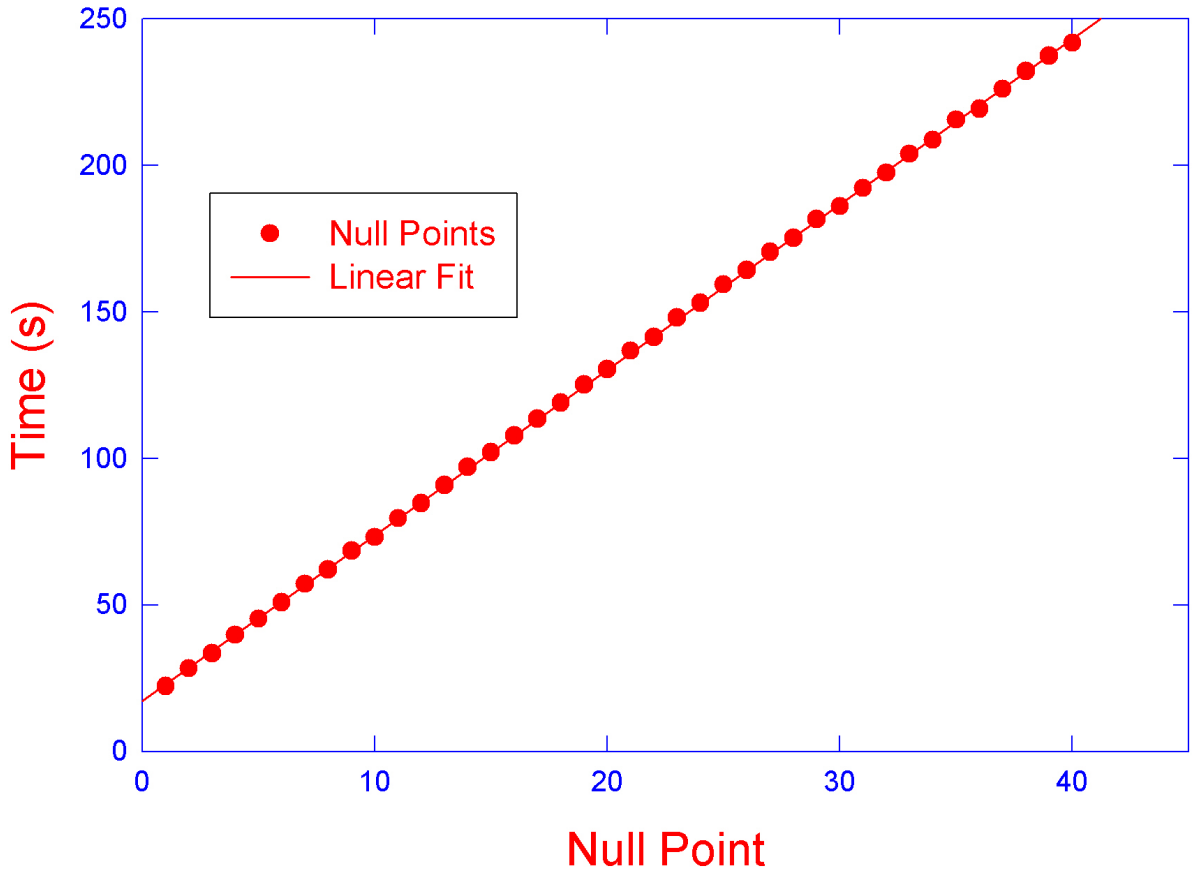
Since the absence of color is easiest to identify, it is straight forward to determine times when the null points occur in the difference video. Figure 7–15 shows a plot of time versus null point number obtained from the difference video. The points fall on a straight line having a slope of 5.647 s $\pm$ 0.008 s (95 % confidence interval). Since the building passes through a null point twice during a single full oscillation, the period required is 11.3 s.

Figure 7-15. The time when null points are observed in the difference video of WTC 2 are plotted versus the null point number. The points fall on a straight line having a slope of 5.647 s ± 0.008 s.

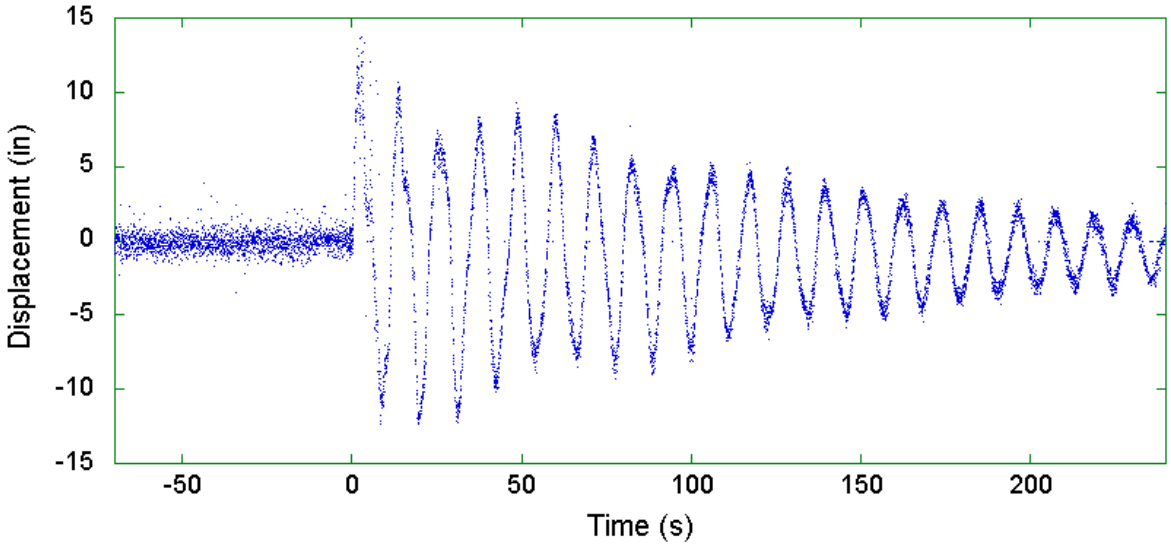
Figure 7-18. The displacement of the first (left-most) window line on the 70th floor of WTC 2 determined using moiré analysis is shown as a function of time.

Detailed frequency analysis of the displacement data shown in Figure 7–18 revealed the fundamental north-south mode with a period of 11.4 s, a torsional mode with a period of 5.3 s, and two higher frequency modes with periods of 3.9 s and 2.2 s. All periods are accurate to better than ± 0.1 s. The period of the fundamental mode is comparable to the computational value for WTC 2 and within normal expected variations as evidenced by measurements on WTC 1 (NIST NCSTAR 1-2). The torsional mode dominates the window spacing variation, as twisting of the building makes the camera's viewing angle of the east face alternatively more and less perpendicular. The highest frequency mode causes some jerkiness in the motion over the first few oscillations.

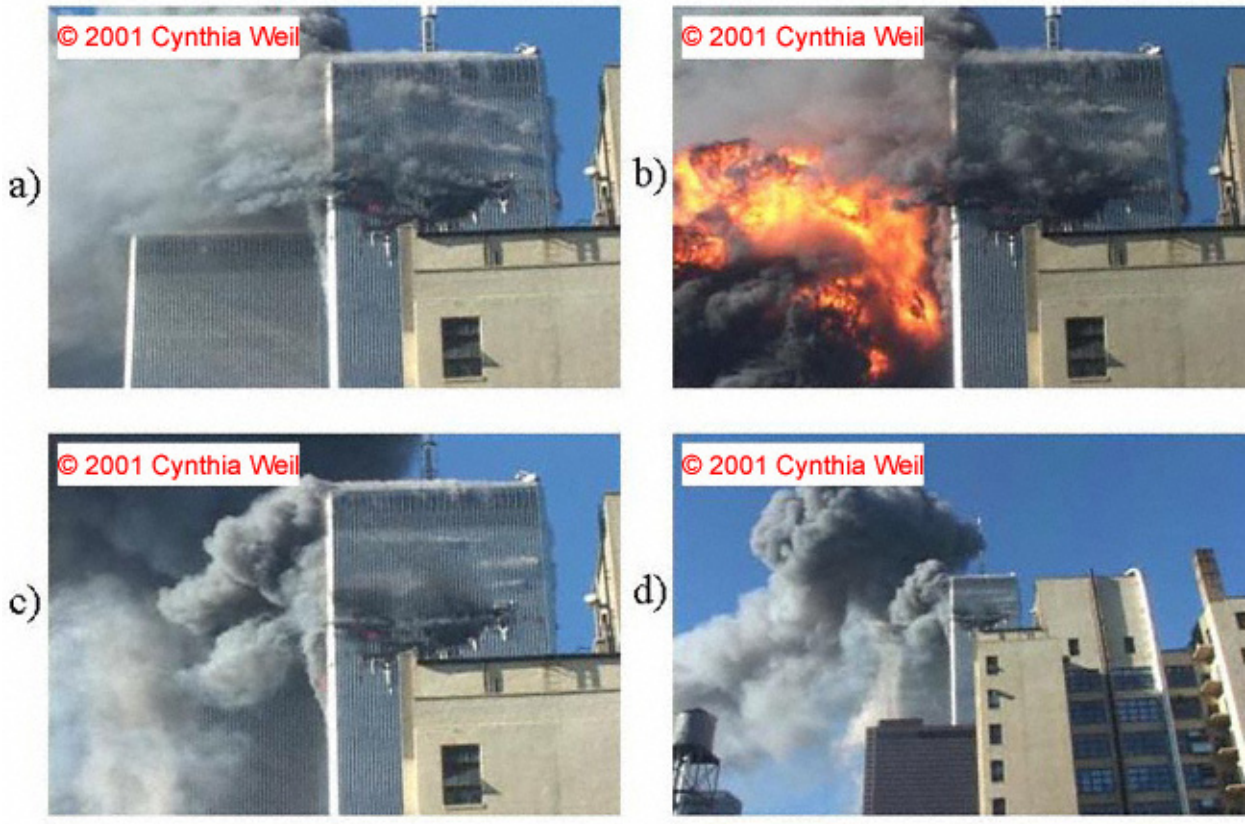
A second video, filmed from the north with the camera mounted on a tripod, provided an opportunity to determine the east-west motion of WTC 2 for a brief period following the aircraft impact. The four frames in Figure 7–19 illustrate the appearance of the video from this time. Frame (a) from just before impact shows the composition, with the top floors of WTC 1 and WTC 2 filling much of the frame. The base of the frame corresponds to the 94th floor of WTC 2. WTC 2 was observed to move for about seven seconds, first to the west then east, until the fireball covered the visible surface of WTC 2, as in frame (b). Frame (c) shows that the smoke gradually cleared from the west (right) side of the north face, allowing the building motion to once again be followed. Unfortunately, the camera zoomed back from the initial view about 19 s after the aircraft impact, as can be seen in frame (d), resulting in the loss of detail necessary for the moiré analysis.

Figure 7-19. These four frames are taken from a video shot from the north around the time of aircraft impact, 9:02:59 a.m., on WTC 2.

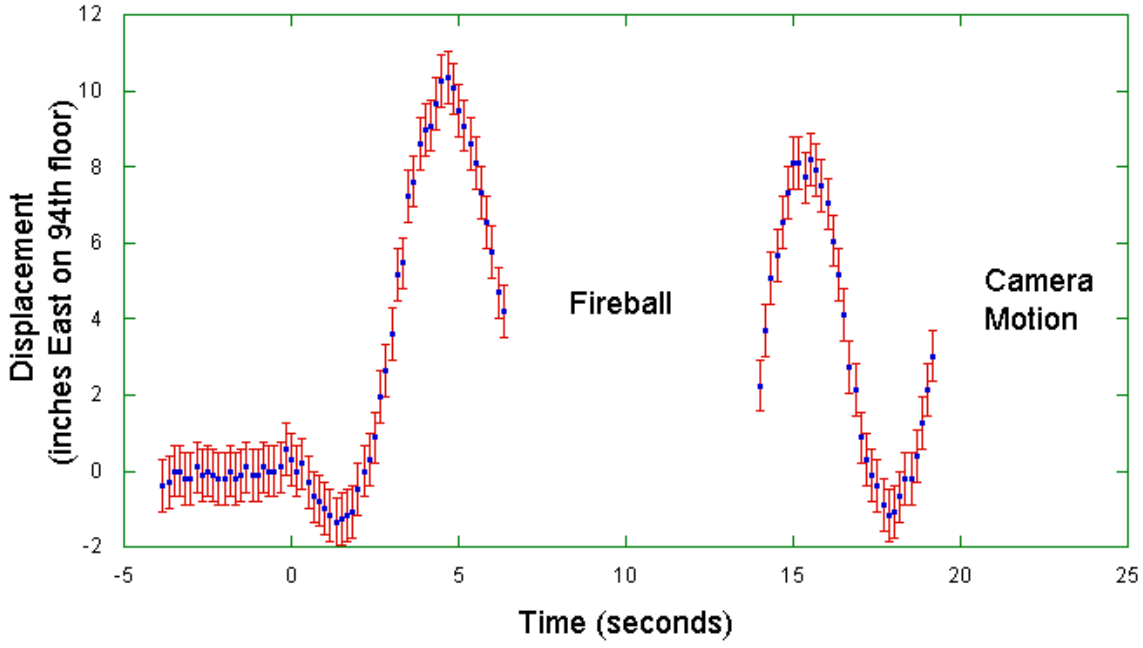
Although the motion of WTC 2 in this video covers less than a pixel width horizontally, the moiré pattern for the nearly vertical lines of windows greatly amplifies this motion. Figure 7-20 shows the calculated east-west displacement of the 94th floor of WTC 2, with a total apparent sway of 12 in. ± 2 in. A frequency analysis of this brief set of data yielded a period of 5.3 s. This is consistent with the torsional mode found in the analysis of north-south motion and can be explained as follows. The aircraft struck WTC 2 on the south face off-center toward the east while moving toward the northeast relative to the tower. As a result, the tower was twisted in the counter-clockwise direction as seen from above, i.e., the aircraft impact imparted a brief angular momentum as seen from above. To an observer from the north, points on the north face appeared to suddenly move toward the west. The tower resisted this motion and tried to return to its original position. In doing so, it rotated clockwise, causing the apparent motion to the east evident in Figure 7-20. The torsional motion would have continued until it died down. It is uncertain why the estimated building motion is asymmetric relative to the original undisturbed position.

Figure 7-20. East-west motion of WTC 2 just before and after the aircraft impact. Error bars indicate measurement uncertainty.

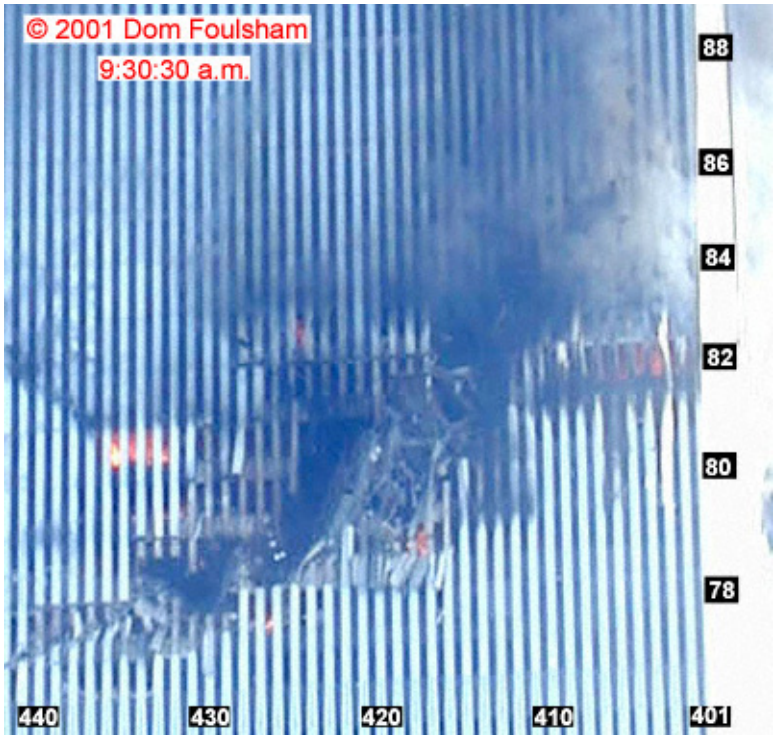
Figure 7-22. This cropped photograph shows the damage to the south face of WTC 2 caused by the aircraft impact. The image was enhanced by adjusting the intensity levels. Column and floor number have been added.

As was true for WTC 1, in areas of the façade struck by the wing tips and the upper portion of the vertical stabilizer, the aluminum covering was marked, but the aluminum covers were not removed and the steel was not cut through. Measurements for the location of the left wing tip were mapped out as shown in Figure 7–25. As already noted, the area at the end of the right wing was obscured by heavy smoke. However, there were brief periods when the location of the last column struck by the wing tip could be discerned. This location is indicated on column 85-404 of the 85th floor in Figure 7–25. The center of the aircraft impact location is clearly toward the east side of the face. The left wing marks extend to the bottom of the spandrel located below the 78th floor. The location of the concrete floor slab is above this point, which means the lowest point struck was on the 77th floor. Thus, the aircraft impact location on WTC 2 extends from the 77th floor to the 85th floor. This finding can be contrasted to the FEMA study (McAllister 2002) and most media sources, which reported that the impact floors extended from the 78th to the 84th floors.

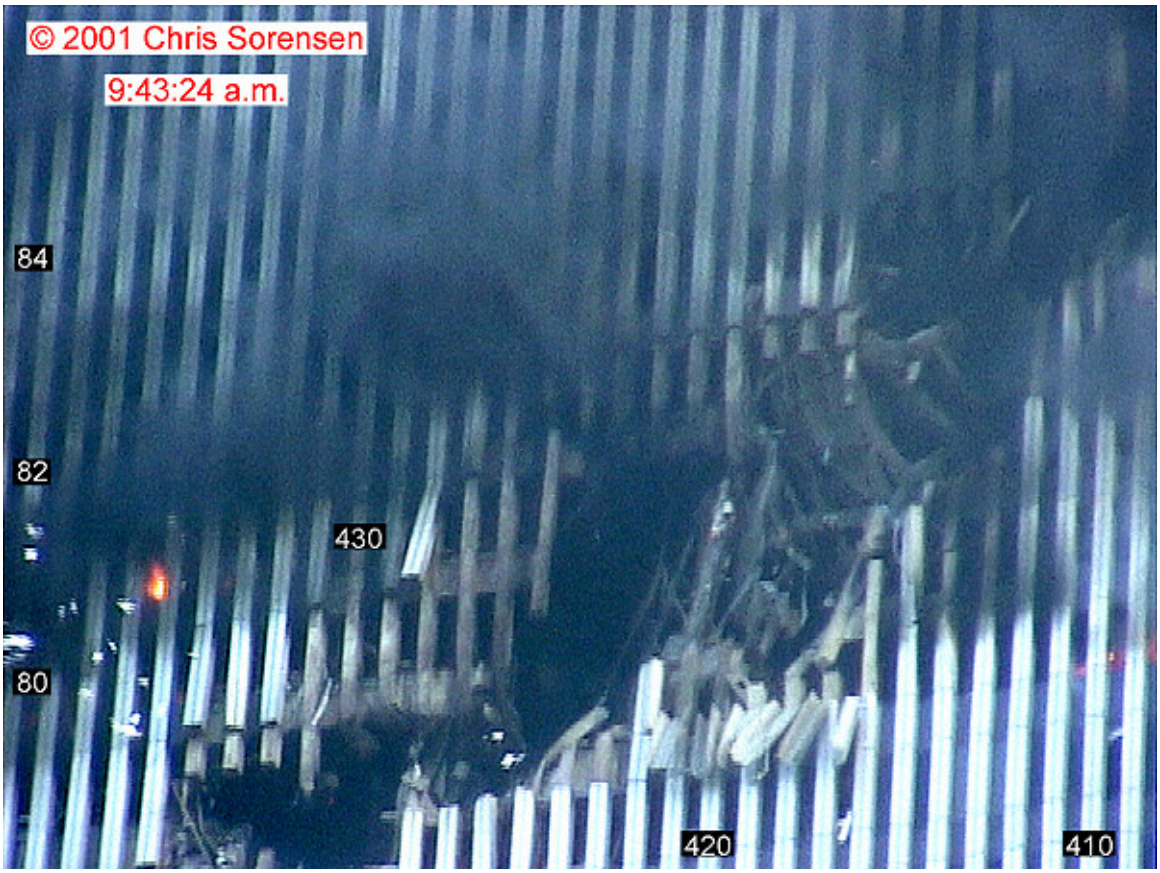
Figure 7-23. A frame captured from a video recording of the aircraft impact location on the south face of WTC 2 is shown. The image has been enhanced by adjusting the intensity levels. Column numbers and floor numbers have been added.

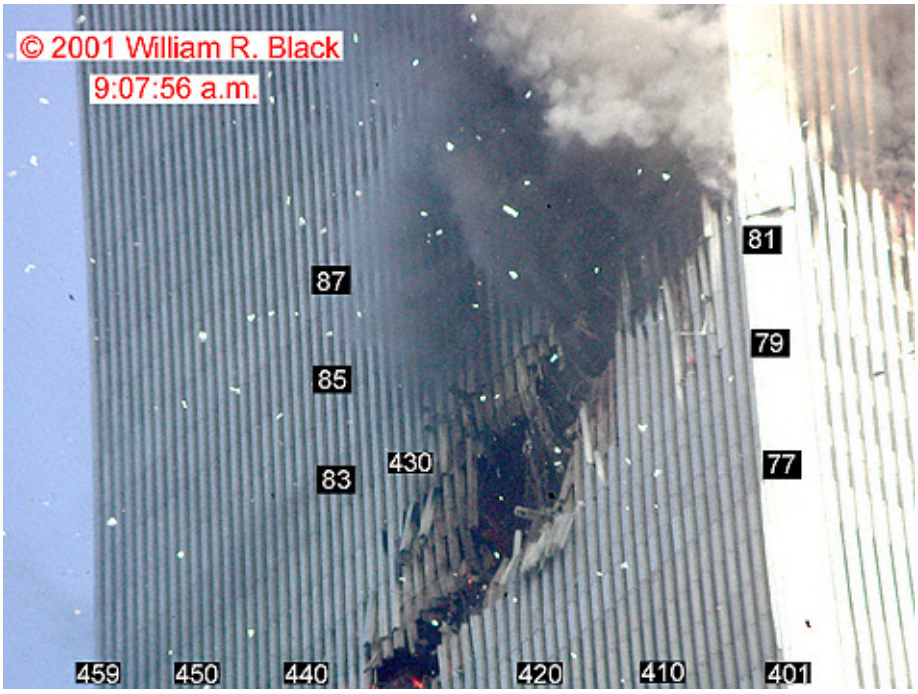
Figure 7-24. This cropped photograph shows the damage to the south face of WTC 2 caused by the aircraft impact. The original image has been enhanced by adjusting the intensity levels. Column and floor numbers have been added.

Close inspection of the photographs and videos reveals a great deal of debris piled on the right-hand side of the opening created by the aircraft impact. This debris, along with the depth of the opening, indicates that floor slabs in this area were partially collapsed by the collision. There is insufficient information to determine the exact areas over which the floor slab collapses occurred or the depth of the collapses inside the building. Visual evidence to be discussed in Section 7.4.3 suggests that at least some of the concrete in the floor slabs was pulverized during the collision.

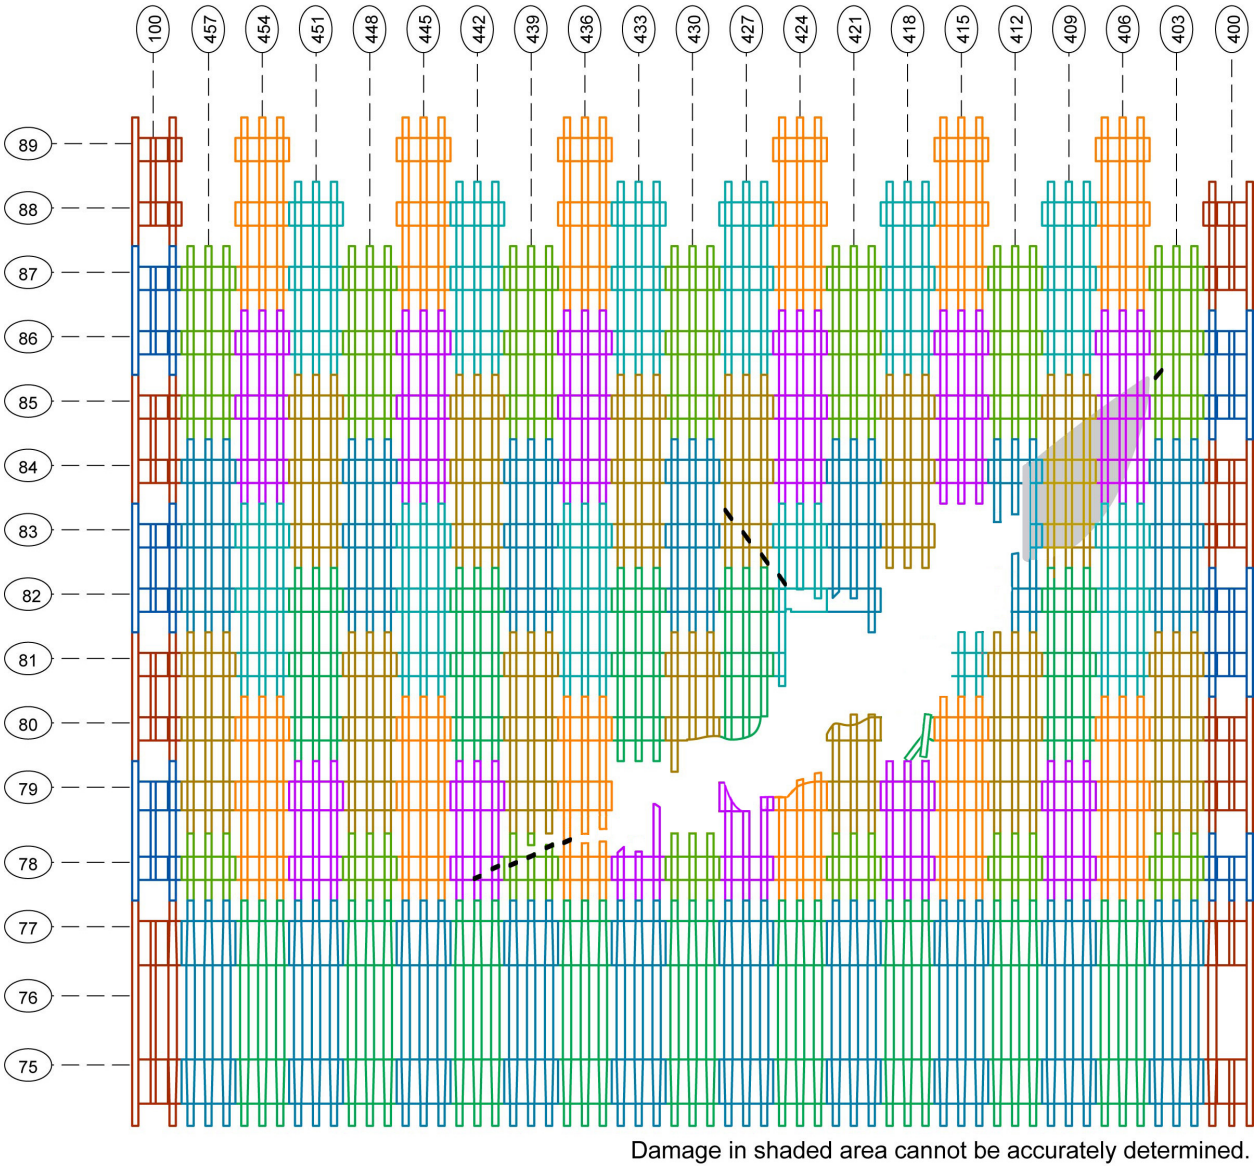
Figure 7-25. A diagram of the south-face steel façade of WTC 2 shows the damage inflicted by the aircraft impact. The dark dotted lines indicate locations where the wings and tail of the aircraft marked the aluminum cladding on columns. The area shaded in gray was hidden by smoke and could not be observed.

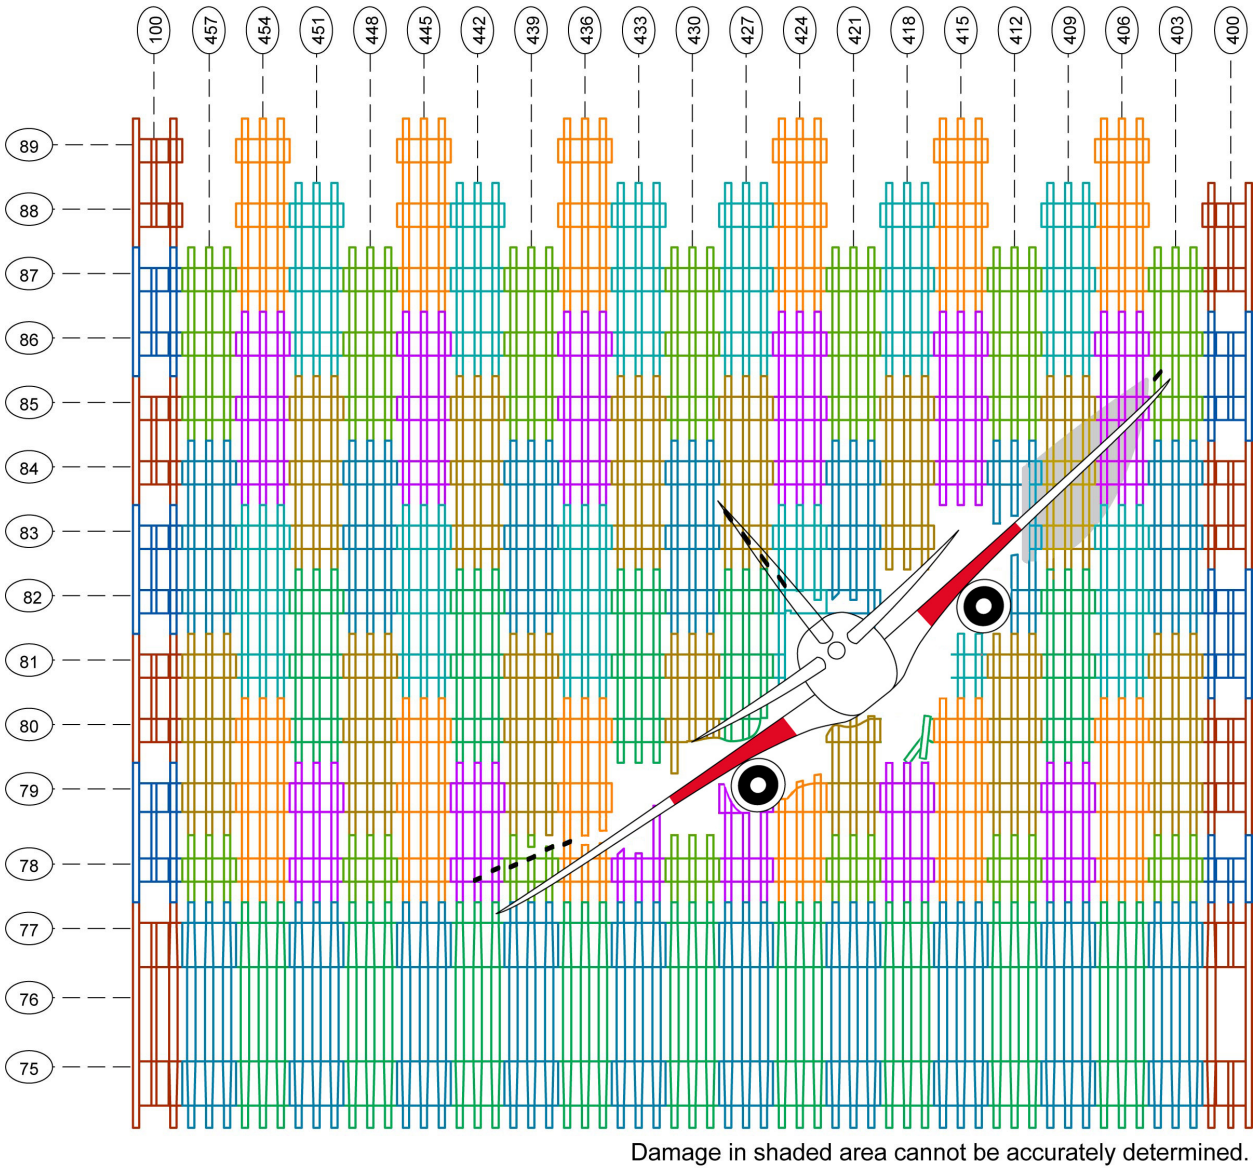
Figure 7-26. A scaled outline of a Boeing 767-200ER is superimposed on the damage diagram shown in Figure 7–25. The position of the aircraft has been adjusted to give the best match with the damage pattern and marks showing where the wing tips and vertical stabilizer struck. The match is not expected to be perfect since the drawing shows the aircraft as it appears when on the ground. The red areas correspond to the approximate locations of fuel on the aircraft based on an analysis reported elsewhere (NCSTAR 1-2B).

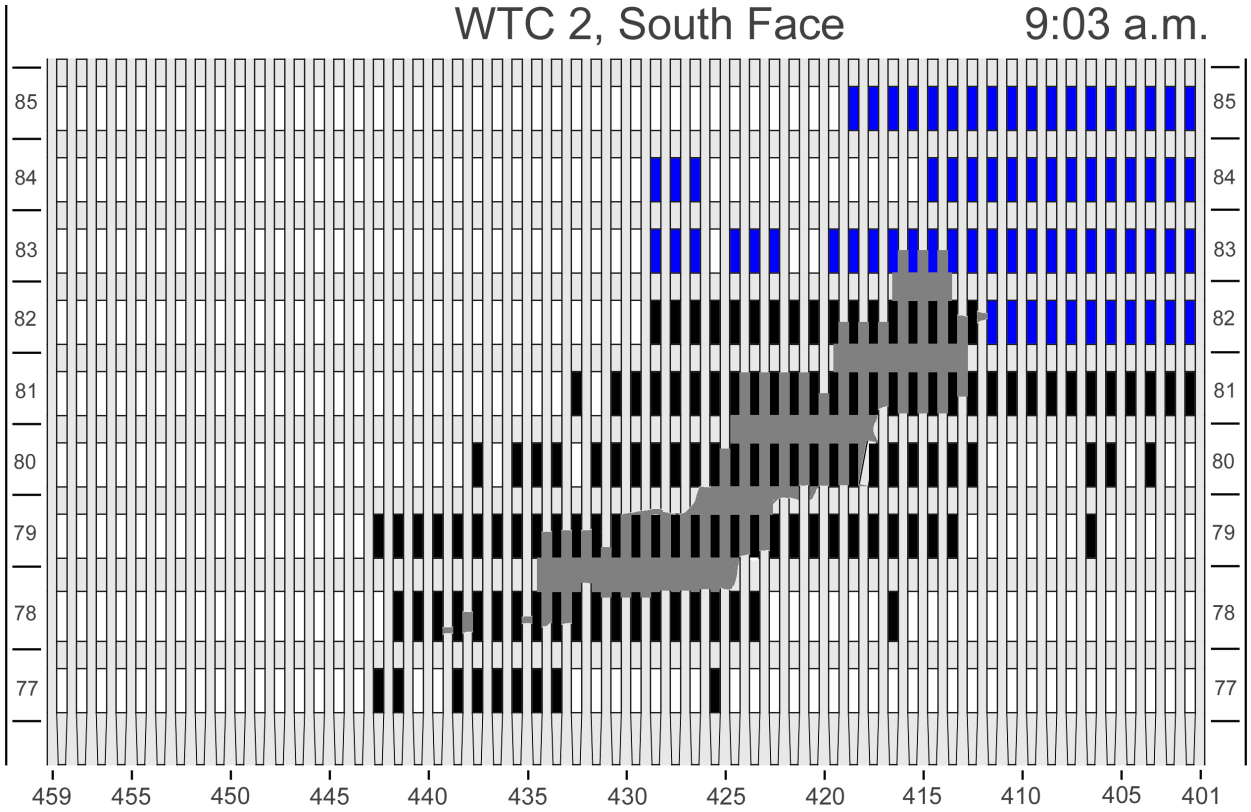
Figure 7-27. A schematic of observed window conditions on the south face of WTC 2 immediately following the aircraft impact is shown. Window and floor numbers are indicated. The colors represent ▌- window broken open, ▯ - glass in place, and ▌- not visible.

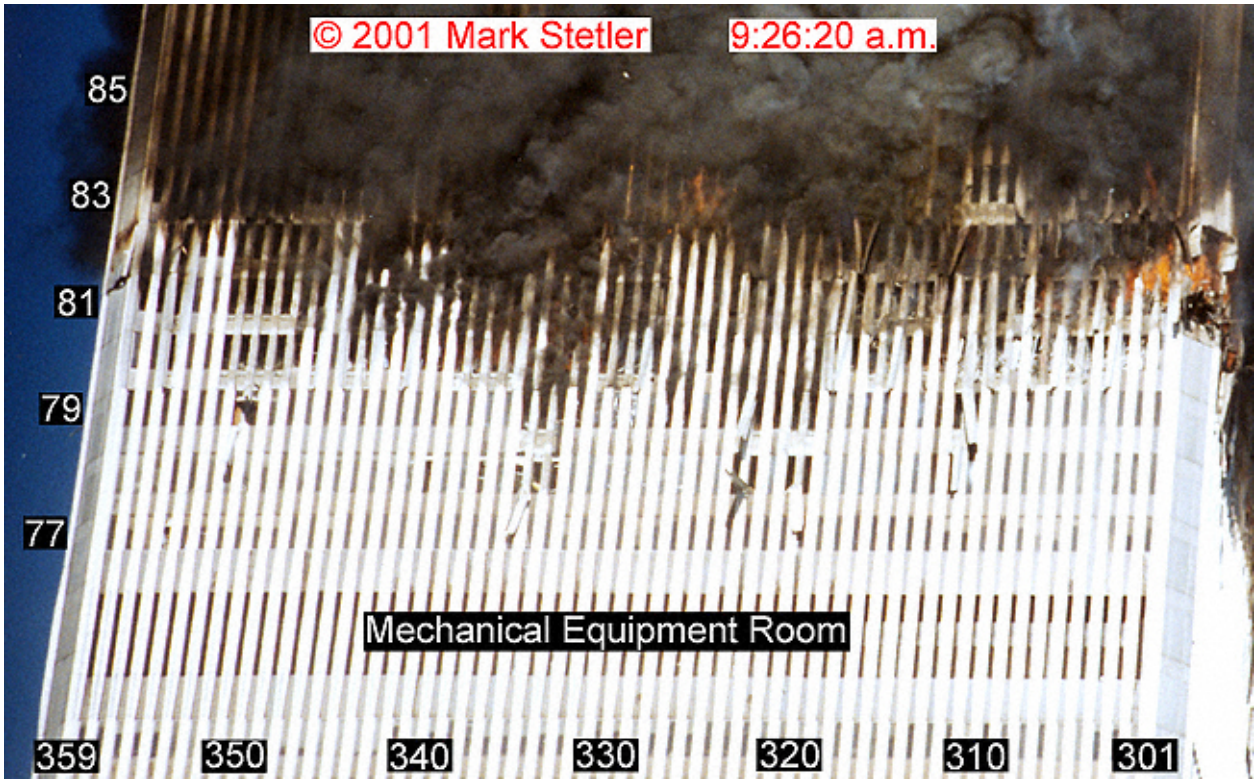
Substantial areas of the aluminum curtain wall have been removed over multiple floors. These areas appear dark due to the color of the underlying column and spandrel steel and fireproofing. In other areas the aluminum column and spandrel covers were disturbed, but remained in place. Video evidence and the wide extent of the damage indicate that much of this damage was due to the overpressures generated within the building by the sudden ignition of atomized aviation fuel and that these overpressures were sufficient to "blow off" numerous sections of the curtain wall. The potential magnitude of the overpressure generated within the tower was discussed in Section 6.5.

Figure 7-28. A cropped photograph shows the east face of WTC 2 at 9:26:20 a.m. The image has been rotated, and column and floor numbers have been added.

Figure 7–30 shows an enlarged region of the northeast corner of the tower taken from Figure 7–28. Large piles of debris can be seen through the windows near the corner on the 80th and 81st floors. It is likely that a large fraction of this debris was derived from the aircraft, since its body impacted on these two floors (see Figure 7–26). This suggests that either the debris was deflected from the core or that the aircraft was moving toward the east when it struck the tower, since the nose struck near column 422 on the south face.

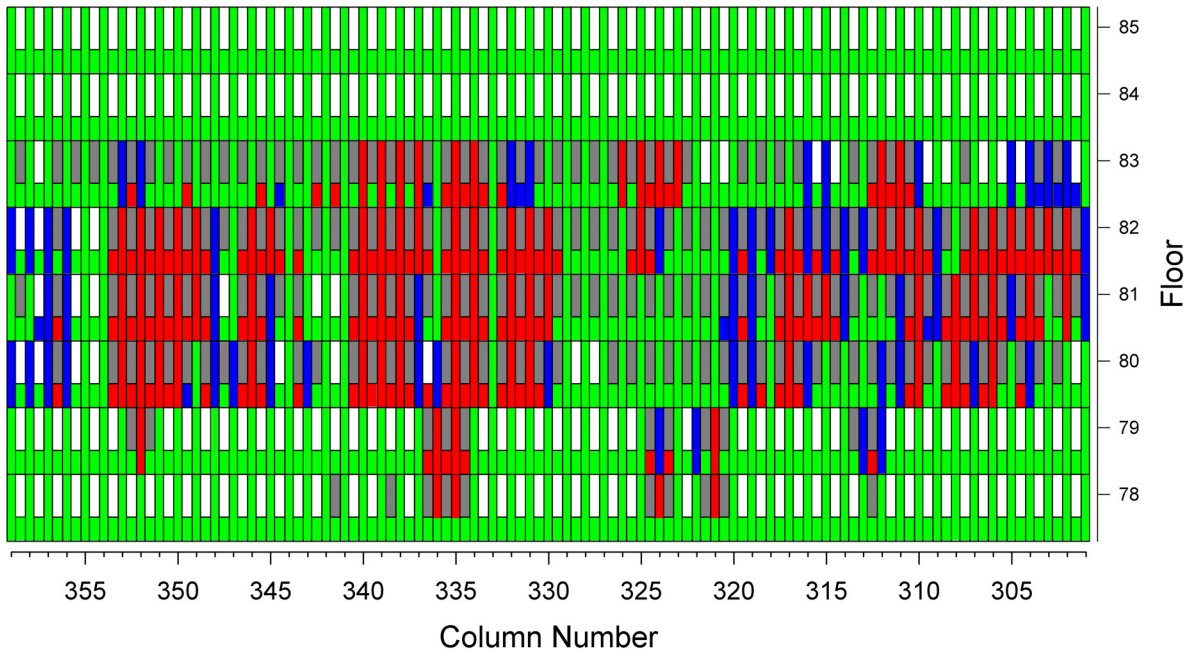
Figure 7–28, along with numerous other photographs and videos, was used as the basis for a detailed assessment of the initial damage to the curtain wall on the east face. Figure 7–29 shows the results. The information displayed includes details about the condition of the aluminum facing and whether or not window glass is missing or is still in place. It is apparent that the largest areas of damage were concentrated on the 80th, 81st, and 82nd floors. Based on Figure 7–26, these correspond to the two floors struck by the body of the aircraft (80th and 81st floors) and the floor where the majority of fuel from the starboard fuel tank was dumped (82nd floor). Interestingly, much less damage is apparent on the 79th floor, which is the floor where most of the fuel from the aircraft's port tank should have been released.

Figure 7-29. A color-coded map of the damage to the east face of WTC 2 as a result of the aircraft impact and fireball is shown. Details concerning damage to the aluminum curtain wall (- undisturbed, - disturbed but still in place, and - aluminum facing missing) and windows (- glass missing and - glass in place) are combined.

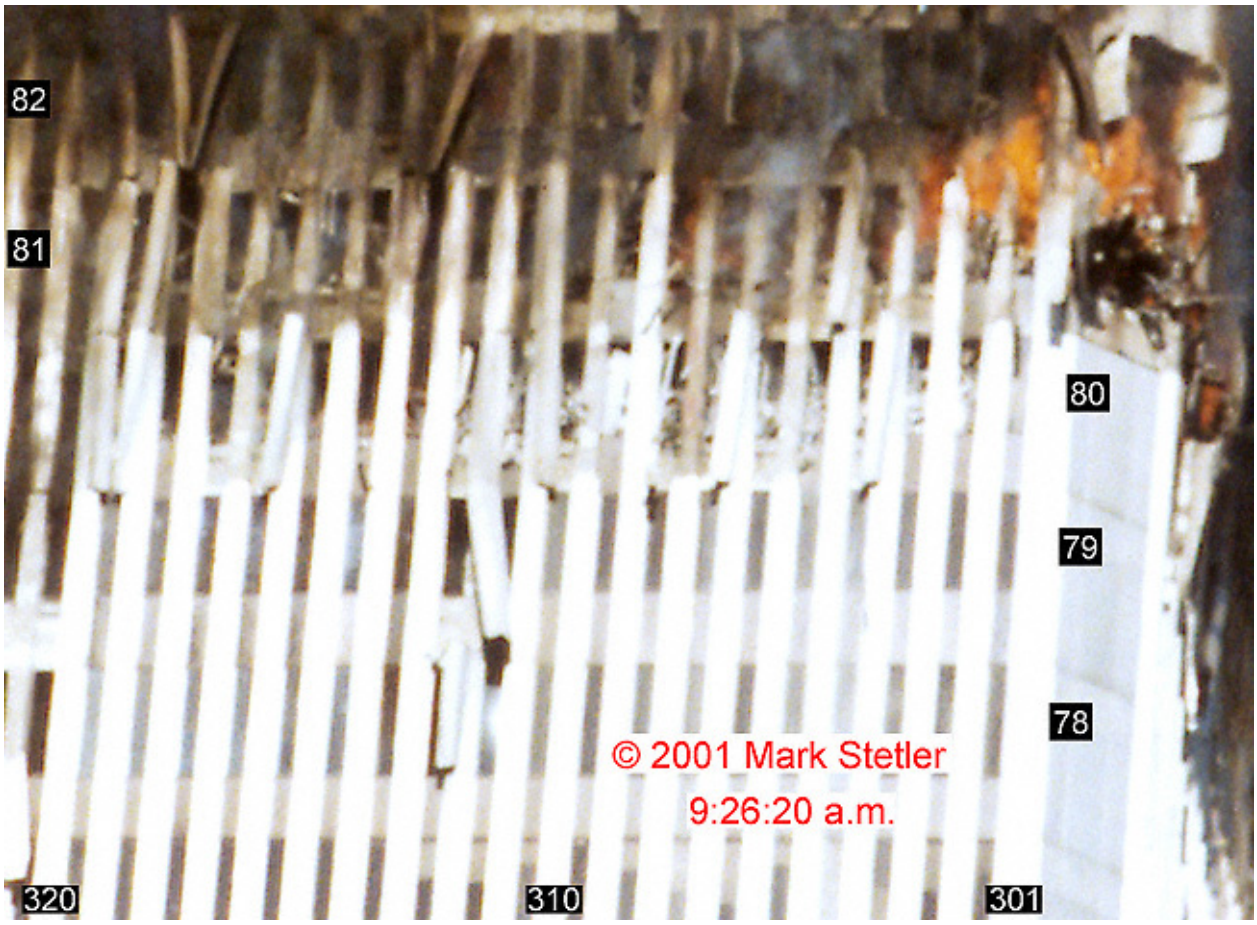
Figure 7-30. This photograph showing a portion of the east face of WTC 2 was cropped from the image shown in Figure 7–28. The image has been rotated, and column and floor numbers have been added. Note the large piles of debris on the 80th and 81st floors.

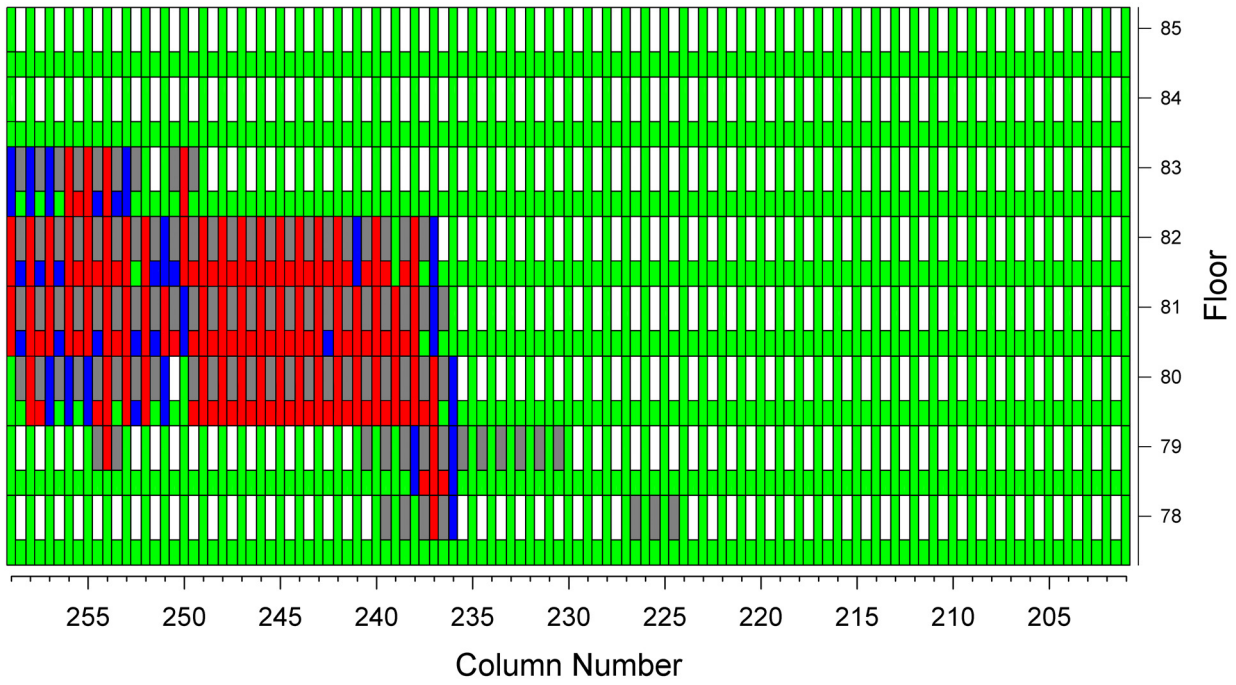
Figure 7–32, along with other photographs and videos, was used to develop the map for exterior damage shown in Figure 7–33 for the north face of WTC 2 that combines damage to the aluminum facing and window glass that make up the curtain wall. Damage on this face is inclined at an angle which roughly matches that at which the aircraft struck the tower on the south face on the opposite side of the tower. This suggests that debris from the aircraft tended to pass straight through the tower, perhaps passing between and being guided by the floor slabs.

Figure 7-33. A color-coded visualization of initial damage to the north face of WTC 2 is shown. Information concerning damage to the aluminum on the curtain wall (- undisturbed, - disturbed but still in place, and - aluminum facing missing) and windows (- glass missing and - glass in place) are combined.

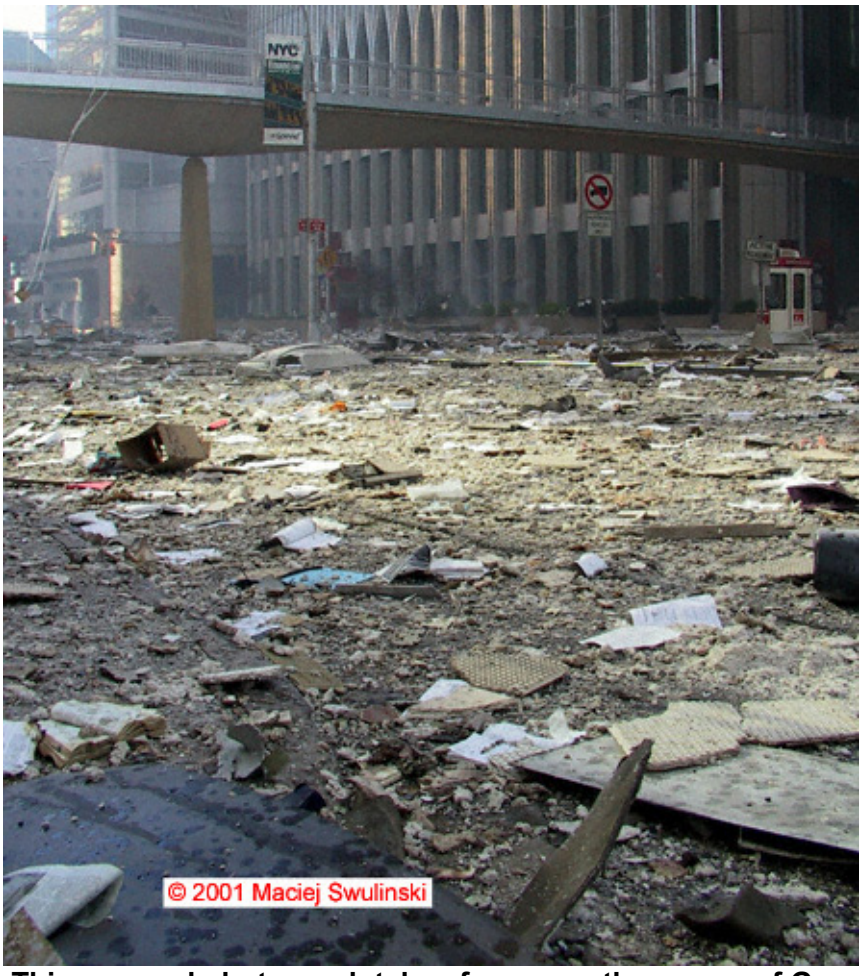
Photographs and videos taken on Liberty Street and in the immediate vicinity show that a great deal of debris was also present on the south side of WTC 2. Some of this debris came from the first aircraft impact on WTC 1, as described in Section 6.4.3, but there was a much larger amount following the second aircraft impact. Figure 7–35 shows a photograph that was taken looking across Liberty Street toward WTC 2 following the second aircraft impact. The street is completely covered with debris.

Figure 7–36 shows an enlarged portion of Figure 7–35. This photograph is typical of other photographs of the debris taken in the vicinity. Various types of debris, including papers and cardboard boxes, are identifiable. There is also a great deal of what appears to be crushed concrete. A dimpled material is evident in the foreground. Similar material is seen elsewhere in the street debris. This material is likely a portion of a ceiling tile.

Figure 7-35. This cropped photograph taken from near the corner of Greenwich Street and Liberty Street shows debris on Liberty Street following the second aircraft impact on WTC 2. WTC 2 and WTC 3 are located in the background.

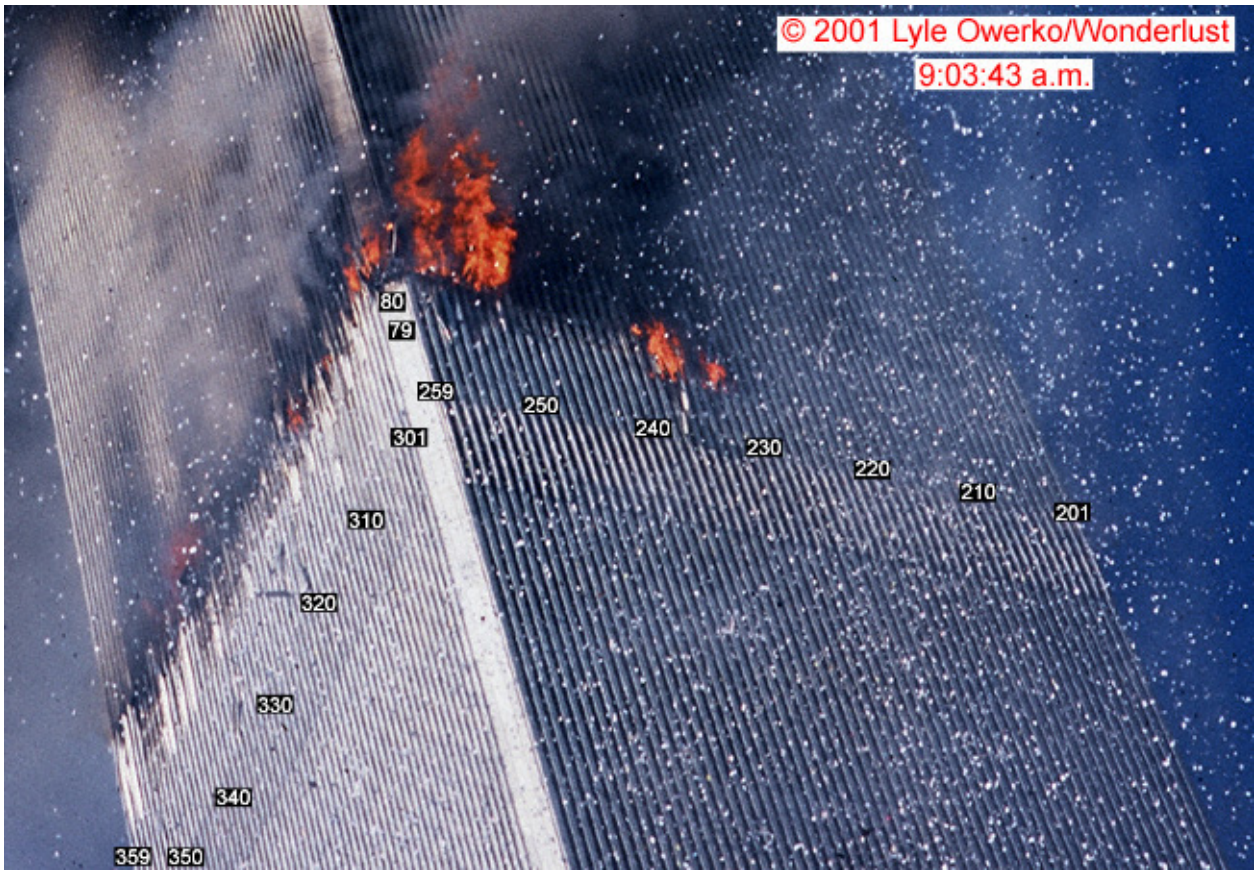
After the initial ten-second period following the aircraft impact, most of the large fires burning around WTC 2 began to decrease in size and to recede back into the building. In many locations fires were no longer visible after about 30 s. Figure 7–37 shows a photograph that was taken 44 s after the aircraft impact. Comparison with Figure 7–6 to Figure 7–8 indicates to what a large extent the flames coming from open windows have died down. Only relatively small fires are now observed on the east face. Substantial flame extension is still present on the north face, with large flames evident on the 81st floor near the northeast corner, and somewhat smaller flames located near the center of the north face on the 79th floor. Both of these flaming regions are in areas where large piles of debris can be seen through the windows. The cold spot discussed earlier stands out between the two fire zones due to the absence of flame. Similar close-up photographs and videos from the south are not available in the database for this early time, but more distant images indicate only a few isolated small fires were present on this face at this time.

Figure 7-37. This cropped photograph showing WTC 2 from the northeast was taken from the corner of Vesey Street and Church Street at 9:03:43 a.m., i.e., 44 s after the aircraft impact. The intensity levels have been adjusted, and column and floor numbers have been added.

The lack of significant burning in interior regions in the immediate aftermath of the fireballs is also reflected in the absence of heavy smoke coming from the tower. Some smoke is evident in Figure 7–37, but it does not obscure the faces of the tower. Most of it seems to be emanating from the flaming areas visible near the outer edge of the tower. Figure 7–38 shows the east side of WTC 2 at roughly the same time. Only very light smoke is present, and most of the façade area above the floors with fires is visible.

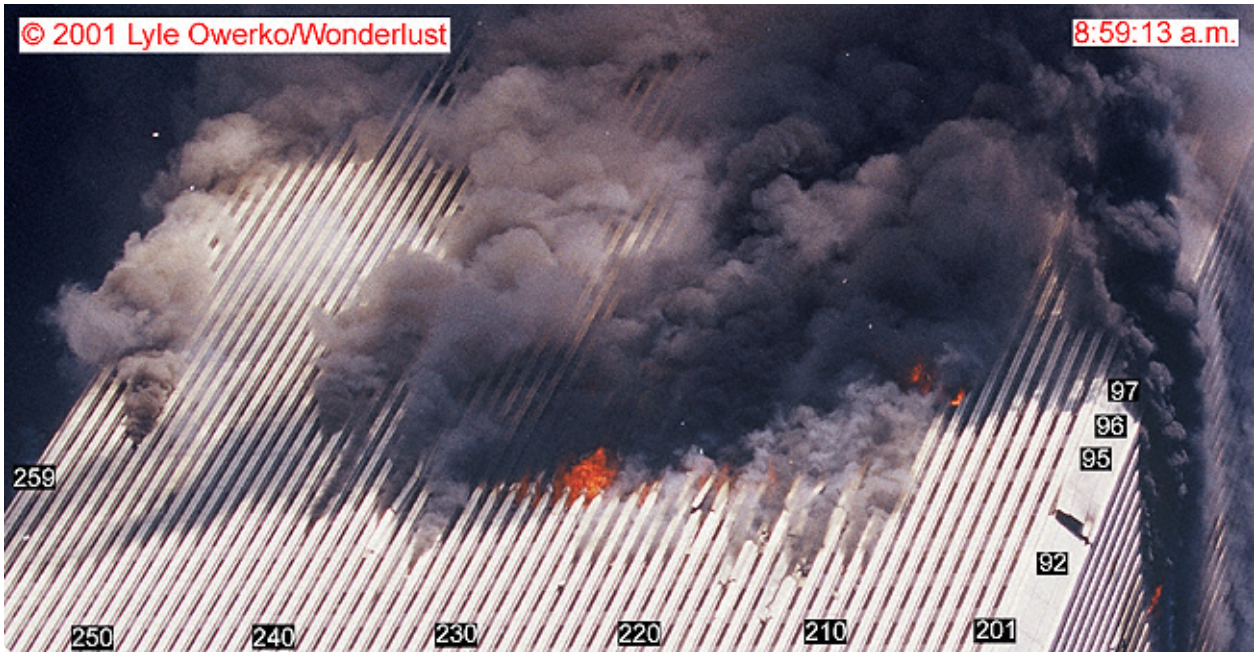
Figure 8–9 shows the east face of WTC 1 at 8:59:13 a.m. As observed earlier, a significant fire continues to burn over a large extent of the 94th floor. Intense burning was particularly evident at windows 94-226 and 94-227. Closer inspection of the photograph shows that distinct "carets" are present on the column covers next to these windows as well as on the covers for columns 94-229 to 94-232. As discussed in Section 5.2, these carets indicate that sometime earlier flames were extended out of windows 94-229 to 94-231 and subsequently withdrew back into the windows. These carets are an additional indicator of the intensity of the fires burning on this floor.

A major change in the east façade fire behavior is also apparent in Figure 8–9. Flames can now be seen at windows 97-208 to 97-210 on the 97th floor. It is difficult to determine exactly when fire growth started at this location due to obscuration by smoke coming from below. However, at least two videos showed flames erupting from these windows at 8:56:45 a.m., while another video showed an intense flame near window 97-211 at 8:58:19 a.m. A close-up photograph showed fire in window 97-114 at 8:57:38 a.m. It seems likely that fire first broke out on the 97th floor on this face around 8:56:45 a.m. and rapidly spread over at least seven windows.

Figure 8-9. This view of the east face of WTC 1 was recorded at 8:59:13 a.m. The original image has been rotated and cropped. Column and floor numbers have been added.
