NIST NCSTAR 1-5A

Federal Building and Fire Safety Investigation of the World Trade Center Disaster

Visual Evidence, Damage Estimates, and Timeline Analysis

William M. Pitts
Kathryn M. Butler
Valentine Junker

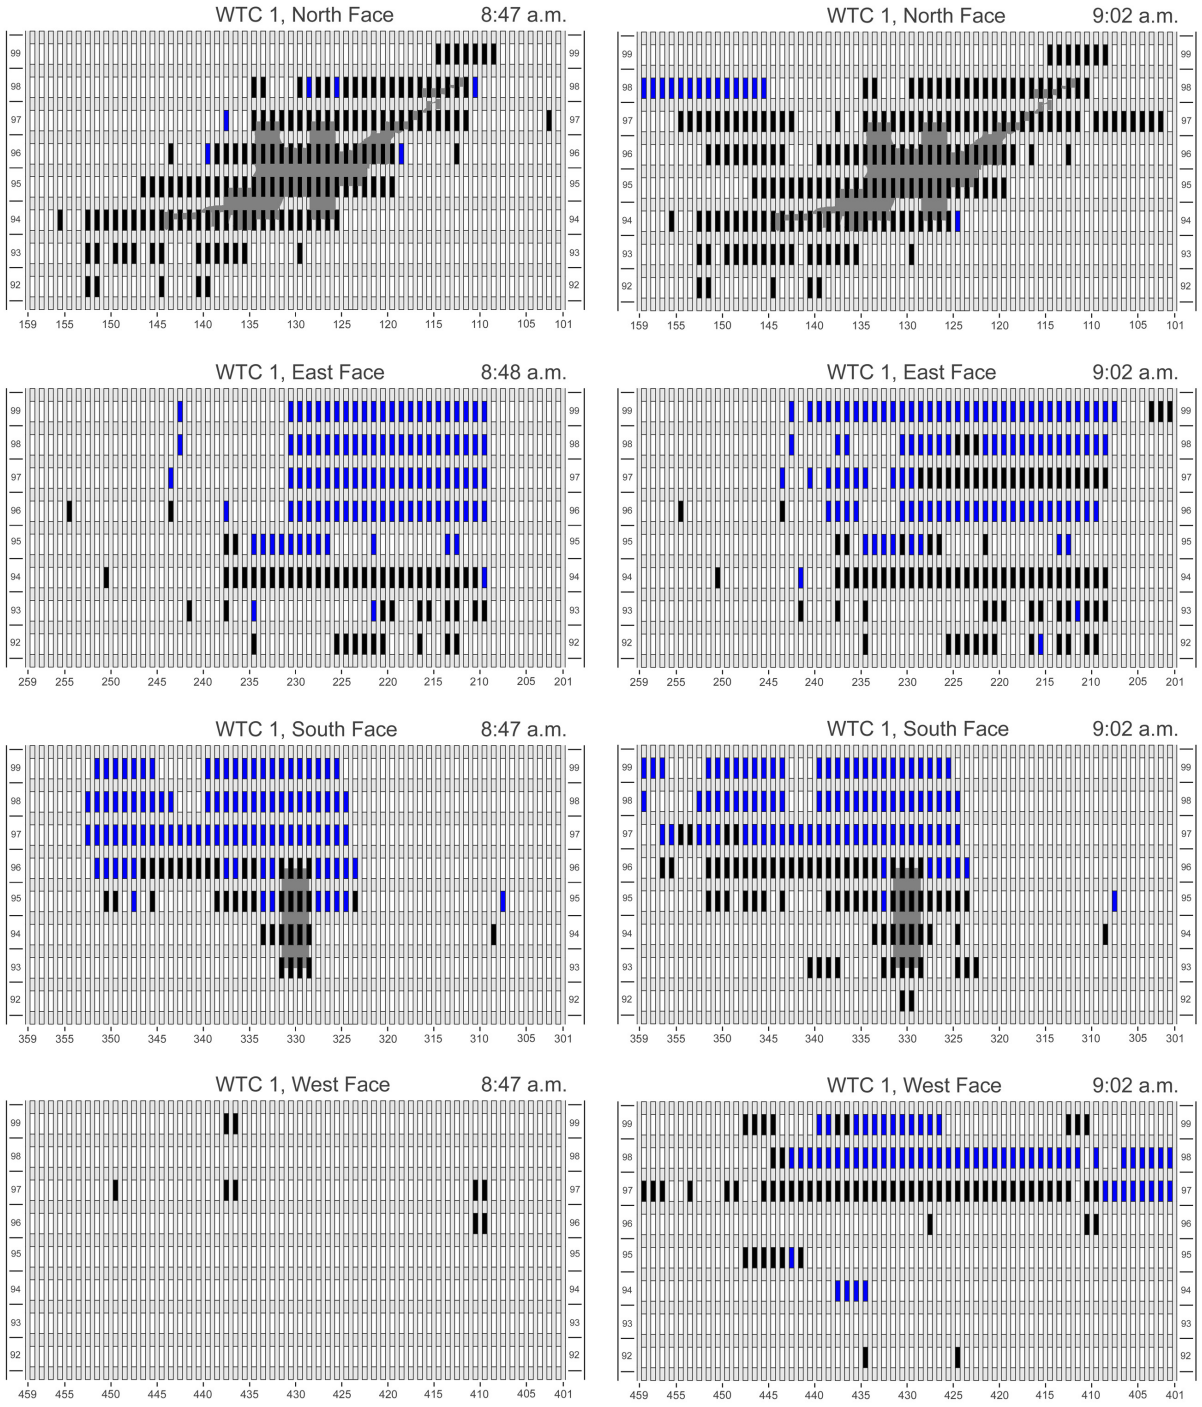
Figure 8-13. Maps for the 92nd through the 99th floors compare missing window glass for the four faces of WTC 1 at two times, shortly after the aircraft impact and roughly 15 minutes later. The color coding used for the maps is indicated in Figure 5-1.

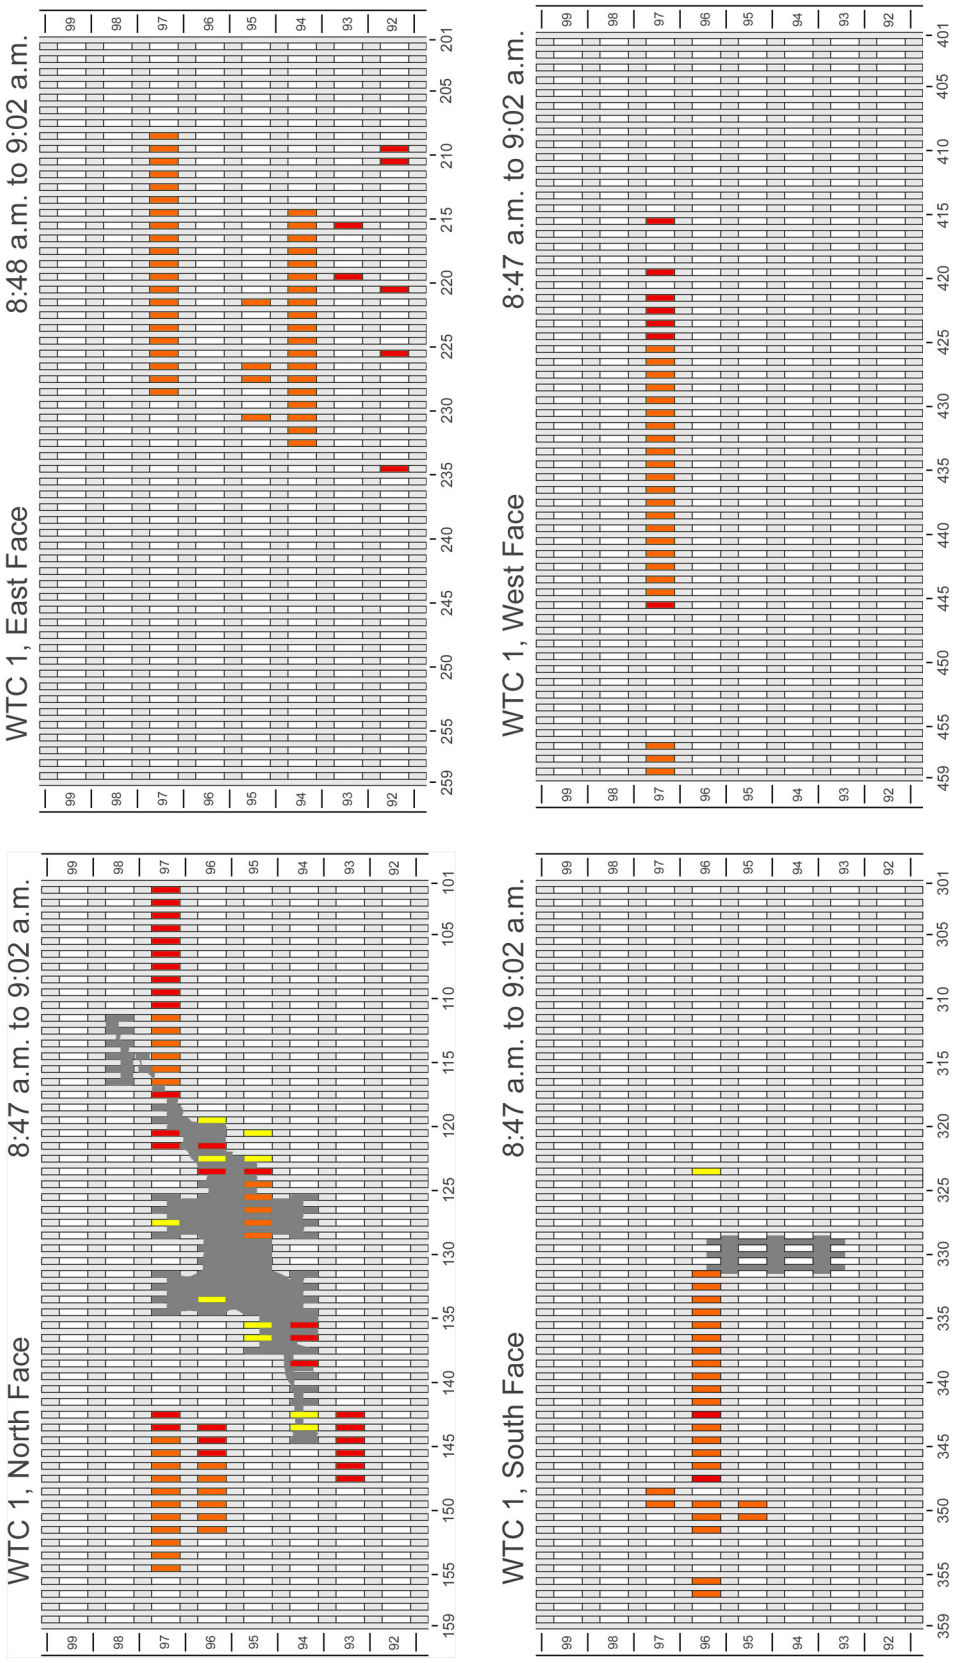
Comparison of these maps with similar maps in Figure 6-19 showing the fire distribution shortly after the aircraft impact provides a clear indication of the fire growth and spread during the period. The extensive fire growth on the 97th floor on the north, east, and west faces stands out. The fire growth on the 94th and 96th floors is also easily identified. The relatively high number of windows which had flames extending from the windows (orange) suggests that the fires that grew during the period were, in general, quite intense.

Figure 8-14. Maps of integrated fire observations between 8:47 a.m. and 9:03 a.m. are shown for the four faces of WTC 1. Colors represent the highest intensity fire observed in a window using the color scale defined in Figure 5-1.

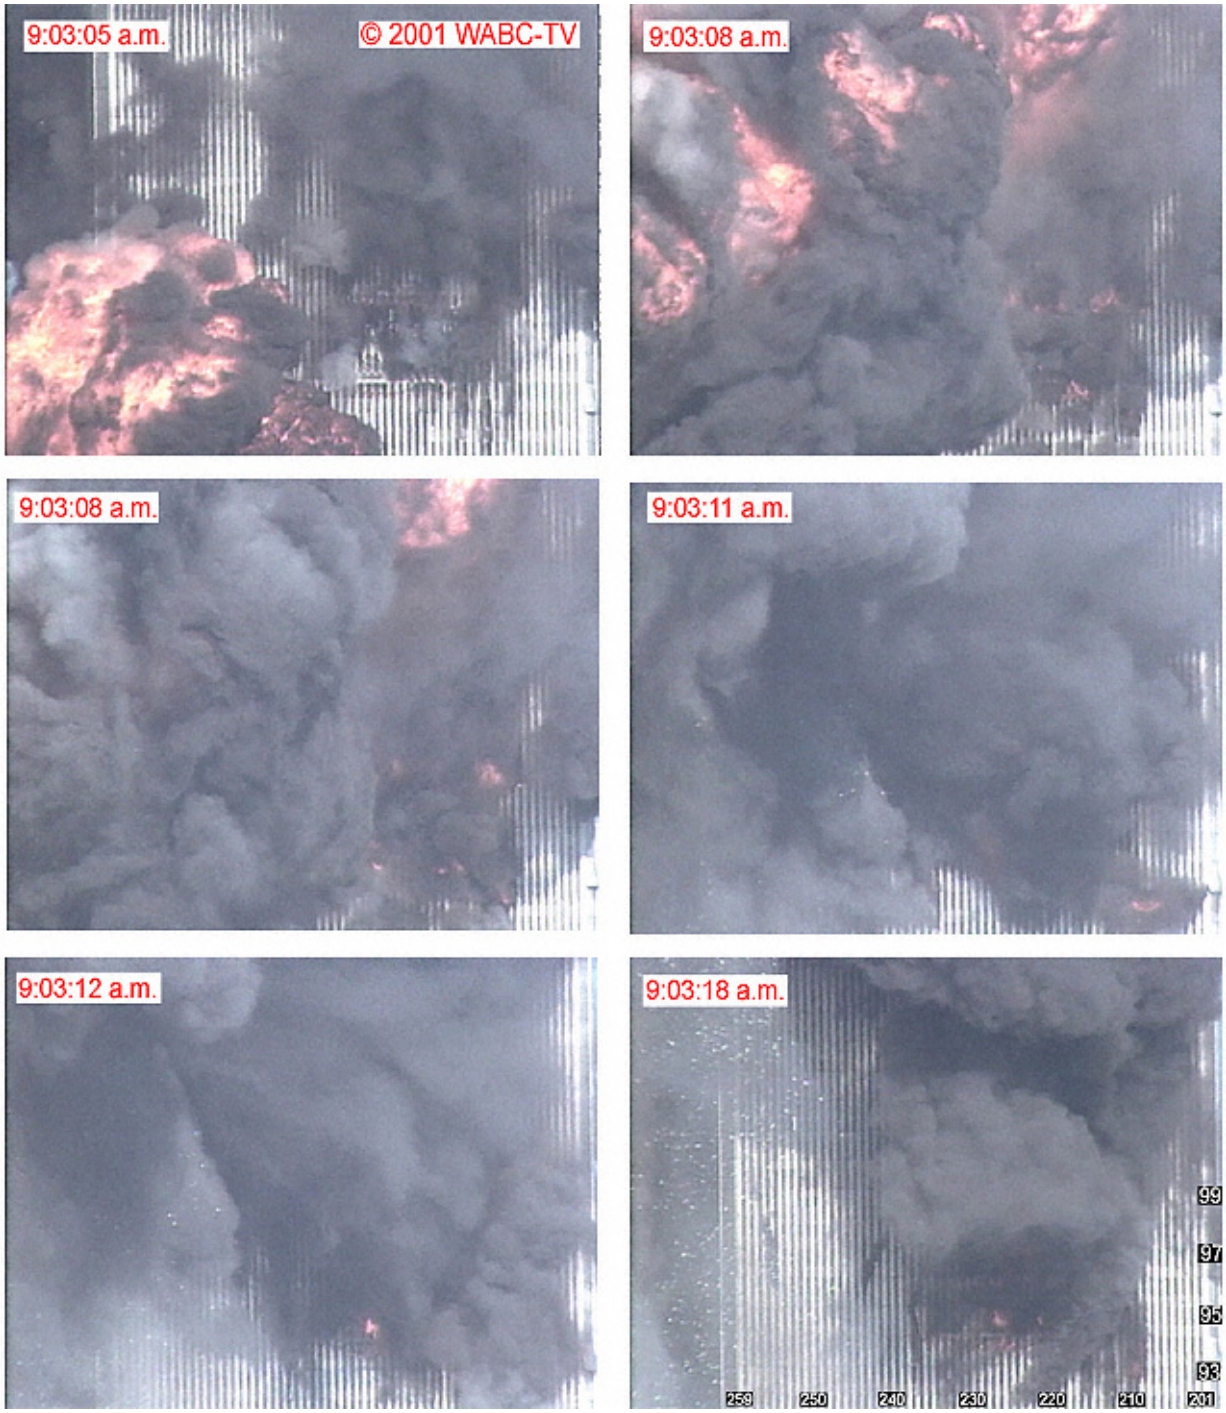
Figure 8–16 shows six frames taken from a video of the east face of WTC 1 during the period when the fireball was forming and rising away from the north face of WTC 2. The fireball itself is visible at the sides of the two earliest images and at the top of the third. In the image at 9:03:05 a.m., much of the smoke has been drawn away from the face of the tower, and it is possible to see the area near the right center of the face where fires have been burning. It is interesting that there are no external flames present at this time. While it still difficult to determine with certainty, it appears as if windows are open on the 94th floor from windows 94-212 to 94-233, on the 95th floor from windows 95-222 to 95-227, on the 96th floor at window 96-224, and on the 97th floor from windows 97-212 to 97-227.

Figure 8-16. Six frames taken from a video of the east face of WTC 1 are shown. These images were recorded during and just after a fireball formed on the north face of WTC 2 following the aircraft impact. Column and floor numbers have been added to the lower right-hand image.

The appearance of the face changed dramatically during the next three seconds. At 9:03:08 a.m. more of the face is hidden by the fireball, but most significantly, flames now appear to have been drawn out of windows 94-216 to 94-218 on the 94th floor, window 95-221 on the 95th floor, and a range of windows on the 97th floor extending from window 97-208 to window 97-227. This is the first image that shows a fire burning on the 95th floor. The next image was recorded 0.6 s later. Flames can now be seen coming from window 93-210 as well as from windows 94-225 and 95-226. At 9:03:11 a.m. the flame extending from around window 93-210 was particularly evident, and at 9:03:12 a.m. the same was true for the flames near windows 95-226 and 95-227. At 9:03:18 a.m. a small flame was observed burning at the top of window 92-212. In this image the flames extending from window 93-209 on the 93rd floor are distinct. Flames are also present on the 94th floor at windows 94-225 and 94-226 and on the 95th floor at two locations around windows 95-220 and 95-226. Even though not easily seen in the captured images, there appeared to be a small fire on the 96th floor near window 96-216 during the sequence.

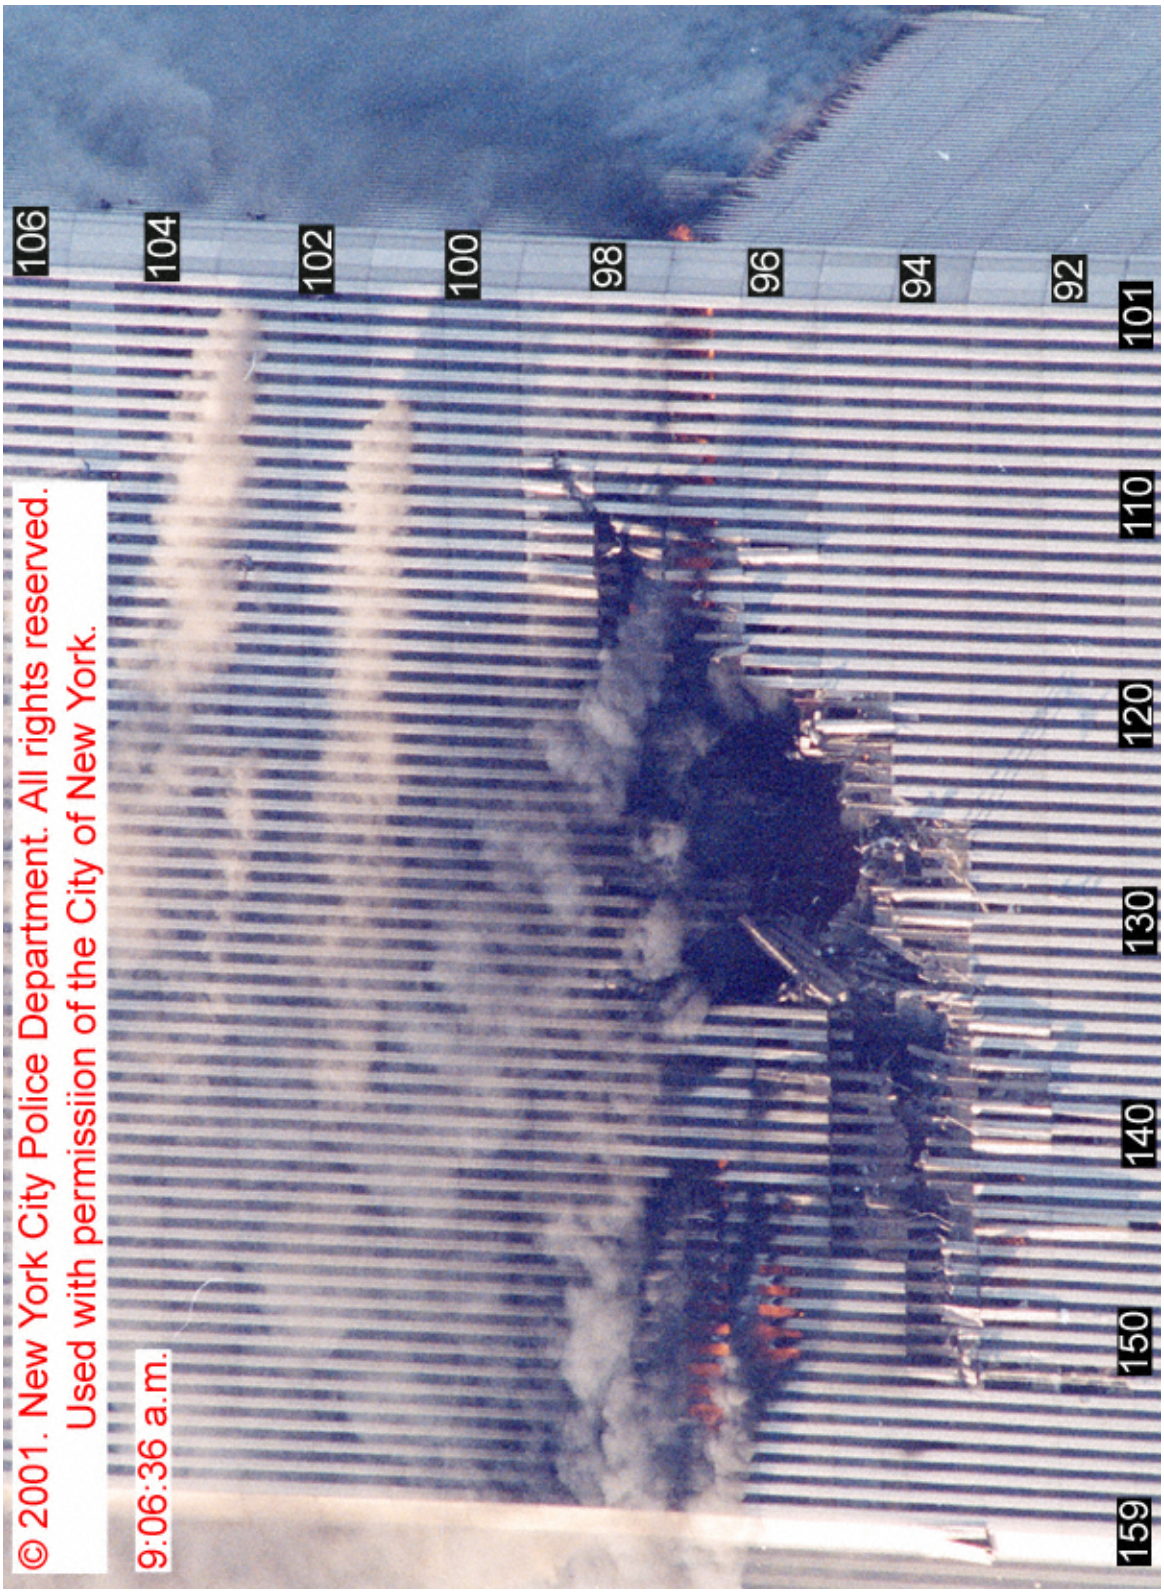
Compared to the rapid fire growth on the north face of WTC 1 during the first fifteen minutes of the event, fire spread during the following fifteen minutes was much reduced. The intense fires that grew on the 96th and 97th floors retreated into the building and began to die down. Figure 8–17 shows a photograph of the north face that was shot at 9:06:36 a.m. Even though the fire on the west side of the 97th floor had spread all the way to the west wall somewhat earlier, the two fires burning eastward on the 96th and 97th floors appear to have stopped spreading. The last window with fire present on the 97th floor is window 97-154. Flames are also evident at the other end of the area, starting at window 97-141. On the 96th floor fire is present at window 96-151, and from window 96-152 on to the east end of the floor, windows appear to be intact. This is clearer in Figure 8–18, which shows a blowup of the area taken from Figure 8–17.

Figure 8-17. A photograph of the north face of WTC 1 recorded at 9:06:36 a.m. is shown. The image has been cropped, rotated, and enhanced. Column and floor numbers have been added.

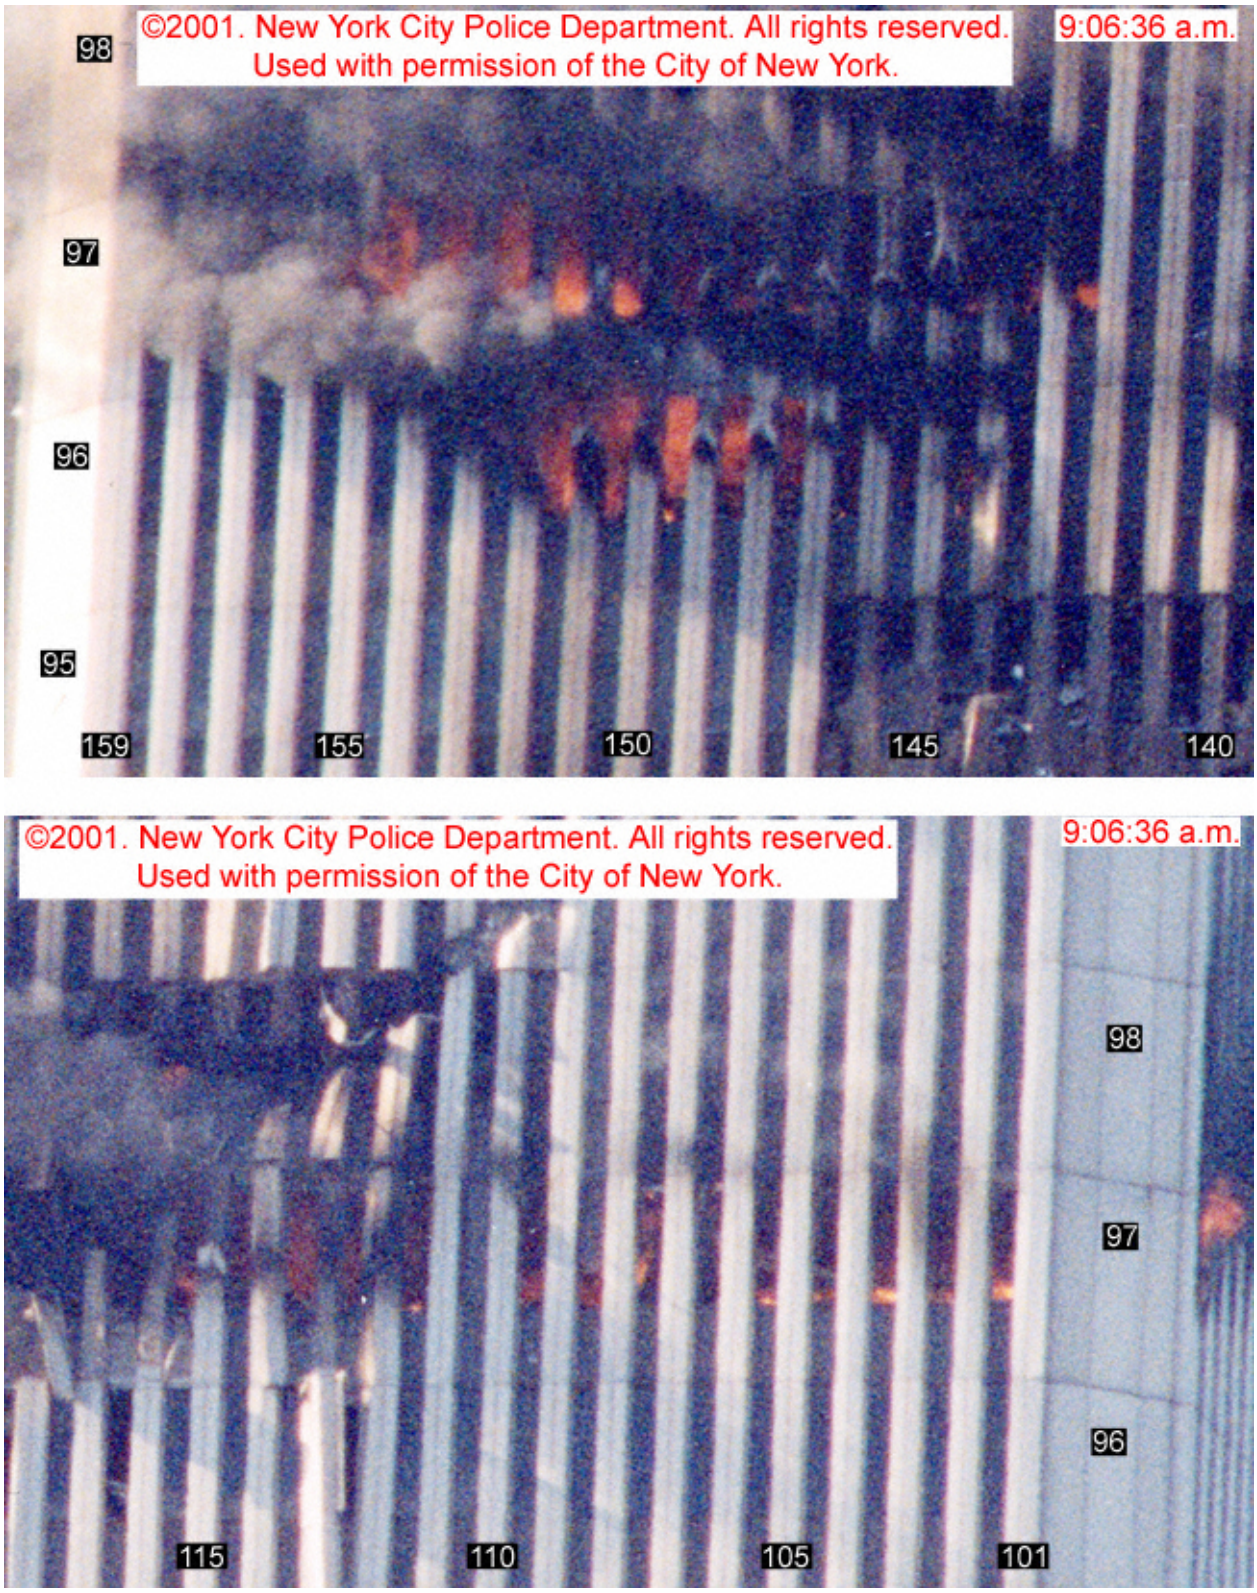
Another prominent feature in Figure 8–18 is the row of carets running across the tops of the column covers. These provide a clear visual indication of how intense the earlier fires in these windows were. It is interesting to compare the appearance of the column covers in this area with those on the 97th floor to the west of the aircraft impact cavity. A blowup of this area is also included in Figure 8–18. The columns are barely marked despite the presence of an active fire in the area for many minutes. This suggests that this fire must be venting somewhere other than through the open windows on the north face. As already discussed, and can be seen in the figure, flames and smoke were coming from this area on the west face of the tower. The smoke issuing from the right side of the aircraft impact cavity may also be due to effluent from this fire. Comparison of Figure 8–17 with earlier images of the north face shows that the flow of smoke from the cavity had also decreased with time. The pathways of venting are expected to influence the local heating of the exterior columns since the imposed heat flux will vary with changes in the flow direction through the opening. Exhausting fire gases will tend to heat the columns, while in-flowing outside air will cool the columns.

Figure 8-18. Two close-ups of the north face of WTC 1 taken from the photograph in Figure 8–17 show the east and west sides of the face around the 97th floor. The photos have been rotated, enhanced, and column and floor number have been added.

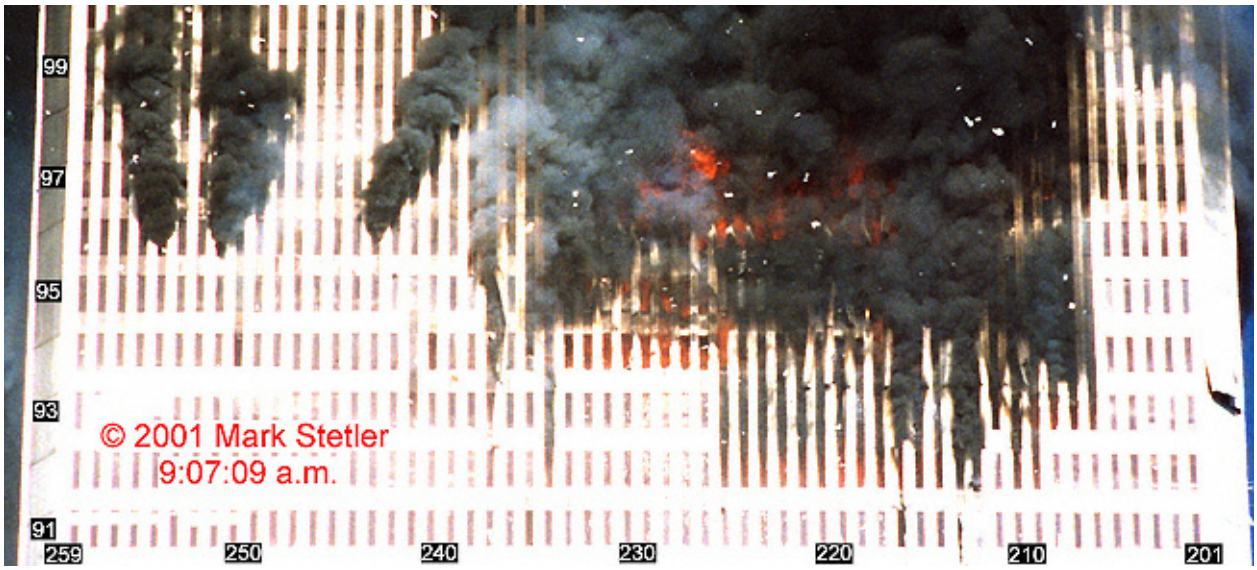
In contrast to the north face of WTC 1, the fires burning on the periphery of the east side of the tower continued to spread during this time period, initiating new areas of intense burning, while areas ignited somewhat earlier were dying down. Figure 8–20 shows the east face at 9:07:09 a.m. The appearance has changed considerably in the four minutes since 9:03 a.m. (see Figure 8–15 and Figure 8–16) and even more so from earlier times. Two important changes are the appearance of extensive areas of flame on the 92nd floor (extending roughly from window 92-216 to window 92-225) and on the 96th floor (visible over at least windows 96-217 to 96-227). Several distinct carets can already be seen on column covers on the 96th floor, indicating that strong external flaming had already taken place from windows adjacent to these columns. At the earlier time there had only been indications of small fires on both of these floors.

Figure 8-20. This cropped photograph shows the east face of WTC 1 at 9:07:09 a.m. It has been rotated slightly and enhanced to emphasize the presence of fire. Column and floor numbers have been added.

Around 9:03 a.m. there was a fire near column 95-225 on the 95th floor. In Figure 8–20, the fire on this floor now extends to window 95-231. The extended flames observed on the 93rd floor near column 93-210 around 9:03 a.m. have receded back into the building and are not obvious in the photograph. In their wake they left a dark caret at the top of the aluminum cover for column 93-210.

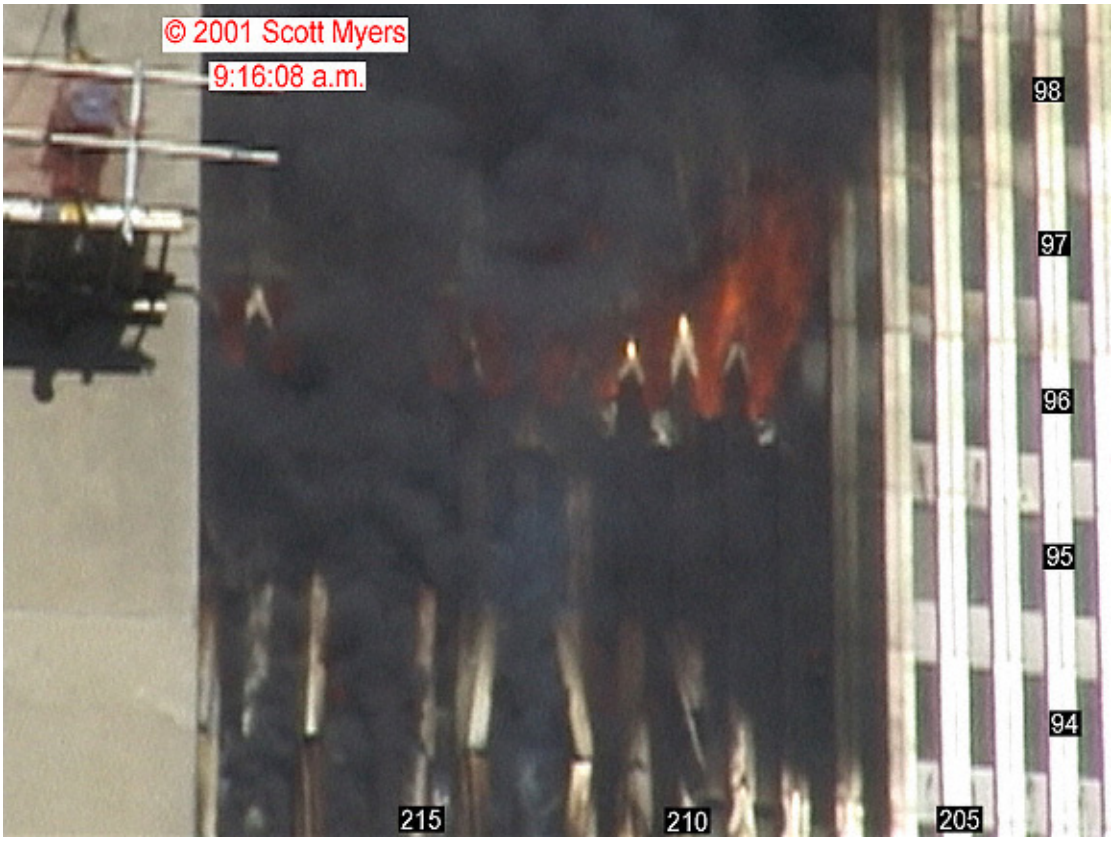
Figure 8–21 shows a close-up frame from a video of a portion of the east face recorded at 9:16:08 a.m. Intense flames are coming from windows 96-208 and 96-209. In the video it is clear that flames are exiting from across the entire burning region that is visible on this floor. A series of carets are seen at the tops of the column covers. The carets appear to be glowing near the center. The physical mechanism responsible for this glow is not known, but it does suggest that significant heating was taking place at this time. Recall that flames were observed on the 97th floor immediately above this location around 8:59 a.m. (see Figure 8–9). These flames are no longer visible, providing additional evidence that flames are growing and then decaying in relatively short period of times.

Figure 8-21. A close up of a portion of the east face of WTC 1 is shown. The image is a frame taken from a video recorded at 9:16:08 a.m. Column and floor numbers have been added. The area to the left with the scaffolding is another building in the foreground.

Even though flames have been observed extending from windows 96-208 and 97-208 on the 96th and 97th floors, the adjacent windows to the north, window 96-207 and window 97-207, are still intact. In fact, the entire area to the east of column 208 on floors 94 through 98 appears to be unaffected by the fires, except for soot deposited on the left side of the area. The sharp demarcation line for the fires on the 96th and 97th floors suggests that fire spread is being inhibited in a manner similar to that already described for the north face. The plan layouts for these floors shown in Appendix B (Figure B-5 and Figure B-6) indicate that both floors had rooms in the northeast corners, with walls that terminated at column 208.

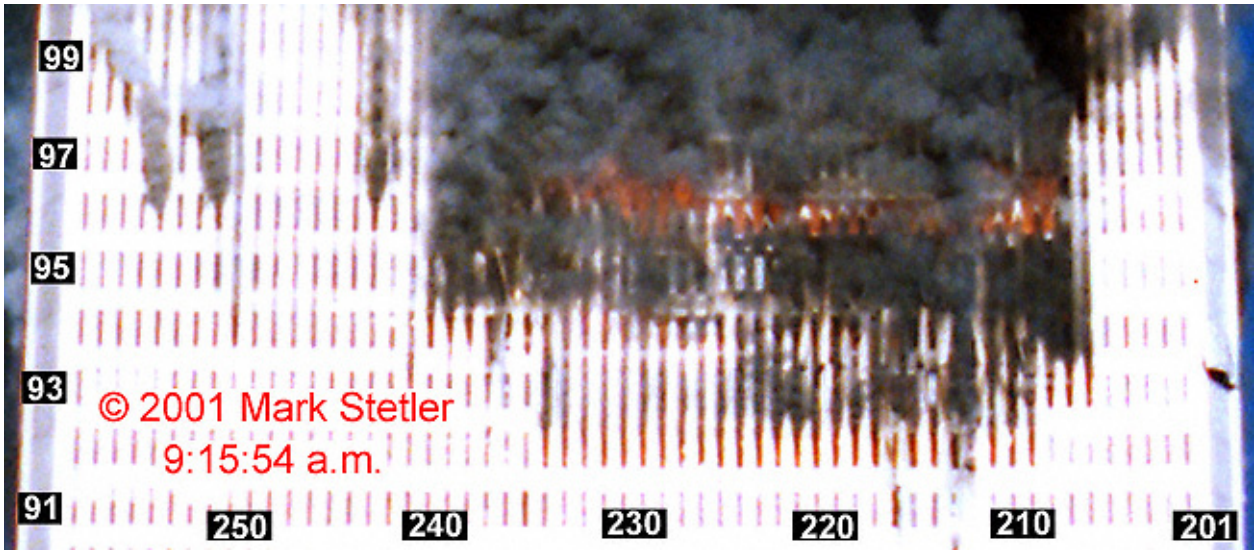
These general trends in the observed fire behavior for the east face continued over the next several minutes. Figure 8–22 shows a photograph that was taken at 9:15:54 a.m. There are regions of extensive fire. Flames can be seen on the 92nd floor from window 92-209 to window 92-235. One curious aspect of these flames is that there is little, if any, flame extension, and there is only heavy smoke coming from windows on the right side of the area. As a result of these characteristics, in many images of the east face recorded around this time, the fire on the 92nd floor is not readily apparent, and the smoke flow from these windows appears to be light. Fire is only observed in images taken nearly perpendicular to the face from relatively long distances. As discussed in Section 4.2.7, such observations are due to the geometry of the building and either suggest the fires are located near the floor or are set back from the windows.

Figure 8-22. This cropped photograph shows the east face of WTC 1 at 9:15:54 a.m. The image has been rotated and enhanced to improve the dynamic range. Column and floor numbers have been added.

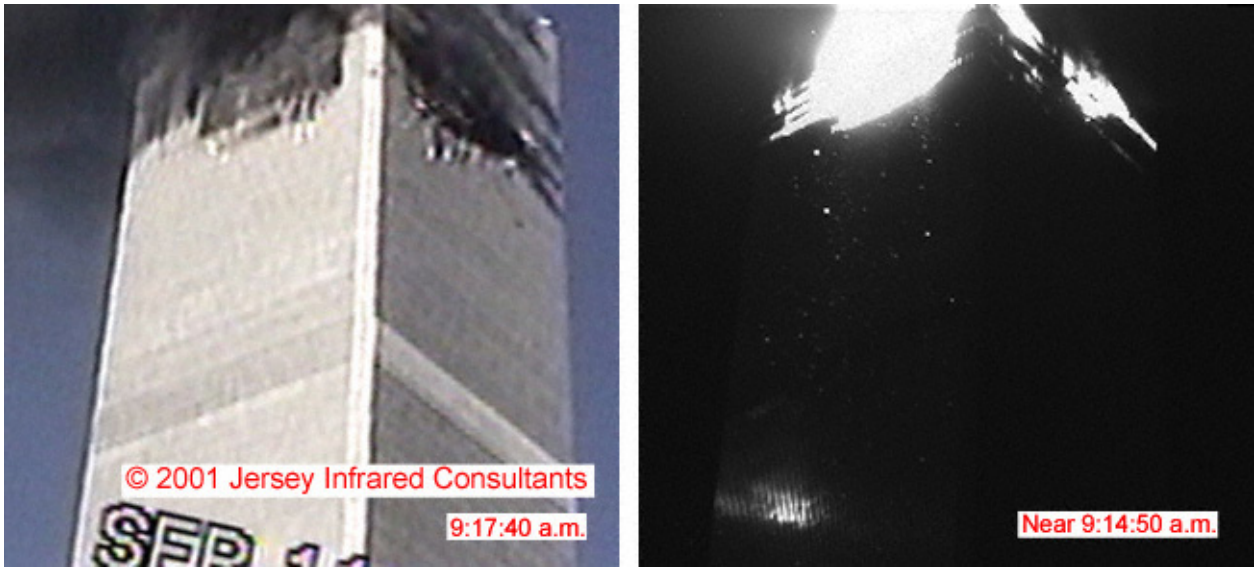
An infrared image showing the north and east faces of WTC 1 that was taken around 9:14:50 a.m. is compared in Figure 8–23 with a standard video frame recorded shortly afterward from the same location. These images were recorded at roughly the same times as Figure 8–19 (9:18:17 a.m.) and Figure 8–22 (9:15:54 a.m.), which show the north and east faces of WTC 1, respectively. Recall from the earlier discussion that the infrared photographs provide only a qualitative indication of where heating of the building façade is taking place.

Figure 8-23. A frame from a standard video camera (left) and an image from an infrared camera (right) showing the north and east faces of WTC 1 are compared. The video frame was shot at 9:17:40 a.m., and the infrared image was taken around 9:14:50 a.m. (an uncertainty of 15 s has been assigned). The infrared image intensity levels were adjusted. The video frame has been rotated and sized to match the infrared image.

Despite this strong heating, there are parts of the east face in Figure 8–23 where individual floors and windows can be identified. On the south side of the face heat has migrated along the 94th through 97th floors, resulting in the bright lines that are visible in the infrared image. Individual windows are barely resolved. Figure 8–22 shows that smoke was flowing from only a few of the windows in this area and that most of the windows were still closed around this time. Heavy smoke can be seen coming from two windows (96-251 and 96-254) on the southern side of the 96th floor in Figure 8–22. In Figure 8–23 these two windows stand out as two larger bright spots near the southern edge of the tower. Using these windows for reference, it can be seen that the heated sections of the 95th, 96th, and 97th floors do not extend beyond column 250, while the heating on the 94th floor seems to have reached the south end of the

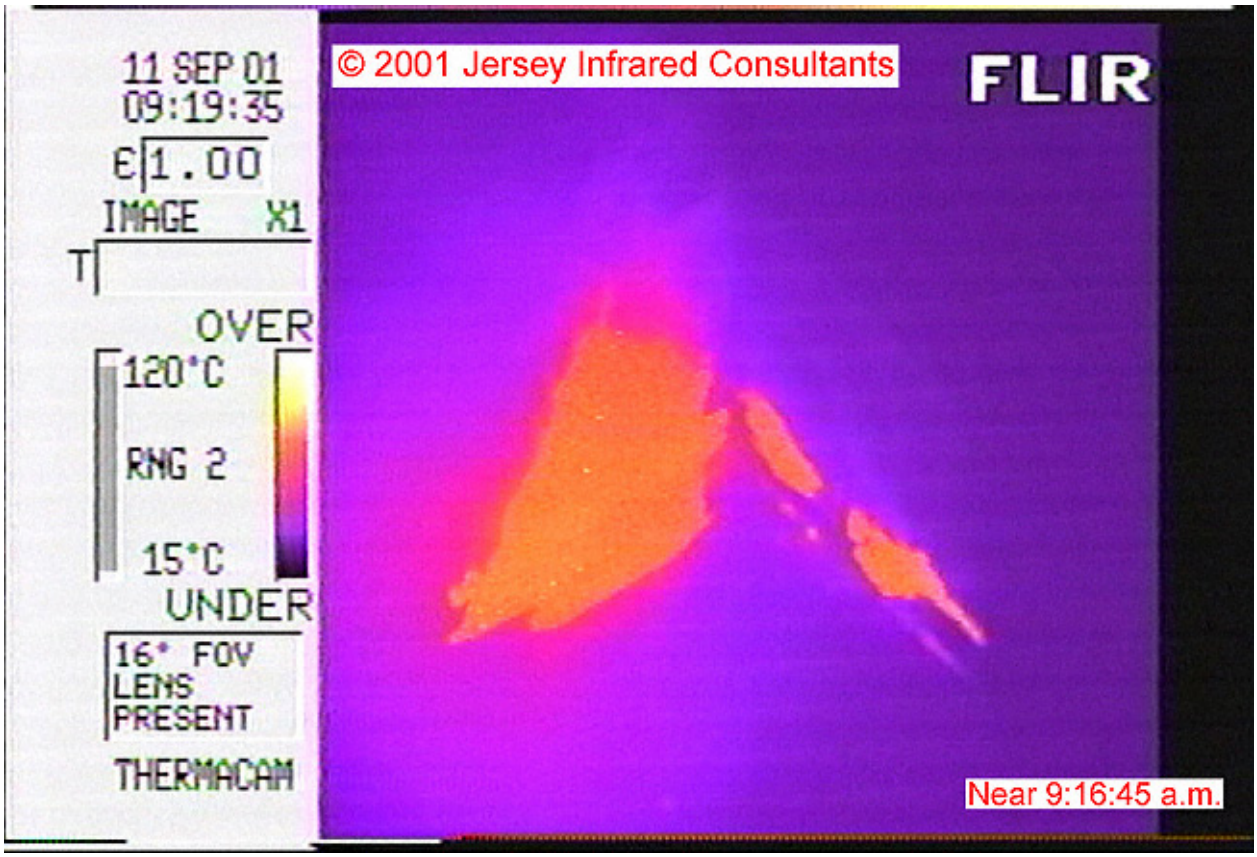
Figure 8-24. This frame from a standard video recording of the display from an infrared camera shows the north and east faces of WTC 1. It was shot around 9:16:45 a.m. (an uncertainty of 15 s is assigned) using a false-color scale for intensity. The output is strongly saturated.

On the northern side of the east face there are heated areas that reach as far as the northeast corner on the 96th and 97th floors. This is clearer in Figure 8–24, which shows more of the tower. Recall that at the times these images were taken the glass for all of the windows inside the northeast corner rooms was still in place on these floors despite the presence of nearby intense fires. On the lower floors there appears to be mild heating at the northern edges of the 92nd and 94th floors, while the 93rd and 95th floors are close to the ambient temperature.

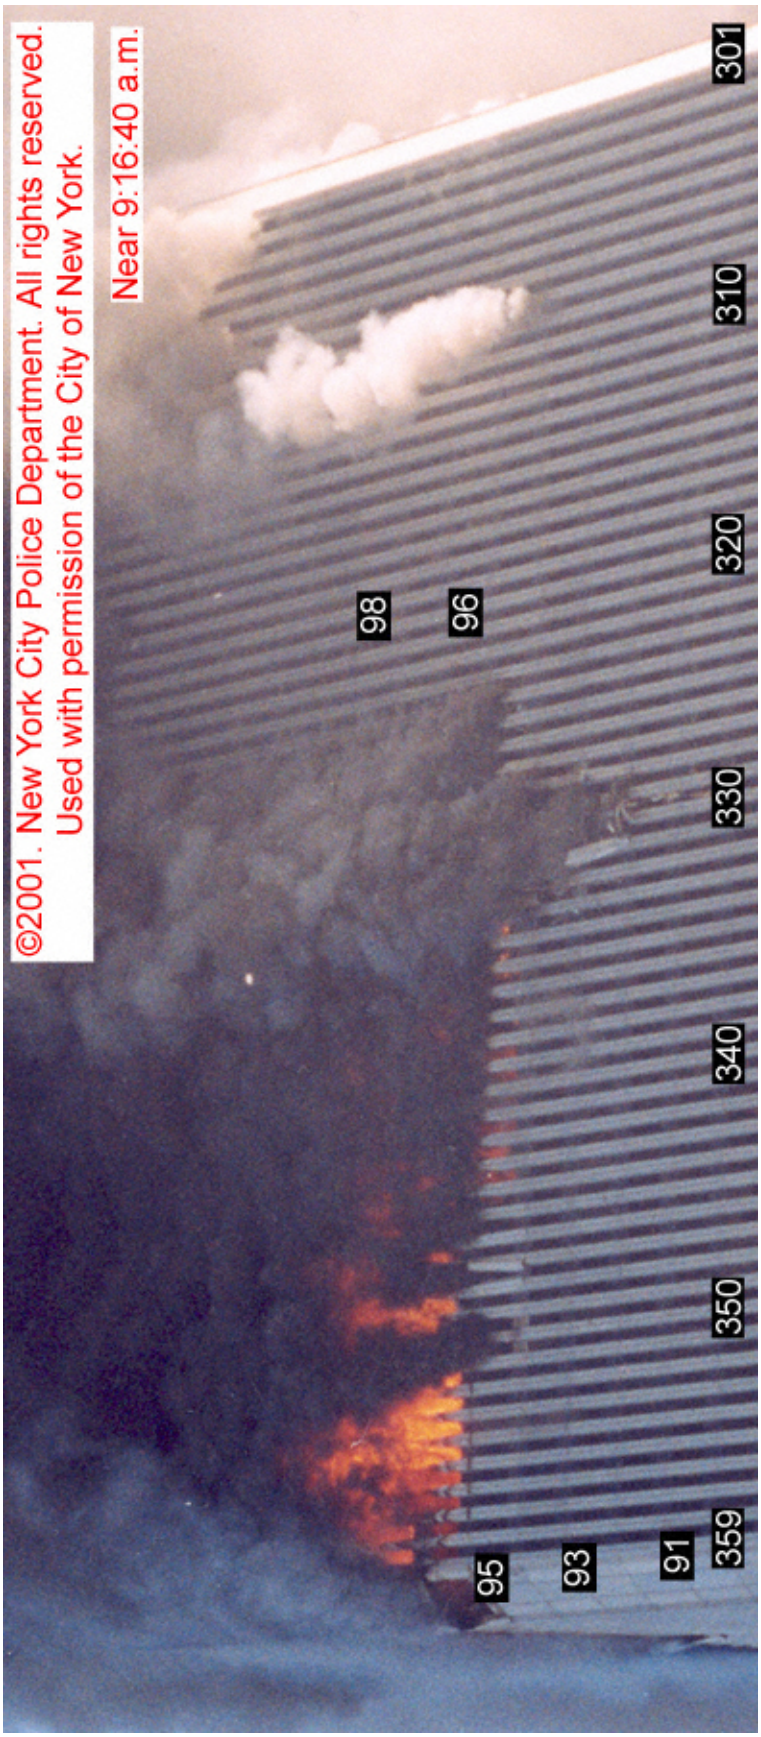
A row of carets is already visible at the tops of the covers for columns 96-352 to 96-359. Despite the intense flames, few streamers were observed falling from the south face as shown in Appendix L. This is not unexpected since imagery from this direction is more limited than for the north and east faces, and many of the available shots are from such distances that streamers are difficult to identify. During this time period, the south face was in shadow, and streamers were not illuminated by sunlight until they had traveled a considerable distance from the building.

Figure 8-27. This image of the south face has been cropped from a high-resolution photograph. There is a 35 s uncertainty in the assigned time of 9:16:40 a.m. The image has been enhanced and rotated. Column and floor numbers have been added.

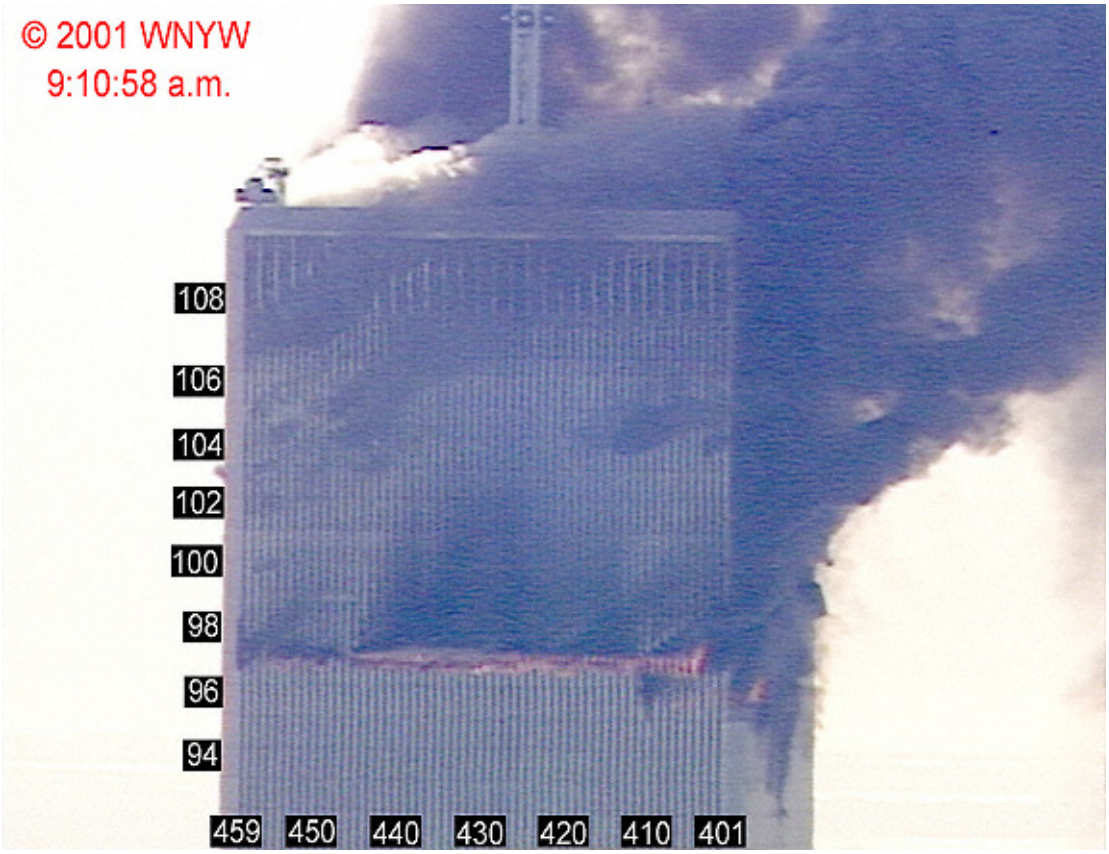
There appears to be a small fire on the 96th floor at window 96-406. Small fires such as this one were not observed on the west face of the 96th floor until around 9:08 a.m. This was the case despite the fact that an intense fire had been burning just around the southwest corner on this floor for over 20 minutes. Several windows did open near the corner during this time period, suggesting that heating was taking place in the area. There is a remarkable difference in the fire growth and spread on the western

peripheries of the 96th and 97th floors. This is especially true when it is recalled that substantial amounts of aviation fuel were likely spread across the western sides of both of these floors (see the discussion in Section 6.5).

Figure 8-30. This image of the west face of WTC 1 and an oblique view of the south face is a frame from a video recorded by a news helicopter at 9:10:58 a.m. Column and floor numbers have been added.

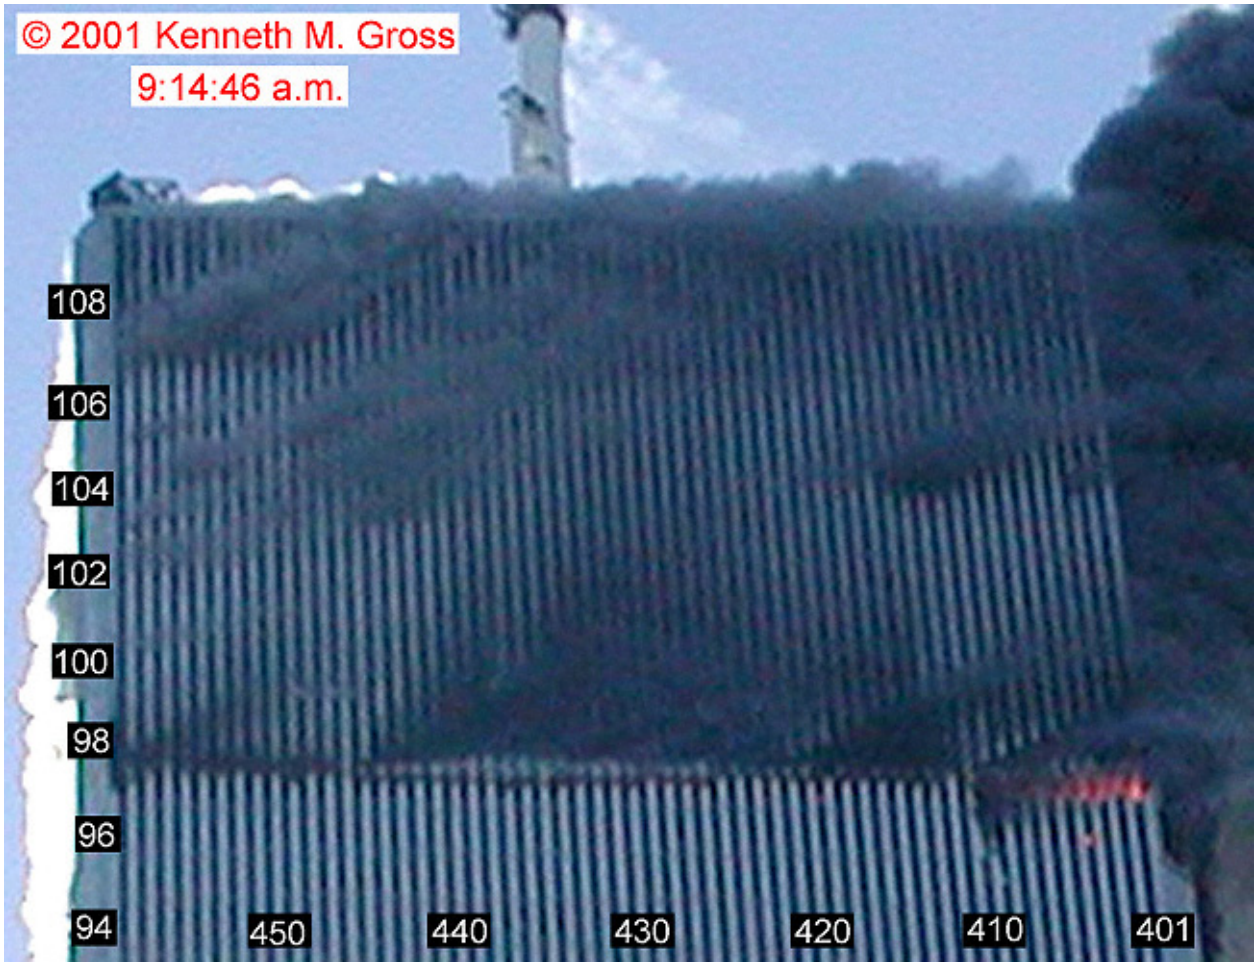
A higher resolution photograph of the west face taken at 9:14:46 a.m. is shown in Figure 8–31. The photographer was located just to the west of the WTC site and was, therefore, shooting up at the building from a steep angle. The only area in which fire is evident in this photograph is on the 97th floor at the south edge in windows 97-401 to 97-406. While the flame lengths are fairly short, there does appear to be some flame extension from these windows. The smoke plumes from higher floors described above are also visible, and a spot fire is present in window 96-404. There are still no indications of smoke or fire on floors below the 96th.

Figure 8-31. This cropped photograph shows the west face of WTC 1 at 9:14:46 a.m. It was shot from the ground a short distance from the WTC site. Column and floor numbers have been added.

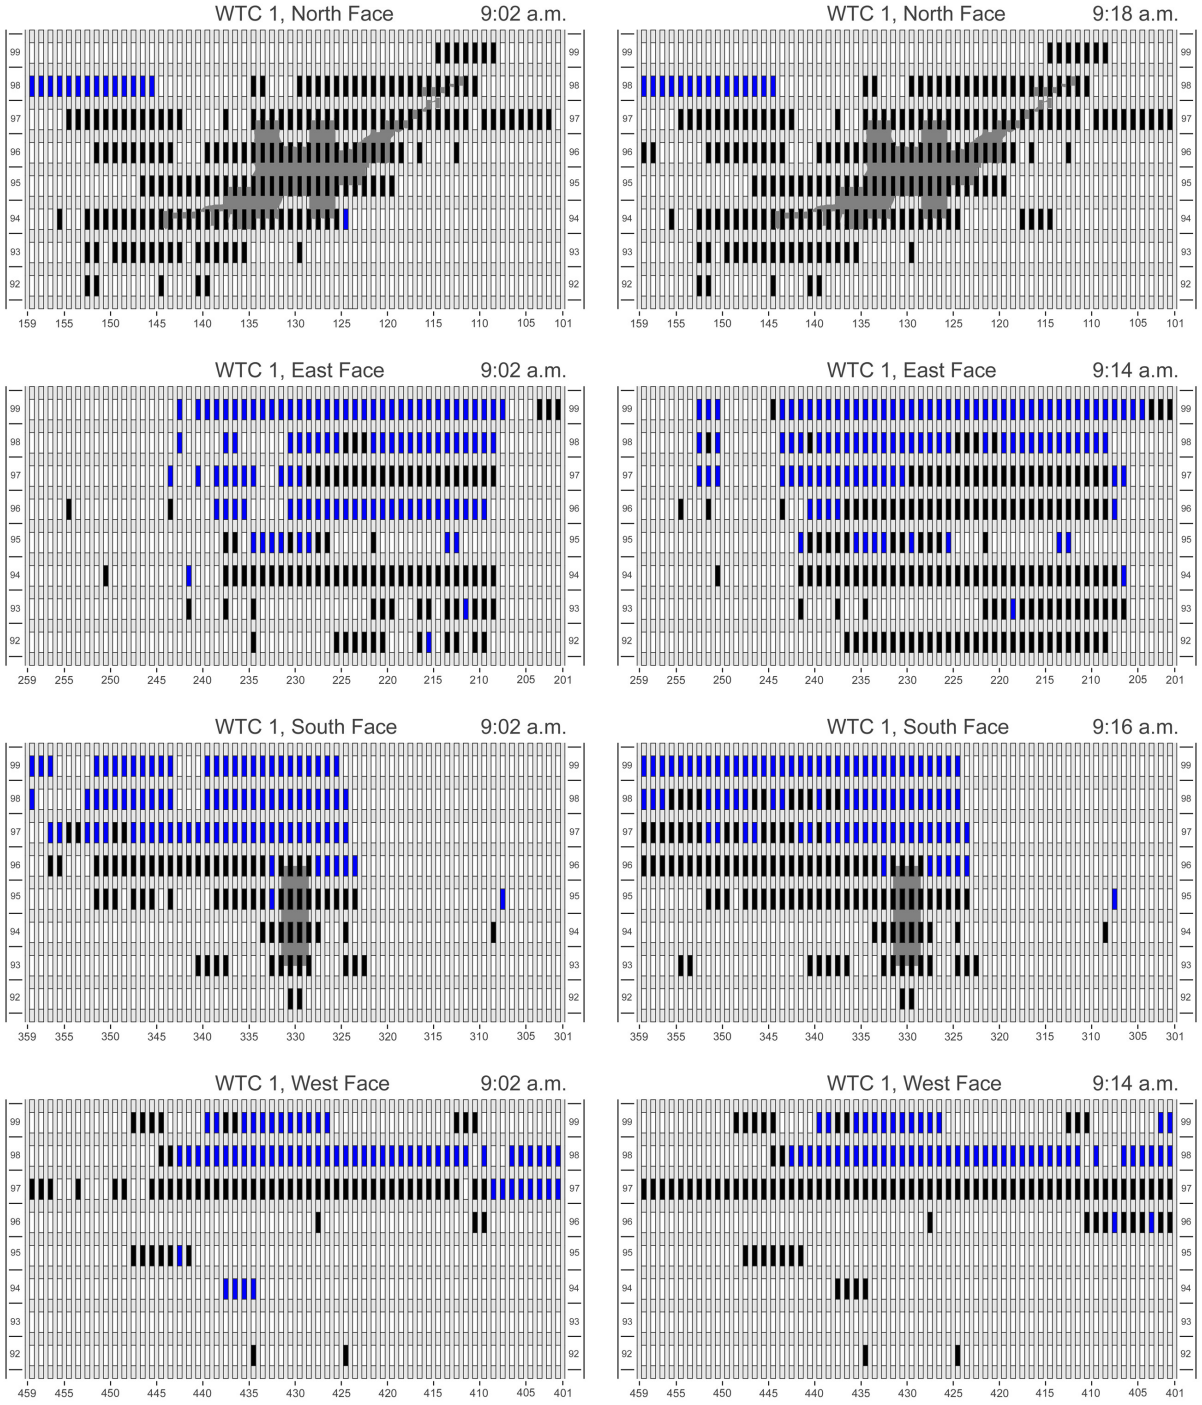
Figure 8-32. Maps for the 92nd through the 99th floors compare missing window glass for the four faces of WTC 1 at two times, around 9:02 a.m. and roughly 15 minutes later. The color coding used for the maps is indicated in Figure 5-1.
