NIST NCSTAR 1-5A

Federal Building and Fire Safety Investigation of the World Trade Center Disaster

Visual Evidence, Damage Estimates, and Timeline Analysis

William M. Pitts
Kathryn M. Butler
Valentine Junker

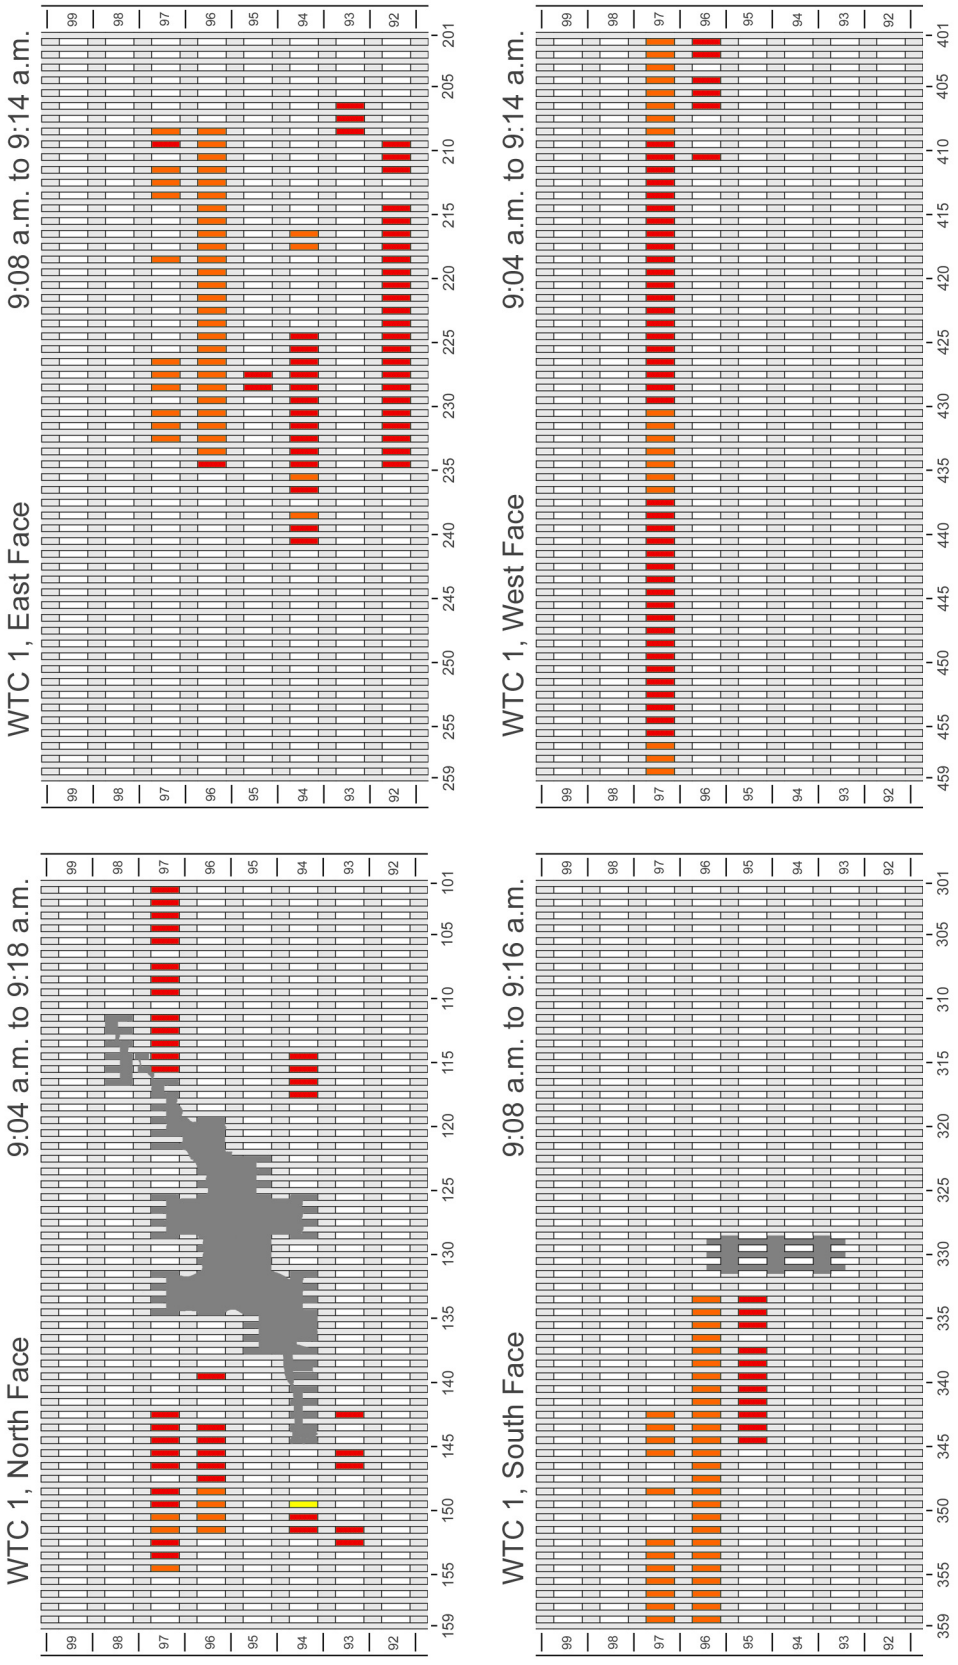
Integrated maps for fire intensity for the period, similar to those shown in Figure 8–14, are included in Figure 8–33. Comparison of these two figures confirms the general trends in fire spread described above. Such a comparison also shows that some of the fires observed during the initial period have died down and are not apparent during the second time period. Examples include fires on the 97th floor on the north face and areas on the 94th and 97th floors on the east face.

From Figure 8–33 it appears as if the most intense and widespread fires during the period from 9:03 a.m. to 9:18 a.m. were on the 96th and 97th floors. The east side of the tower had the most widespread fires, with flames visible from the 92nd floor to the 97th floor. The absence of burning in the southwest quadrant of the tower is evident from the maps.

In Section 6.4.2 it was pointed out that the aircraft and fireball damage to the tower was asymmetrical and that the southeast quadrant appeared to be relatively undamaged. Figure 8–32 and Figure 8–33 show quite distinctly that major fire development has not yet occurred at the periphery of this quadrant. This is further evidence that aircraft debris and/or fuel did not reach the periphery of this quadrant to any great extent.

Figure 8-33. Maps of integrated fire observations between 9:03 a.m. and 9:18 a.m. are shown for the four faces of WTC 1. Colors represent the highest intensity fire observed in a window using the color scale defined in Figure 5-1.

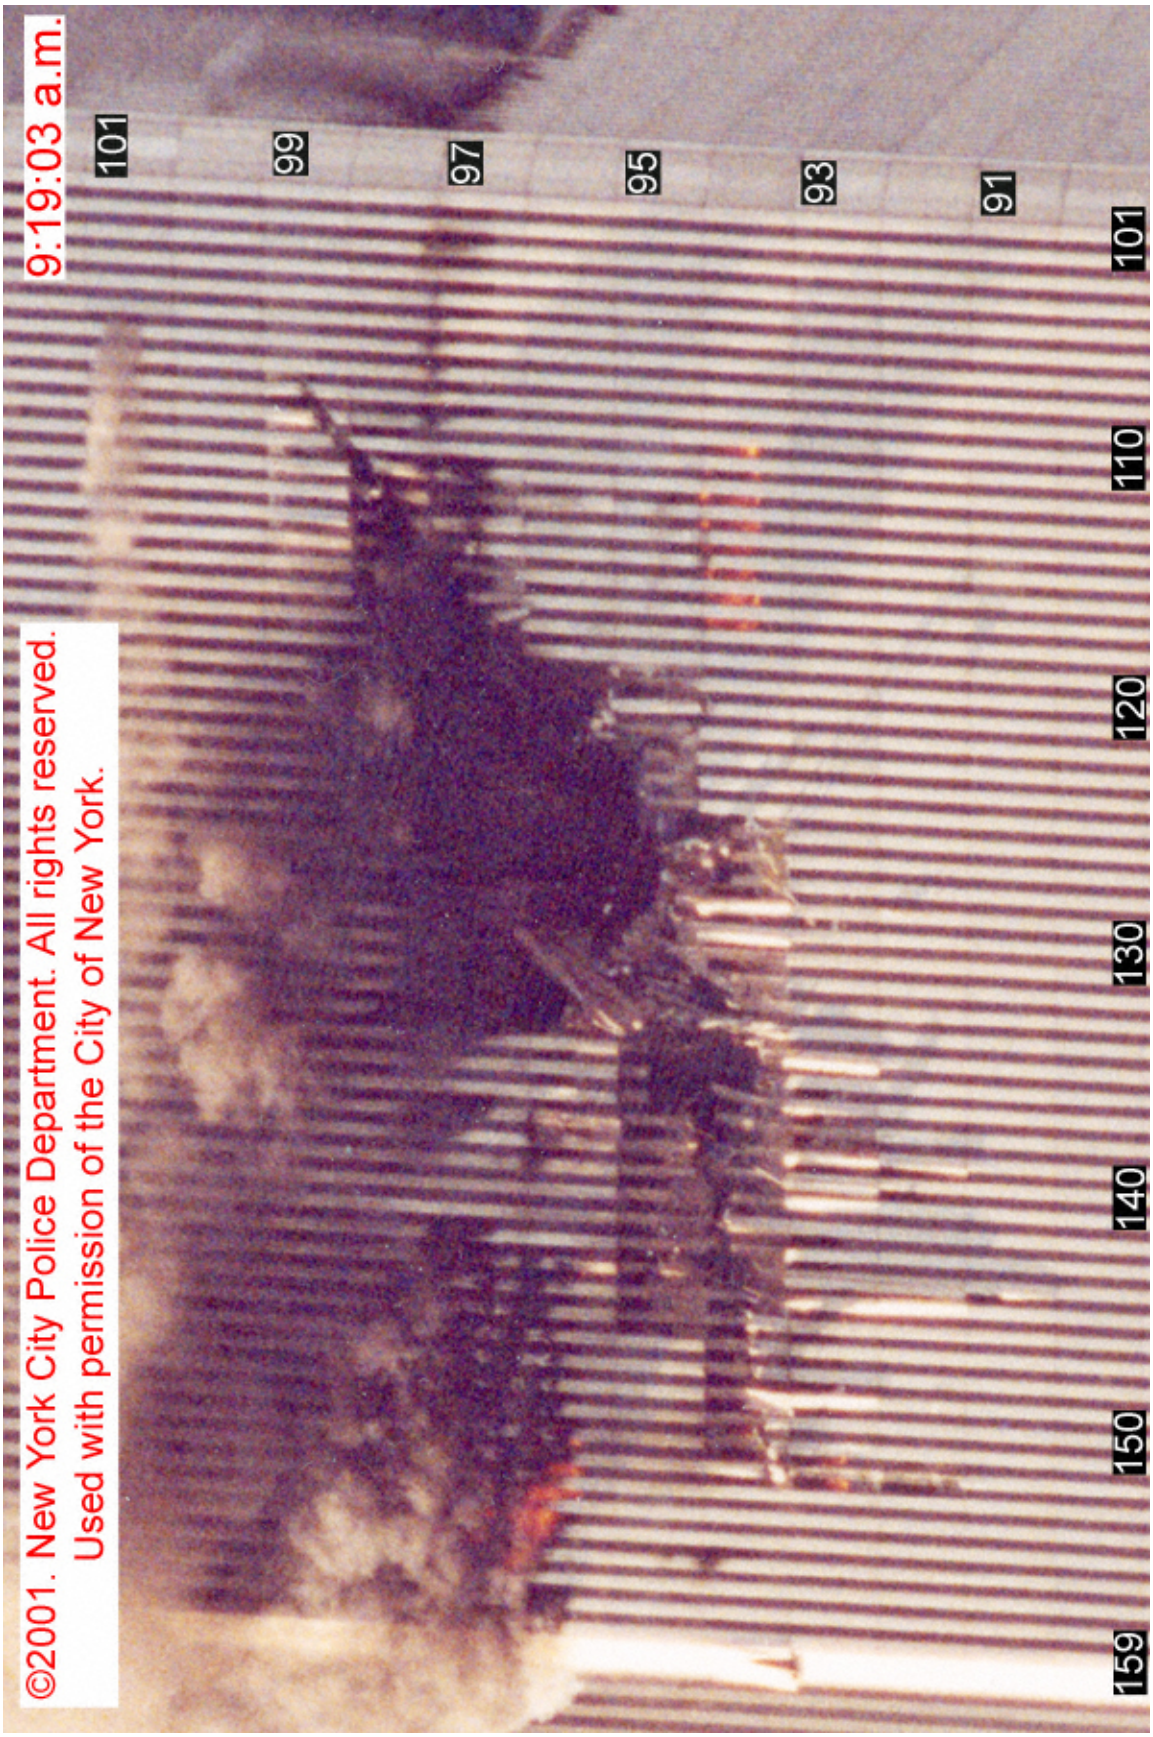
A close-up photograph taken at 9:20:51 a.m. shows that the appearance of the fires on the 96th and 97th floors was somewhat changed from that seen in Figure 8–34. Heavy flames were present in all of the north side windows that were originally within the corner rooms. Flames were extended primarily from the two windows nearest the east face on both floors. The fire on the 94th floor had a similar appearance to that in Figure 8–34, with extensive flames present inside the building, numerous areas burning at the tops of window openings, and only light smoke coming from the windows. This fire had continued to spread to the east and now extended from windows 94-106 to 94-117.

Figure 8-34. An image recorded at 9:19:03 a.m. shows the north face of WTC 1. The original has been cropped, rotated, and enhanced. Column and floor numbers have been added.

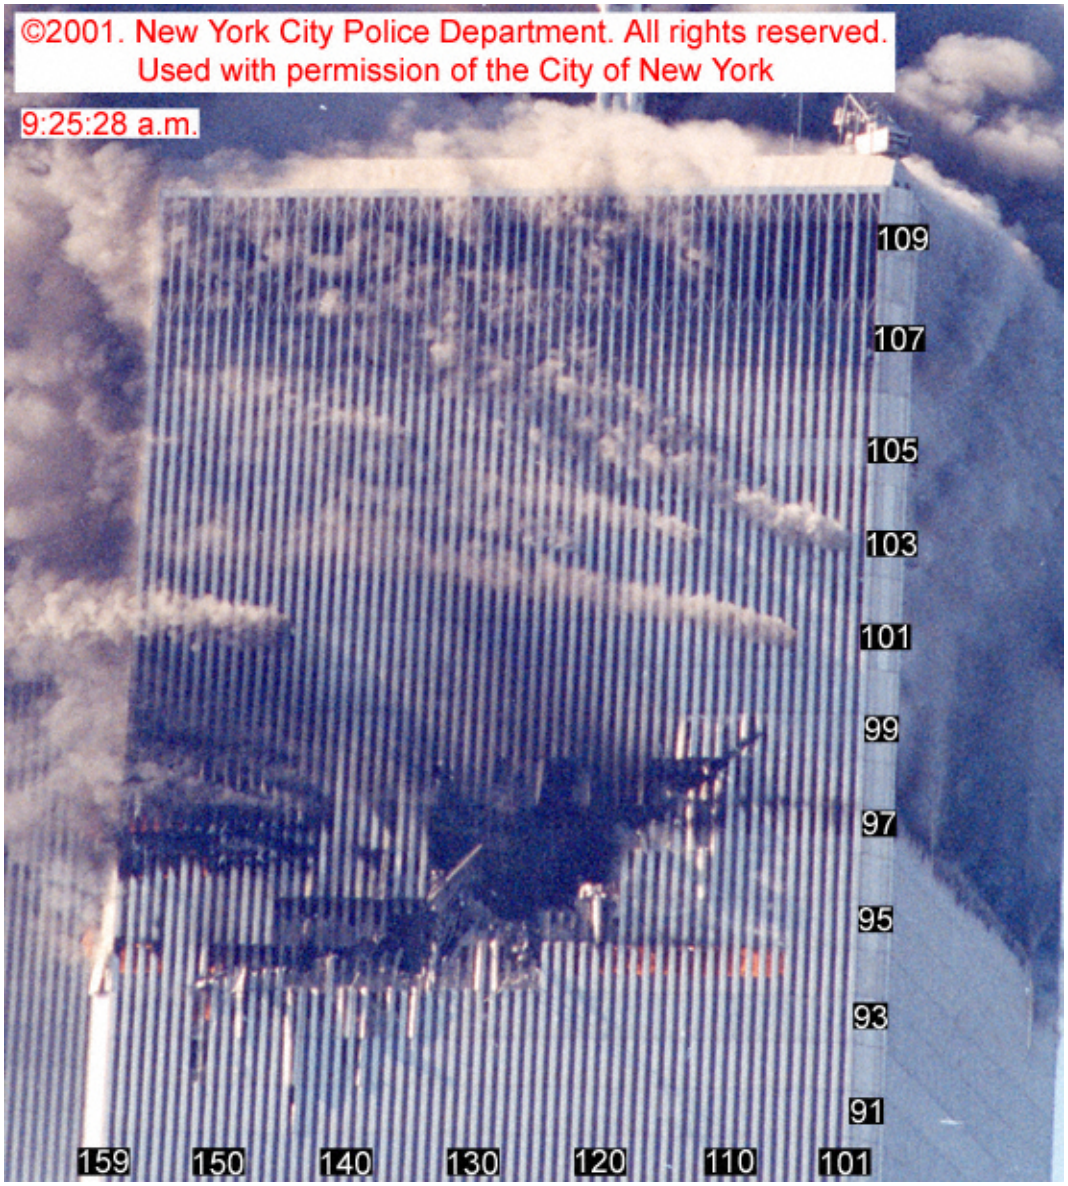
Figure 8–35 shows the north face of WTC 1 as it appeared at 9:25:28 a.m. The amount of smoke coming from the north face, particularly the aircraft impact cavity, has decreased markedly as compared to images taken earlier. There are fires visible on multiple floors, but the amount of smoke coming from these floors is very low. In fact, the densest smoke appears to be coming from open windows that are well above the fire floors. This observation indicates that smoke is still moving upward inside the building and following flow pathways to windows opened by people trapped above the aircraft impact floors. Smoke is still flowing from the air intakes on the 108th and 109th floors.

Figure 8-35. An image recorded at 9:25:28 a.m. shows the north face and an oblique view of the west face of WTC 1. The original has been cropped, rotated, and enhanced. Column and floor numbers have been added.

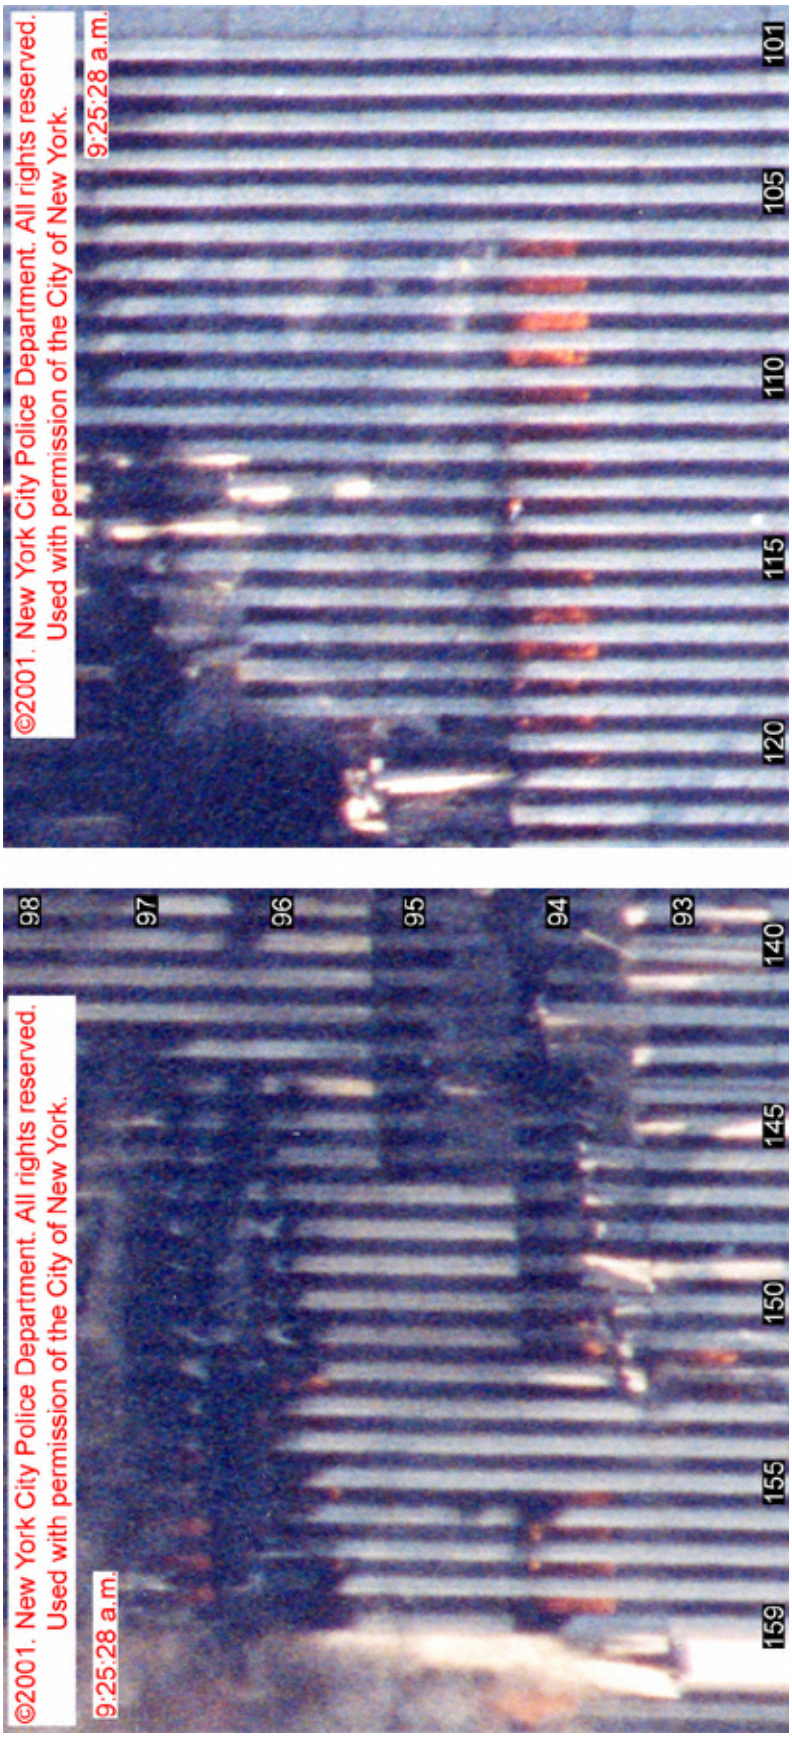
In Figure 8–36 two areas on either side of the aircraft impact cavity in Figure 8–35 have been blown up in order to provide a better view of the active fires. On the east side, fires can be seen on the 93rd, 94th, 96th, and 97th floors. Fires that appear to be relatively small and isolated are present at two locations centered near windows 93-139 and 93-151 on the 93rd floor. On the 94th floor an isolated fire is also present near window 94-151, but the major change from earlier times is that the glass in windows 94-155 to 94-158 is now missing, and an intense fire is evident burning within the building behind the four open windows. Isolated fires are present at the tops of the two windows in the center of the group. Note that that the two adjacent windows, 94-153 and 94-154, are still in place. Flames can be seen through multiple open windows on the 96th and 97th floors. There is now no flame extension from the north face windows, and the fires have died down considerably from their levels of a few minutes earlier (e.g., compare with Figure 8–34 recorded at 9:19:03 a.m.).

On the west side of the north face, fire is only visible on the 94th floor. The apparent intensity of this fire has also died down somewhat from a few minutes earlier. The fire has broken into two sections on either side of a central region running from roughly windows 94-109 to 94-113, where only small fires near the bases or tops of the windows are evident. The fire spread to the west has paused at window 94-106, and the five windows to the west have glass in place. This suggests that the fire spread to the west had been slowed down by an internal wall located at column 94-106. The floor plan layout in Figure B-3 indicates that there was indeed an internal wall that terminated on this column.

The areas of the north face of WTC 1 included in Figure 8–36 provide good examples of the correlation of local fire behavior with the column cover marks observed next to windows where fire is present. On the 96th and 97th floors the fires created conditions in which flames extended from the windows. A series of carets are present at the tops of the windows running across these two floors. The heights of the carets vary over the region providing an indication of the local maximum burning intensity. In contrast, fires on the 93rd and 94th floors did not generally extend from windows and did not generate a great deal of smoke flow from the windows. For these windows there were sometimes narrow, dark lines at the tops of the adjacent aluminum column covers, and for others very little marking of the column covers occurred.

An enlarged image of the fires on the west side of the north face is also included in Figure 8–36. The marks on the column covers on the 97th floor show evidence for both types of fires. Those nearest the airplane strike point are marked with carets. Flame extension was observed in this area shortly following the aircraft impact. Further to the west there are black marks above the windows, except for the column covers on either side of window 97-102, which are marked with carets. As discussed earlier, fires on this part of the 97th floor did not extend from these windows for any significant period of time. The same types of narrow black bands are observed at the tops of the columns above the burning region on the 94th floor. Recall that this was a region of heavy burning, but without flame extension.

Figure 8-36. Two blowups from Figure 8–35 of areas on the north face of WTC1 are shown. The photograph was taken at 9:25:28 a.m. The images have been enhanced, and column and floor numbers have been added.

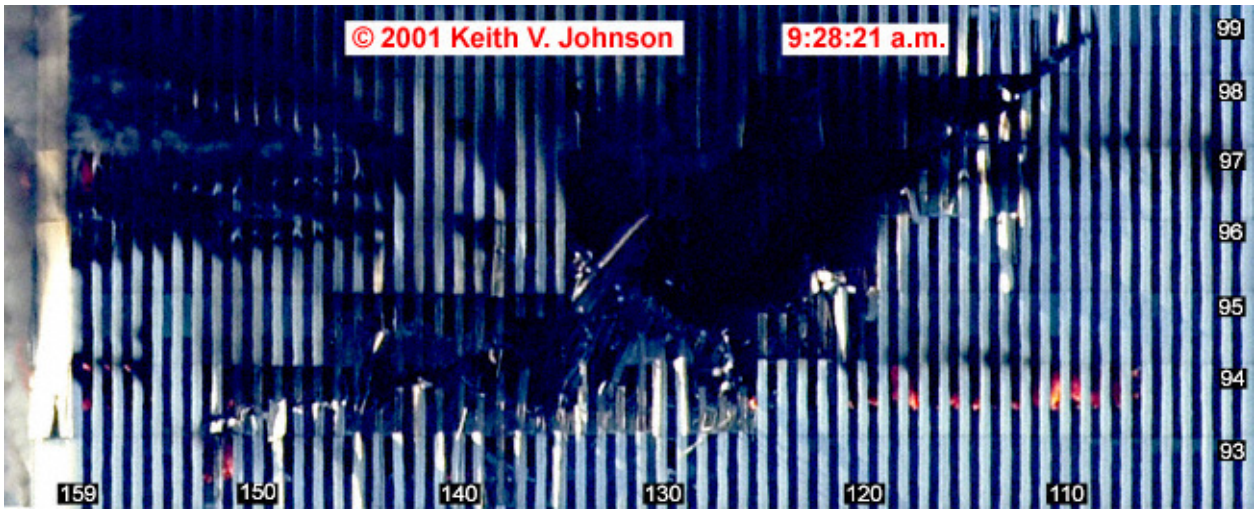
Figure 8-37. This cropped photograph shows the north face of WTC 1 at 9:28:21 a.m. The image has been rotated and enhanced. Column and floor numbers have been added.

Figure 8–37 shows a photograph of the fire floors on the north face taken at 9:28:21 a.m. The fires which grew rapidly at the start of the period are continuing to die down. In particular, the large fires that appeared within the rooms on the northeast corners of the 96th and 97th floors are now barely visible. The fires on either side of the aircraft impact cavity on the 94th floor are also decreasing in size. On the east side there are still fires burning at the window head casings of windows 94-156 to 94-158. An isolated fire can still be seen on the 93rd floor through open windows 93-152 and 93-153.

While it is difficult to make out in Figure 8–37, close inspection shows that there is a small spot fire visible in window 98-123 on the 98th floor. Recall that a similar fire was observed on this floor in window 98-115 around 9:06 a.m. Most windows were still in place on this floor around the time Figure 8–37 was taken.

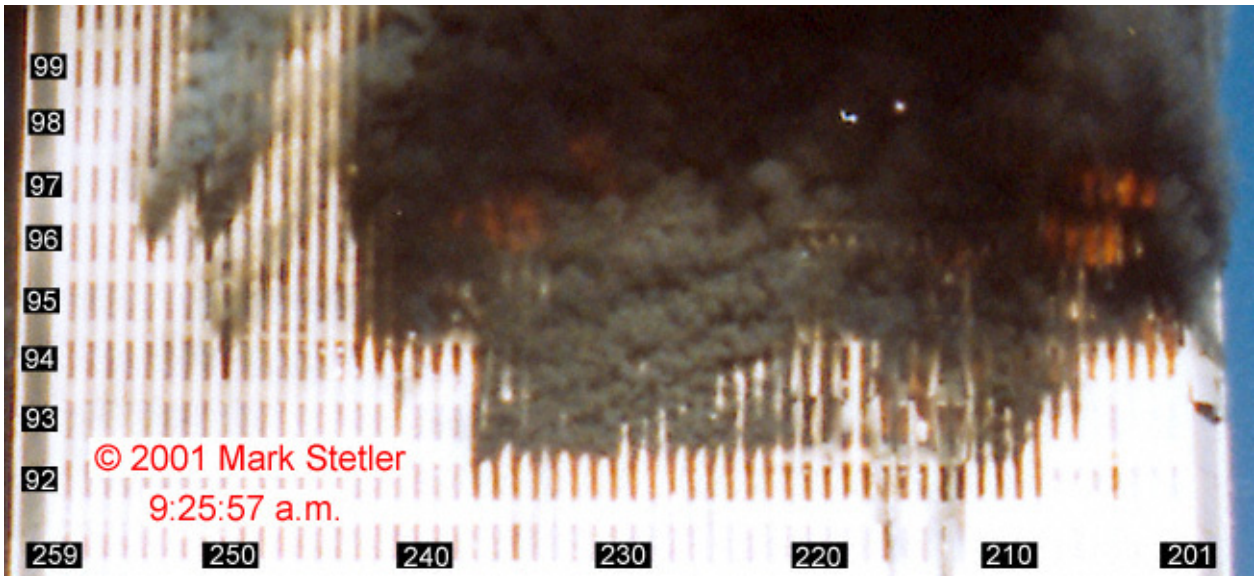
Figure 8–42 is a photograph of the east face taken at 9:25:57 a.m. The flames which had earlier spread into rooms located on the northeast corners of the 94th and 96th floors are still burning intensely. There is also now a large fire burning in the northeast corner room on the 97th floor. It has not been possible to identify exactly when this fire appeared because smoke and fire from the 96th floor hid its development from view. However, a video taken near 9:23:30 a.m. shows that flames were coming from window 97-203 at that time, so it must have appeared between 9:20:45 a.m., when fire was first visible in the area on the 96th floor, and this time.

Figure 8-42. This cropped photograph shows the east face of WTC 1 at 9:25:57 a.m. The image has been rotated slightly and column and floor numbers have been added.

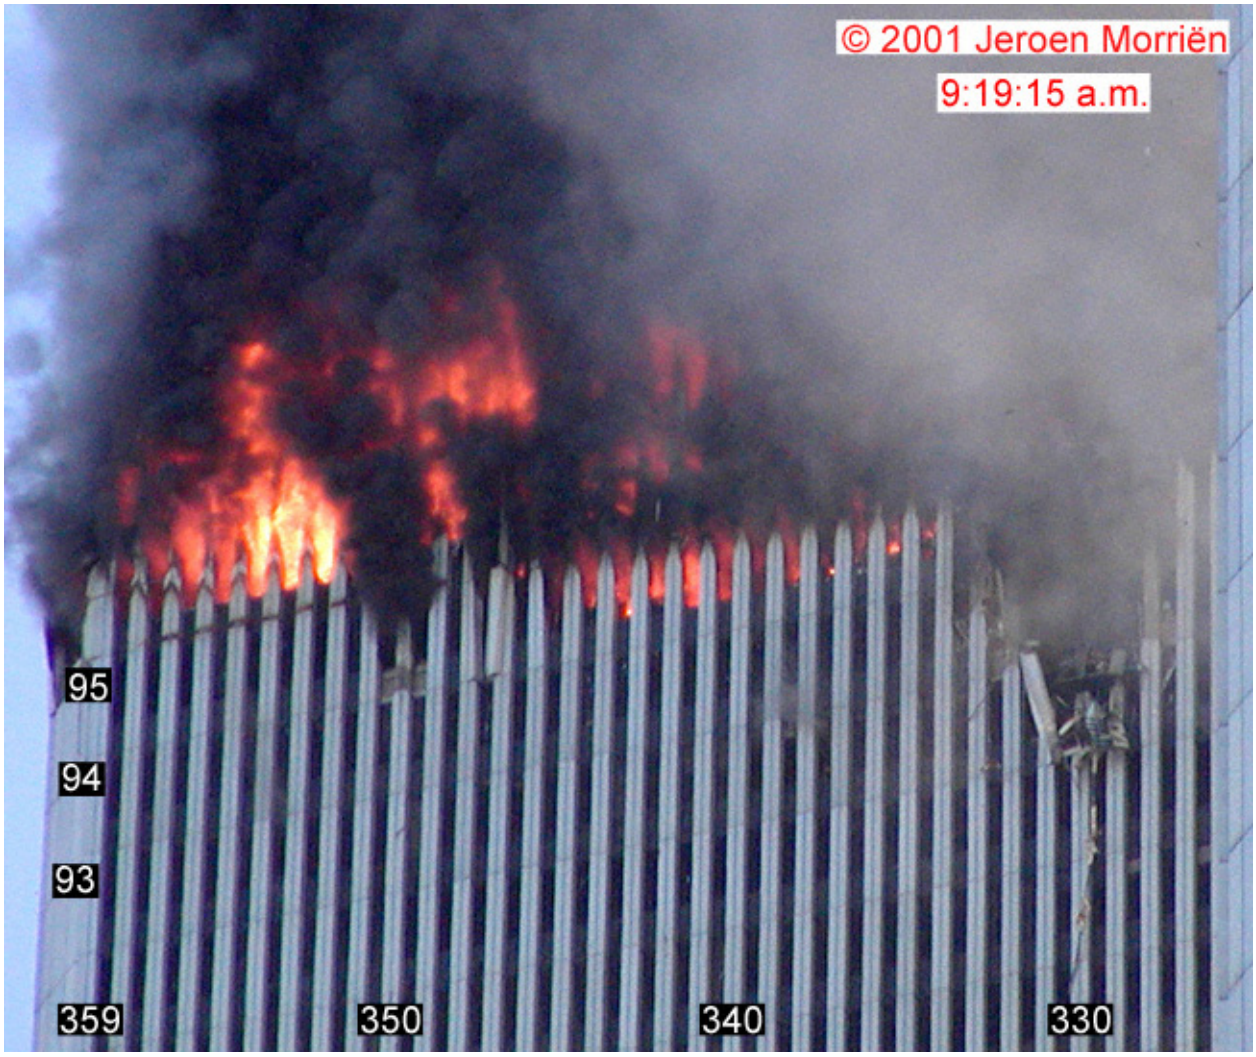
Figure 8–44 provides a view of the south face at 9:19:15 a.m. The general appearance of the fires is little changed from that in Figure 8–27, which was recorded near 9:16:40 a.m. The intense jets of flames coming from windows 96-352, 96-353, and 96-354 on the 96th floor remain a prominent feature. This image provides a particularly good view of the area on the 93rd floor, near column 330, where the steel panel section, which was found near the corner of Cedar and West Streets, is believed to have originated. Extensive damage is evident in the vicinity, but it is not possible to visually confirm that the section is actually missing. There is a long section of what appears to be a pipe hanging below the suspected opening that appears to be attached to a cylindrical object. Recall that a long section of pipe was seen in photographs of the detached panel section lying in the street (see Figure 6-16 and Figure 6-17). The presence of piping near the suspected origin for the panel section provides further support that the panel section actually did come from this spot.

Figure 8-44. This cropped image shows a portion of the south face of WTC 1 at 9:19:15 a.m. The photograph has been enhanced and column and floor numbers have been added. The corner of WTC 2 is visible at the far right side of the image.

A line of deposited soot is visible at the top of columns 95-351 to 95-357 at the western side of the 95th floor. These markings can be seen more clearly in Figure 8–44. No smoke is apparent coming from the windows, and it appears likely that the glass is still in place for these windows. The formation of these marks may be an indication that fire gases and smoke were leaking from the tower at locations where windows still had intact glass. Presumably, the leaks took place through the expansion joints located between column covers on different floors.

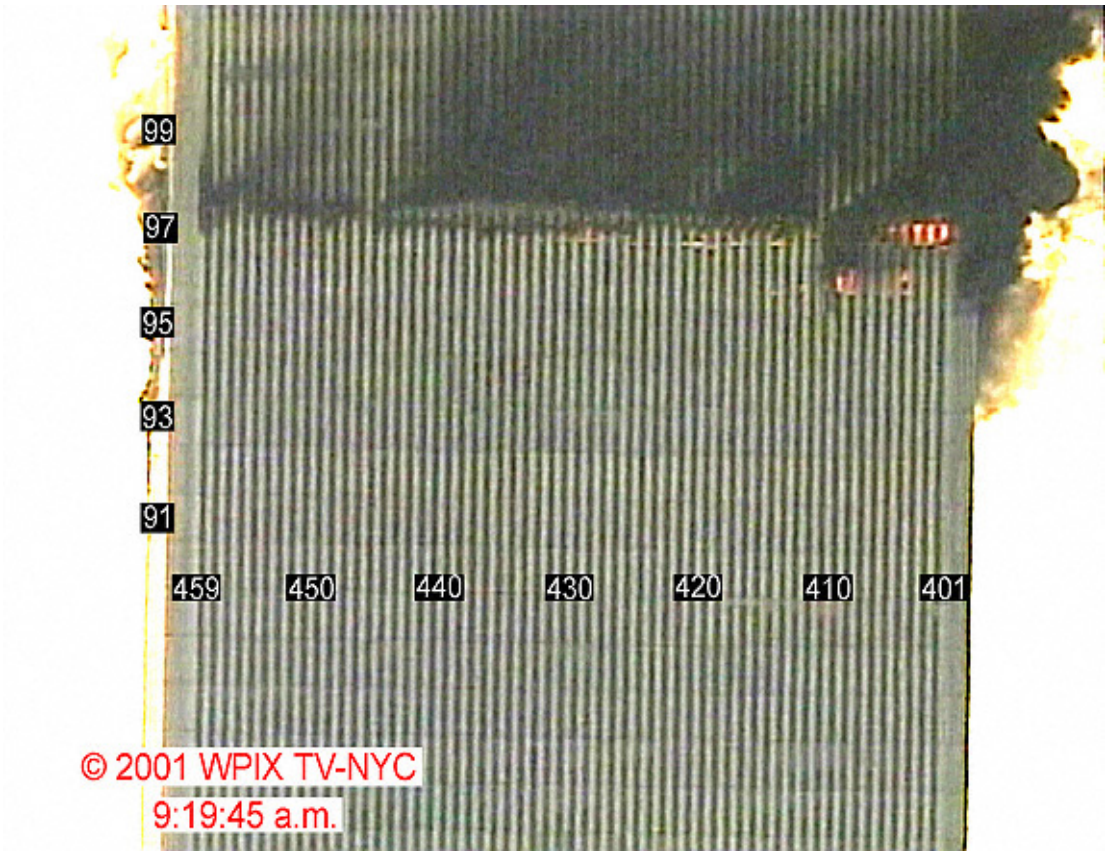
One such image taken from a video recorded at 9:19:45 a.m. is shown in Figure 8–47. The fire distribution is consistent with that observed from the ground at 9:14:46 a.m. in Figure 8–31. A flaming region is prominent at the south edge of the 97th floor over windows 97-401 to 97-405. While these flames appear to fill the windows, they do not seem to extend out of them. Further toward the north on the 97th floor, a number of relatively small fires are visible through the lowest portions of the window openings. Most of these flames are observed between the intensely burning corner and the center of the face. When viewing the video, it appears as if this gentle burning is relatively continuous across this length. The only location on the face where flames are apparent even further to the north is in window 97-455. Keeping in mind that the bases of the windows are raised 15 in. from the floor, it is clear that most of the intense fires that were burning earlier on the west side of the 97th floor have died down to a condition in which widely distributed flames are gently burning near the floor on the remaining fuel. A comparison of Figure 8–47 with Figure 8–30, which was recorded at 9:10:58 a.m., provides a good visual measure of how much the fire intensity on this floor has decreased over this nearly 9 min period.

The only other floor on which flames are apparent in Figure 8–47 is the 96th. A region of fire, which fills the window openings, runs from window 96-404 to perhaps window 96-410. The flames in windows 96-408 and 96-409 extend from these windows. As discussed above, fire was present in the

same general location around 9:11 a.m. (see Figure 8–30). Two regions of small flames around windows 96-412 and 96-414 are visible just to the north of the flaming area. Even though these flames are similar in appearance to the dying flames just above on the 97th floor, there is a major difference. Based on the visual evidence, there has not yet been an intense burning phase in this region of the 96th floor. The absence of smoke marks on the nearby aluminum cladding is consistent with this conclusion.

Figure 8-47. This image of the west face of WTC 1 is a frame captured from a video recorded by a news helicopter at 9:19:45 a.m. The image has been enhanced by adjusting the intensity range, and areas to the left and right of the tower are saturated. Column and floor numbers have been added.

It is interesting to compare Figure 8–47 with the view of the south face shown in Figure 8–44. These images were taken approximately 30 s apart. While there are intense flames issuing from numerous windows on the 95th, 96th, and 97th floors on the west side of the south face, from the west flames are only observed near the south corners of the 96th and 97th floors, and they do not appear to be nearly as intense. These observations indicate that either the flames on the south face are isolated near the outer wall or that interior portions of these floors are actually hidden from view by obscuring smoke or walls. There is no indication of fire on the 95th floor from the west. Figure B-4 in Appendix B shows that there were a group of rooms in the southwest corner of this floor with a wall extending to column 95-350. The walls associated with these rooms may still be in place, protecting the west side of the floor from the fire raging on the south face. One piece of visual evidence argues against this conclusion. In Figure 8–44, smoke is observed coming from windows 95-349 and 95-350 on the south face, and there is evidence of façade damage below both of these windows. This suggests that both windows were removed during the

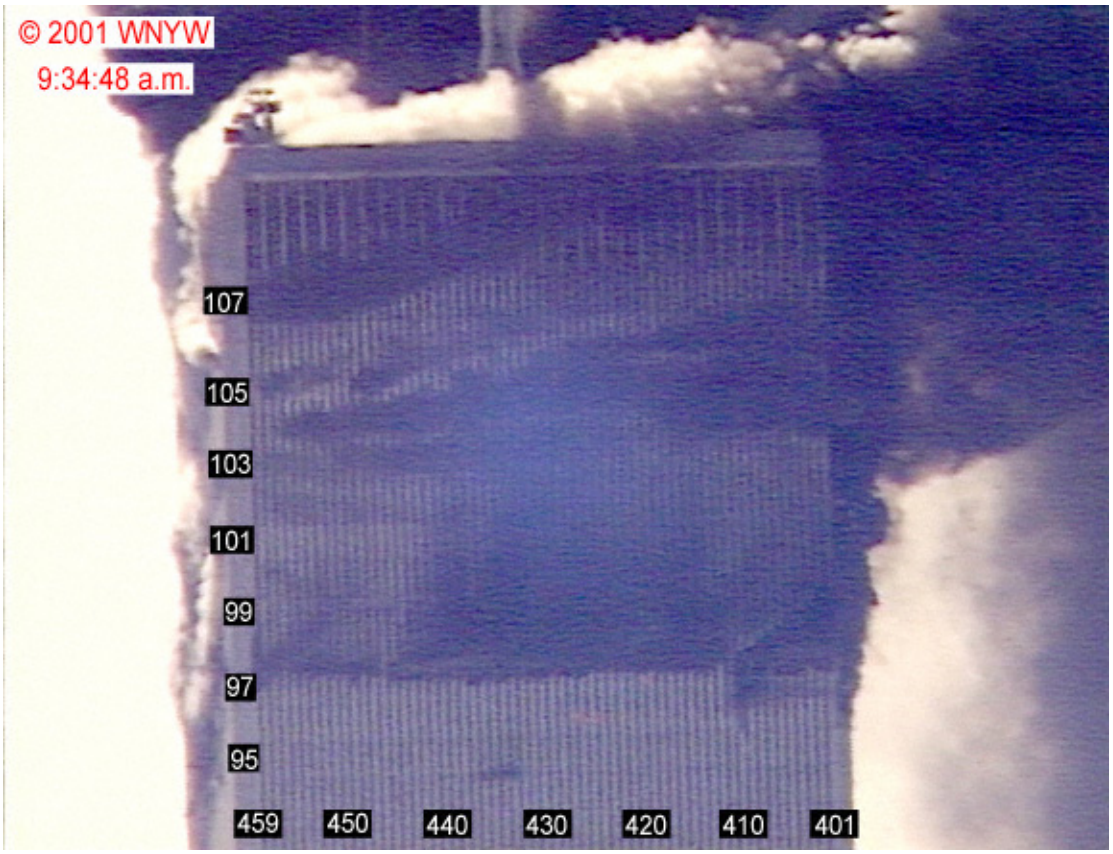
Figure 8–49 shows another view of the west face of WTC 1 taken from a video that was recorded from a helicopter at 9:34:48 a.m. The fires on the south ends of the 96th and 97th floors are no longer as prominent as they were earlier. In fact, at this distance and clarity it is difficult to identify fires in these locations. There is evidence of low-intensity fires further to the north on both the 96th and 97th floors. The most visible flames on the 96th floor are in windows 96-224 to 96-226. This area is north of where flames were observed earlier, indicating that the fires are continuing to spread slowly toward the north.

Figure 8-49. This image of the west face of WTC 1 is a frame captured from a video recorded by a news helicopter at 9:34:48 a.m. The image has been enhanced by adjusting the intensity range, and some areas to the left and right of the tower are saturated. Column and floor numbers have been added.

Even at the distance from which Figure 8–49 was taken, a black mark is visible running across the tops of windows 94-433 to 94-436 on the 94th floor. These marks are not evident in Figure 8–47, which was taken at 9:19:45 a.m. This suggests that smoke began to flow from these windows at some point between these two times. A review of video recordings shows that visible smoke was apparent coming from these windows starting around 9:26 a.m. As discussed earlier, windows had been opened in this general area as early as 9:04 a.m. Recall also that several windows are open just to the north on the 95th floor. There is still no indication of smoke coming from these windows.

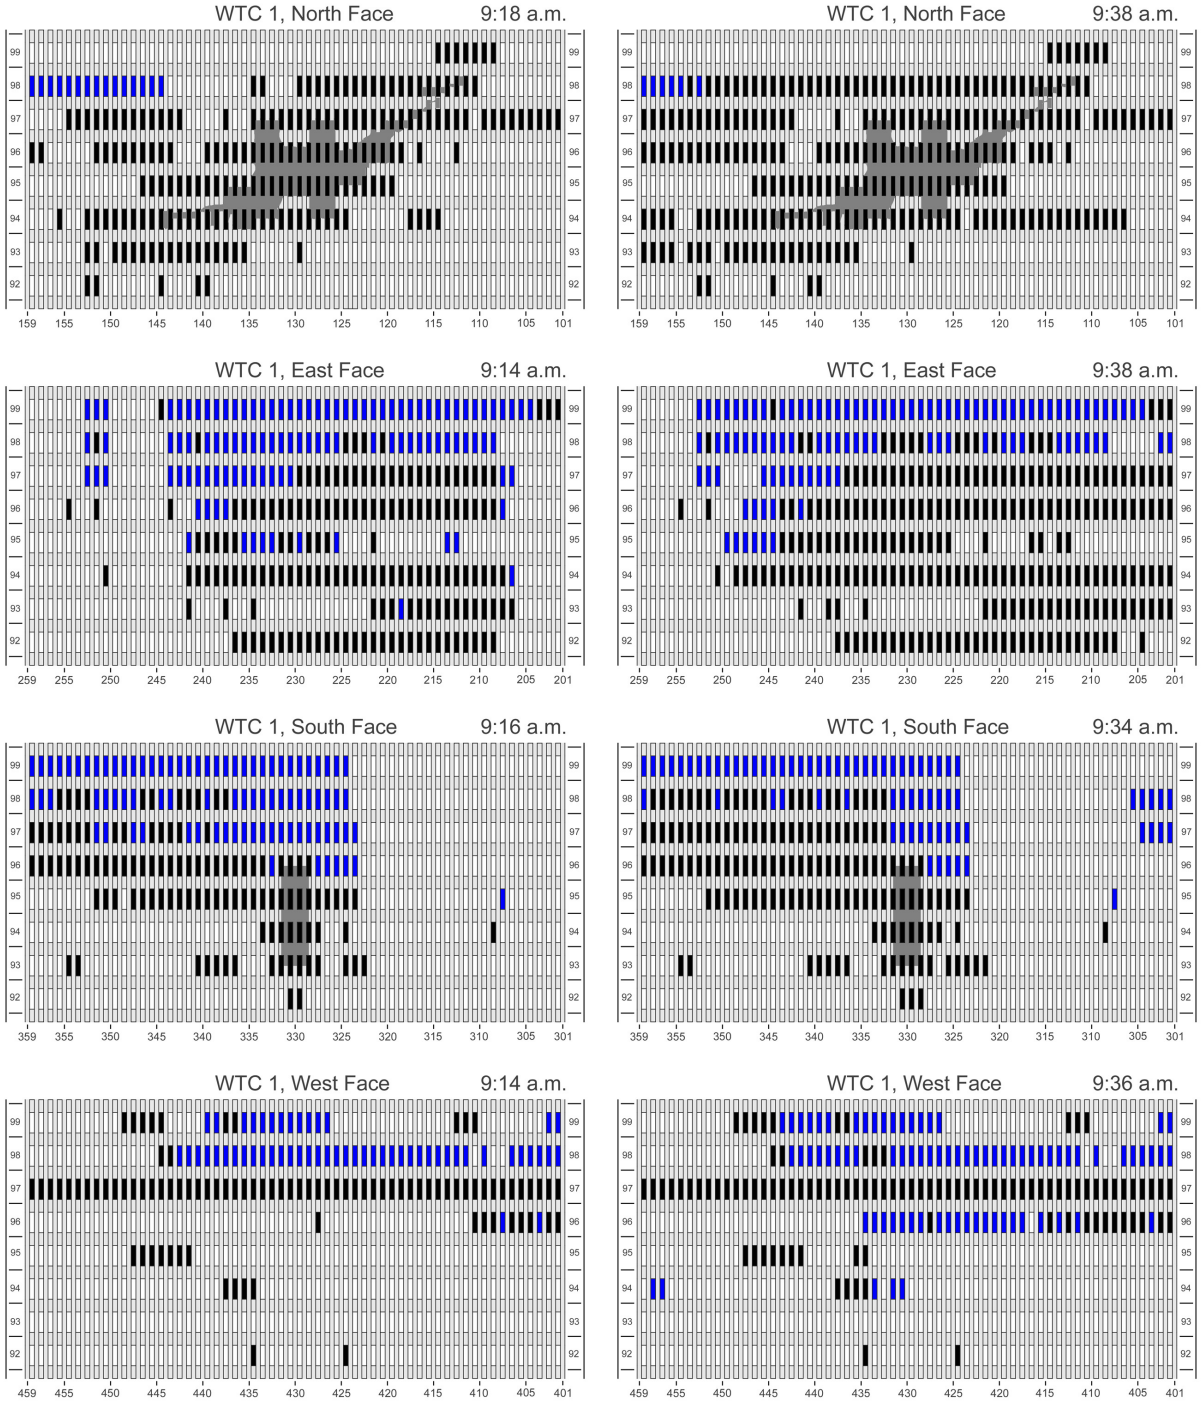
Figure 8-50. Maps for the 92nd through the 99th floors compare missing window glass for the four faces of WTC 1 at two times, around 9:18 a.m. and roughly 17 minutes later. The color coding used for the maps is indicated in Figure 5-1.

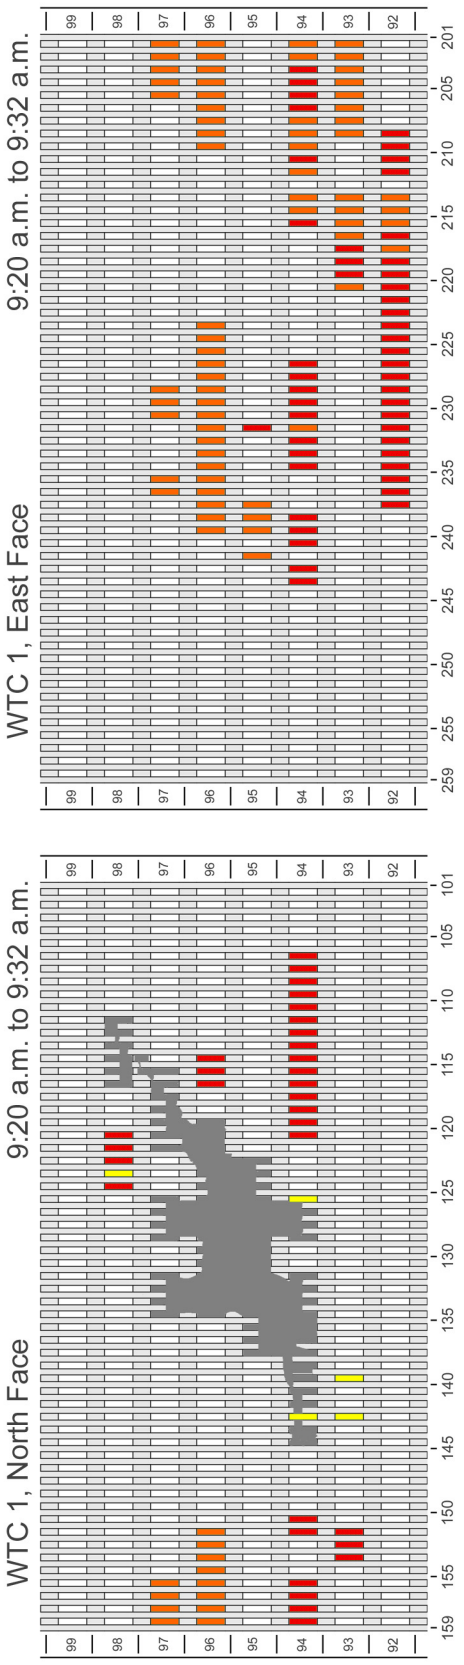
Figure 8-51. Maps of integrated fire observations between 9:19 a.m. and 9:35 a.m. are shown for the four faces of WTC 1. Colors represent the highest intensity fire observed in a window using the color scale defined in Figure 5-1.

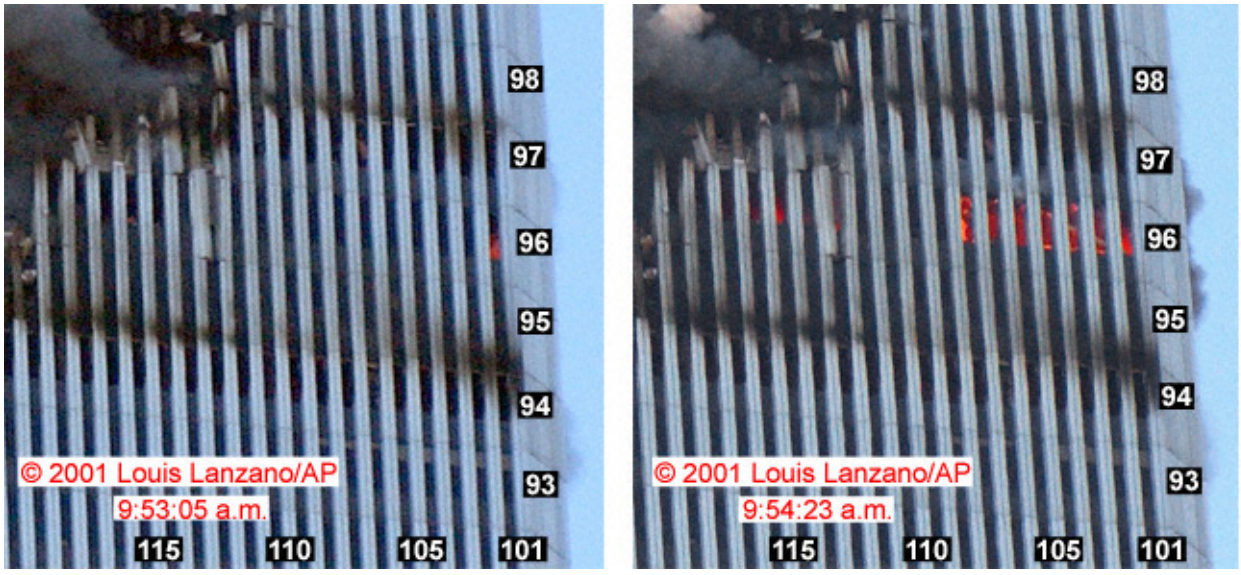
Figure 8–54 includes a photograph of this area taken at 9:53:05 a.m. Windows 94-101 to 94-105 are clearly open. The fires in the corner room have already died down to the point where they are no longer visible from this vantage point. All of the windows on the 94th floor within the view of the image are missing. At the same time, windows on the 92nd, 93rd and 95th floors and windows 98-101 to 98-108 on the 98th floor still have glass panes in place.

Figure 8-54. Two photographs of the west side of the north face of WTC1 taken at 9:53:05 a.m. and 9:54:23 a.m. are compared. The original photographs were cropped and enhanced. Column and floor numbers have been added.

In the photograph taken at 9:53:05 a.m., a small fire can be seen at the western edge of the 96th floor in window 96-101, while the glass for windows 96-102 to 96-110 is still in place. Videos show that there was a flash of light at window 96-101 at 9:53:00 a.m., which was likely associated with this window opening. At 9:53:20 a.m. the fire in window 96-101 grew visibly larger. During the following 13 s, fire appeared, moving from west to east over windows 96-102 to 96-107. This fire is evident in the second photograph included in Figure 8–54, which was taken at 9:54:23 a.m. The adjacent window, 96-108, was still in place at this time. According to the floor plan layout shown in Figure B-5, one of the walls for the room at this corner was located at column 96-108.

Even though the glass panes for windows 96-108 to 96-111 are still in place, a fire is visible growing rapidly further to the west in windows 96-112 to 96-115. The fire seen in window 96-113 is one of the few examples where flames are observed through a closed window. As discussed below, a significant fire was observed on the west face near the northwest corner prior to the rapid fire growth in the northwest corner room. This suggests that the fire broke into this corner room through the south wall located at column 96-456 (see Figure B-5). Note that there were two adjacent rooms attached to the south side of this wall. Fire movement from the south is also the likely source for the fire seen in windows 96-112 to 96-115.

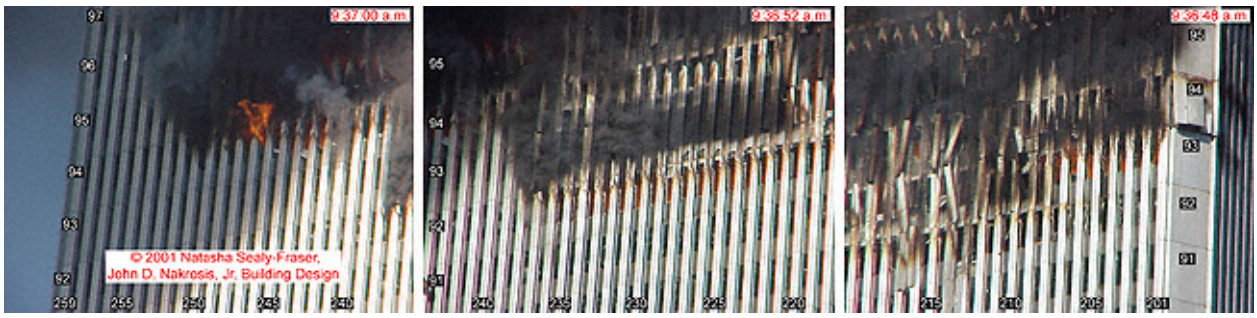
A number of close-up photographs and videos that provide views of the east face are available during the current time period. Figure 8–56 shows a series of three photographs that were taken around 9:37 a.m. They show the lower floors where fires have been burning. Note that the fires that are present on the 96th and 97th floors are not visible. In the right-most photograph fire is visible near the northeast corner of the

Figure 8-56. This series of three photographs shows various locations along the east face of WTC 1 around 9:37 a.m. Column and floor numbers have been added.

92nd floor in windows 92-201 to 92-207. Flames first appeared in this area around 9:33 a.m., and at 9:34:20 a.m. flames were coming from these windows. These flames had already begun to die down two and a half minutes later. The smoke markings on the adjacent column covers are interesting. They are a combination of carets and horizontal bands. There is also a smoke band above these windows. These markings suggest that while flames did extend from the windows, they were not intense enough or sustained for a long enough time to create well-defined carets. Well-defined carets are present just above on the 94th floor, as well as on numerous column covers on the 96th floor.

The same photograph provides an indication of the degree to which the flames that were present earlier on the 94th and 96th floors have died down. Only a couple of isolated fires are observed on the 94th floor, and no flames are obvious in windows 96-201 to 96-220.

In the center photograph of Figure 8–56, the fires that were present earlier on the 93rd, 94th, and 95th floors near the center of the east face have also died down and are no longer evident. There is still considerable evidence of interior fires on the 92nd floor, but the flames still do not seem to have progressed beyond window 92-237. As discussed earlier, flames were observed at window 92-237 at 9:21:01 a.m. The fires on the 92nd floor have caused some interesting effects on the surrounding façade. The variations in the types of smoke marks on the column covers adjacent to the windows have already been mentioned. Inspection shows that in the area immediately above windows 92-223 to 92-228, the aluminum spandrel covers have partially disappeared. The shapes of the missing areas indicate that they mostly likely melted due to heating from the hot fire gases flowing from below. In fact, spots of what appear to be solidified drops of aluminum can be seen on windows below this floor. Based on the melting temperature of aluminum, the fire gases leaving these windows must have been well in excess of 600 ºC. Even though these gases were quite hot, they have not broken out the glass in the windows immediately above on the 93rd floor, which are heavily coated with soot, but remain in place.

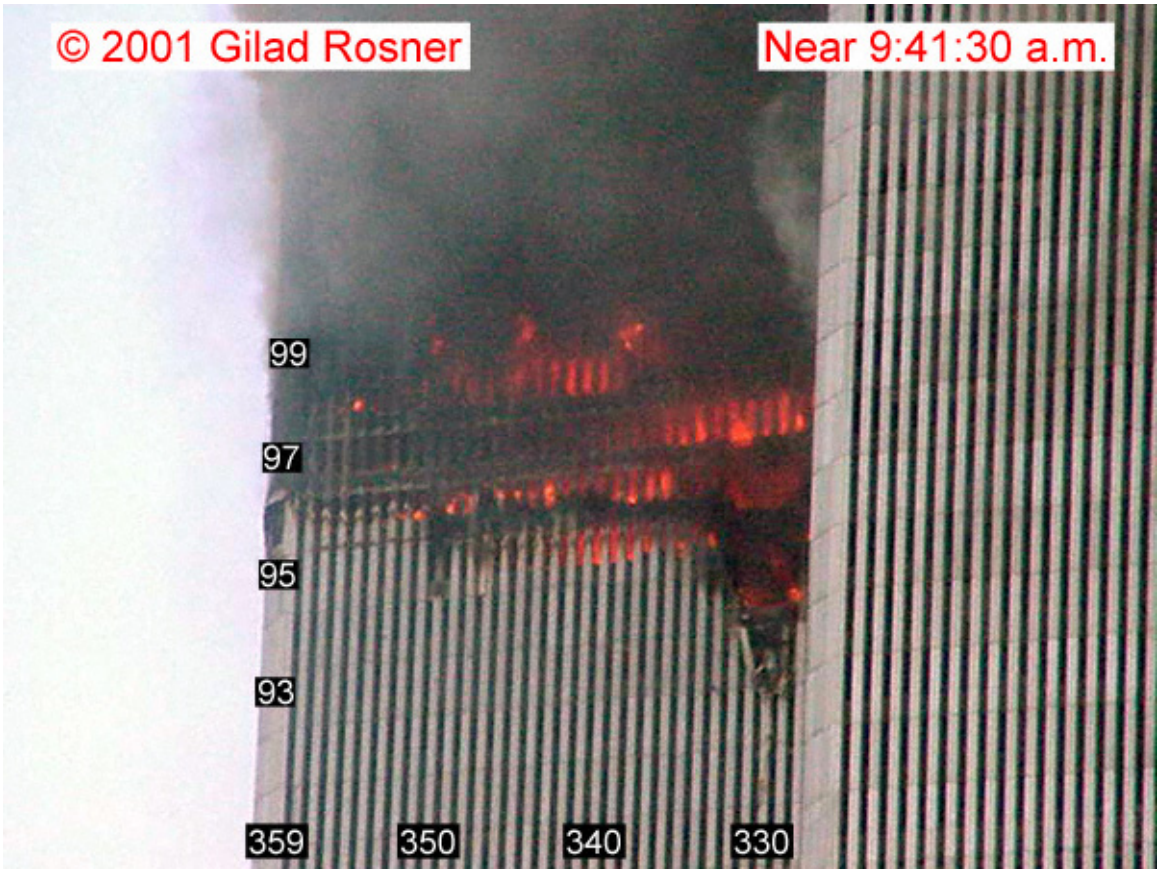
The photograph in Figure 8–61 was taken shortly after the initial rapid fire growth on the south face took place on the 98th floor. The exact time of the photograph is unknown. The assigned time of 9:41:30 a.m. has an uncertainty of just over one minute. The fire on the 98th floor has already covered a number of windows, and flames are extended from many of these. Significant fires are also evident on the 95th, 96th, and 97th floors. The intensities of these fires have continued to decrease relative to earlier times. Burning is also present on the 94th floor near the center of the face, where the panel section is believed to have been displaced during the aircraft impact. Flames were not evident at this location in Figure 8–46, which was taken at 9:33:13 a.m.

Figure 8-61. This untimed photograph shows the south face of WTC 1. It is estimated that it was taken between 9:40:40 a.m. and 9:42 a.m. Column and floor numbers have been added.
