NIST NCSTAR 1-5A

Federal Building and Fire Safety Investigation of the World Trade Center Disaster

Visual Evidence, Damage Estimates, and Timeline Analysis

William M. Pitts
Kathryn M. Butler
Valentine Junker

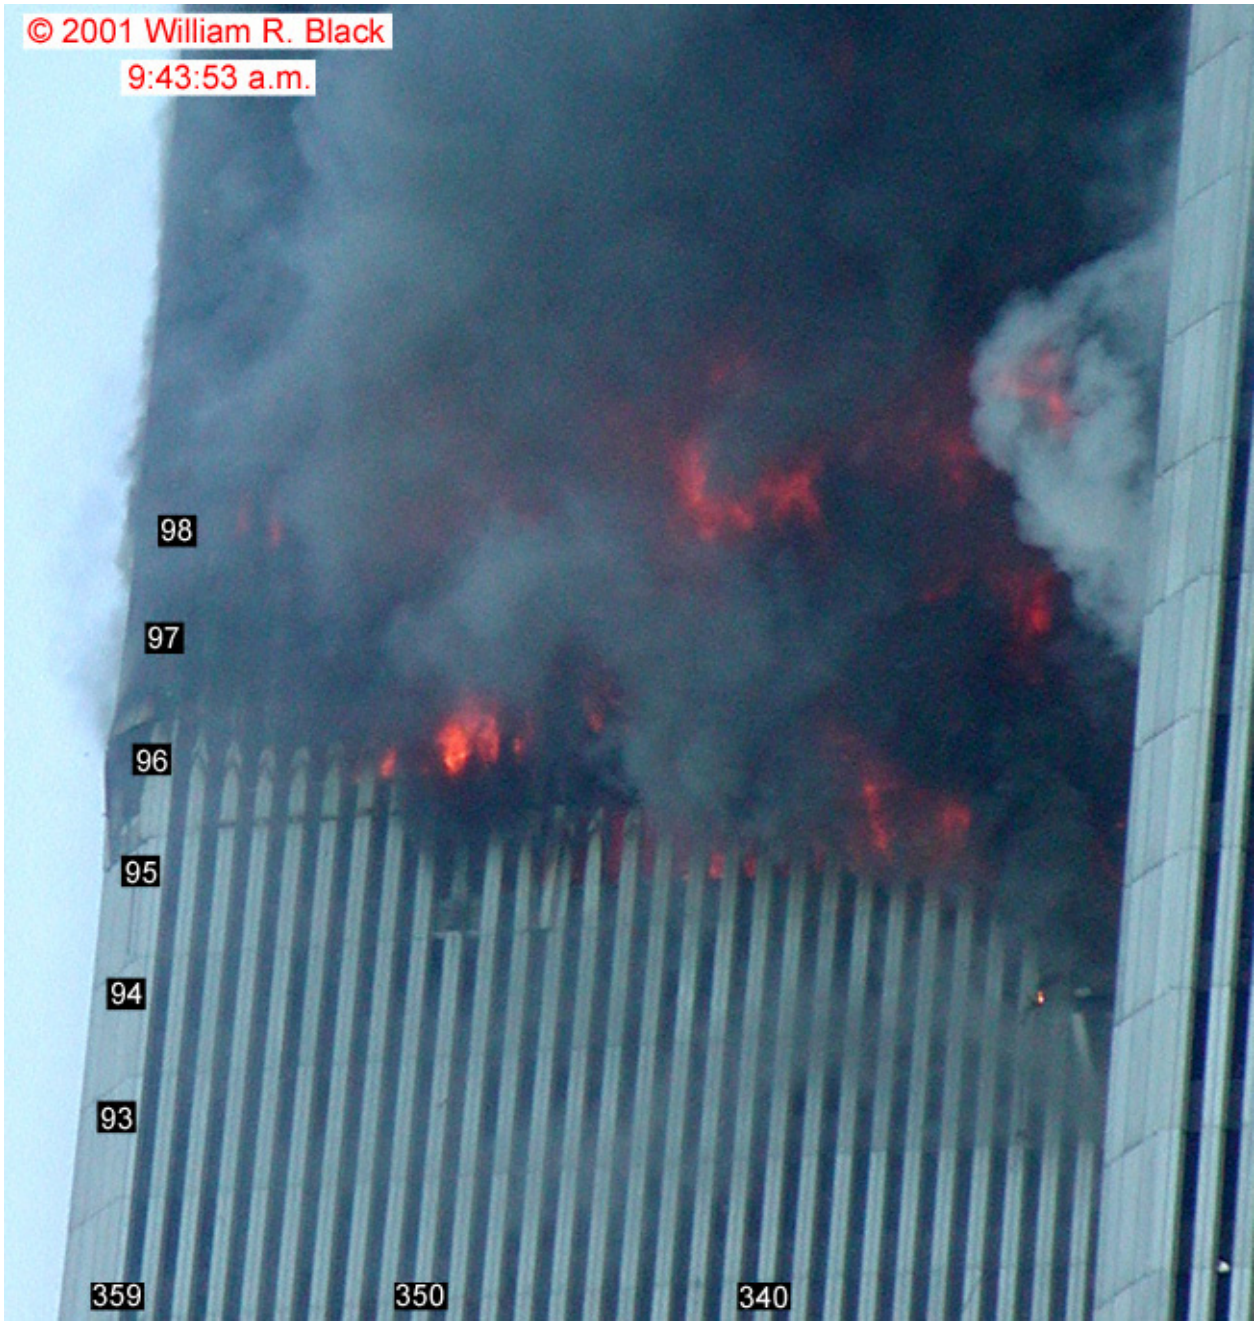
Figure 8–64 shows a long-distance view of the south face taken at 9:52:27 a.m., or roughly eight and a half minutes after Figure 8–63. Compared to the earlier time, fire intensities on floors 95 to 98 have decreased markedly. The fire on the 98th floor is still burning vigorously, but does not seem to have moved significantly following its very rapid spread around 9:41 a.m. The fires on the 96th and 97th floors are much less intense than observed earlier, being evident at only limited locations on the west side of the face, with very little flame extension. While the intensity of the fire on the 95th floor has decreased, there are still relatively intense flames near the center of the face. Flames are evident just to the east of the area where the panel section is missing, i.e. near windows 95-327 and 95-328.

Figure 8-63. This cropped photograph of the south face of WTC 1 was recorded at 9:43:53 a.m. The image has been rotated and enhanced. WTC 2 appears at the right. Column and floor numbers have been added.

Even though it has been over an hour since the aircraft struck WTC 1, the majority of flames observed on the south face are still present to the left, i.e., west, of column 330. However, unlike earlier times, there are indications that fires have begun to burn in the southeast quadrant of the tower. There appears to be a small fire visible near window 94-315 in Figure 8–64. In another photograph, taken at roughly the same time, flames with a similar intensity are visible at window 94-314. Figure 8–65 provides a view of the south face at 9:53:47 a.m. taken from the southwest. While flames are not apparent in this area of the 94th floor from this angle, smoke is visible coming from at least two locations on the 94th floor to the

east of the center. Window glass appears to be missing in other nearby windows. Taken together, these observations suggest that a relatively low intensity fire is present at this time on the 94th floor on the east side of the south face.

Figure 8-64. This cropped photograph shows the south face of WTC 1 at 9:52:27 a.m. The intensity levels have been adjusted and column and floor numbers have been added. For reference purposes, the missing aluminum panel on the southwest corner of the towers is on the 96th floor, and the heaviest fire is on the 98th floor.

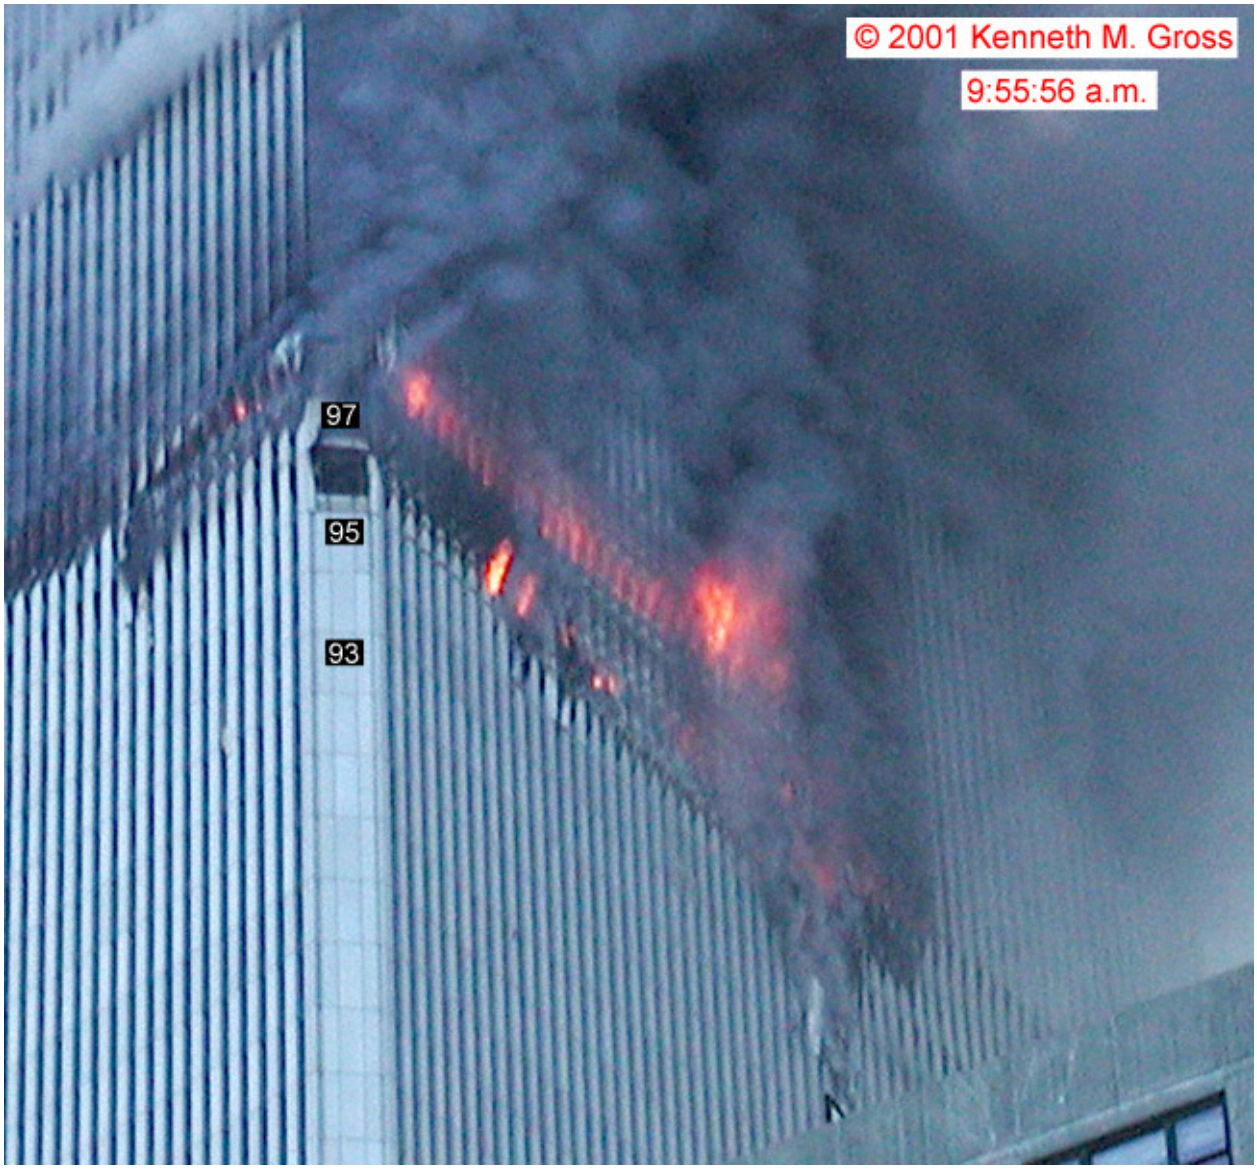
Figure 8-66. A photograph shot from the southwest shows the west and south faces of WTC 1 at 9:55:56 a.m. The original image has been cropped and enhanced. Floor numbers have been added.

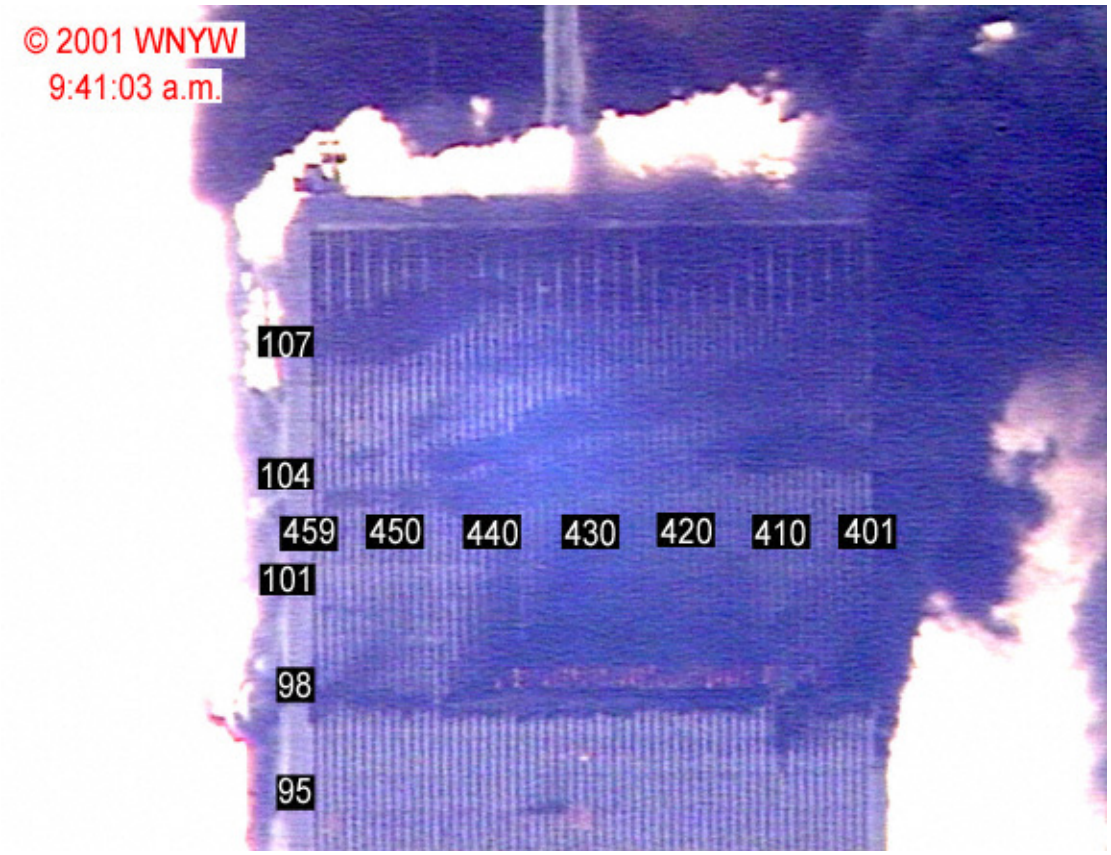
Fires are now visible near the center of the 94th floor just to the right of the black mark at the top of the columns covers, which starts at column 94-433, and very close to the north edge of the face. Flames are

also present on the 96th floor near the center of the face. This fire has apparently continued its movement to the north, since at 9:34:48 a.m. its northern edge appeared to be near window 96-426, and it can now be seen at least as far as window 96-433. While the flames are not completely visible in the frozen frame shown in Figure 8–68, by reviewing the video it is apparent that this low-intensity fire covers at least thirteen windows.

Figure 8-68. This image of the west face of WTC 1 is a frame captured from a video recorded by a news helicopter at 9:41:03 a.m. The image has been enhanced by adjusting the intensity range, and areas to the left and right of the tower are saturated. Column and floor numbers have been added.

The most dramatic change in the fire distribution is on the 98th floor. At the earlier time there was no indication of fire on the west side of this floor, while in Figure 8–68 flames can be seen over a length running from the south edge of the face to at least window 98-440. From the available imagery, it has proven difficult to determine precisely when this fire appeared, but a review of helicopter video suggests it occurred between 9:38:10 a.m. and 9:39:05 a.m. Given the low intensity of the fire, such apparent rapid fire spread is difficult to understand.

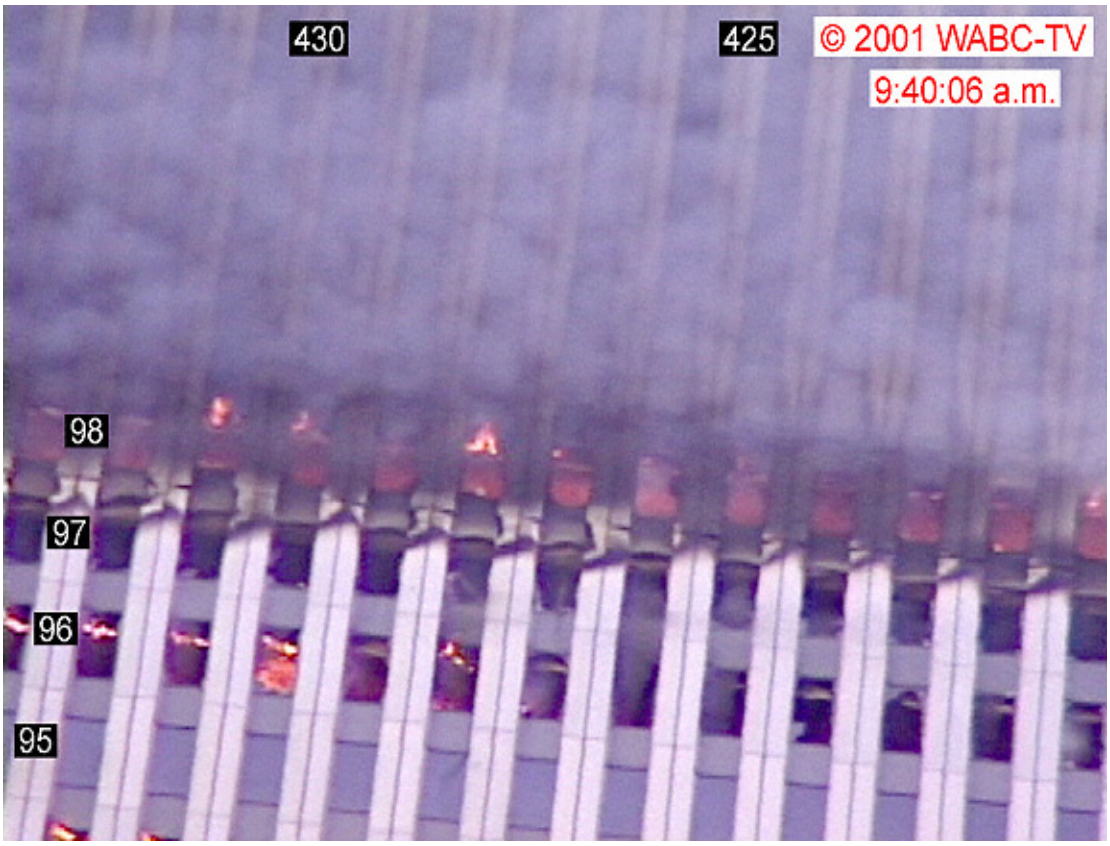
On the 98th floor, a red glow is present in all of the windows, indicating that a fire is burning away from, but near the windows. This is consistent with the appearance of the fires on this floor in Figure 8–68, which was recorded a short time after Figure 8–69. Flames are visible at the tops of several of the windows, particularly windows 98-427, 98-429, and 98-430. It is clear that the flames are positioned just inside of the open windows near the tops of the window frames. The burning material appears to be located on the tops of plates that are hanging down from above. Several of these plates are also visible in windows on the 96th and 98th floors in windows where flames at the tops of windows are not present. It is likely that the plates are actually hanging aluminum head casings (see the discussion in Section 4.2.2) that have dropped down from above the windows as the result of heating. These observations provide additional visual evidence that the burning areas that were frequently observed at the tops of open windows were due to burning polyurethane that was exposed when the aluminum head casings located just inside the tops of the windows at the ceiling dropped down.

There is no indication of active fire on the 97th floor in the video frame. However, the presence of carets at the tops of the aluminum column covers attests to the intensity of the fires that burned on this floor earlier. On some of the columns, portions of the aluminum column covers near the tops of windows appear to have melted.

Figure 8-69. This close up view of the west face of WTC 1 was captured from a video recorded at 9:40:06 a.m. It has been enhanced by adjusting the intensity levels. Column and floors numbers have been added.

Even though fires are clearly present on the 96th floor in the vicinity of the windows at 9:40:06 a.m., they appear to be burning with low intensity. This is consistent with videos shot from helicopters that showed that the fires on this floor were visible intermittently and were located close to the floor. With the exception of the fires at the tops of the windows, flames fill only one opening, window 96-429, and there are no indications of flames coming from the windows. There is very little smoke flowing from this floor, and there are no smoke marks at the tops of the column covers.

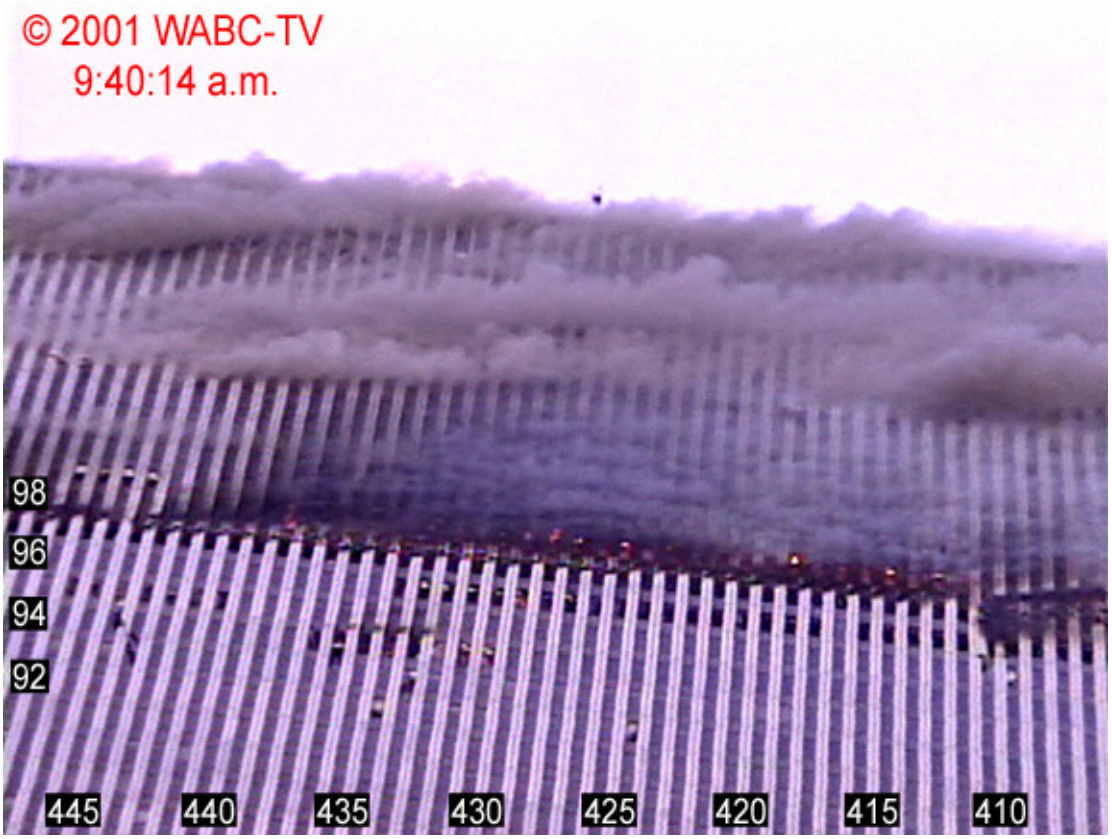
With one exception, window 96-416, all of the windows on the 96th floor as far north as window 96-434 are open. Light flames are visible at the tops of several of the windows, and flames are present in window 96-429. Despite the fact that these windows have apparently been opened by nearby fires on this floor, there is very little or no smoke coming from any of the windows, and, with the exception of column covers near the south end of the floor, the covers are unmarked.

There are no flames evident in the open windows across the entire extent of the 97th floor visible in Figure 8–70. The carets and smoke marks on the column covers near the tops of the windows on this floor contrast sharply with the appearance of the column covers next to the tops of the 96th floor windows.

Figure 8-70. This view of the west face of WTC 1 was captured from a video recorded at 9:40:14 a.m. It has been enhanced by adjusting the intensity levels, and some locations above the building are saturated. Column and floors numbers have been added.

The expanded view of Figure 8–70 shows that fire is visible on the 98th floor from roughly window 98-411 to window 98-439. Further to the north, the window glass appears to be intact. Bright fires are present at the tops of several of the open windows. Larger flames are also present in windows 98-428 and 98-439. Even so, compared to the intense burning observed on the other faces of the tower, these fires appear to be burning relatively gently at this time.

The smoke flows coming from some of the open windows above the 98th floor are quite heavy. At other open windows relatively little smoke is present. The four open windows on the 99th floor, windows 99-445 to 99-448, are an example of the latter behavior.

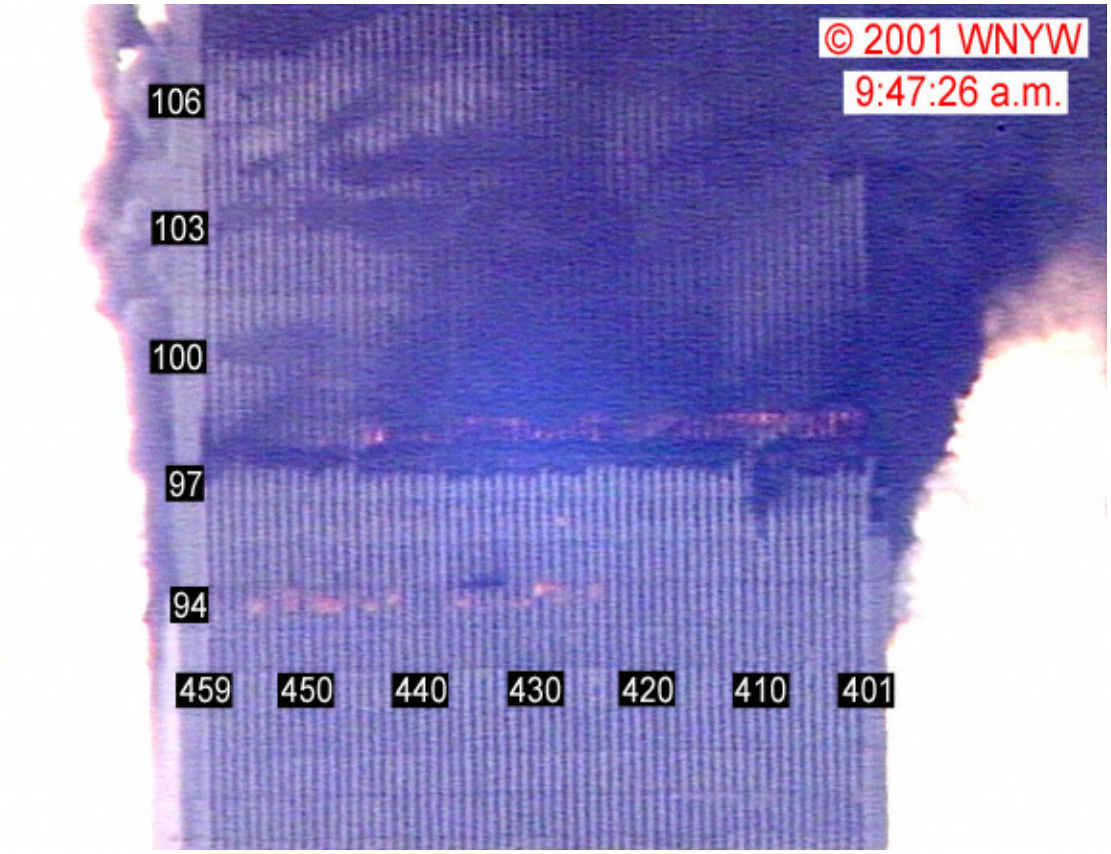
Another view of the west face taken from a video recorded from a news helicopter at 9:47:46 a.m. is shown in Figure 8–71. Since 9:41:03 a.m. (compare with Figure 8–68), the fires on the 94th floor have continued to spread; now appearing at several different locations ranging from the north edge of the face to window 94-425. By comparing the fire locations with the floor plan layout shown in Figure B-3, it is discovered that fires have entered seven of the eight rooms located along the west face, running from the north edge to as far south as column 94-425 The one exception is the room with walls at columns 94-438 and 94-442. Even though the fire area is extensive, the flames are not very vigorous. There is no apparent external flaming, and no smoke is visible coming from the windows.

Figure 8-71. This image of the west face of WTC 1 is a frame captured from a video recorded by a news helicopter at 9:47:26 a.m. The image has been enhanced by adjusting the intensity range, and areas to the left and right of the tower are saturated. Column and floor numbers have been added.

Small fires are still evident on the 96th floor. In the video the flames appear intermittently over a range of windows that reaches as far north as window 96-441. As at the earlier time, there is no smoke or flame coming from the windows.

The fire on the 98th floor has continued to spread north. It now extends from the south edge continuously to at least window 98-444. From this distance, the fire still appears to be located away from the west wall. There is little indication of fire or smoke coming from the windows on this floor.

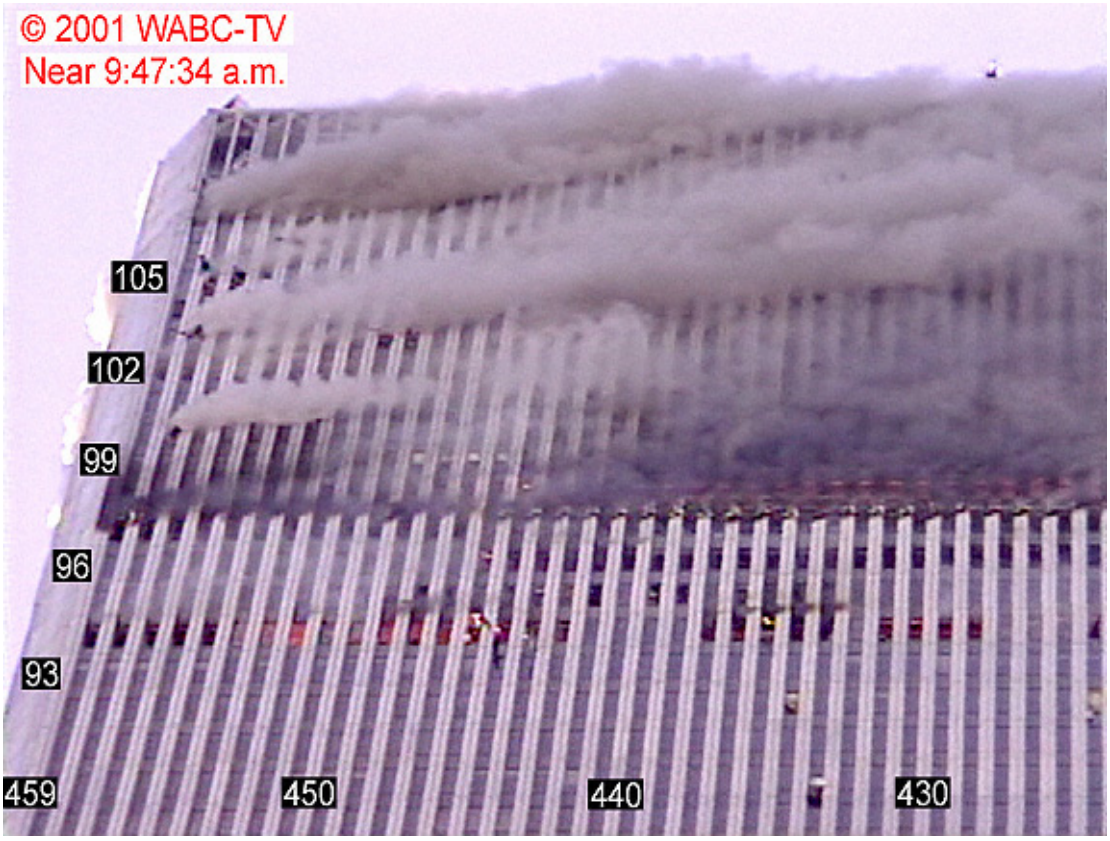
A much closer view of the north side of the west face recorded at roughly the same time as Figure 8–71 is shown in Figure 8–72. Even though this image is assigned a time of 9:47:34 a.m., there is an associated uncertainty of 30 s. The closer image provides confirmation of many of the conclusions drawn from Figure 8–71. On the 94th floor fire is visible at many of the windows, and a number are open from window 94-424 to window 94-459. The glass panes between windows 94-438 and 94-442 are indeed in place, with no indication of fire in the room located between these columns (see Figure B-3). The five windows along the west face in the northeast corner room are open. The adjacent room to the south has walls at columns 94-450 and 94-454 (Figure B-3). The fire is apparently just growing in this room since flames are visible, but three of the four windows are in place. Flames are visible, and most of the windows are missing for the next two rooms to the south. Window 94-424 is open, but the panes are still in place in nearby windows. This indicates that the observed fire has moved one room further south since 9:41:03 a.m.

Figure 8-72. This view of the west face of WTC 1 was captured from a video recorded at 9:47:34 a.m. There is a 30 s uncertainty in the assigned time. The image has been enhanced by adjusting the intensity levels, and some locations above the building are saturated. Column and floors numbers have been added.

On the 95th floor, two additional windows (95-438 and 95-439) have opened since 9:40:14 a.m. Since there is still no indication of fire in this area, it is possible that people have broken out the glass. Very

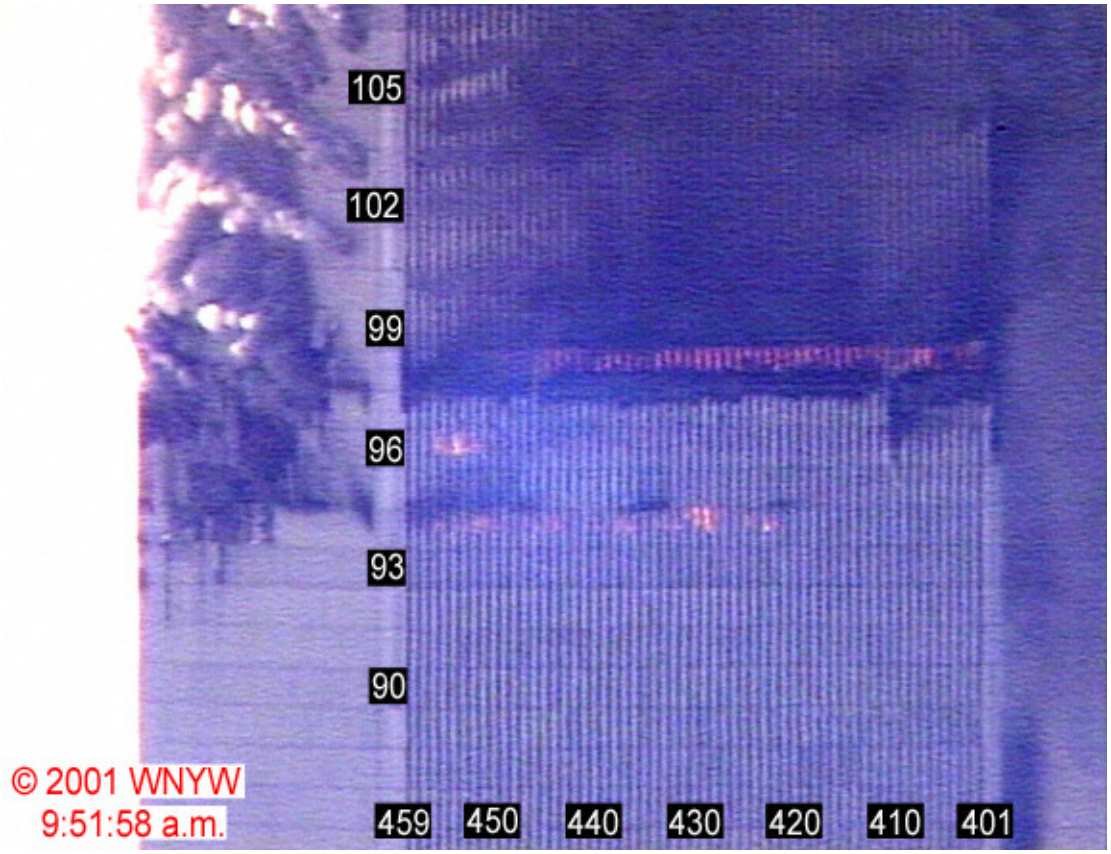
Another frame taken from a video shot from a helicopter at 9:51:58 a.m. is shown in Figure 8–73. Fire development on the west face has continued. The largest differences as compared to Figure 8–71, which was recorded at 9:47:26 a.m., are the appearance of fire at multiple windows on the 96th floor near the north edge of the west face and the spread of the fire toward the south on the 94th floor. It has not been possible to determine exactly when the fire at the north edge of the 96th floor appeared, but it was between 9:50:09 a.m. and 9:51:19 a.m. The flames are visible in windows 96-453 to 96-455. The floor plan layout in Figure B-5 indicates that these windows were inside a room with internal walls at columns 96-452 and 96-456. Fire is not yet visible from windows in the room on the northeast corner with walls at columns 96-456 and 96-108. On the 94th floor flames are now visible in windows 94-423 and 94-424. This indicates that a fire was growing within the room with walls located at columns 94-421 and 94-425. (see Figure B-3) The appearance of the fire on the 98th floor did not change dramatically over the four and a half minute period between the images.

Figure 8-73. This image of the north and west faces of WTC 1 is a frame captured from a video recorded by a news helicopter at 9:51:58 a.m. The image has been enhanced by adjusting the intensity range, and areas to the left of the tower are saturated. Column and floor numbers have been added.

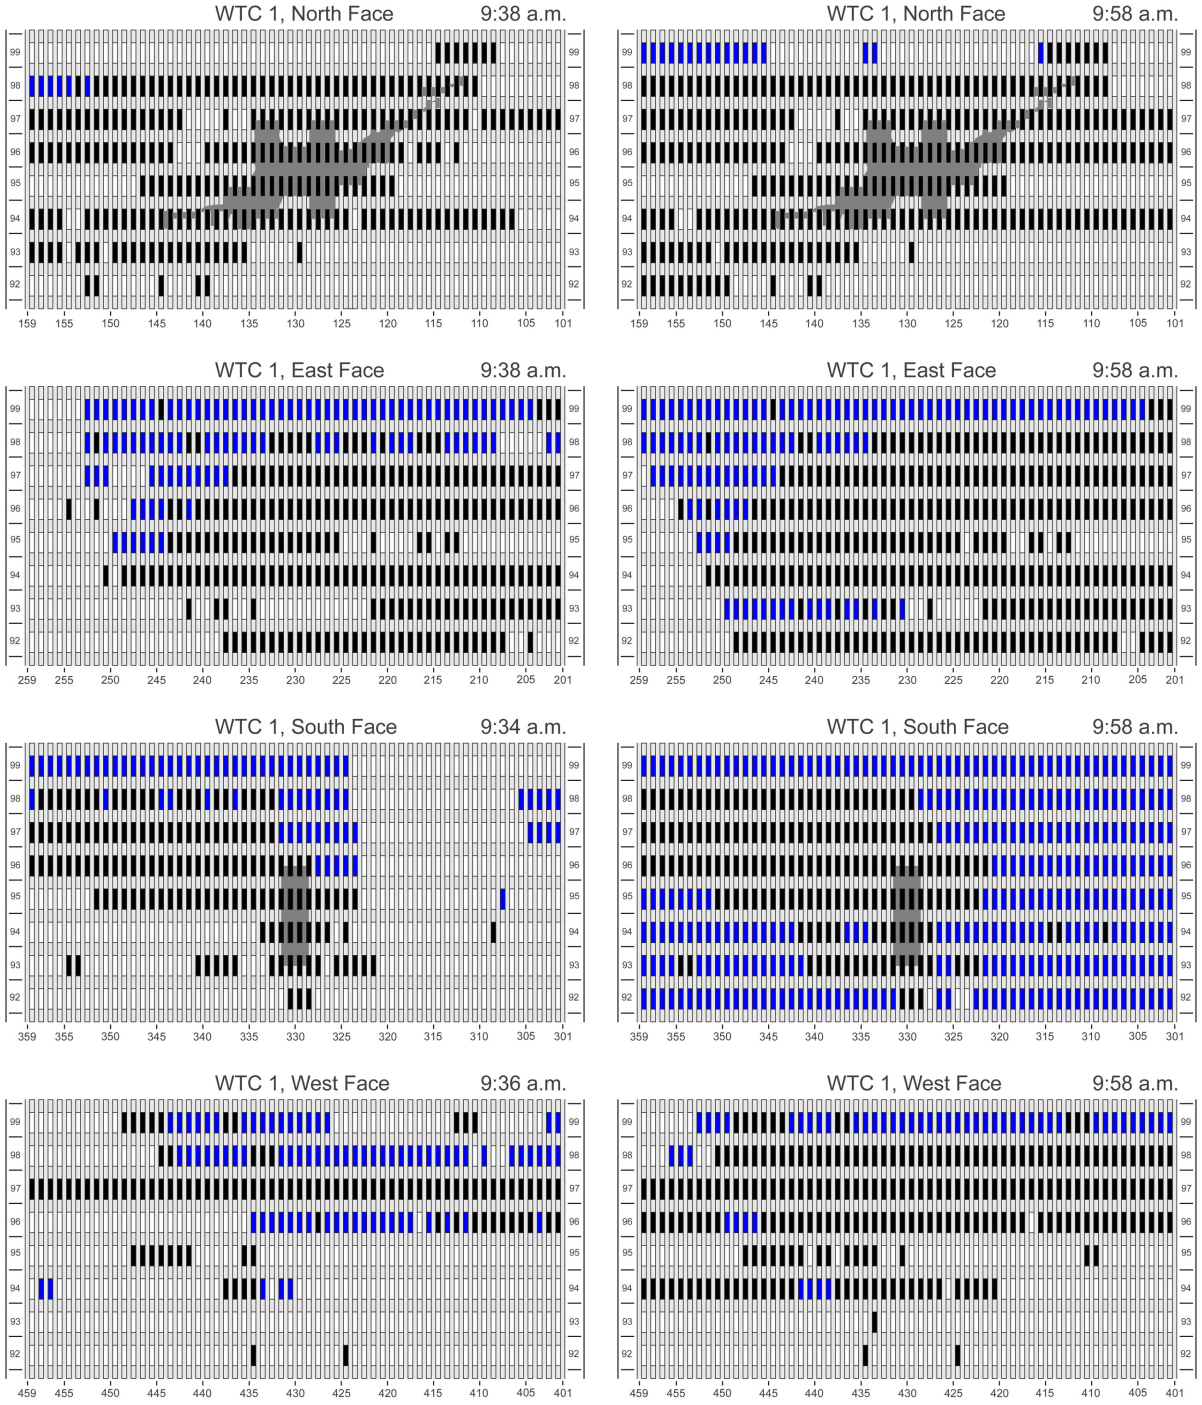
Figure 8-75. Maps for the 92nd through the 99th floors compare missing window glass for the four faces of WTC 1 at two times, around 9:35 a.m. and at 9:58 a.m. The color coding used for the maps is indicated in Figure 5-1.

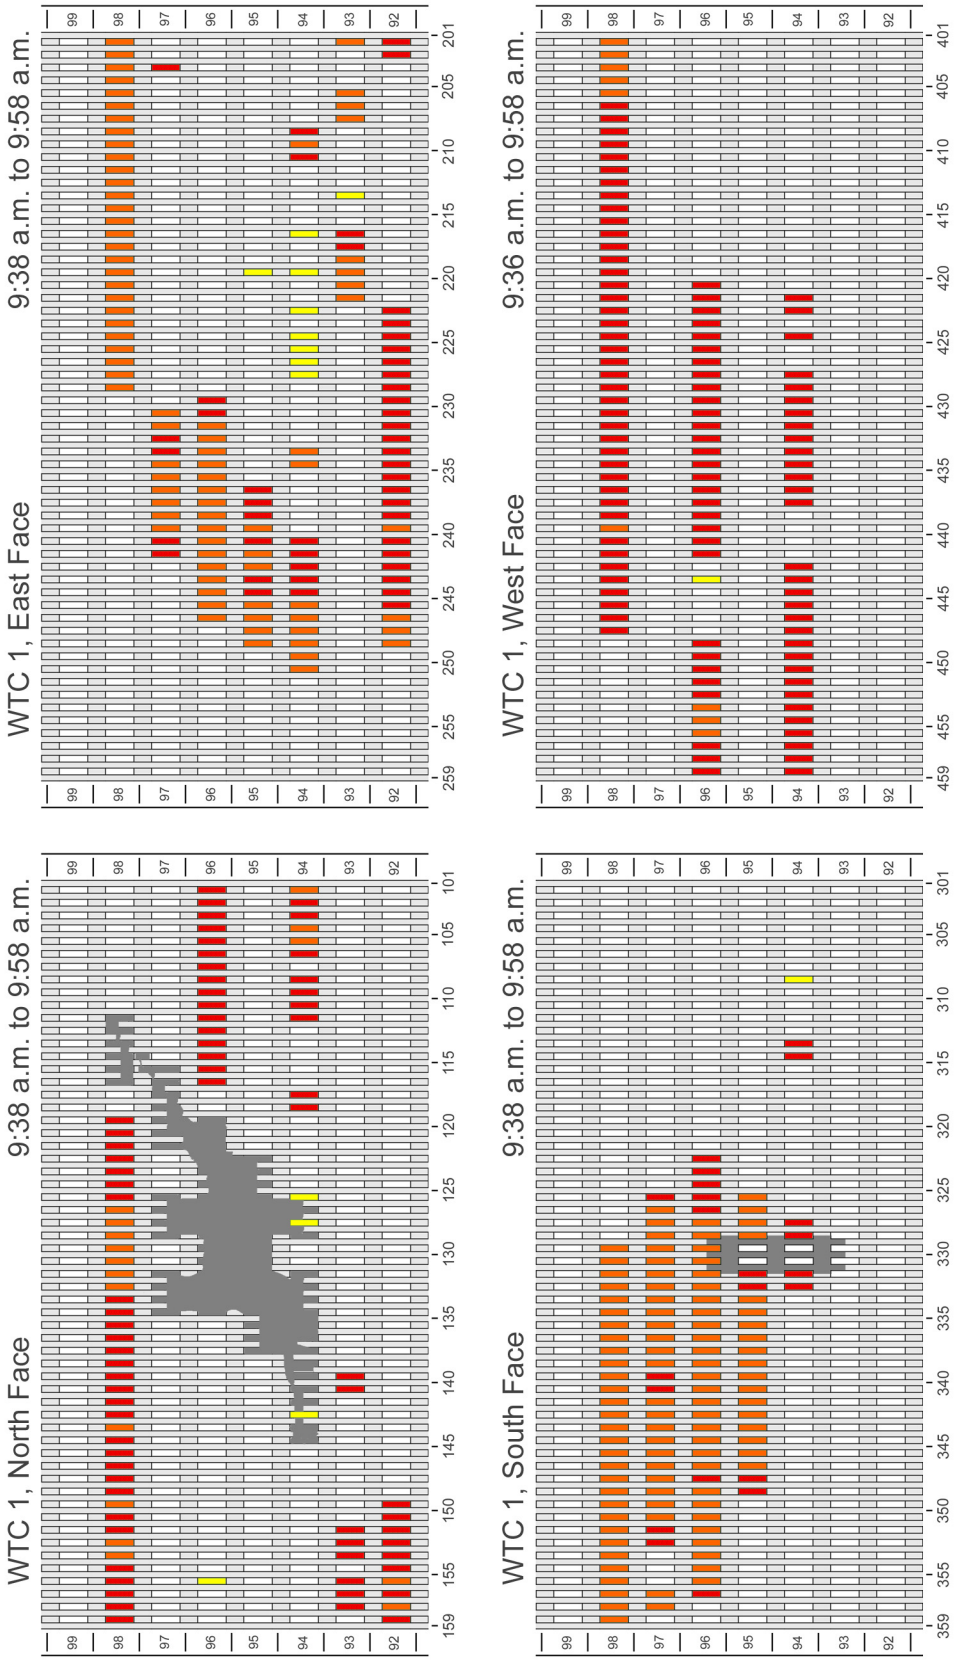
The most distinctive change in the window condition and integrated fire maps between 9:35 a.m. and 9:59 a.m. was the wide-spread appearance of fire on the 98th floor. By roughly twenty minutes after a growing fire first became evident on the north side of the 98th floor, fire was visible on this floor in two long bands. One of these bands started near the center of the south face, ran to the southwest corner and extended north on the west face to at least window 98-444. The second band began near window 98-119 on the north face and ran around the northeast corner to the vicinity of window 98-223 on the east face. The observed fire behavior of these rapidly developing fires varied from face to face. On the east and south faces very intense flames were observed extending large distances from open windows, while on the west and north sides, the fires appeared much less intense and to be burning at interior locations removed from the outer walls. These observations are reflected in the integrated fire distribution maps shown in Figure 8–76.

Figure 8-76. Maps of integrated fire observations between 9:36 a.m. and 9:59 a.m. are shown for the four faces of WTC 1. Colors represent the highest intensity fire observed in a window using the color scale defined in Figure 5-1.

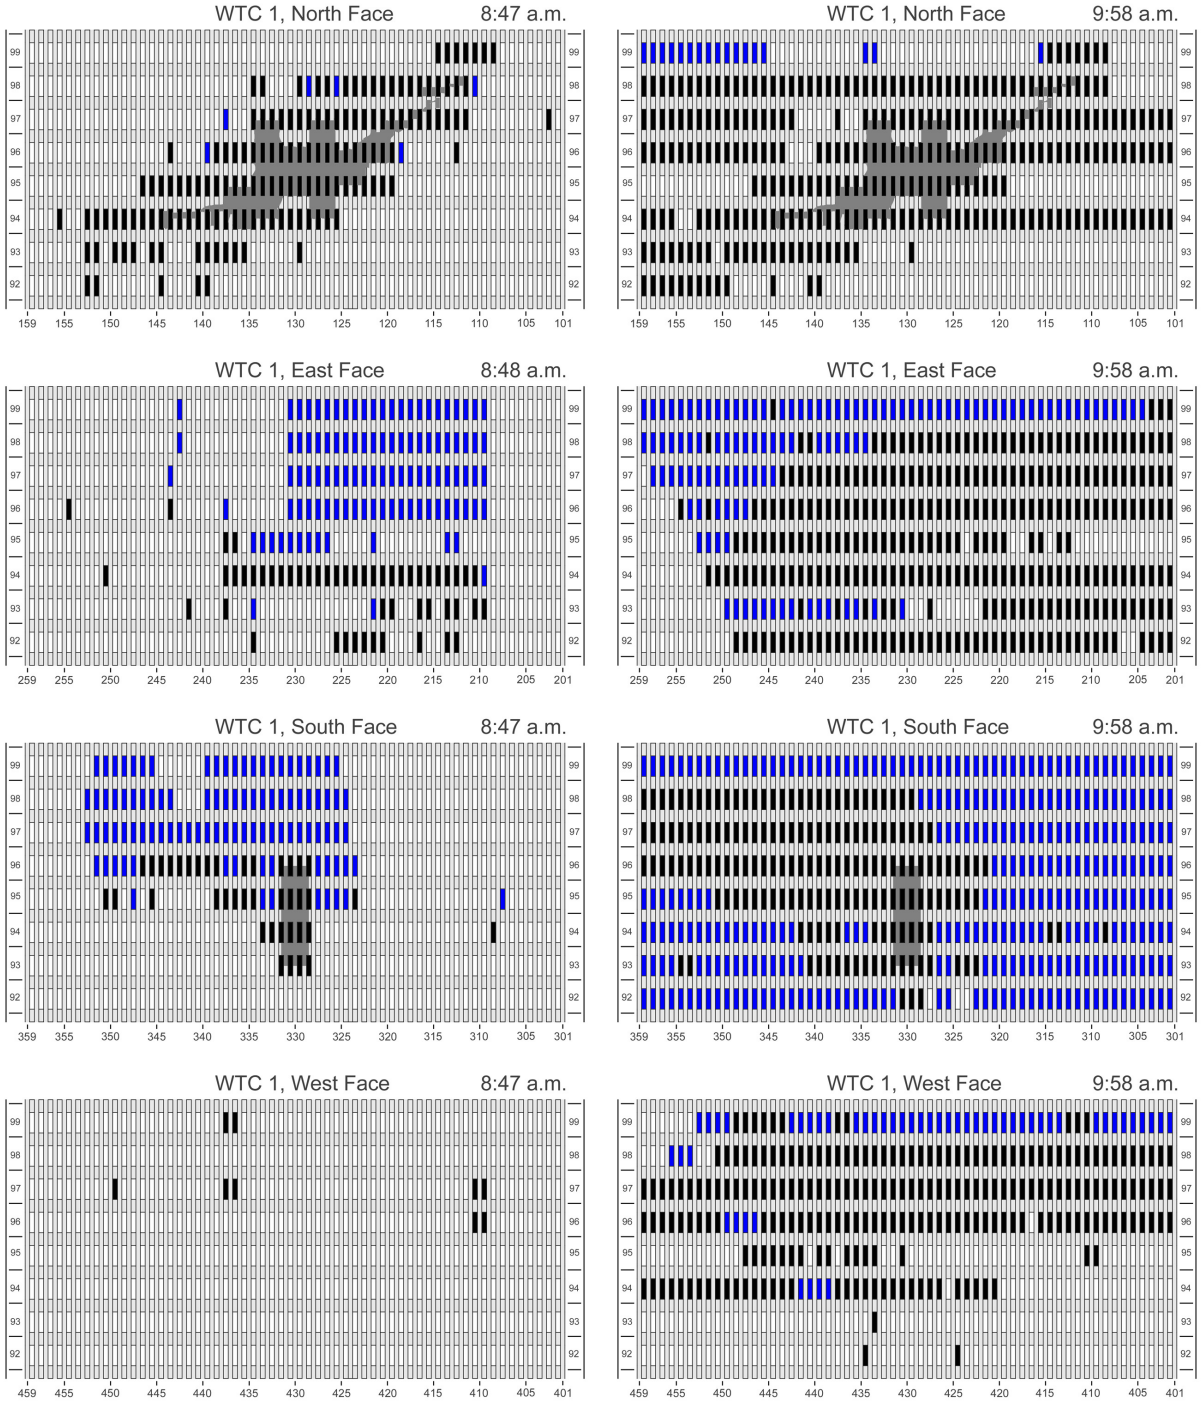
Figure 8-77. Maps for the 92nd through the 99th floors compare missing window glass for the four faces of WTC 1 at two times, immediately following the aircraft impact on WTC 1 at 8:46:30 a.m. and just prior to the collapse of WTC 2 at 9:58:59 a.m. The color coding used for the maps is indicated in Figure 5-1.

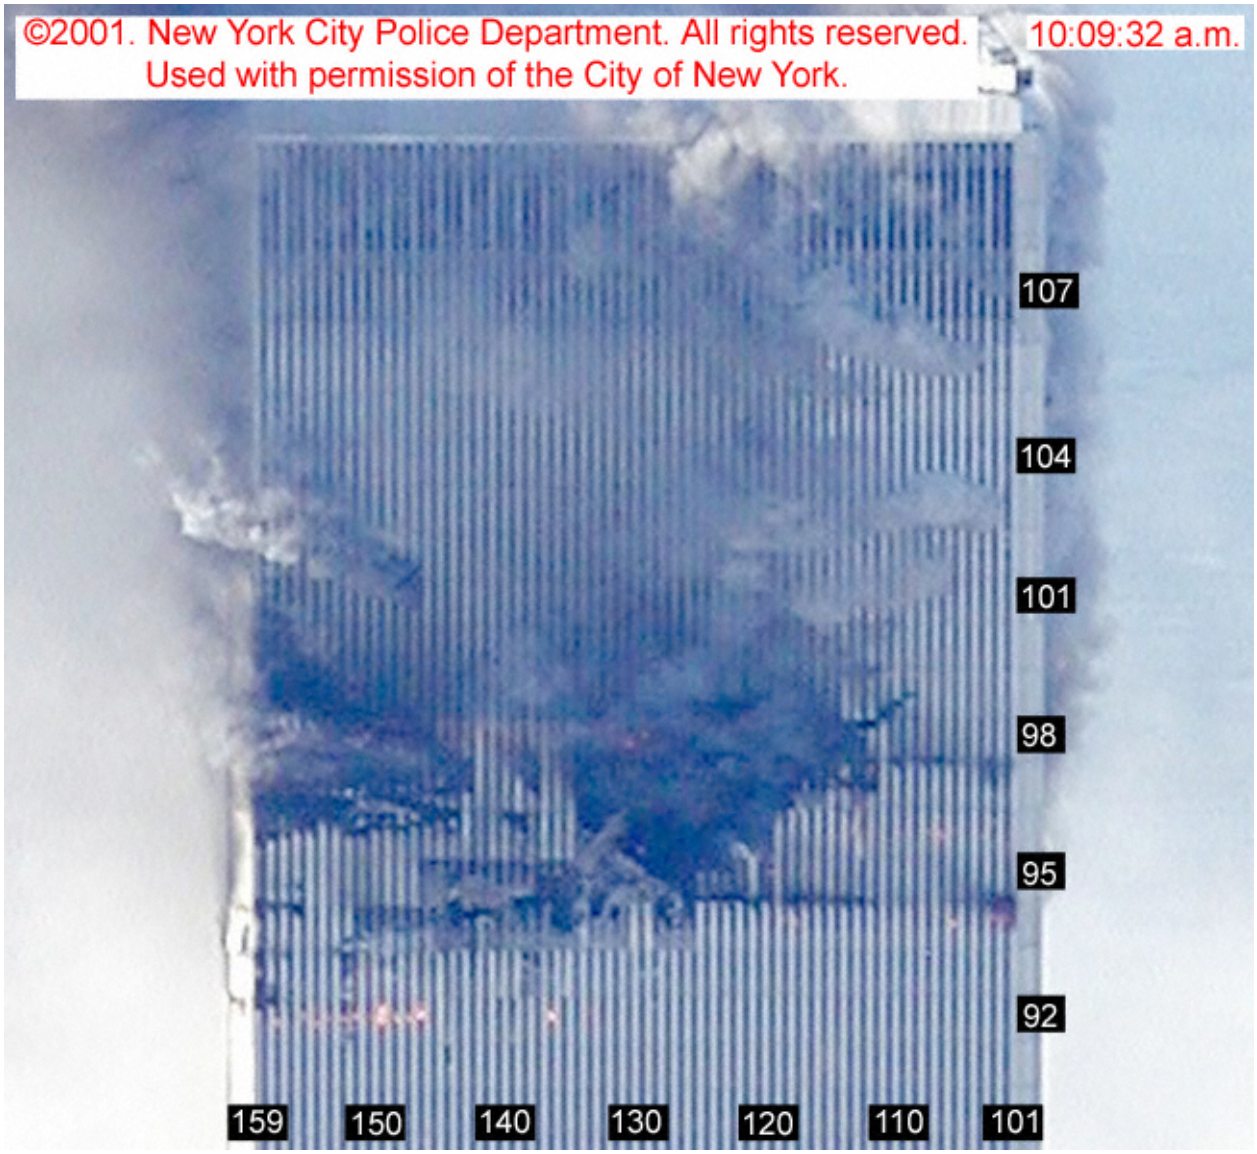
Low intensity fires are also visible in Figure 8–82 on the west sides of the 94th and 96th floors and over much of the eastern half of the 98th floor. These are locations where much larger fires were present at earlier times, and these fires are likely the remnants. They were not visible from the ground around this time because they were low intensity and were burning near the floors, where they were hidden from view.

In Figure 8–82 there is no evidence of fire on the north face near the west edge of the 98th floor. At 10:10:15 a.m. a burst of heavy smoke was released from window 98-105, and less than two seconds later smoke came from window 98-102. A series of photographs taken around this time indicates that fire appeared in window 98-102 between 10:10:19 a.m. and 10:10:20 a.m. A photograph recorded at 10:10:55 a.m. showed flames were present in windows 98-101 to 98-108 and that flames were coming from windows on the adjacent west face.

Figure 8-82. This cropped photograph was shot from a helicopter looking down on the north face of WTC 1 at 10:09:32 a.m. The intensity levels have been adjusted and column and floor numbers have been added.

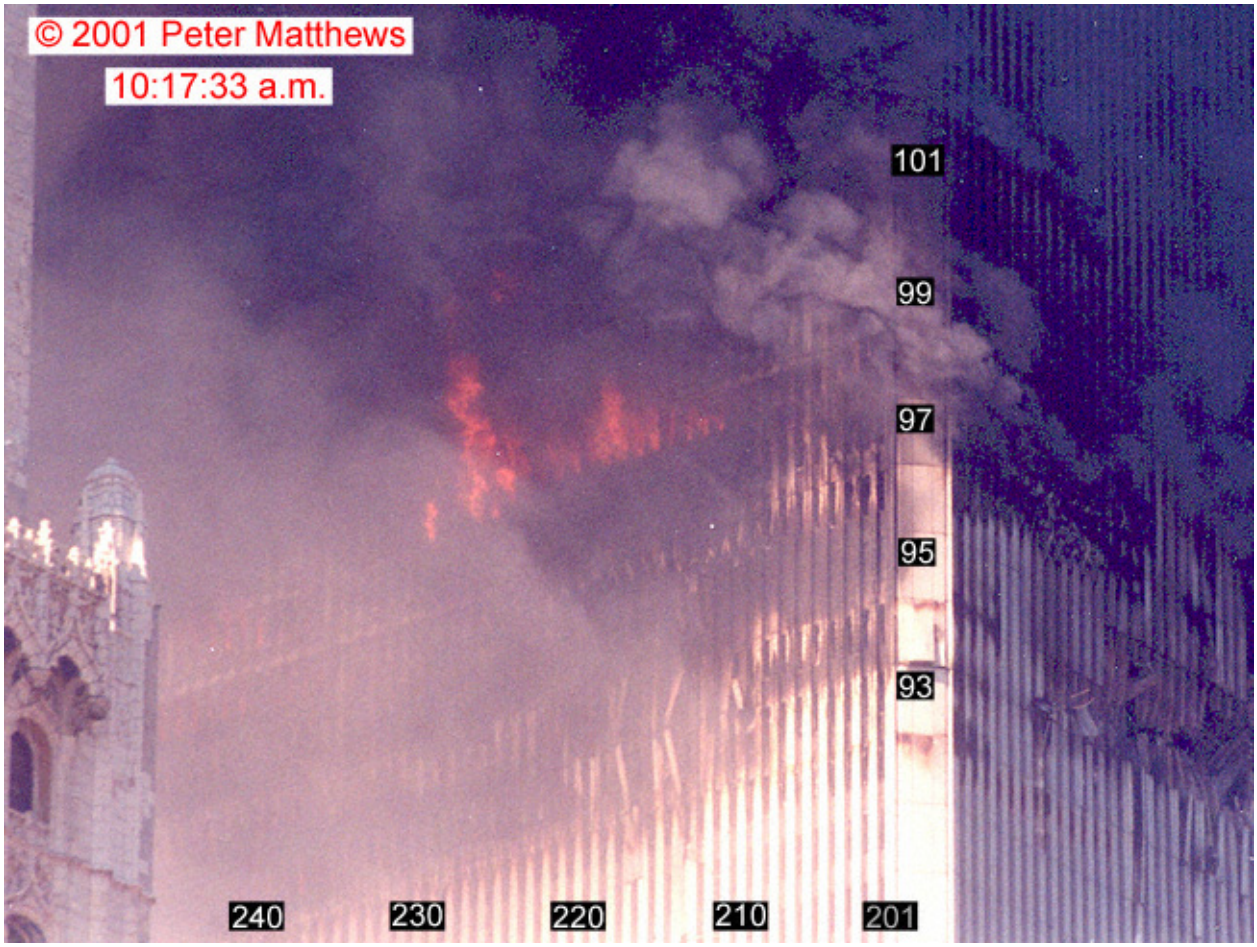
Figure 8-86. This photograph shows the north and east faces of WTC 1 at 10:17:33 a.m. The original has been cropped and enhanced by adjusting the intensities. Column and floor numbers have been added.

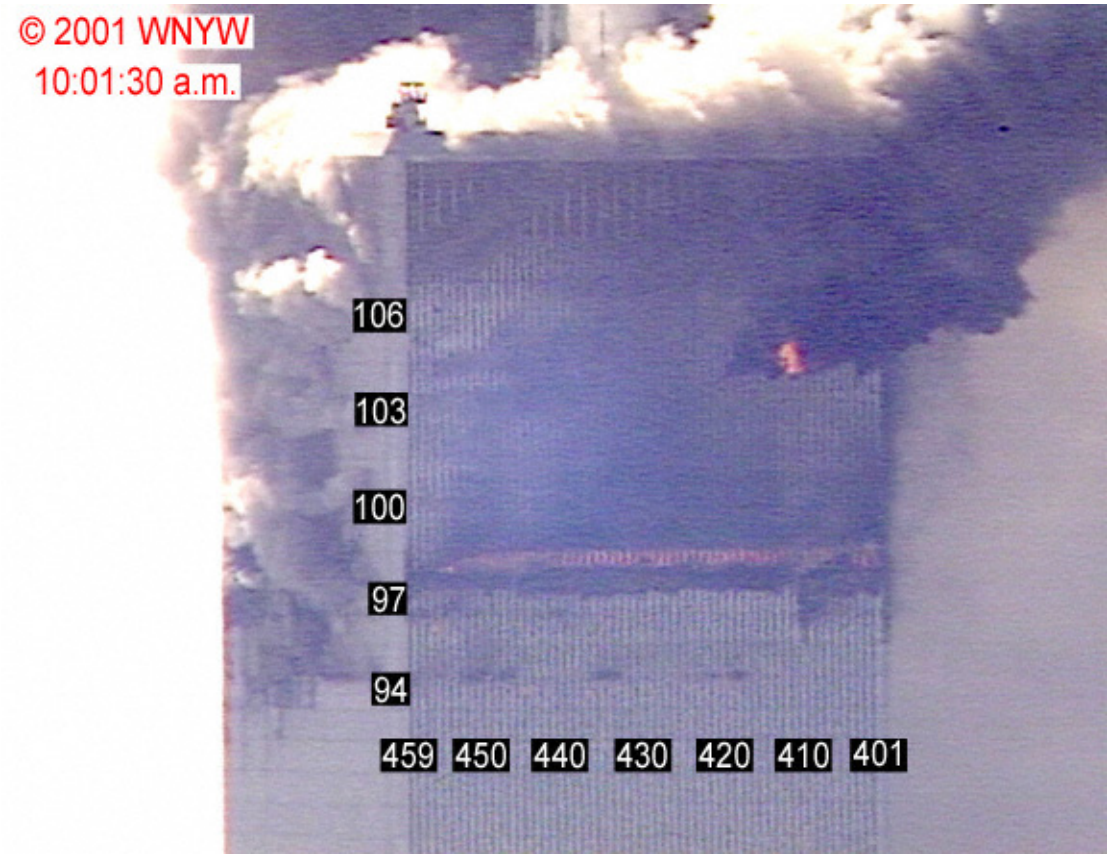
Figure 8–89 shows an image of the west face shot from a news helicopter at 10:01:30 a.m. The flames on the 104th floor are coming from several windows centered near window 104-411. Heavy black smoke is venting from multiple windows over a much larger area. It is informative to compare the appearance of the smoke in Figure 8–89 with that in Figure 8–74, which shows the west face at 9:56:10 a.m. The smoke has clearly become much heavier and darker.

Figure 8-89. This image of the north and west faces of WTC 1 is a frame captured from a video recorded by a news helicopter at 10:01:30 a.m. The image has been enhanced by adjusting the intensity range, and some areas are saturated. Column and floor numbers have been added.

The deep orange glow along the 98th floor in Figure 8–89 indicates that the interior fire on this floor is continuing to burn along much of the length of the west face. The fire on this floor has moved north since around 9:58 a.m. Flames can now be seen as far as window 98-455. The floor plan layout shown in Figure B-7 indicates that there were two rooms along the west face in the northwest corner of the 98th floor. Fire has entered the southernmost of these rooms, which had interior walls at columns 98-452 and 98-456. There is as yet no visual evidence for fire on the west side of the corner room with walls at columns 98-456 and 98-108.
