NIST NCSTAR 1-5A

Federal Building and Fire Safety Investigation of the World Trade Center Disaster

Visual Evidence, Damage Estimates, and Timeline Analysis

William M. Pitts
Kathryn M. Butler
Valentine Junker

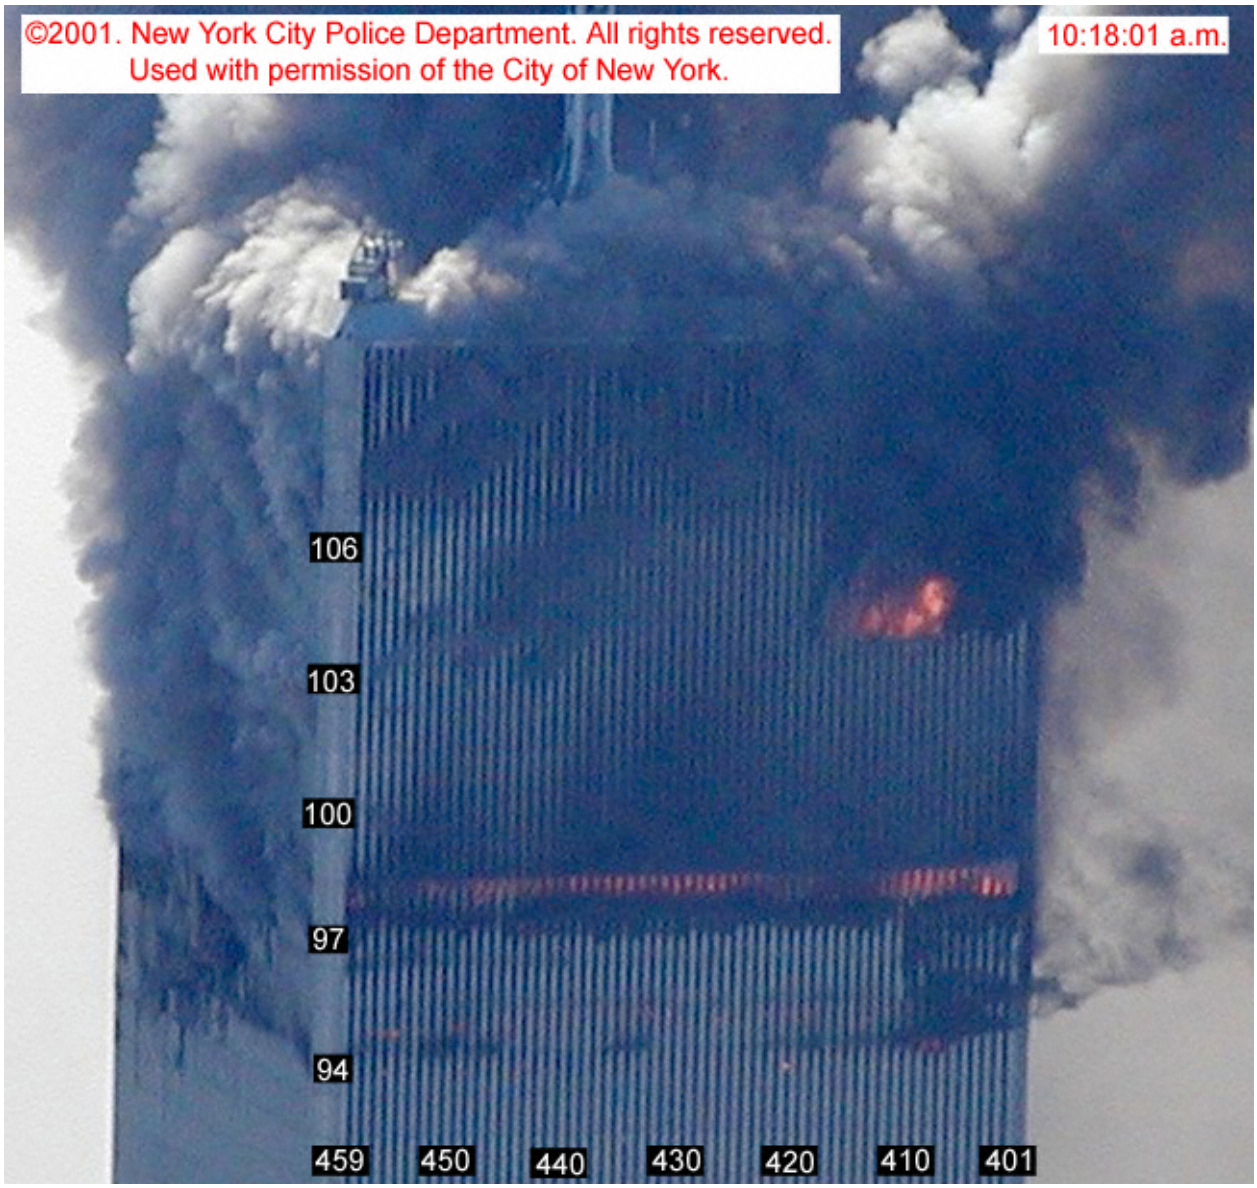
Figure 8–92 shows an image of the west face of WTC 1 recorded at the end of the current time period at 10:18:01 a.m. With a few exceptions, the appearance is similar to that seen around 10:10 a.m. The fire on the 95th floor has spread in both directions across the face. Low intensity flames can be seen in windows over a length from window 95-413 to window 95-455. Even though the fire extends over a long length of the face, there is very little smoke, and there are no flames coming from the windows on this

floor. The absence of significant smoke marks on the column covers near the tops of the windows is consistent with these observations. Based on the floor plan layout shown in Figure B-4, the fire on this floor has penetrated the room with walls at columns 95-452 and 95-456, but there is no indication that it is yet inside the room on the northwest corner with walls at columns 95-456 and 95-108.

Figure 8-92. This cropped photograph of the west face of WTC 1 and an oblique view of the north face was shot at 10:18:01 a.m. The image was enhanced by adjusting the intensity levels, and column and floor numbers have been added.

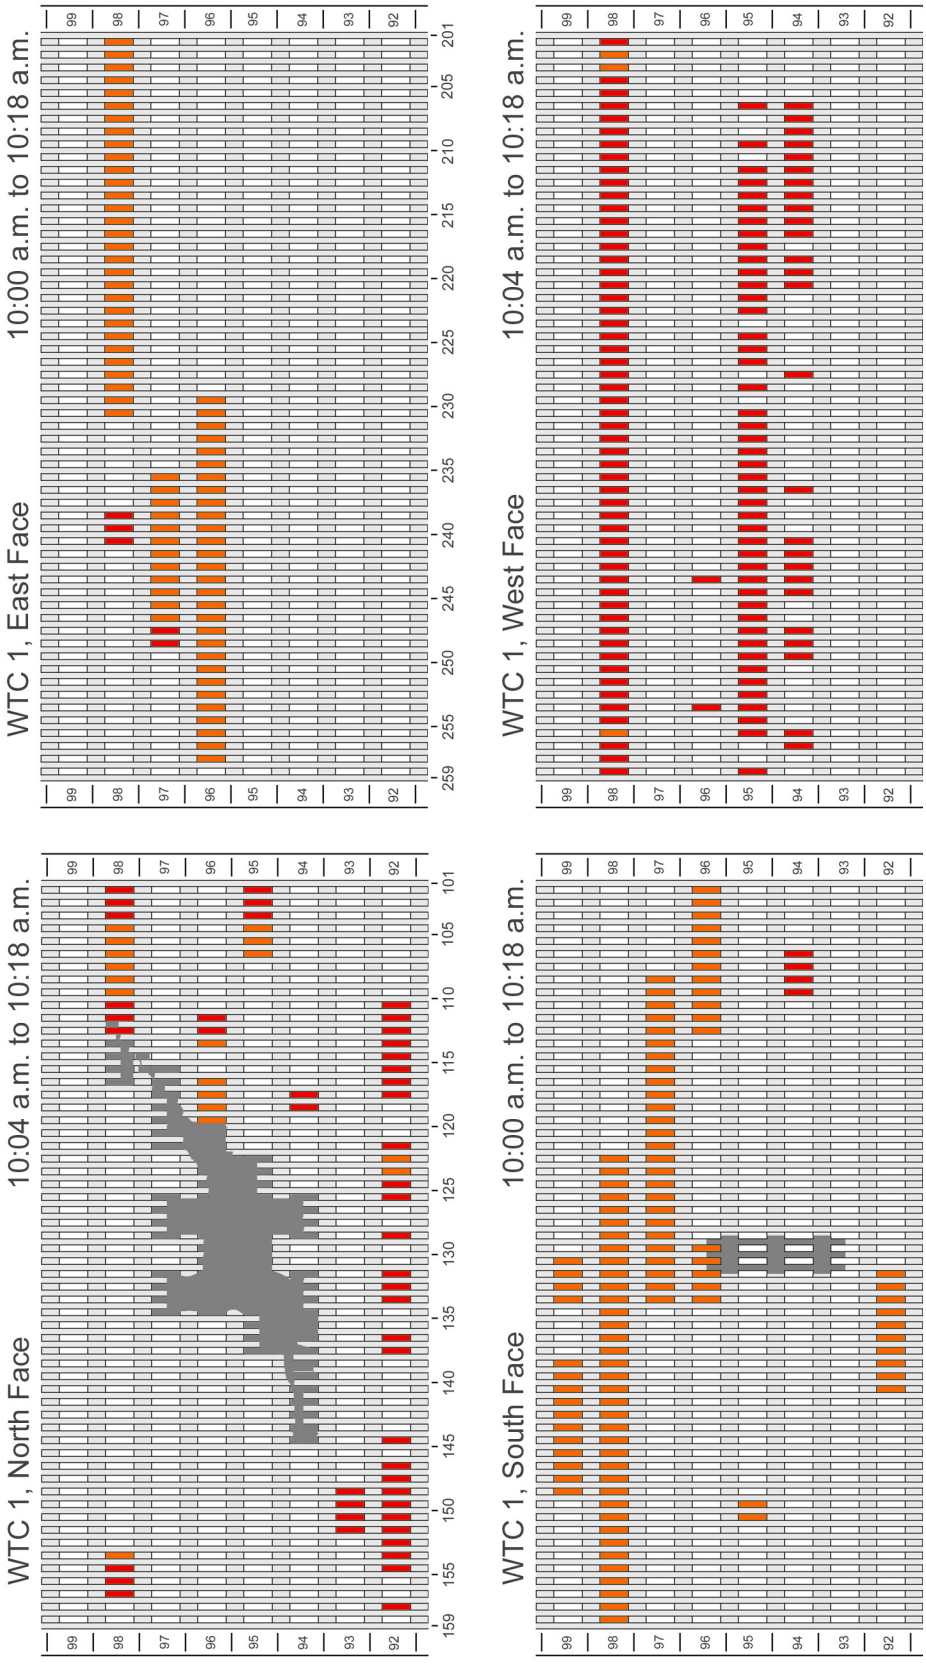
The most prominent feature of the fire growth on the west face was the appearance (not included in Figure 8–93) of an intense fire with extended flames on the 104th floor shortly after the collapse of WTC 2. This fire continued to burn intensely during the entire period. The fire on the 98th floor continued moving toward the north, reaching the north face during the period. A relatively low-intensity fire appeared on the 95th floor and subsequently covered a large fraction of the floor across the face. The fire burning on the 94th floor continued to spread toward the south early in the period, but then seemed to halt near window 94-108 for several minutes.

Figure 8-93. Maps of integrated fire observations between 10:00 a.m. and 10:18 a.m. are shown for the four faces of WTC 1. Colors represent the highest intensity fire observed in a window using the color scale defined in Figure 5-1.

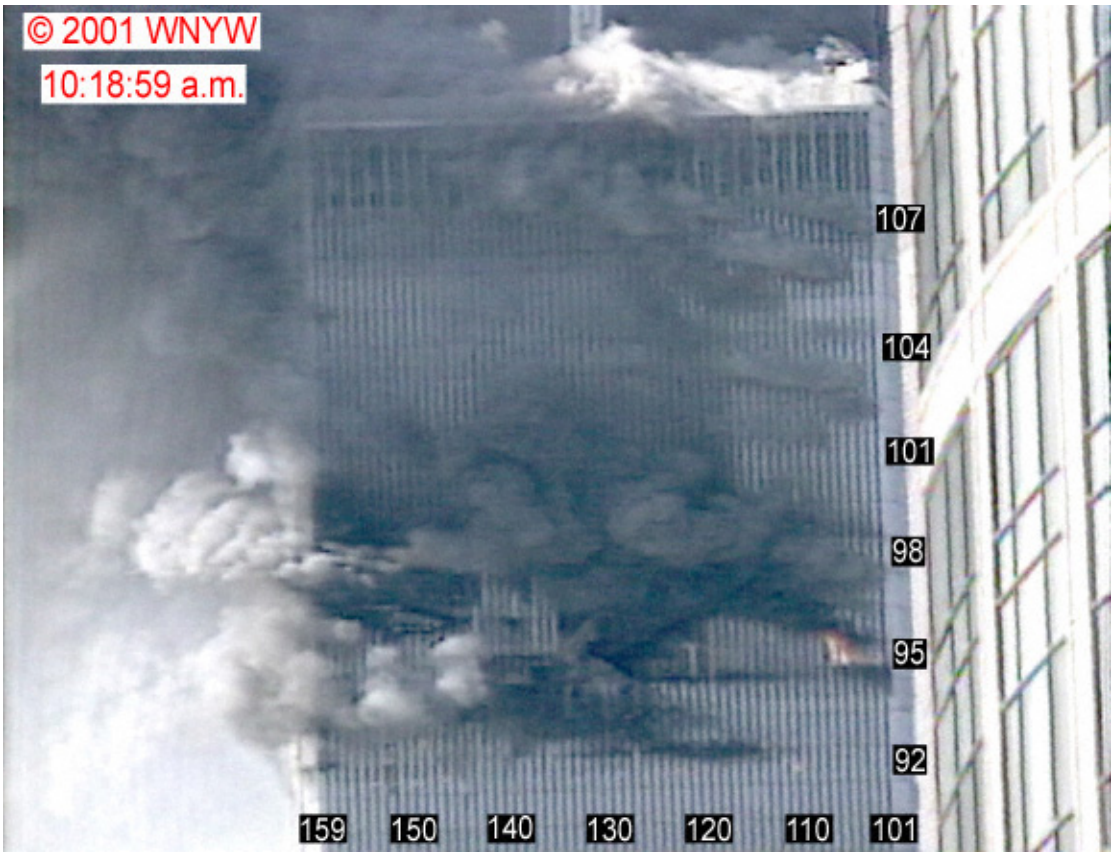
Figure 8–96 shows a closer view of the north face recorded at 10:18:59 a.m. This image is taken from the same video as Figure 8–94, which was recorded 14 s earlier. The effects of the changes in the smoke and fire described above are easily seen. The black line at the tops of the column covers on the 92nd floor created by the smoke release is visible. The fire on the western edge of the 95th floor has grown dramatically, and flames now extend from windows 95-105 and 95-106. Heavy smoke is now coming from windows on the 95th floor as well as windows at the western edge of the face on the 96th and 97th floors. Smoke is also now flowing from window 102-101 on the 102nd floor.

Figure 8-96. This image of the north face of WTC 1 was captured from a video shot at 10:18:59 a.m. It has been enhanced by adjusting the intensity range. Column and floor numbers have been added.

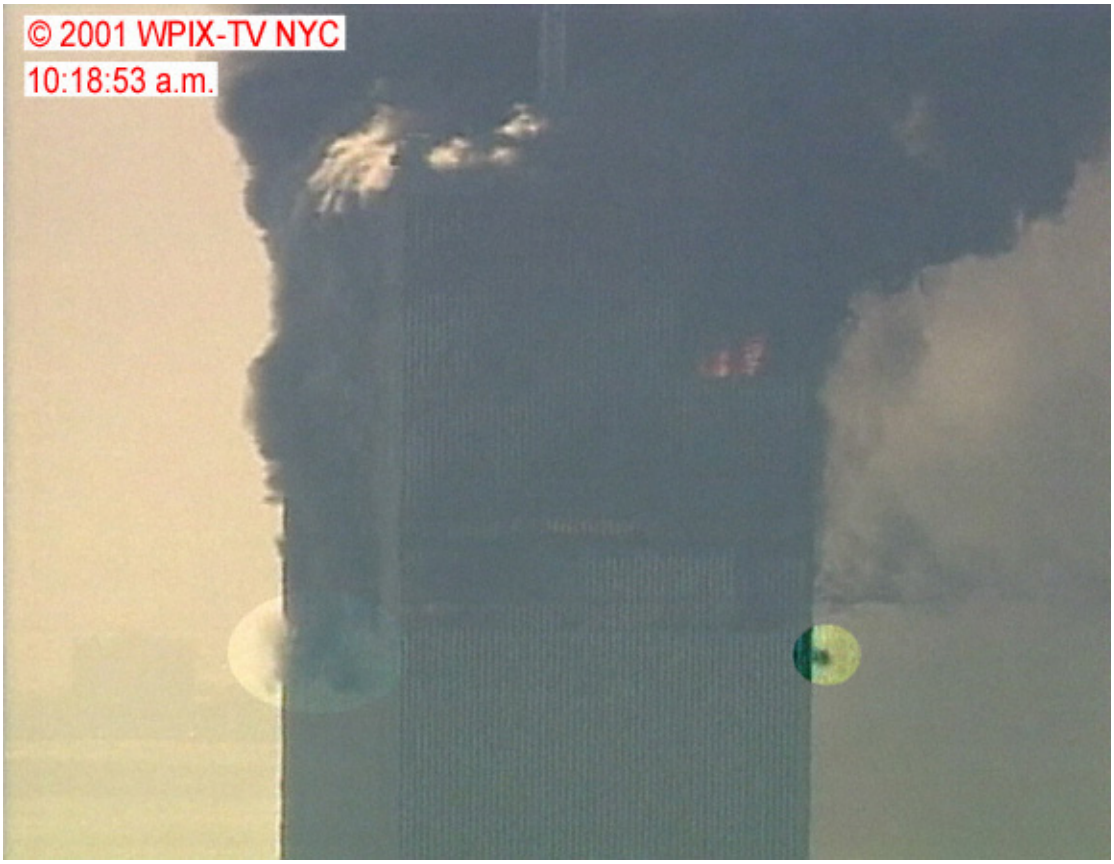
Figure 8-97. This image showing the west face and an oblique view of the north face was captured from a video shot from a news helicopter at 10:18:53 a.m. The highlighted areas with adjusted intensities indicate smoke and/or dust plumes that were pushed from the north and south faces by a pressure pulse that passed through the tower at 10:18:48 a.m.

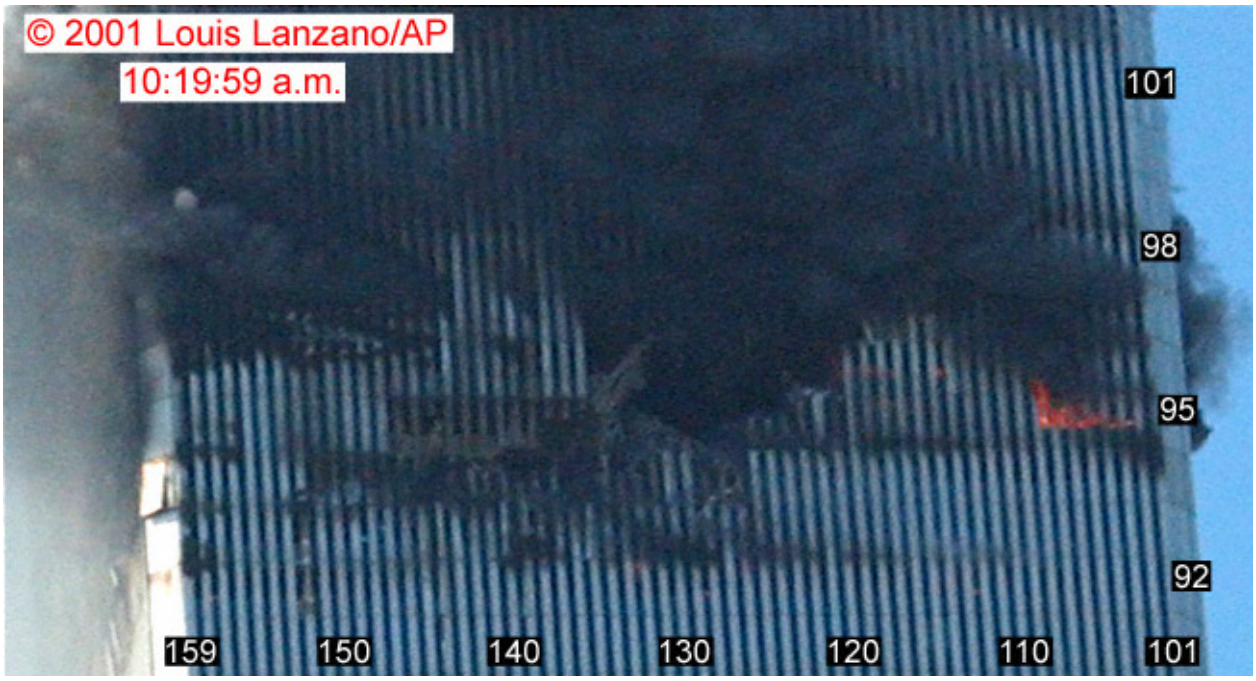
Figure 8–98 shows an image of the north face cropped from a photograph that was taken a minute later than Figure 8–96. Light smoke continues to come from the 92nd floor, where low level fires are apparent in windows 92-112 to 92-132. The fire that grew rapidly on the 95th floor immediately following the pressure pulse is still burning intensely, with flames coming from windows 95-106 and 95-107. A review of the floor plan layout for this floor in Figure B-4 shows that this fire is burning within a corner room with walls located at columns 95-456 and 95-108. Apparently, at this time the wall at column 95-108 has halted the spread of the fire toward the east. There does appear to be a fire even further to the east on this floor near window 95-115. A low level fire continues to burn on the 96th floor, with flames visible from windows 96-113 to 96-118. Heavy smoke is still flowing from windows on the 96th and 97th floors.

Figure 8-98. This cropped photograph shows the north face of WTC 1 at 10:19:59 a.m. The image has been enhanced by adjusting the intensity range. Column and floor numbers have been added.

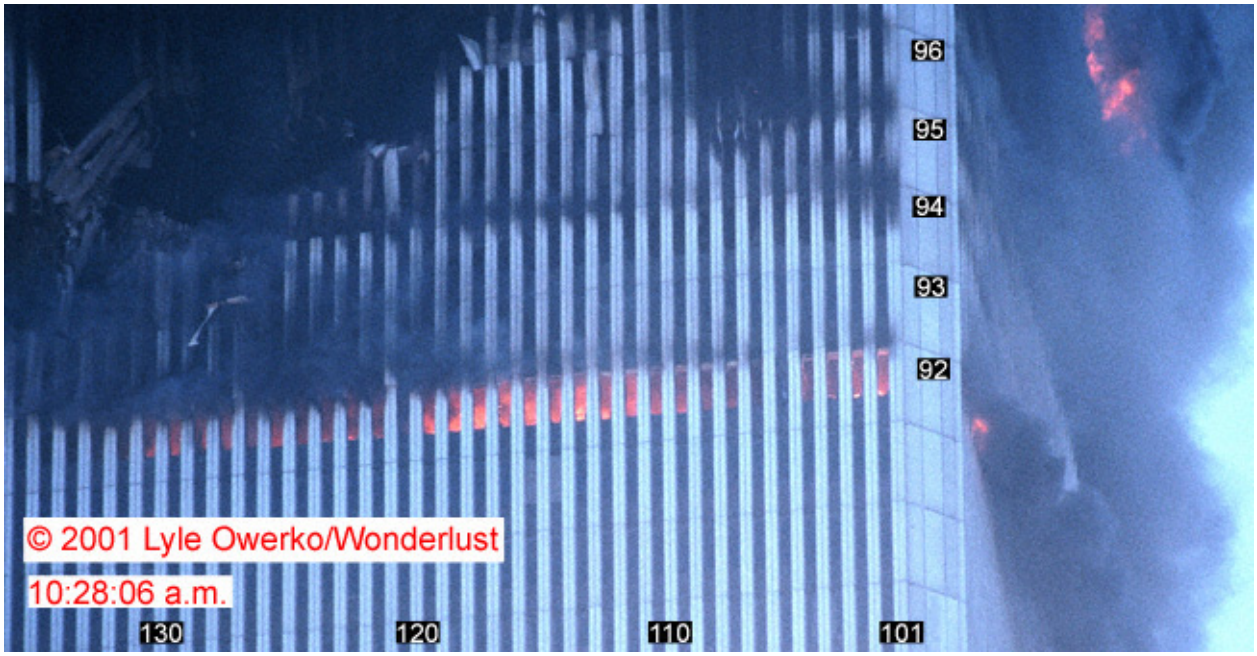
Figure 8-100. This cropped photograph shows a portion of the north face and an oblique view of the west face for WTC 1 at 10:28:06 a.m. The intensity levels of the image have been adjusted, and column and floor number have been added.

This photograph has sufficient resolution and contrast to allow a determination of whether windows are open or intact. It appears as if three windows on the 92nd floor, windows 92-105, 92-106, and 92-120, still have glass in place. The other windows visible on this floor are open.

The photograph in Figure 8–100 was shot from a ground location relatively close to and slightly west of the tower. For this reason it may not provide as complete a view of interior fires as some of the other images shown earlier. Nonetheless, it is clear that the fires that were easily identified minutes earlier on the 95th, 96th, and 97th floors are not visible and must be burning at relatively low levels. The fact that the fire on the 92nd floor is so prominent supports this conclusion.

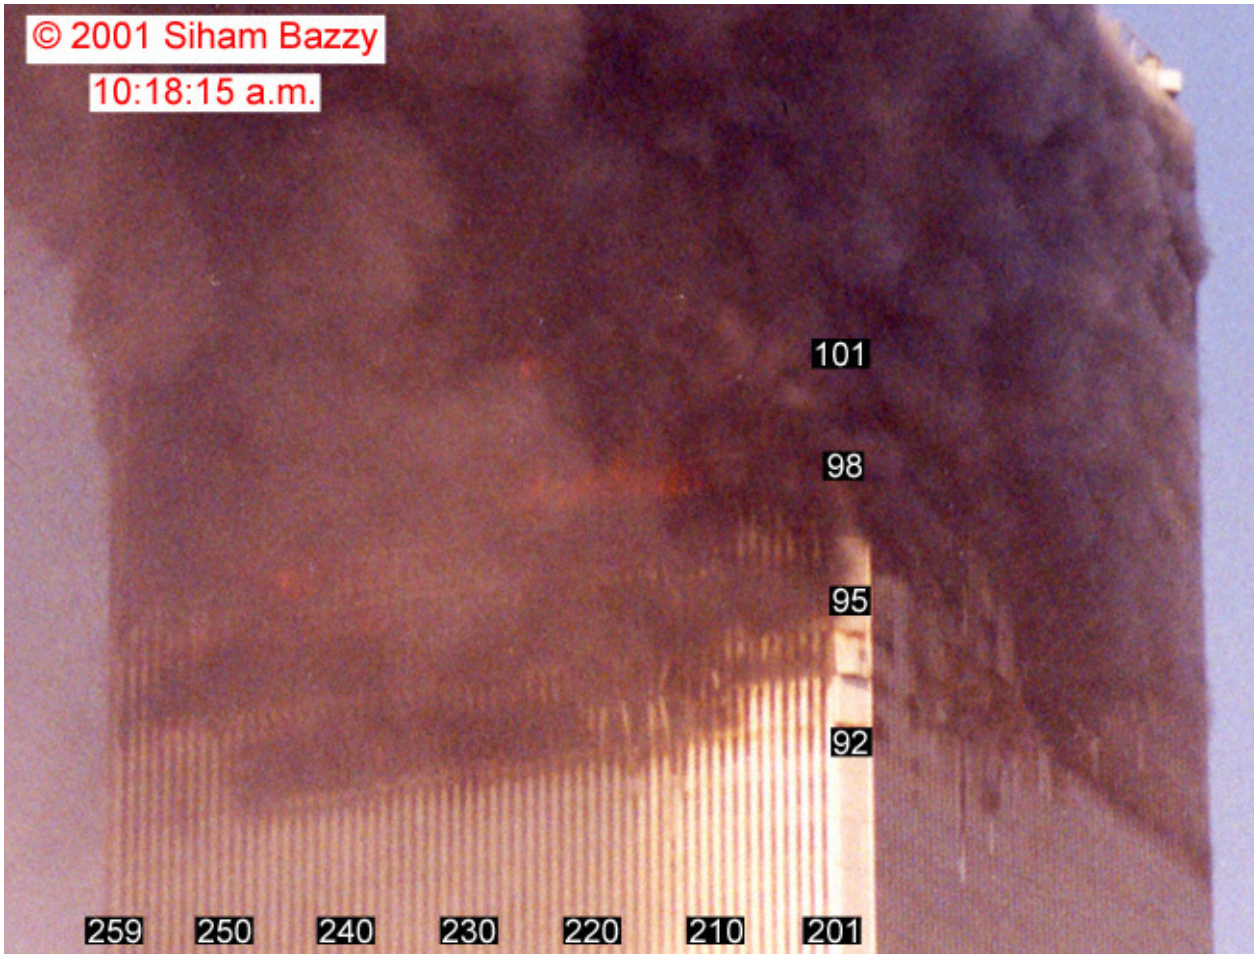
Figure 8-102. This cropped photograph showing the east and north faces of WTC 1 was shot at 10:18:15 a.m. It has been enhanced by adjusting the intensity levels. Column and floor numbers have been added.

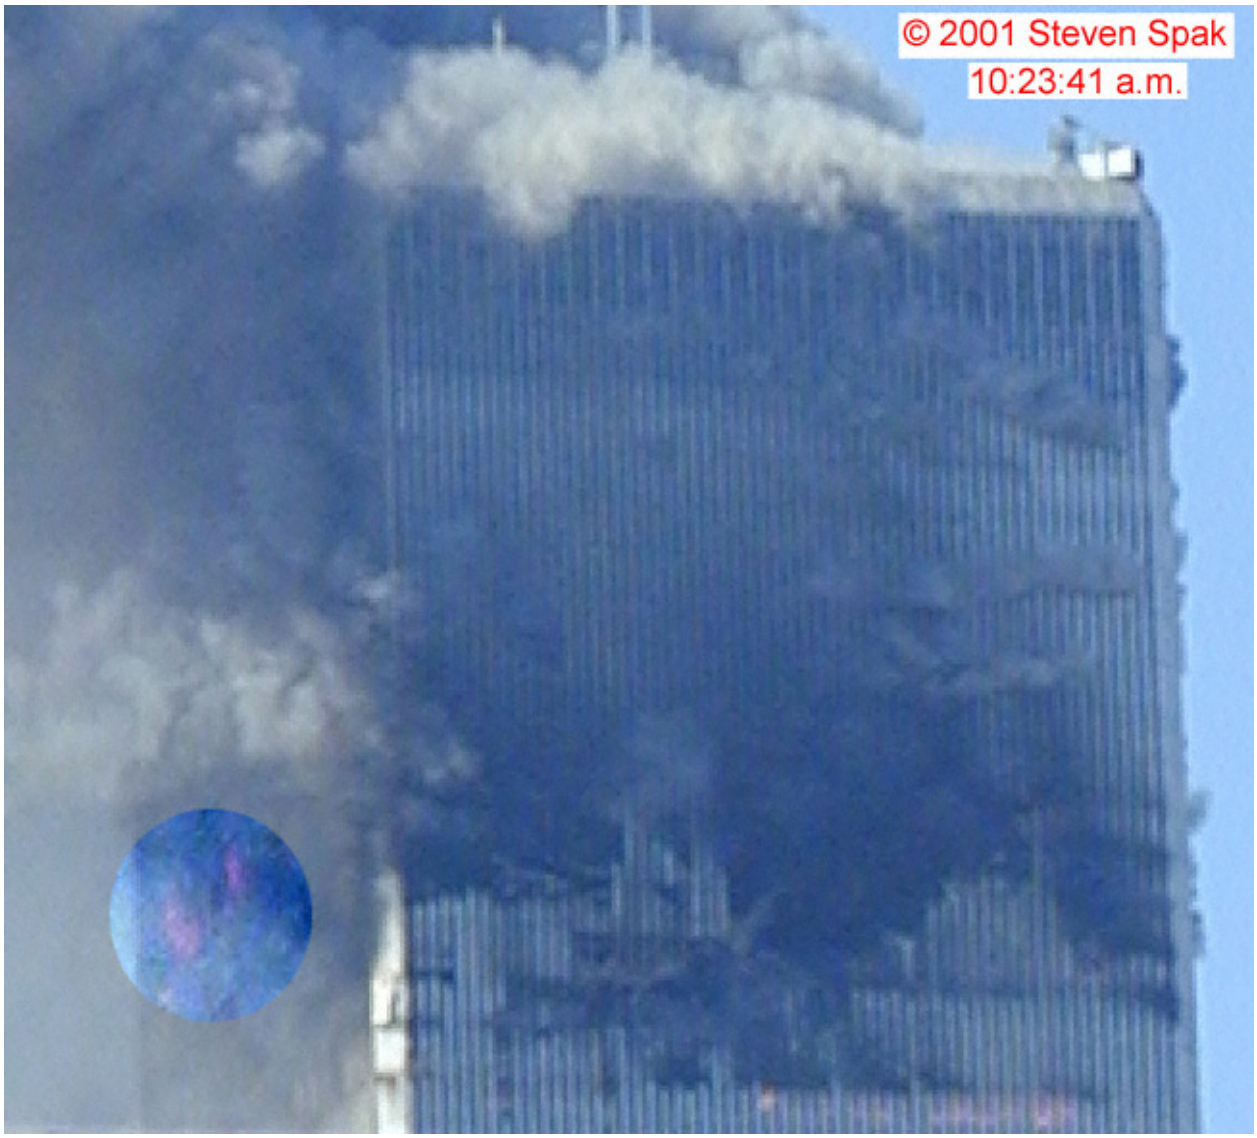
This area of flame on the southern side of the east face is visible in Figure 8–99, which was taken at 10:23:30 a.m. The fire is burning intensely with extended flames. Figure 8–103 shows a lower-resolution photograph taken at 10:23:41 a.m. that provides a slightly less oblique view of the east face in which it is easier to identify the flame location. The area where flames are visible coming from open windows has been highlighted. Flames can be seen on the 98th floor at two apparently separated locations. One of these is near the center of the face, and the second is well to the south. Even though the flames appear to be separated, videos and Figure 8–99 show that the flaming region was continuous over this length. A small area of fire is also visible on a lower floor. This fire is most likely on the 97th floor near the location where fire was present (near window 97-145) in Figure 8–102 at 10:18:15 a.m.

Figure 8-103. This cropped photograph shows the north face and an oblique view of the east face of WTC 1 at 10:23:41 a.m. The intensity levels in an area of the east face have been adjusted to highlight an area of extended flame.

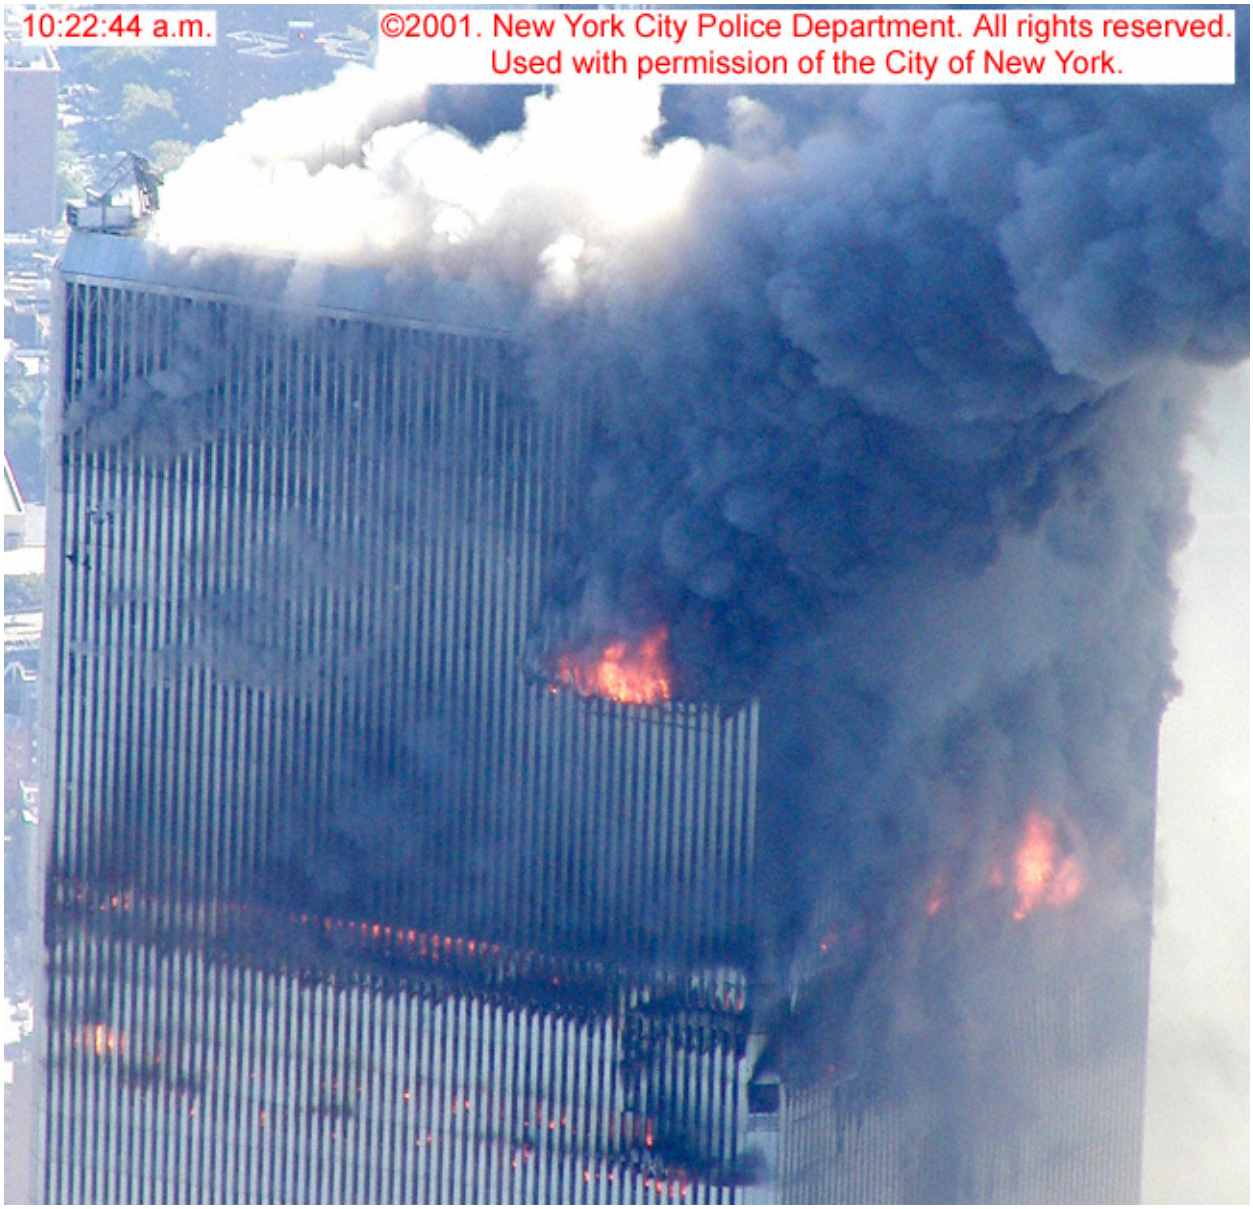
Figure 8–106 shows WTC 1 shot from the southwest at 10:22:44 a.m. The photographer was in a helicopter looking down on the tower. Individual floors are identifiable. Floor numbers can be assigned by noting that the floor with the missing aluminum panel on the southwest corner is the 96th floor. Fires are visible on both the south and west faces. Focusing on the south face, the most prominent feature is a flame jet emanating from an open window on the 98th floor on the east side. Flames are also coming out of nearby windows on this floor. Regions of fire are also visible on the 99th floor at locations starting on the west side of the face and reaching a position just to the east of the center of the face. From this angle, there are no flames evident on the 97th floor. Otherwise, the flame distribution is consistent with that described above.

Figure 8-106. This cropped photograph showing the south and west faces of WTC 1 was shot from a helicopter at 10:22:44 a.m. It has been enhanced by adjusting the intensity levels.

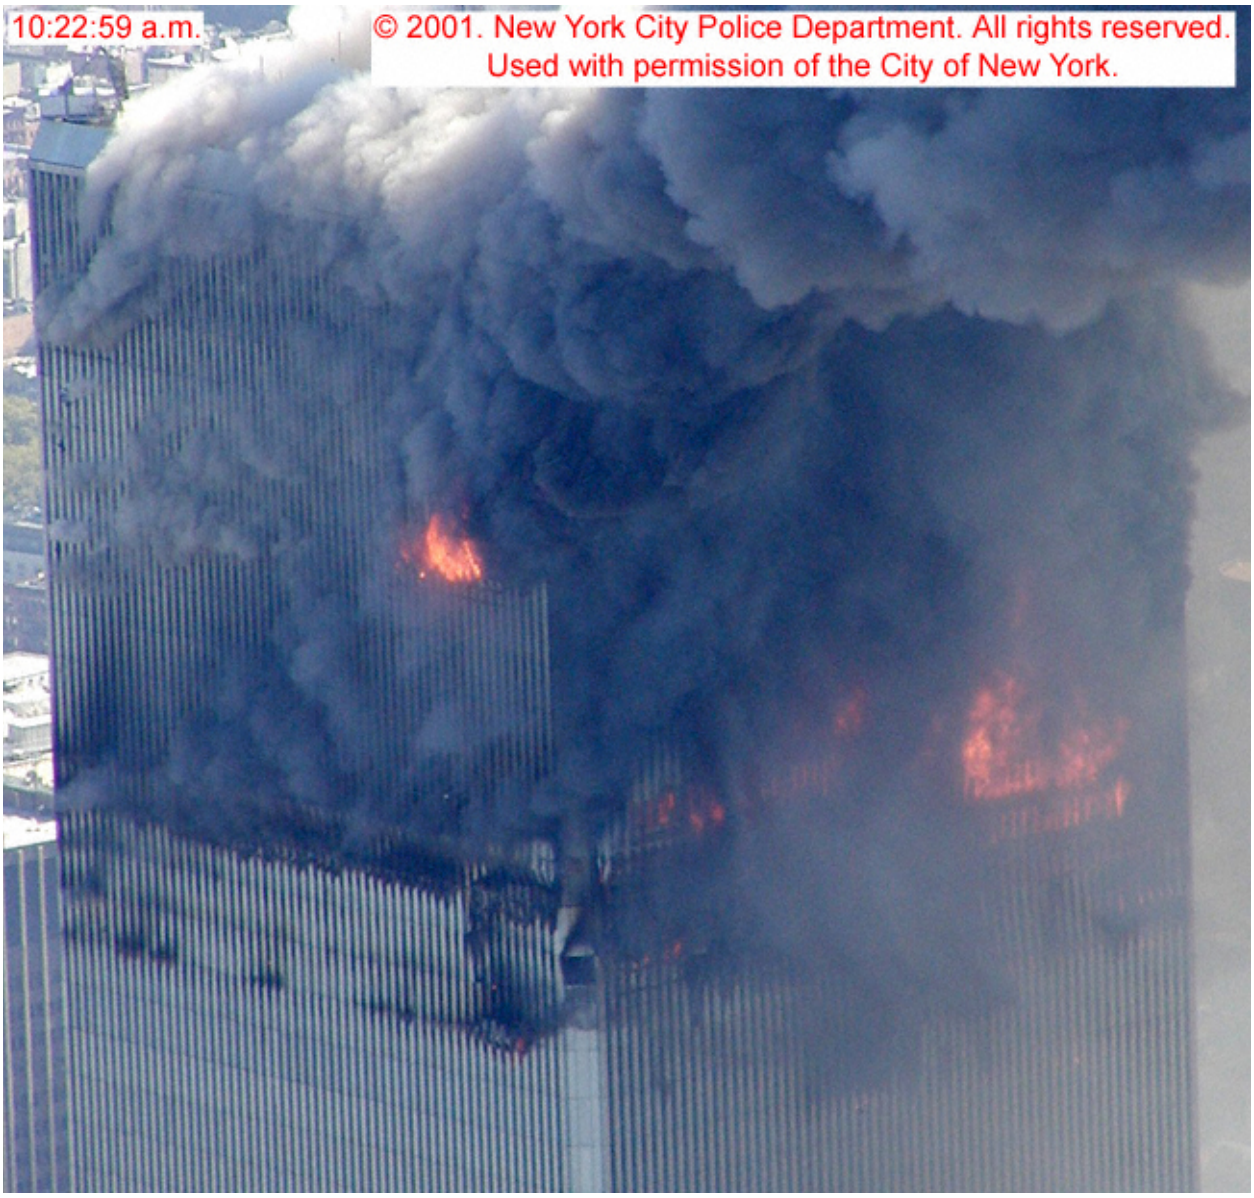
As the helicopter flew toward the south, the photographer continued to take pictures. Figure 8–107 shows a photograph taken 15 s later at 10:22:59 a.m. Since the helicopter was further south, this image has a more direct view of the south face than in Figure 8–106, and the view of the west face is from a more oblique angle. The fire distributions on both faces look quite different in the two photographs. This demonstrates the strong effects that the angle from which an image is taken can have on fire observations.

Figure 8-107. This cropped photograph showing the south and west faces of WTC 1 was shot from a helicopter at 10:22:59 a.m. It has been enhanced by adjusting the intensity levels.

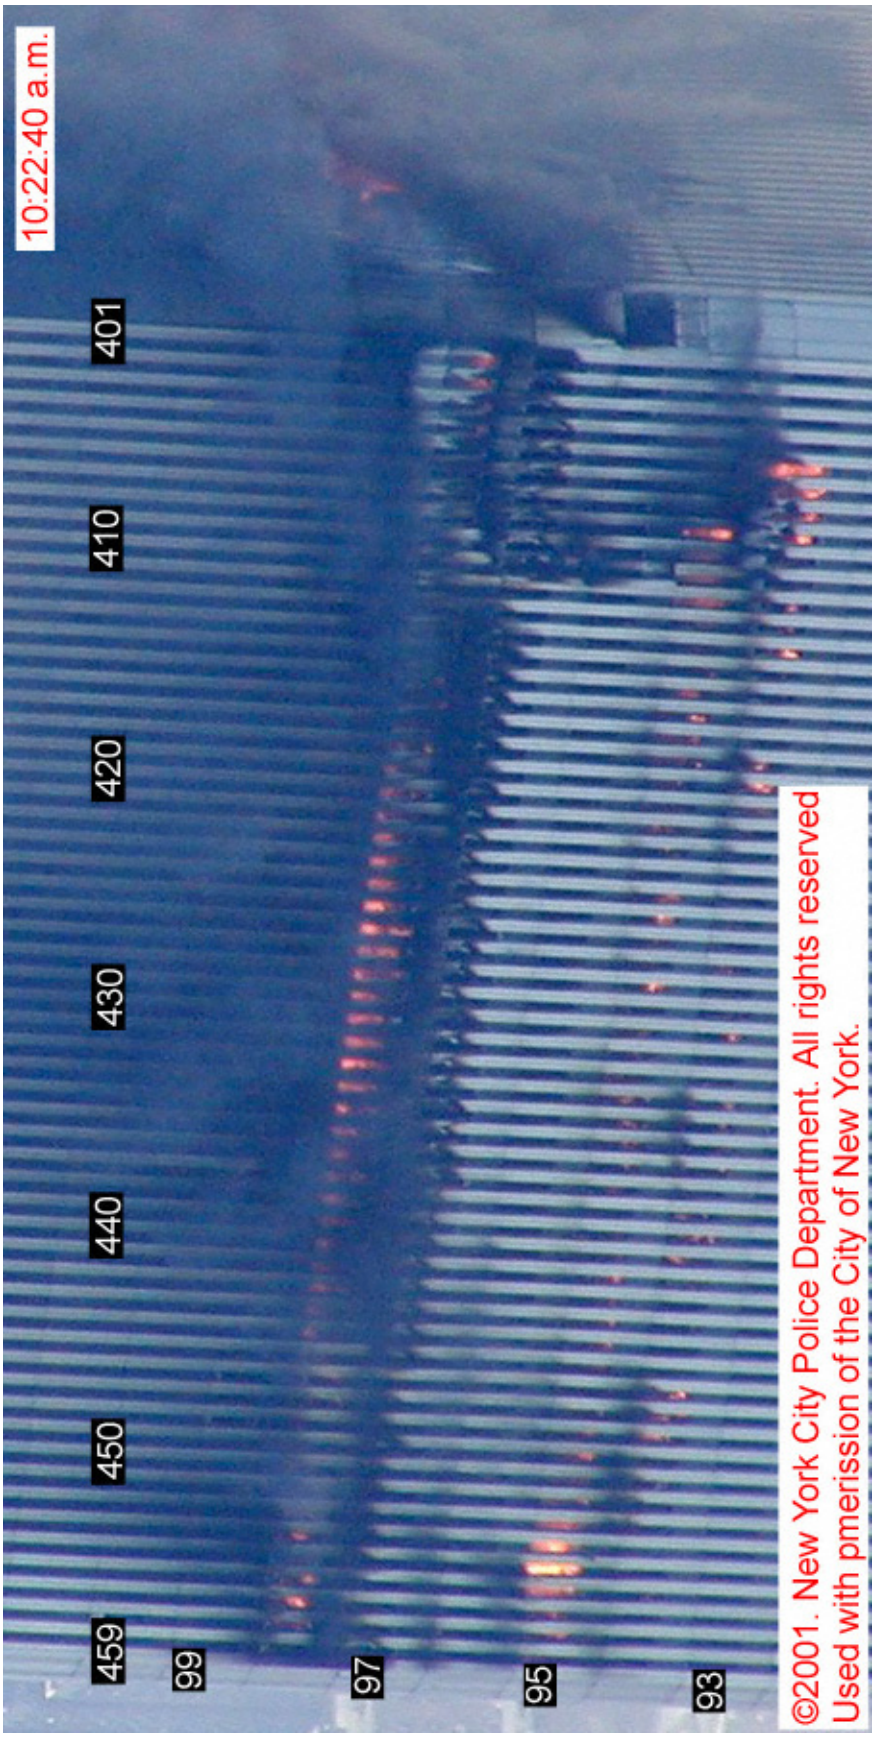
On the 94th floor fires can be seen at many locations between windows 94-405 and 94-448. Most of the fires are burning at isolated locations near the floor. The only window where flames are protruding out is 94-405. The presence of carets on nearby column covers is consistent with the intense fire seen earlier at windows 94-407 and 94-408. The smoke marks at the tops of the column covers indicate that at many locations only light smoke or no smoke had passed through the open windows. This agrees with earlier observations that the fires burning on the west side of the 94th floor were relatively gentle at most locations. In Figure 8–112 windows 94-438 to 94-441 appear to be open, and flames are visible in windows 94-438 to 94-440. These windows were clearly intact at 9:47:34 a.m. in Figure 8–72. The floor plan layout in Figure B-3 indicates that these four windows were located in a room with walls at columns 94-438 and 94-441. Fire had clearly spread into this room since 9:48 a.m. Many other windows on this floor that had intact glass at the earlier time are also open in Figure 8–112.

Figure 8-112. This cropped photograph was shot from a helicopter at 10:22:40 a.m. and shows the west face of WTC 1 from above. The image has been enhanced by adjusting the intensity levels, and column and floor numbers have been added.

Fires are visible on the 95th floor over most of the length of the west face. At most locations the fires look similar to those on the 94th floor, appearing to burn with low intensities near the floor. Exceptions are the most intense flames located in the room having walls at columns 95-452 and 95-456 (see Figure B-4) and the fire in windows 95-408 to 95-411. The fire on the north side has already been described, while the fire on the south side is located next to a room with walls at columns 95-404 and 95-408. Over most of this floor there are no smoke marks on the column covers despite the wide spread fires. This observation most likely means that the smoke from fires on this side of the 95th floor vented within the building elsewhere.

From the angle from which Figure 8–112 was taken the internal fires on the 98th floor are only visible near the center of the floor and at a few locations on either end. This fire has clearly died down considerably since Figure 8–92 was taken at 10:18:01 a.m. Carets are visible at the tops of the column covers near the two ends, but very little marking is evident elsewhere. This suggests that the only places flames came out of windows were from fires burning inside the corner rooms (see Figure B-7). Consistent with earlier observations, the absence of column cover marks elsewhere indicates that neither fire nor smoke flowed from most 98th floor windows on the west face where fire was present.

There is no indication of fire on the 96th or 97th floors on the west face. Both of these floors were on fire much earlier and have apparently completely burned out. It is worthwhile to point out once again the difference in column cover markings between the two floors. Heavy smoke and fire came from most of the windows on the 97th floor, as revealed by the numerous carets on the covers. On the other hand, the 96th floor seemed to burn much more like the fires seen on the 94th and 95th floors, i.e., gently with little smoke and fire coming from windows.

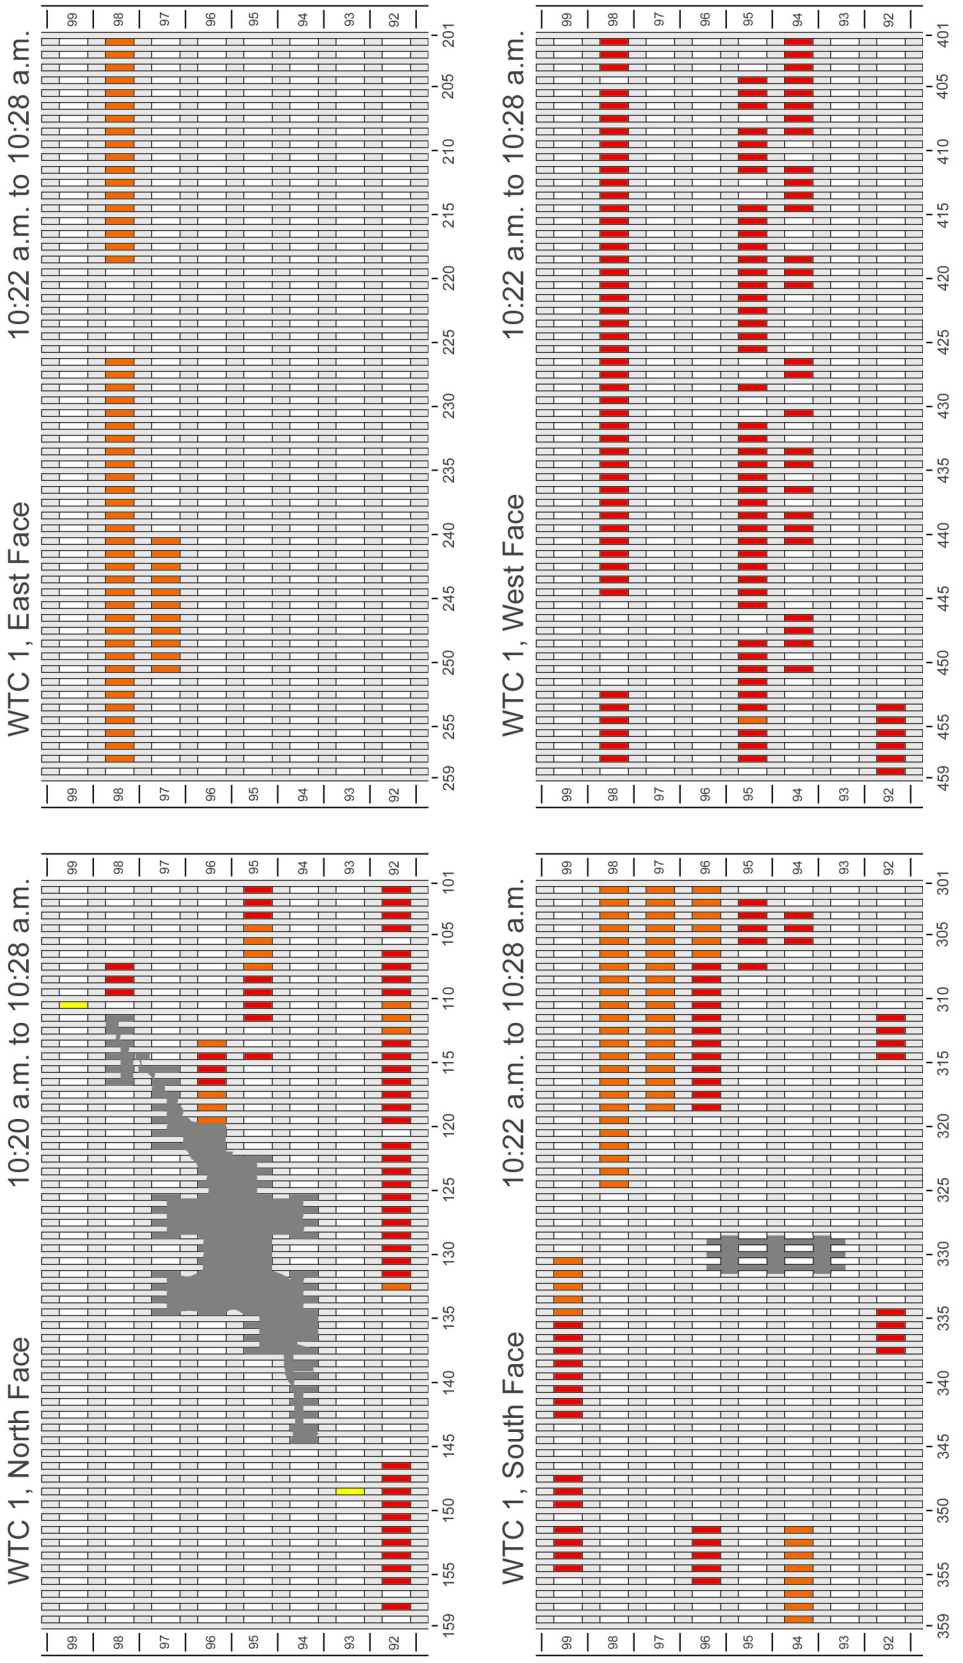
Figure 8-115. Maps of integrated fire observations between 10:20 a.m. and 10:28 a.m. are shown for the four faces of WTC 1. Colors represent the highest intensity fire observed in a window using the color scale defined in Figure 5-1.

With the exceptions of the 92nd floor, where a large fire burning on the north face worked its way around the northwest corner, and the 94th floor, where the fire spreading from the north passed around the southwest corner; only limited fire spread took place on the west face during the period. In general, fires that were burning on the 94th, 95th, and 98th floors earlier, while still widespread, became less intense and were less visible than earlier. A large fire on the west face that grew on the 104th floor shortly after the collapse of WTC 2 (not shown in Figure 8–115) continued to burn intensely throughout the period. Most of the 92nd floor, the exception being at the northern edge, and the 93rd floor appeared to be fire free on the west side when the tower collapsed.

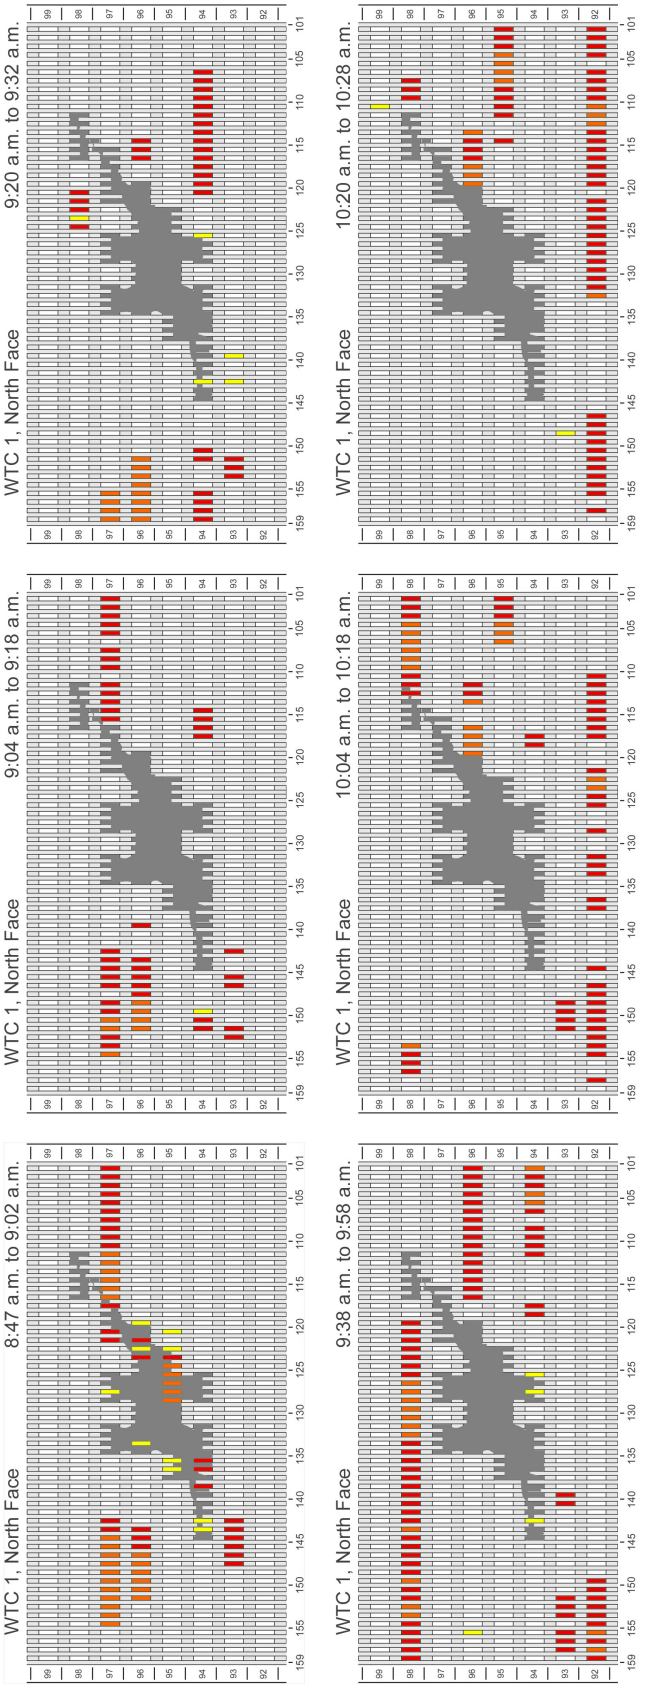
Figure 8-116. Maps of integrated fire intensity data for the north face of WTC 1 are plotted in sequence for the six time periods. Colors represent the highest intensity fire observed in a window using the color scale defined in Figure 5-1.

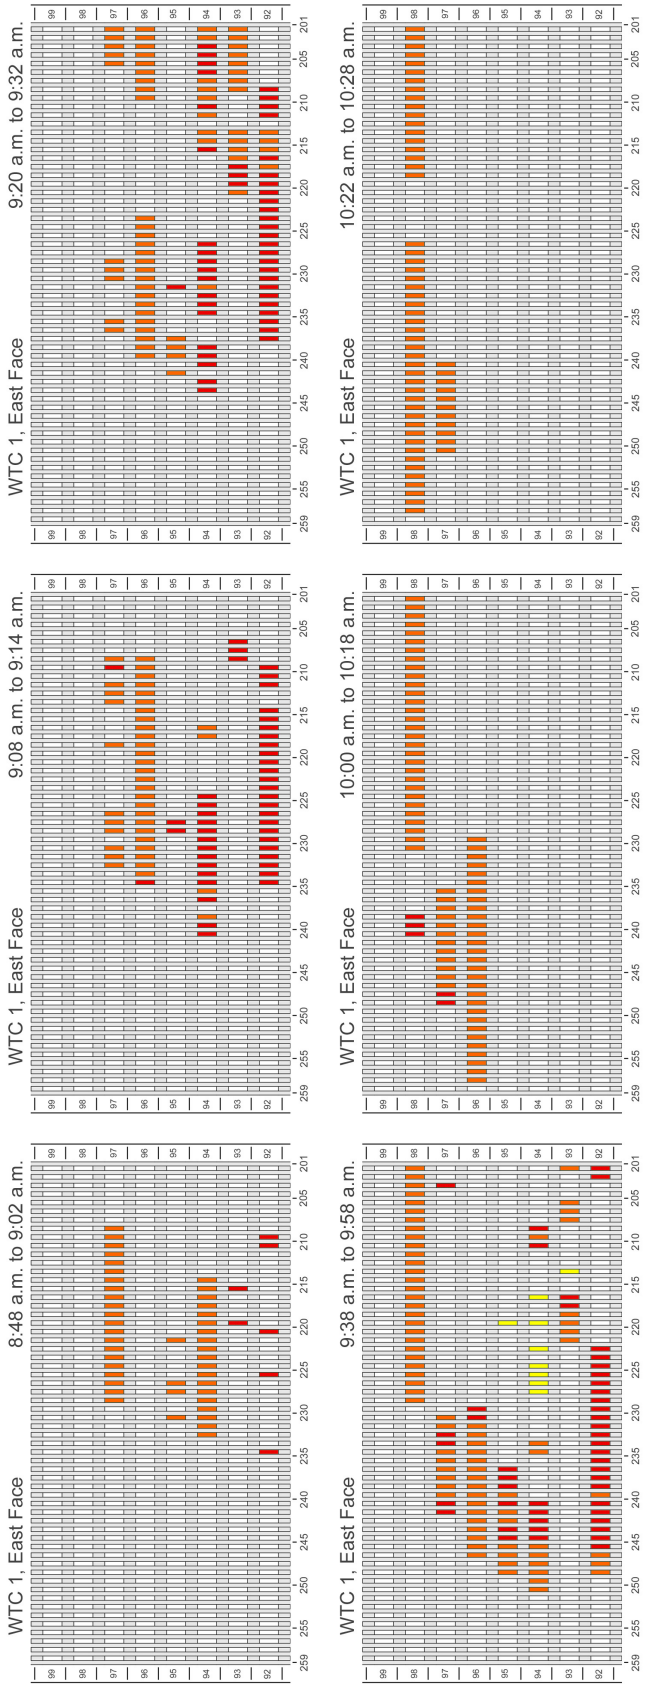
Figure 8-117. Maps of integrated fire intensity data for the east face of WTC 1 are plotted in sequence for the six time periods. Colors represent the highest intensity fire observed in a window using the color scale defined in Figure 5-1.

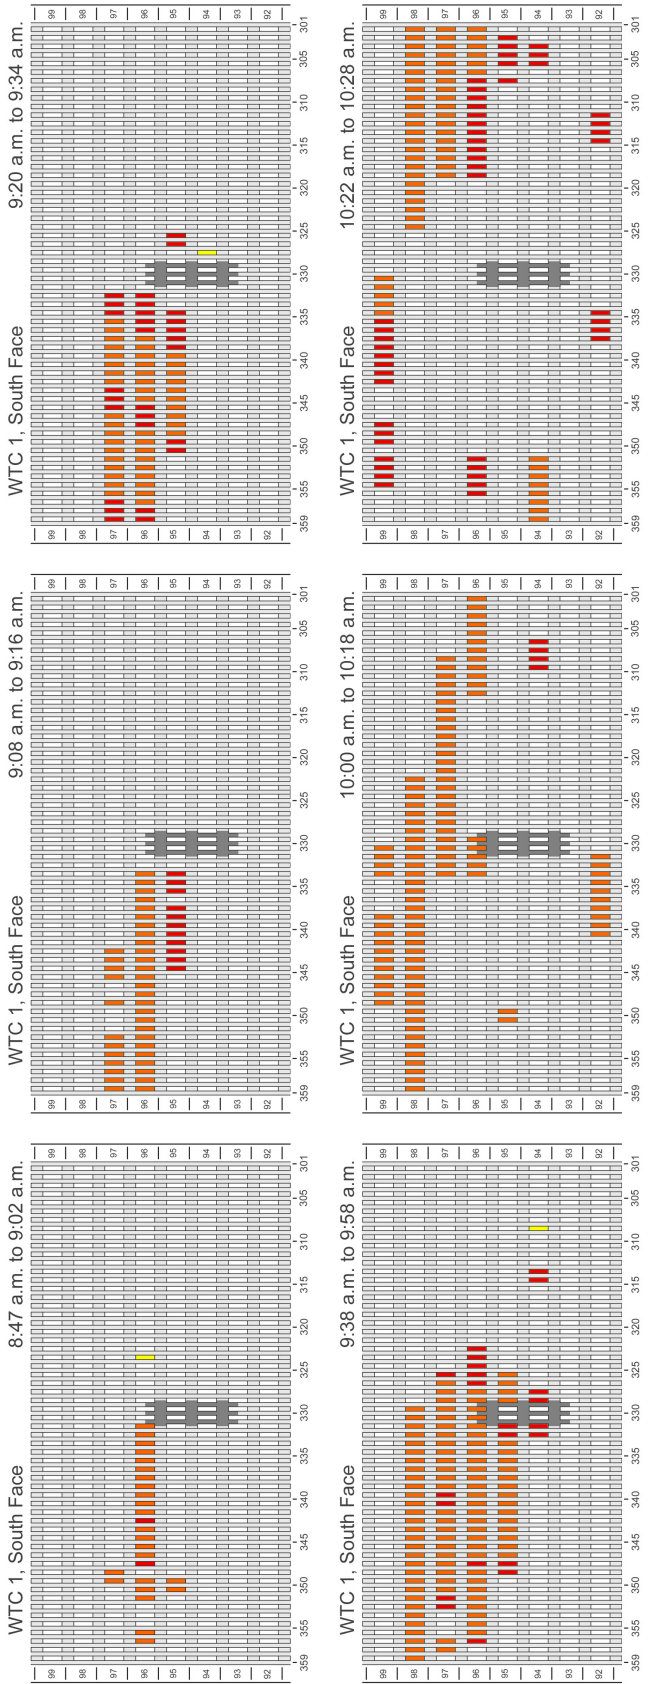
Figure 8-118. Maps of integrated fire intensity data for the south face of WTC 1 are plotted in sequence for the six time periods. Colors represent the highest intensity fire observed in a window using the color scale defined in Figure 5-1.
