NIST NCSTAR 1-5A

Federal Building and Fire Safety Investigation of the World Trade Center Disaster

Visual Evidence, Damage Estimates, and Timeline Analysis

William M. Pitts
Kathryn M. Butler
Valentine Junker

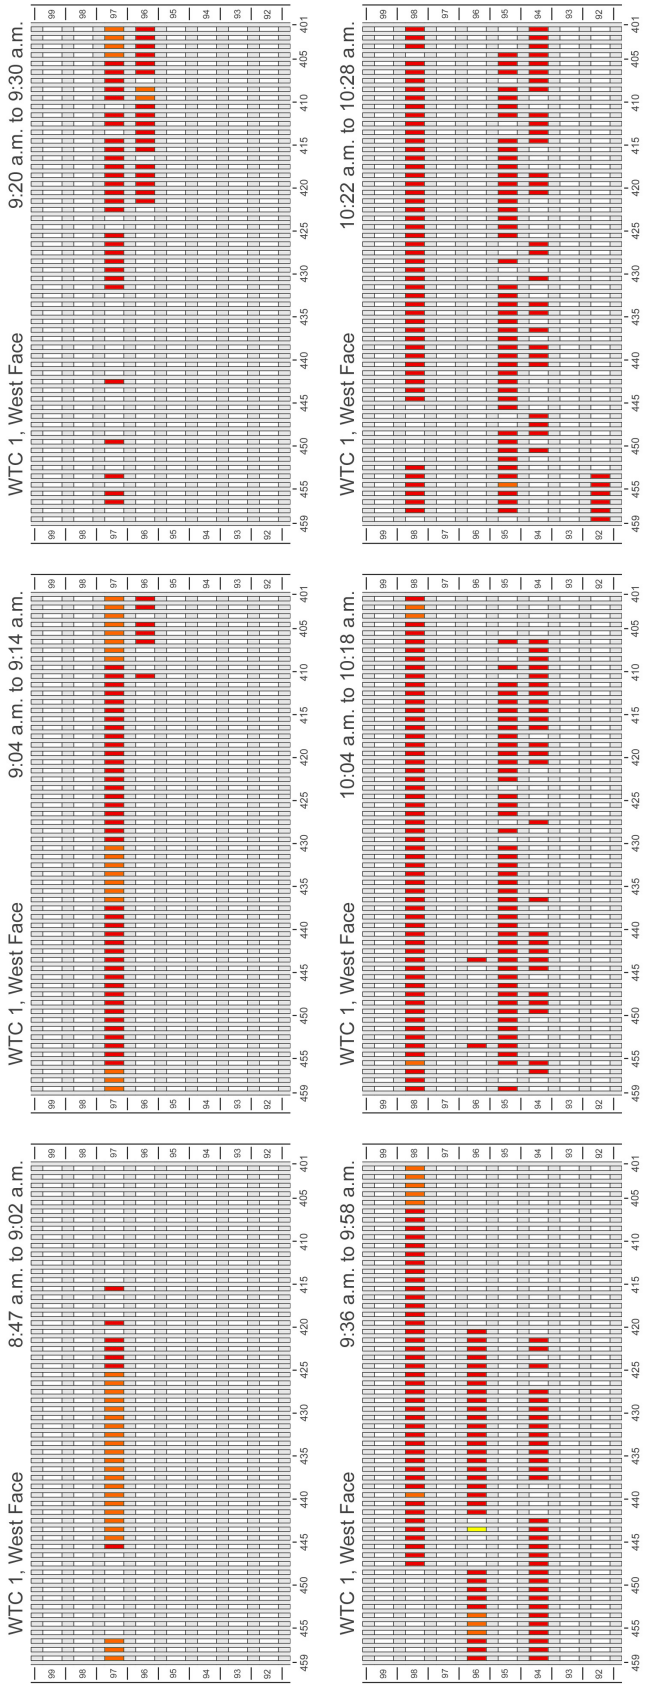
Figure 8-119. Maps of integrated fire intensity data for the west face of WTC 1 are plotted in sequence for the six time periods. Colors represent the highest intensity fire observed in a window using the color scale defined in Figure 5-1.

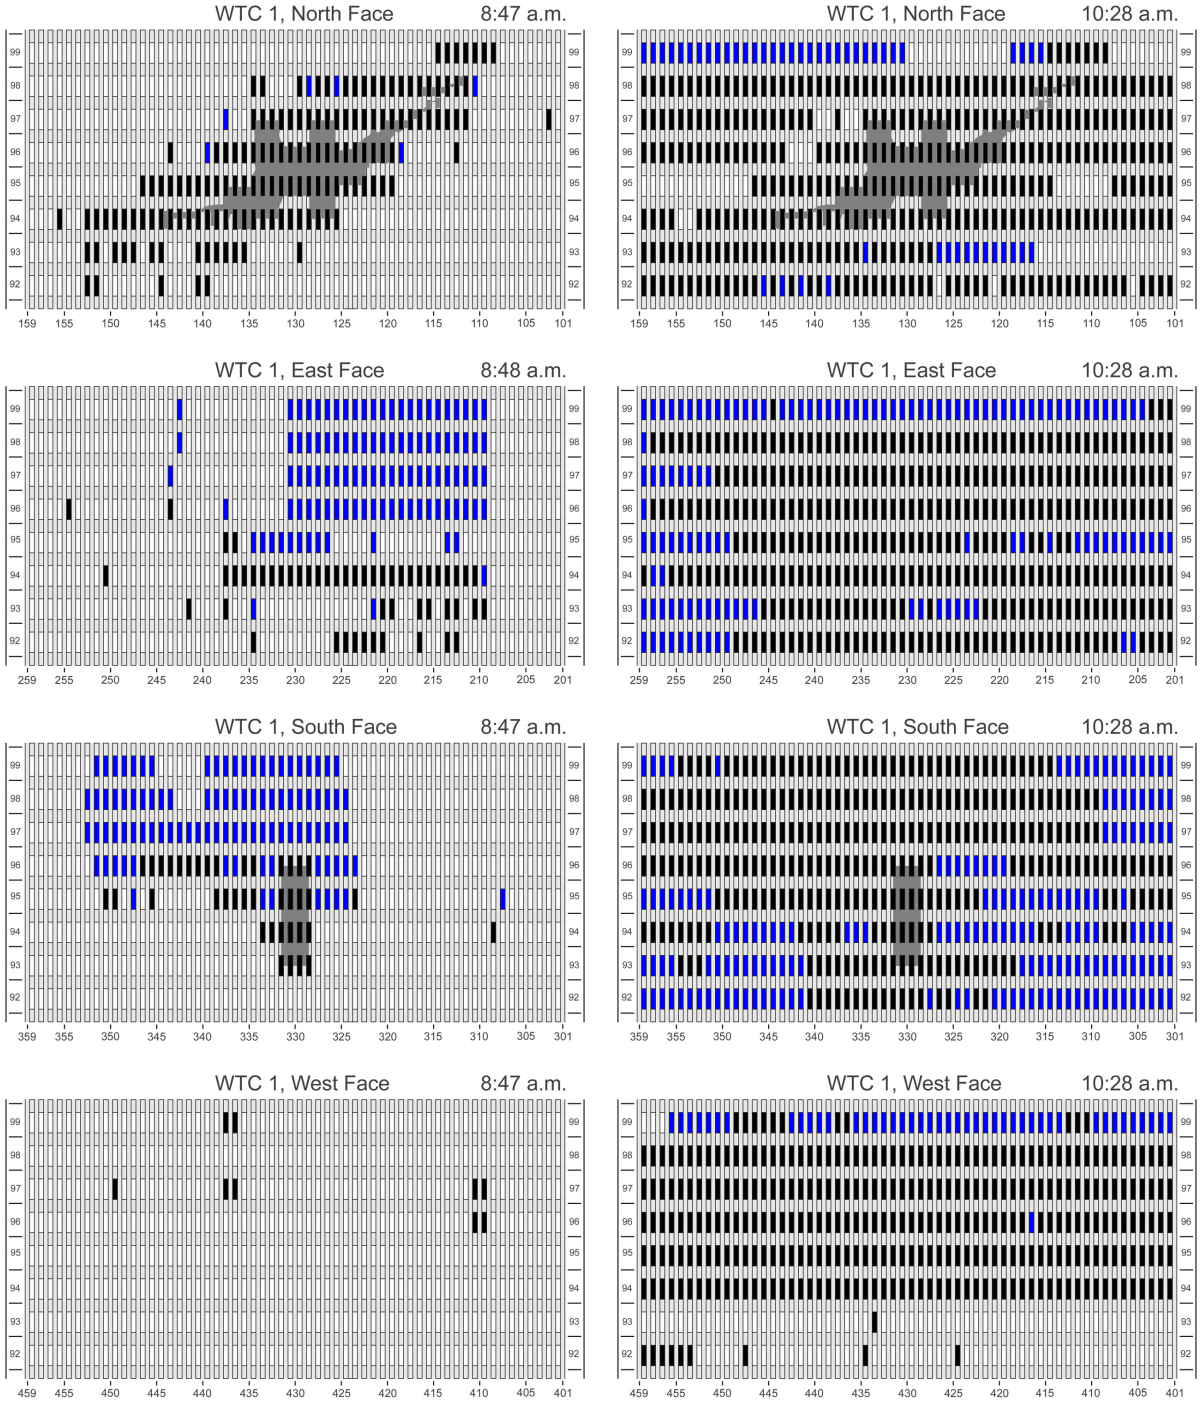
The information shown visually in Figure 8–120 is summarized numerically in Table 8–4 and Table 8–5. These two tables are similar to Table 8–2 and Table 8–3, which were generated using data from shortly after the aircraft impacted WTC 1 and just prior to the collapse of WTC 2. The results indicate that the total number of open windows on these floors increased by roughly 333 windows between 9:59 a.m. and 10:28 a.m. The increase in the number of open windows between the time from shortly after the aircraft struck WTC 1 and the collapse of the tower was approximately 1,048 windows, or a factor of 4.2. This corresponds to an increase in the open area on the façade available to provide air to the fires on these floors of around 12,190 ft^2.

Figure 8-120. Maps for the 92nd through the 99th floors compare missing windows for the four faces of WTC 1 at two times, immediately following the aircraft impact at 8:46:30 a.m. and just prior to the collapse of WTC 1 at 10:28:22 a.m.

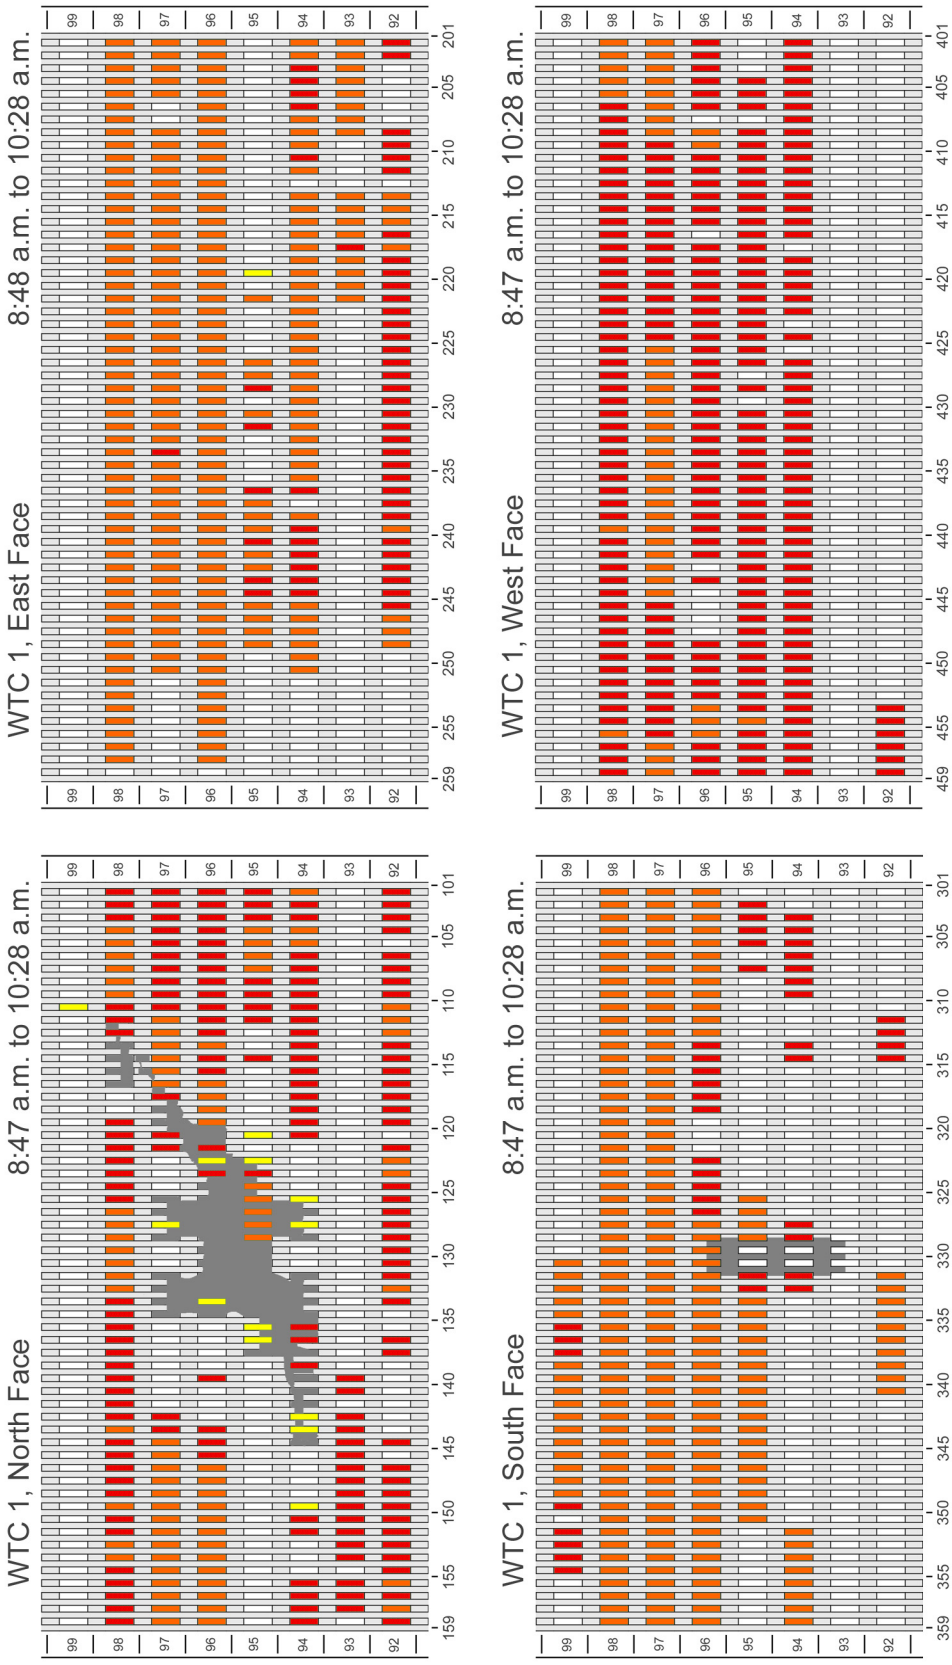
The results in the fire data sheets have been utilized to generate integrated fire data for the entire period between the aircraft impact and the collapse of WTC 1. The results are shown graphically in Figure 8–121 for the four faces of the tower. These maps demonstrate the extensive area of WTC 1 that was subjected to fire. Comparison with Figure 6-19, which shows the fire distribution on the four faces shortly after the aircraft impact, provides a graphic illustration of the amount of fire spread and growth that occurred. The relative numbers of windows in Figure 8–121 where external flames (orange) were observed compared to the total number of windows with observed fire reflects the differences between fire behaviors on the west and north faces as compared to the east and south faces, where external flaming was much more likely.

Figure 8-121. Maps of integrated fire observations between 8:47 a.m. and 10:28 a.m. are shown for the four faces of WTC 1. Colors represent the highest intensity fire observed in a window using the color scale defined in Figure 5-1.
