11-4403-cv

United States Court of Appeals *for the* Second Circuit

JOINT APPENDIX Volume 12 of 16 (Pages JA-3067 to JA-3320)

-----	x	
	:	
IN RE: SEPTEMBER 11 PROPERTY DAMAGE	:	21 MC 101 (AKH)
AND BUSINESS LOSS LITIGATION	:	
	:	
-----	:	
AEGIS INSURANCE SERVICES, INC., et al.,	:	04 CV 7272 (AKH)
	:	
Plaintiffs,	:	
-against-	:	SUPPLEMENTAL AND
	:	AMENDED SECOND
7 WORLD TRADE CENTER COMPANY, L.P.,	:	DECLARATION OF
et al.,	:	COLIN G. BAILEY
Defendants.	:	
-----	x

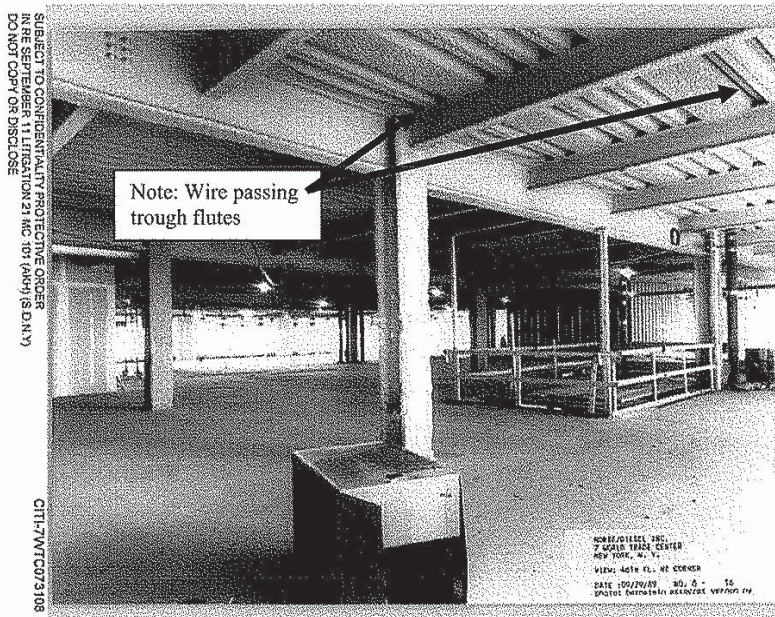
The construction of WTC7 was completed in 1987. These photographs were taken during 'fit-out' of the floors in 1989. They show that the flutes were not filled with fire protection as required. They also show in a number of cases wires being passed through the open flutes.

Figure A1: Photograph showing wire placed through flutes (46th Floor).

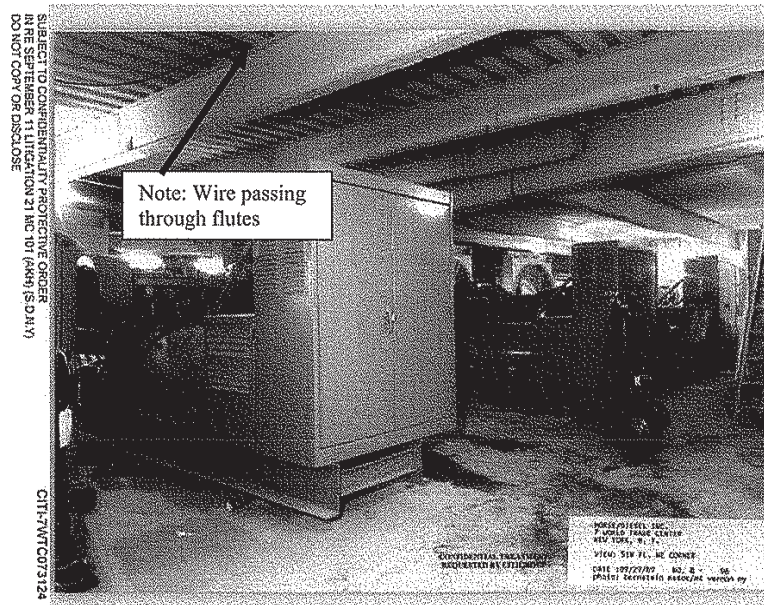
Figure A2: Photograph showing wire placed through flutes (5th Floor).

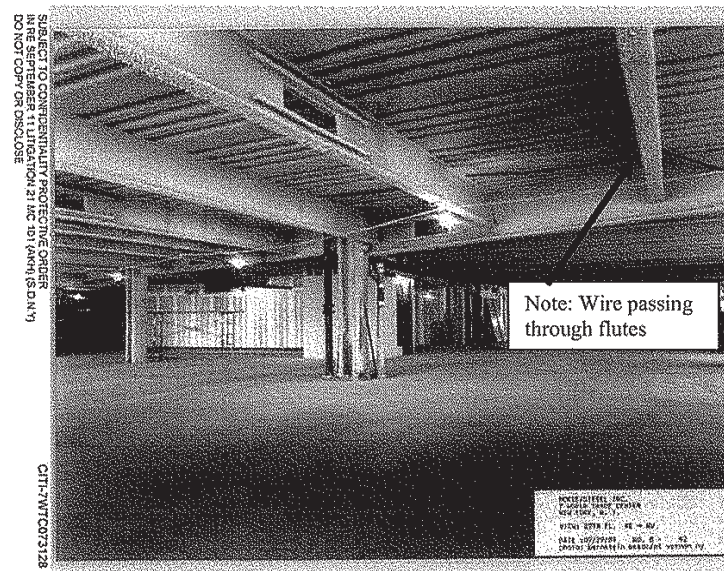
Figure A3: Photograph showing wire placed through flutes (29th Floor).

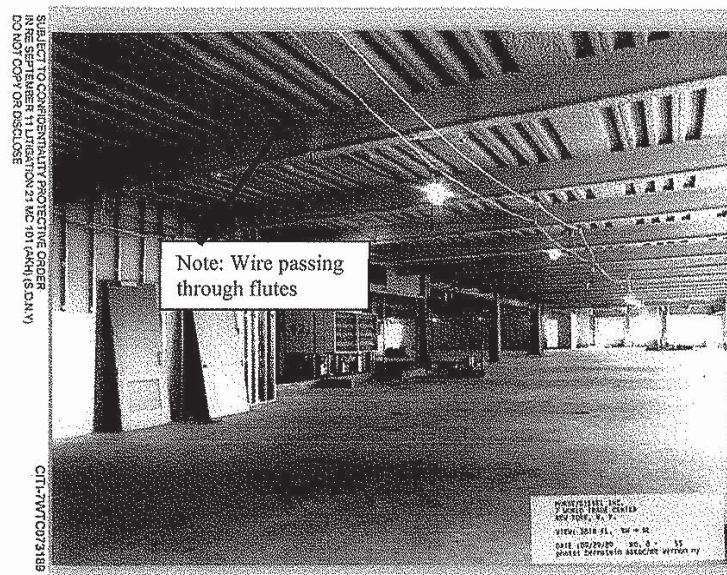
Figure A4: Photograph showing wire placed through flutes (38th Floor).

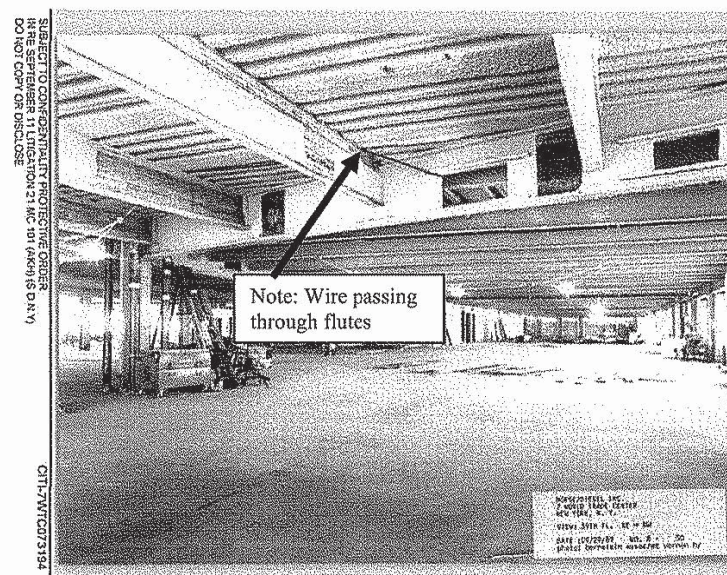
Figure A5: Photograph showing wire placed through flutes (39th Floor).

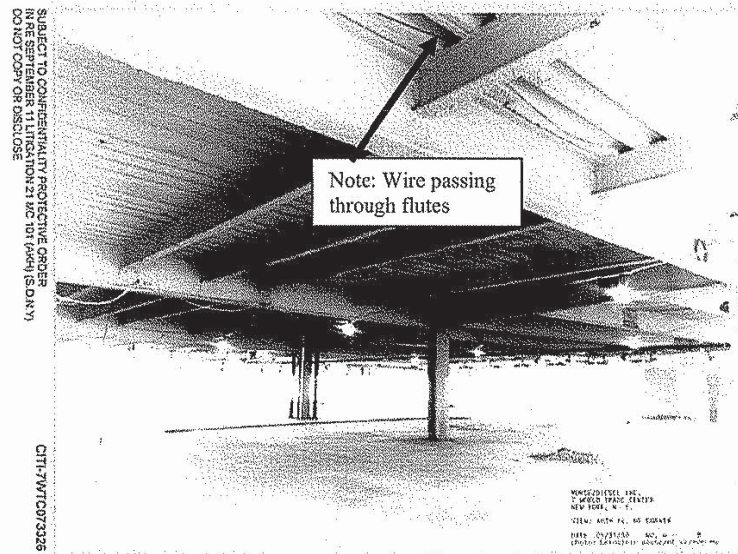
Figure A6: Photograph showing wire placed through flutes (46th Floor).

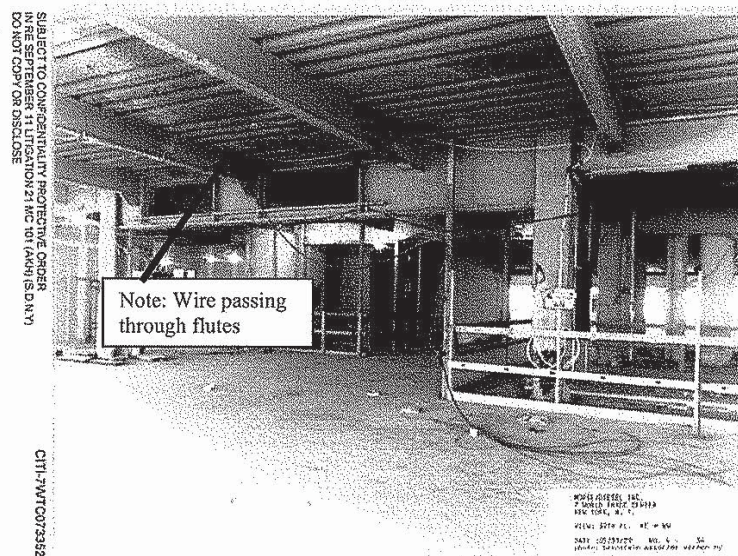
Figure A7: Photograph showing wire placed through flutes (39th Floor)

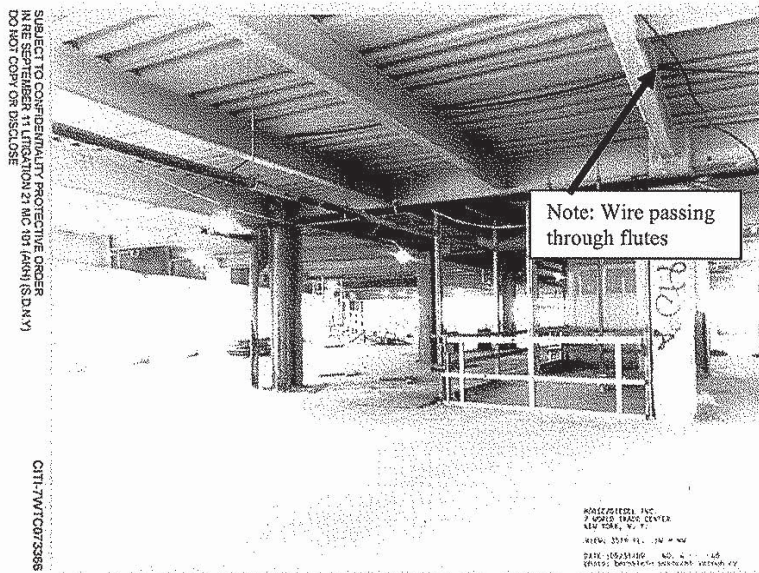
Figure A8: Photograph showing wire placed through flutes (35th Floor)

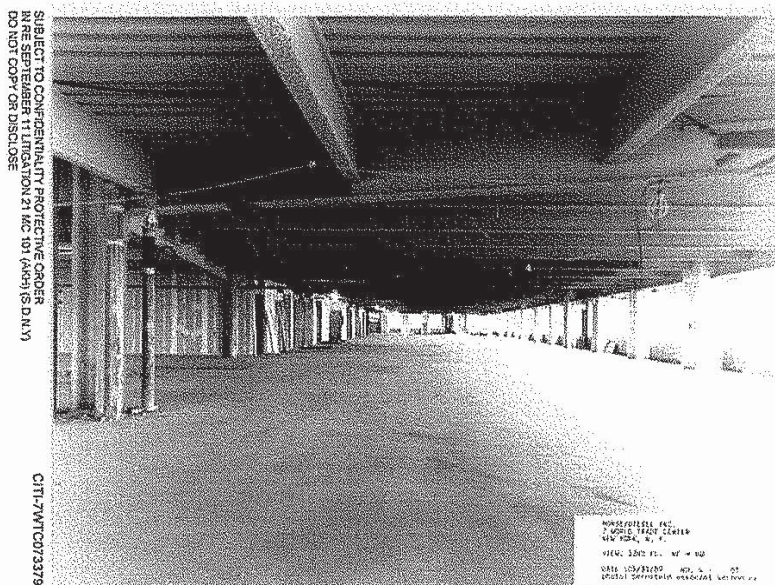
Figure A9: Photograph showing wire placed through flutes (32nd Floor)

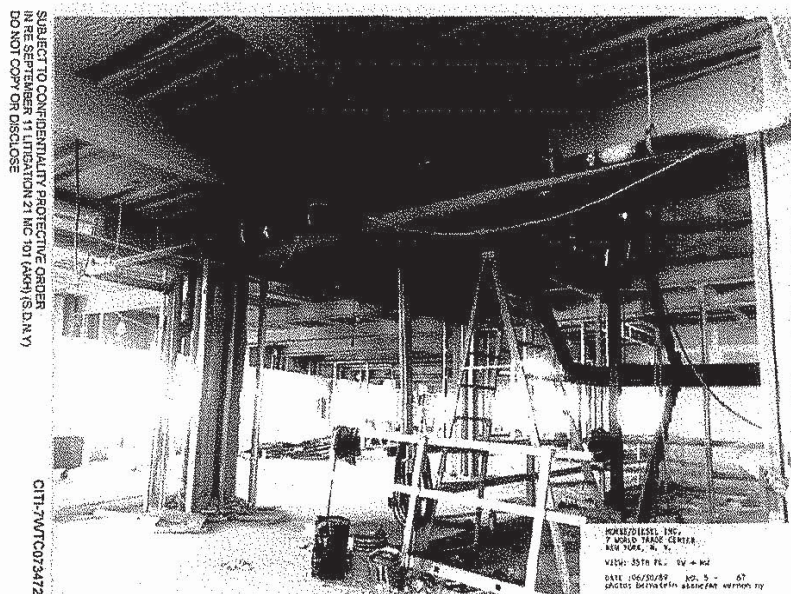
Figure A10: Photograph showing wire placed through flutes (35th Floor)

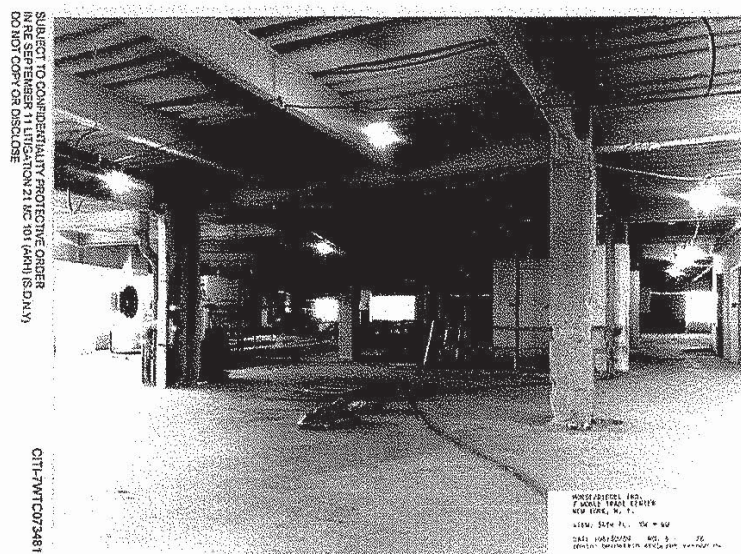
Figure A11: Photograph showing wire placed through flutes (34th Floor)

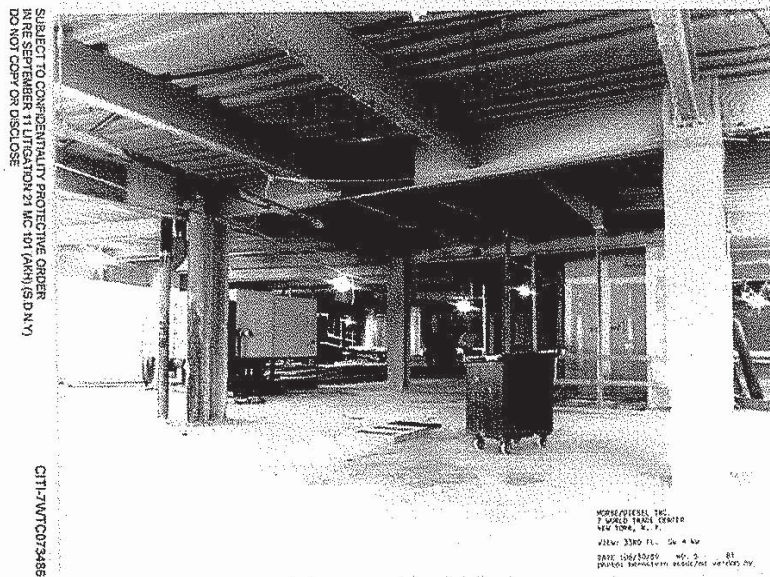
Figure A12: Photograph showing wire placed through flutes (33rd Floor)

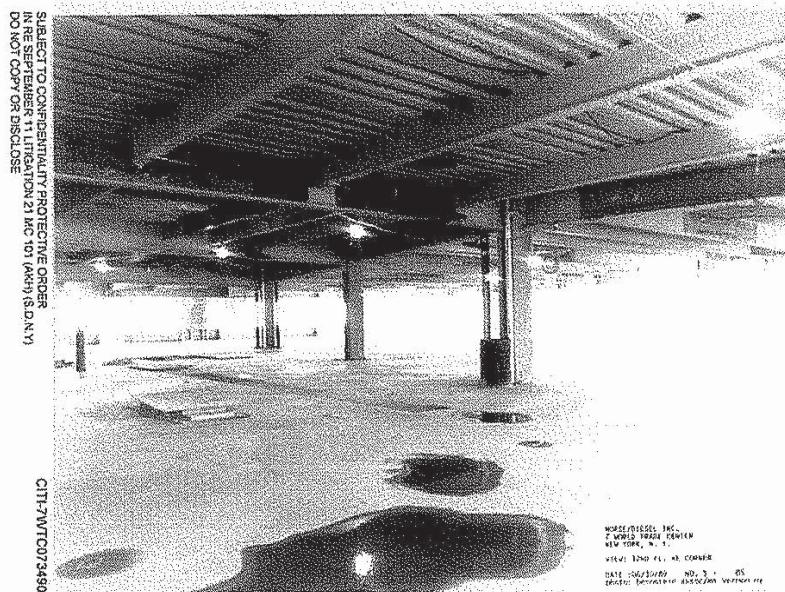
Figure A13: Photograph showing wire placed through flutes (32nd Floor)

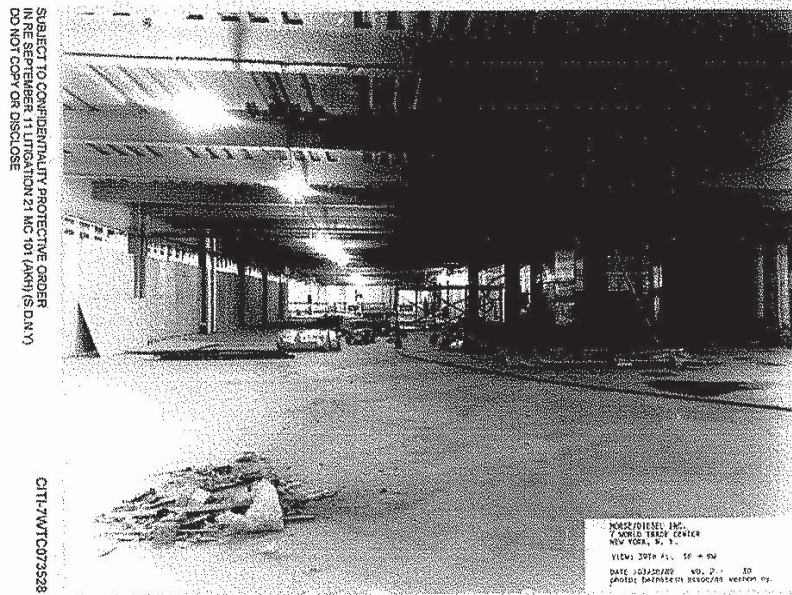
Figure A14: Photograph showing light through flutes (39th Floor)

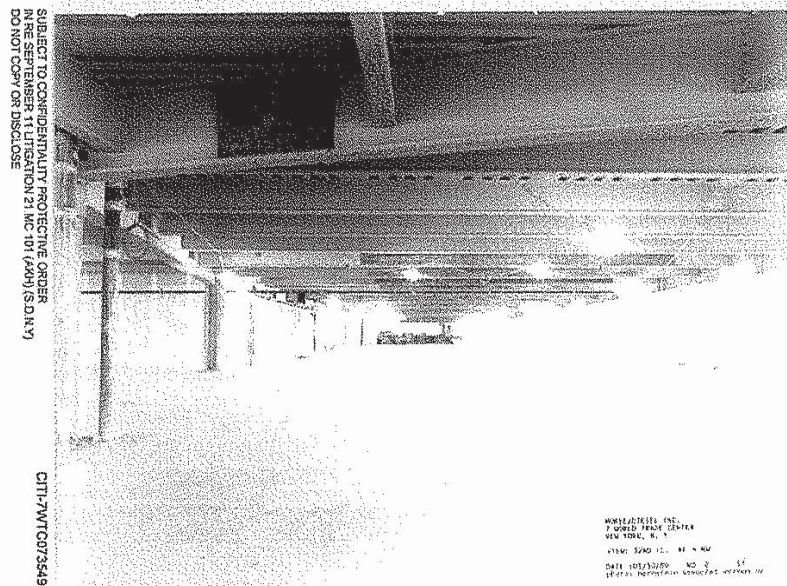
Figure A15: Photograph on 32rd floor showing unfilled flutes above girder

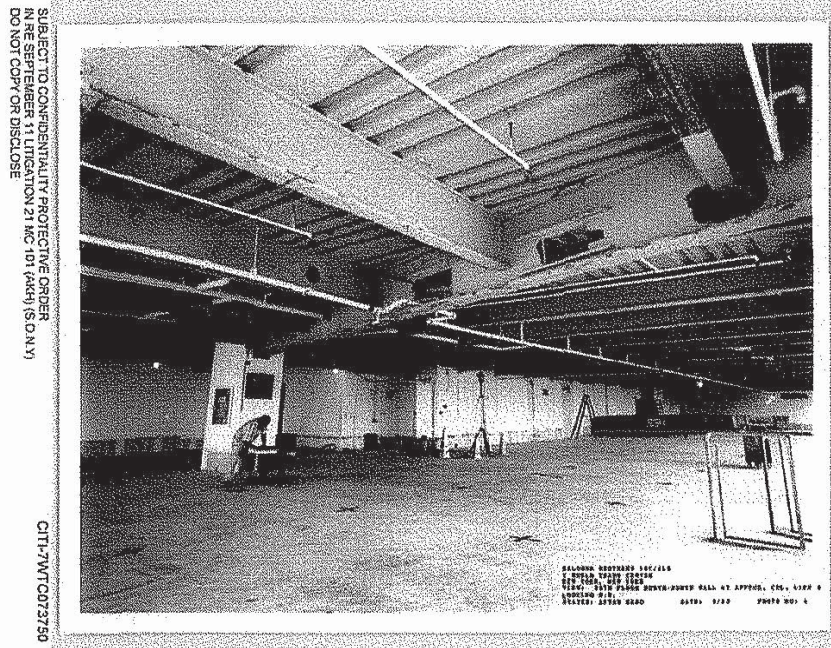
Figure A16 Photograph on 24th floor showing unfilled flutes above girder

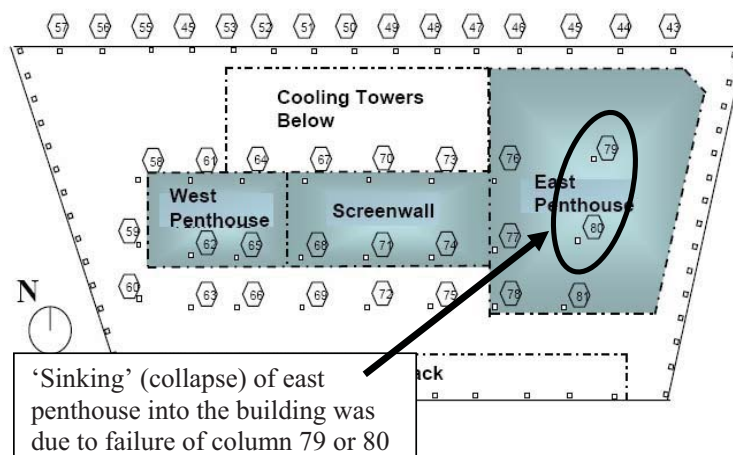
Photographic evidence (Figure 1) shows that the east roof penthouse collapsed first into the building. Figure 2 shows the location of the east penthouse highlighting that failure of column 79, or possibly column 80, occurred allowing the penthouse to sink into the building. Overall progressive collapse occurred following the collapse of the east penthouse.

Figure 2 Location of east penthouse

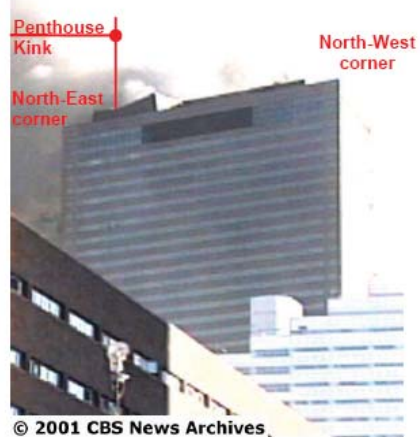
Closer investigation of the collapse of the penthouse also indicates that it was column 79 which failed first. Figure 4 shows a clear ‘kink’ in the north face of the penthouse, with the east and west walls being pulled inwards as it collapses into the building. This suggests that the girder 79-44 which is supporting the steel post to the penthouse on the roof at the location of the kink (Figure 4), is failing. Since the external column 44 remains stable as the penthouse sinks into the building (Figure 1) then Column 79 must have collapsed first.

Figure 4 Collapse of the penthouse.

Due to the lack of significant glass breakage (Figure 4), as the penthouse sinks into the building, it can be concluded that the collapse of column 79 initiated lower down in the building at the location of the office fires below Floor 13. Visual evidence shows that there were two primary ways in which the standard office floor fires moved within WTC7: clockwise and counterclockwise, as outlined in expert report by Dr Fred Mower⁽⁹⁾. The office fires on Floors 11, 12, and 13 were first observed on the eastern side of the building and travelled in a counterclockwise direction. Conversely,

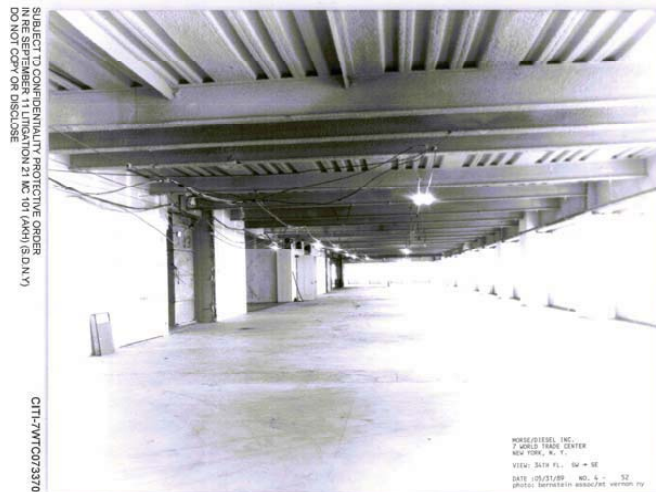
In the UL Fire Resistance Directory for 1983⁽²⁾ it is stated *'Cavities, if any, between the upper beam flange and floor or roof units shall be filled with the fire protection material applied to the beam, unless stated otherwise on an individual design.'* The identical statement was repeated in the UL Fire Resistance Directory for 1985⁴. The issue of filling the flutes between the top flange of the supporting beam and underside of the floor continues to be specified in the Underwriters Laboratories (UL) documentation with the June 2006 version of BXUV.D739 stating that *'when steel deck is used, the area between the steel deck and the beams top flange shall be filled'*.

Therefore the flutes should have been filled with fire protection on WTC7. Figure 5 shows the flutes (voids) above the top flange of the beam for the protected beams in WTC7, where it can be seen that the flutes are not filled with fire protection as required. Further pictures of the applied fire protection on WTC7 are presented in Appendix A, where it can be seen that throughout the building the flutes were not filled. In many cases the photographs in Appendix A show wires being simply passed through the flutes during the tenant fit-out work in 1989, which was 2 years after completion of the building and application of the fire protection in 1987.

Figure 5 Picture of the WTC7 showing unfilled flutes.

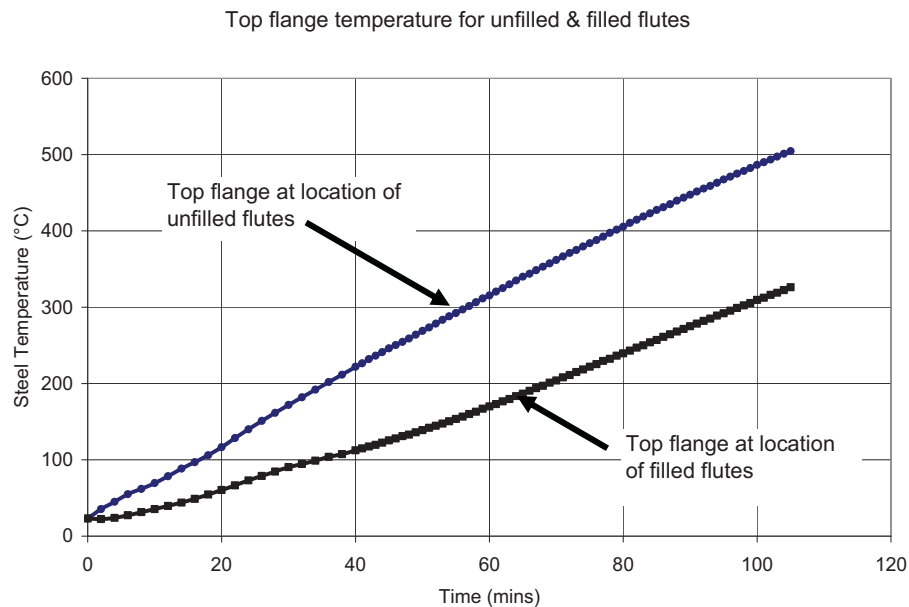
In the UK a series of tests⁽⁶⁻⁸⁾ were conducted in the late 1980s and early 1990s. The results from these tests are discussed in detail in the report present in Appendix C. As an example, Figure 10 shows the results from a test where the temperatures of the top flange were measured at locations where the flute was filled and the flute was left unfilled. It can be seen that leaving the flutes unfilled increases the top flange temperature by 55%, significantly reducing the fire resistance to the beam.

Figure 10 *Top flange temperatures at location of filled and unfilled flutes for trapezoidal deck (PMF CF60) with normal weight concrete.*

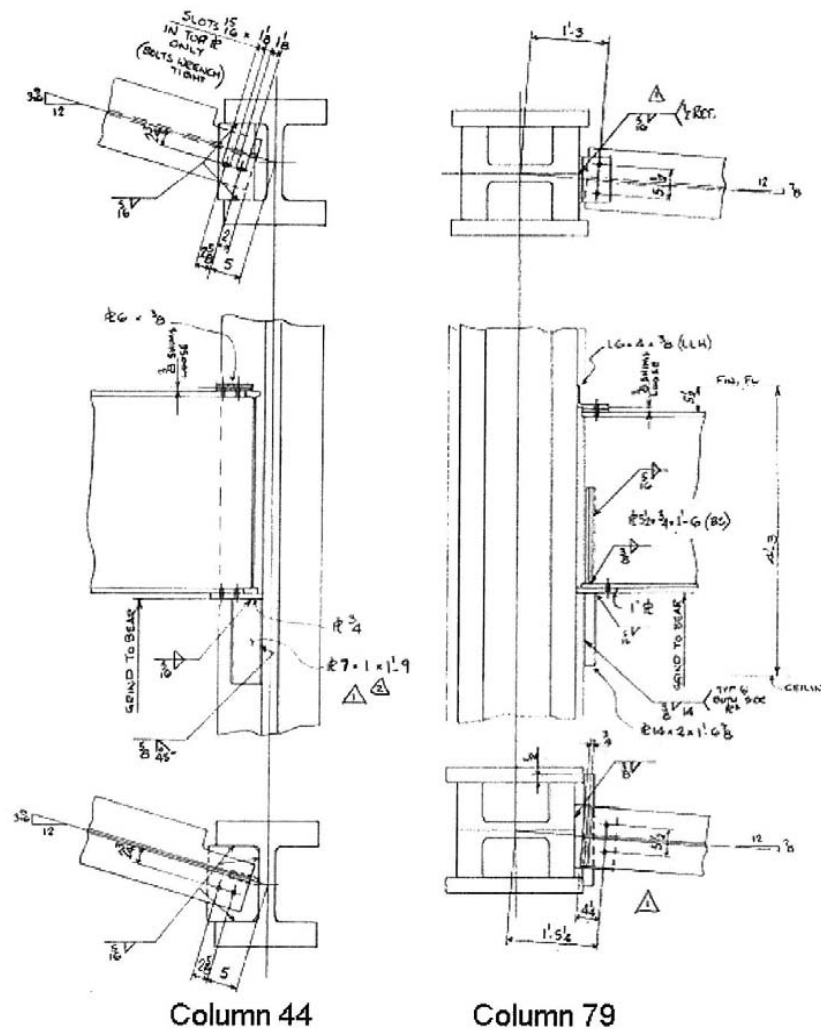
Figure 12 Details of seated connections at columns 44 and 79

The connections have four bolts (7/8in A325) at each end, 2 fixing the girder to the bottom seat and 2 fixing the girder to the top cleat, with an overall shear capacity of 180kip. From the fabrication drawings it can be calculated that the gap between the end of girder and the columns is a total of 3.5in, with the length of the girder being 537in. (Frankel Steel Shop Drawing Numbers 1352, 1090, 9102 and 9114).

This force far exceeds the strength of the bolts indicating that the bolts will fail below 100°C (i.e. very early in the fire).

Although a simple calculation, this gives an indication of the compression force on the connections as the girder expands which is only resisted by four 7/8in bolts, which will fail very quickly in a fire.

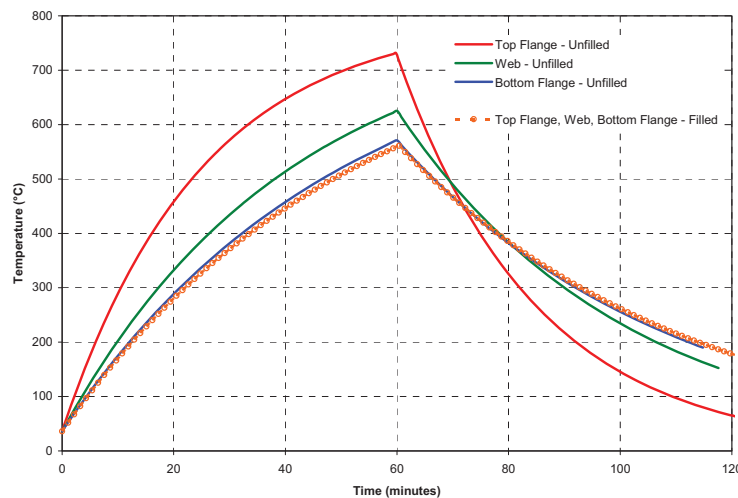
An example of the different temperature distribution in the girder between columns 79-44 for 800°C one hour heating followed by a further hour at 20°C is shown in Figure 26. It can be seen that for the filled case the temperature is assumed uniform, whereas for the unfilled case the temperature of the top flange and web is higher. The temperature distribution for the 700°C fire curve for the secondary composite beams is shown in Figure 27, which highlights a similar heating response.

Figure 26 Heating distribution through girder 79-44 for unfilled and filled flutes (800°C heating).

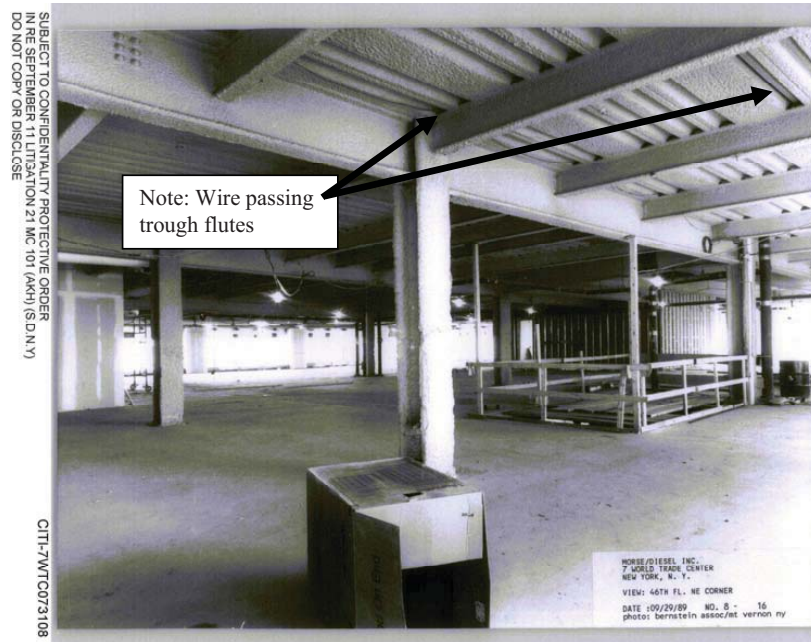
The construction of WTC7 was completed in 1987. These photographs were taken during 'fit-out' of the floors in 1989. They show that the flutes were not filled with fire protection as required. They also show in a number of cases wires being passed through the open flutes.

Figure A1: Photograph showing wire placed through flutes (46th Floor).

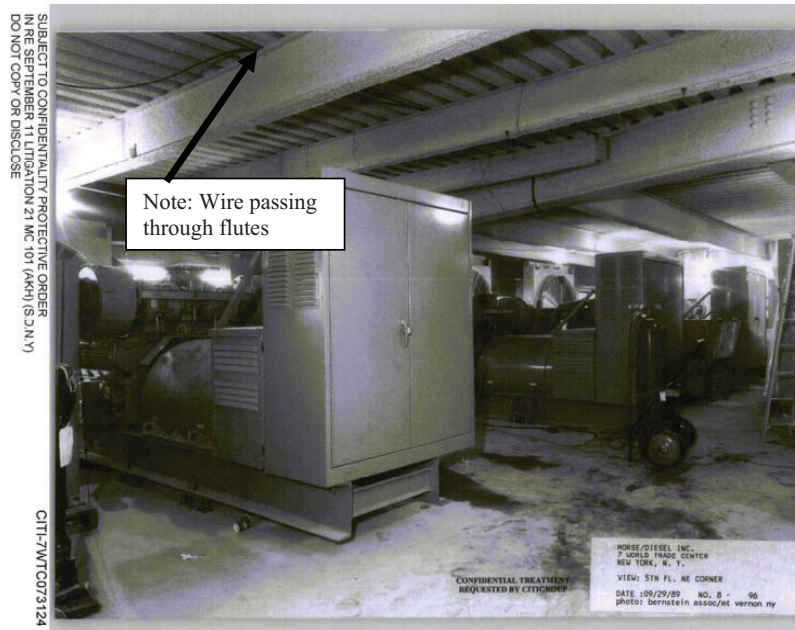
Figure A2: Photograph showing wire placed through flutes (5th Floor).

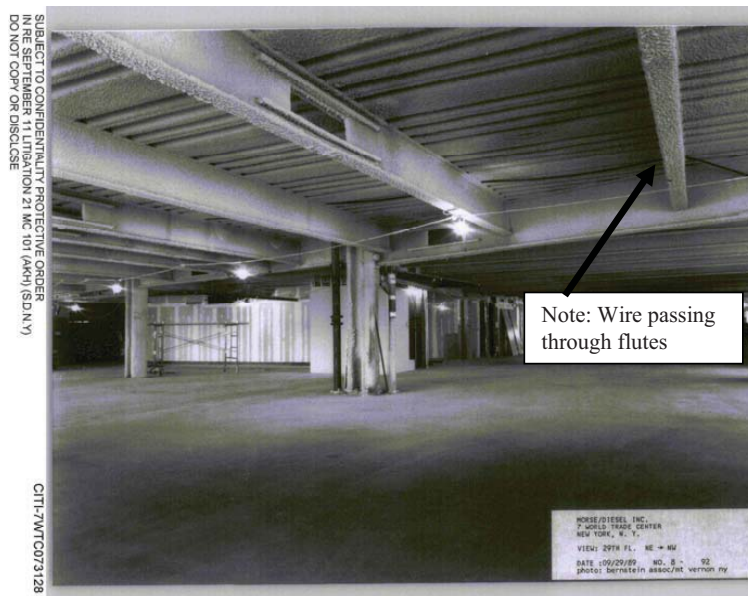
Figure A3: Photograph showing wire placed through flutes (29th Floor).

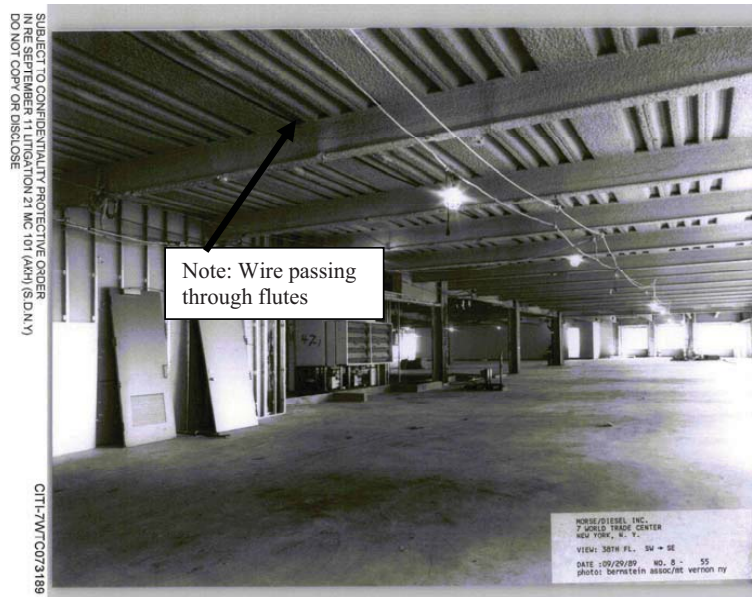
Figure A4: Photograph showing wire placed through flutes (38th Floor).

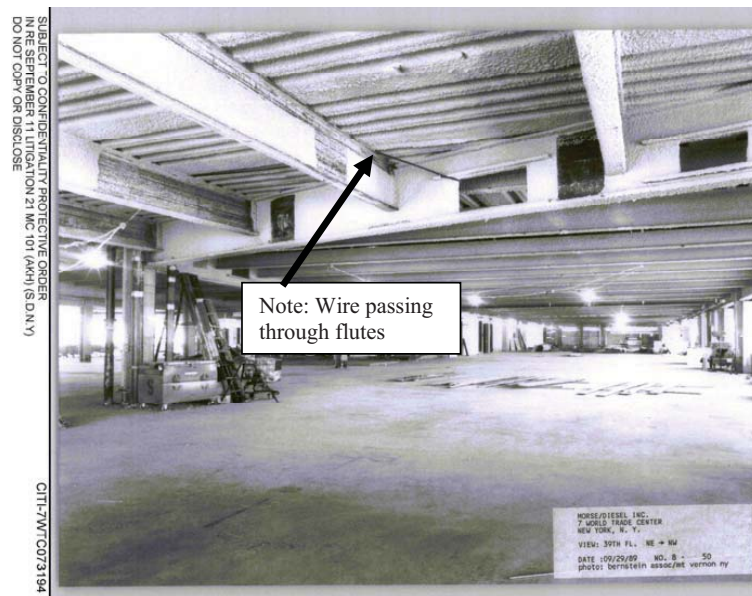
Figure A5: Photograph showing wire placed through flutes (39th Floor).

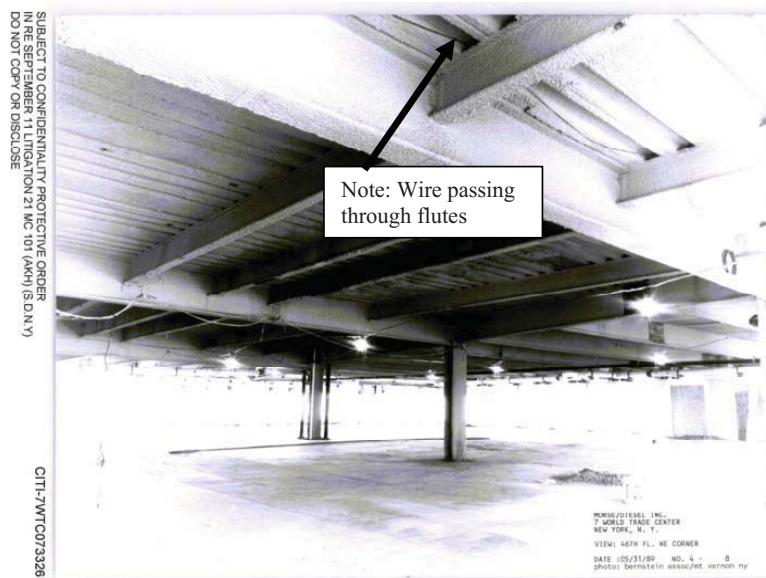
Figure A6: Photograph showing wire placed through flutes (46th Floor).

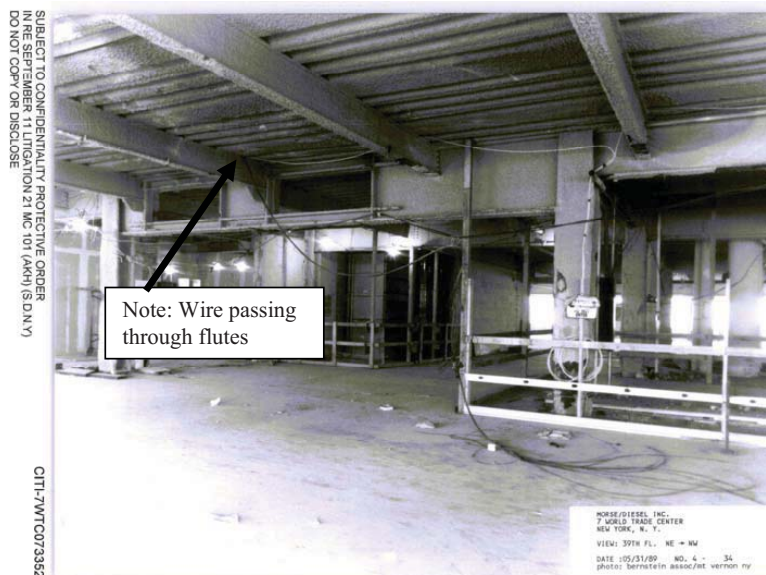
Figure A7: Photograph showing wire placed through flutes (39th Floor)

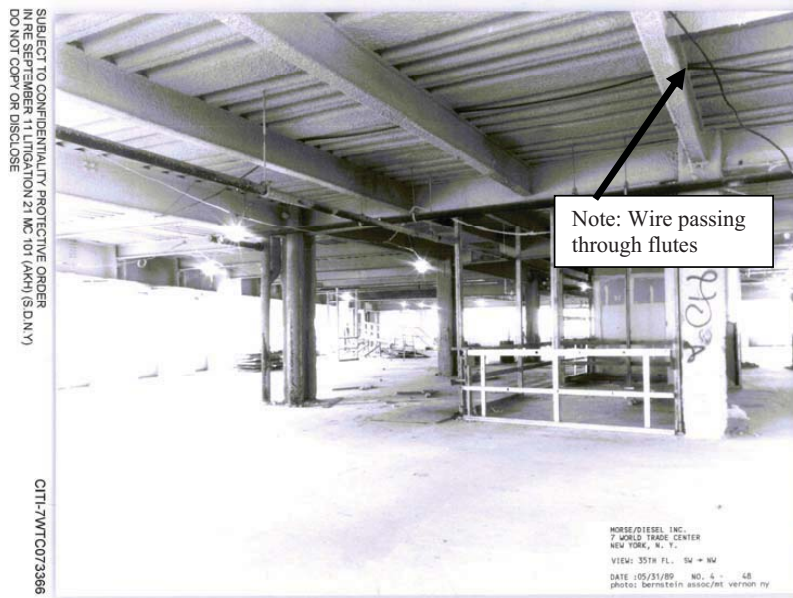
Figure A8: Photograph showing wire placed through flutes (35th Floor)

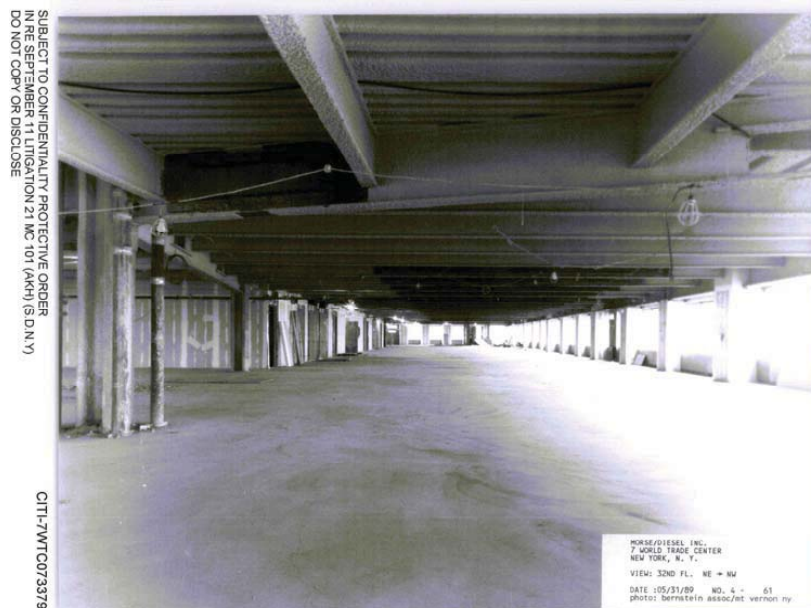
Figure A9: Photograph showing wire placed through flutes (32nd Floor)

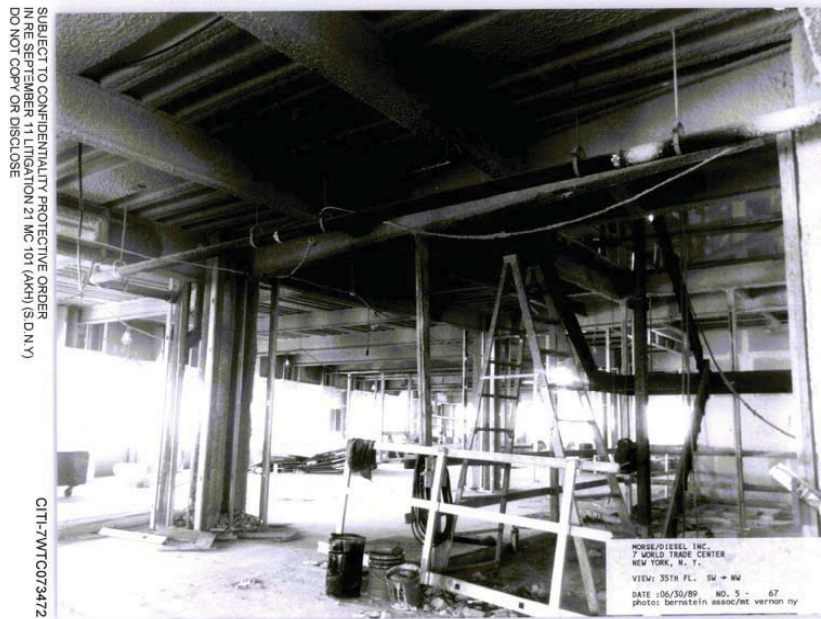
Figure A10: Photograph showing wire placed through flutes (35nd Floor)

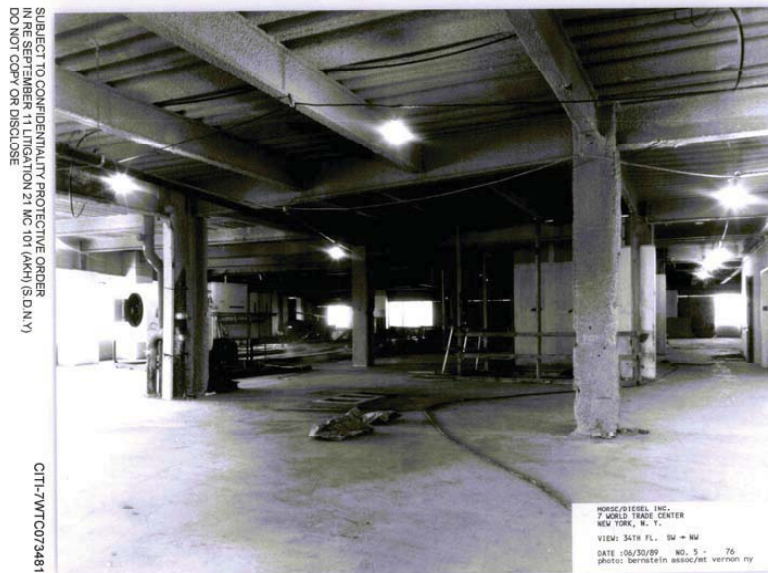
Figure A11: Photograph showing wire placed through flutes (34th Floor)

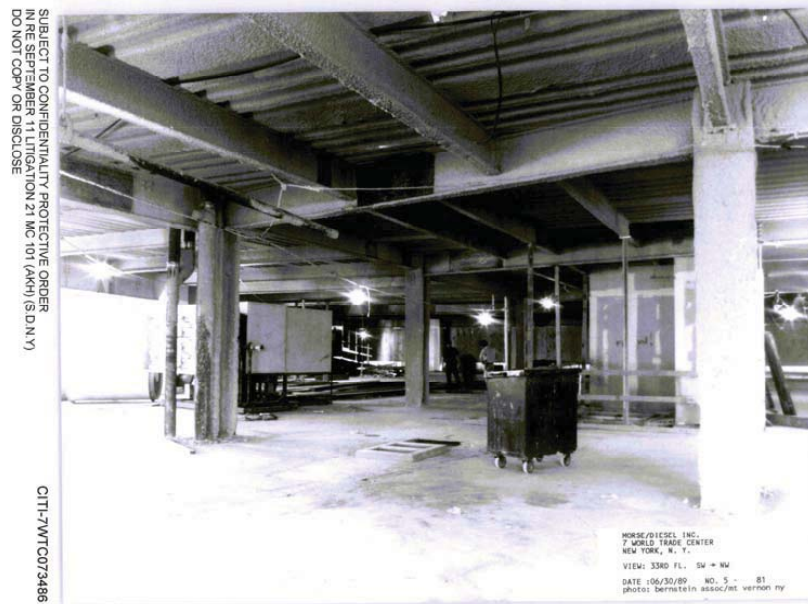
Figure A12: Photograph showing wire placed through flutes (33rd Floor)

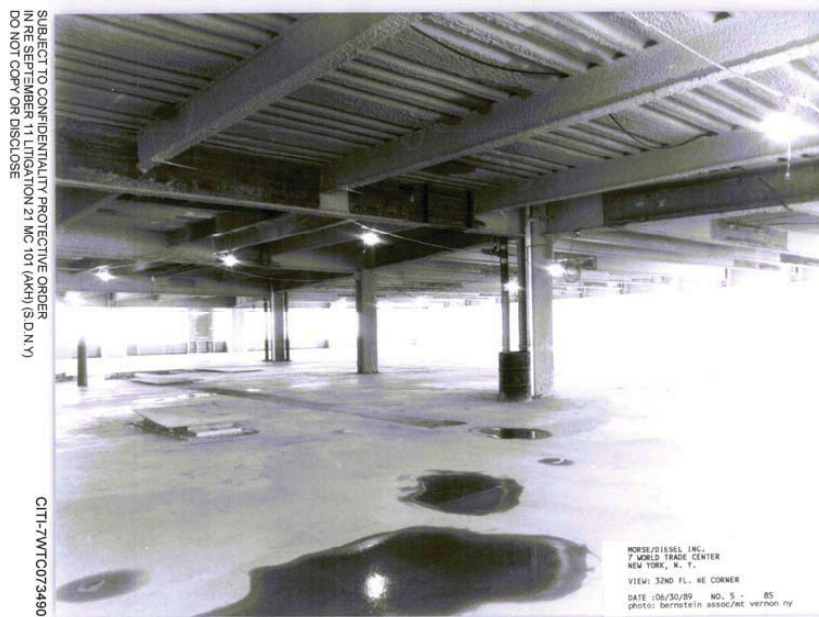
Figure A13: Photograph showing wire placed through flutes (32nd Floor)

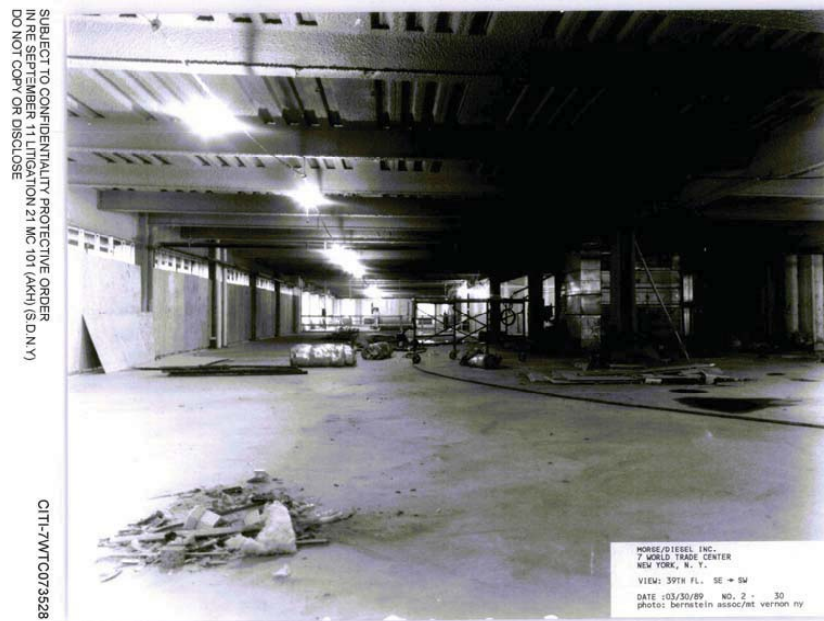
Figure A14: Photograph showing light through flutes (39th Floor)

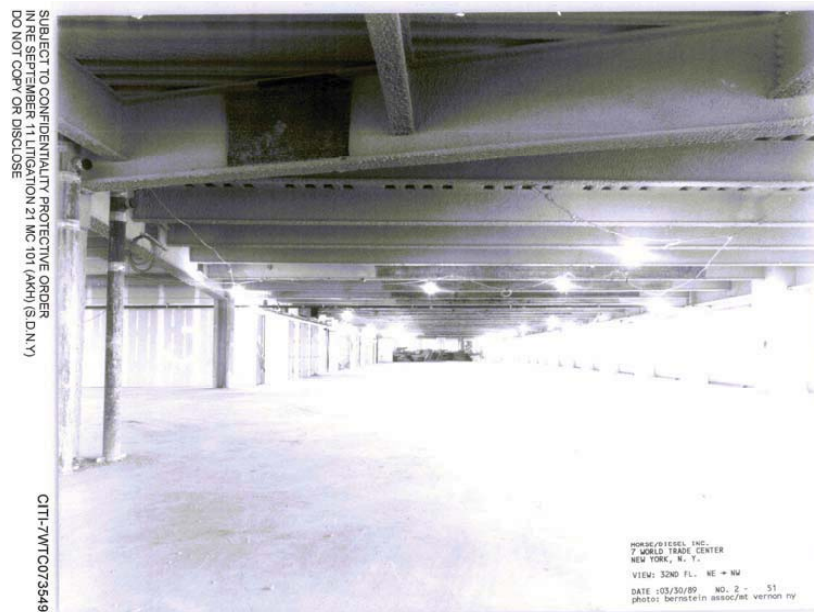
Figure A15: Photograph on 32rd floor showing unfilled flutes above girder

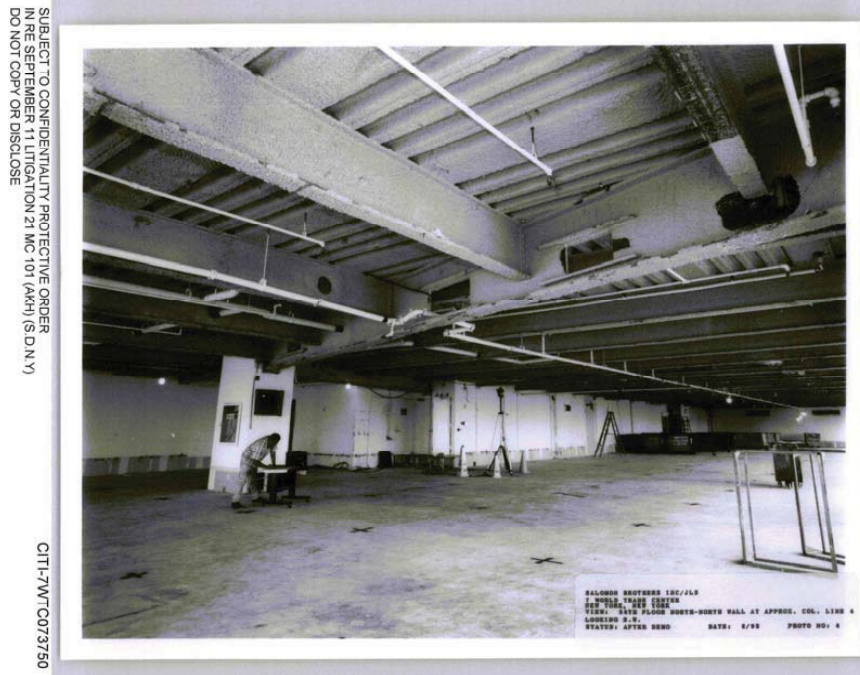
Figure A16 Photograph on 24th floor showing unfilled flutes above girder

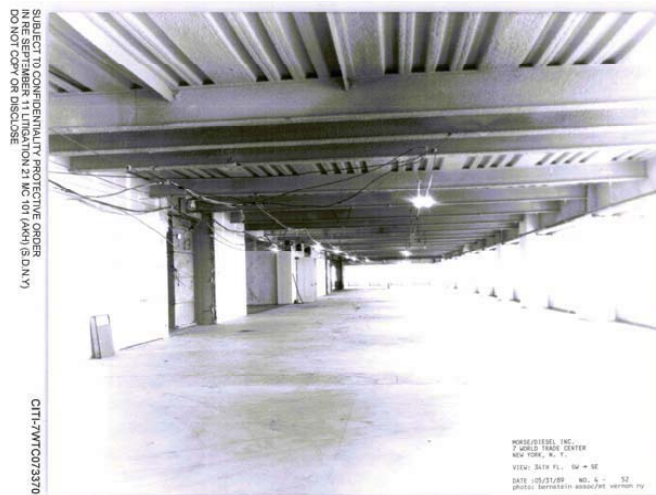
When a steel beam supports a composite deck, comprising a steel deck, concrete and mesh reinforcement, a void is formed between the top flange of the beam and deck. For trapezoidal shaped decks, such as that used on WTC7, this void can be large. Figure C1 shows the voids above the top flange of the beam for the protected beams in WTC7. Leaving the voids between the deck and top flange of the beam unfilled with fire protection results in:

Figure C1 Picture of the WTC7 showing unfilled voids.

the 1980s. The Underwriters Laboratories (UL) document BXUV.D739 covered the specification of Monokote MK-5. The June 2006 version of BXUV.D739 states that *'when steel deck is used, the area between the steel deck and the beams top flange shall be filled'*. In the UL Fire Resistance Directory for 1983 it is stated *'Cavities, if any, between the upper beam flange and floor or roof units shall be filled with the fire protection material applied to the beam, unless stated otherwise on an individual design.'* The identical statement was repeated in the UL Fire Resistance Directory for 1985.

It can therefore be concluded that the voids (cavities) should have been filled with fire protection on WTC7. Figure C2 shows an example where the voids have been filled with SFRM. Comparison with Figure 1 shows clearly that the voids on WTC7 were not filled, resulting in a lower fire resistance compared to that specified.

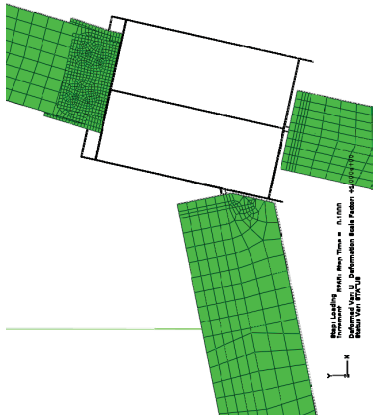
- Seating bolts break early in the fire due to longitudinal expansion of Girder 79-44. The bolts in the top clip break shortly thereafter.
- End of girder is then free to be moved about on the seating plate. This movement is consistent with the response seen in the other three cases analysed.
- Toward the middle of the heating phase the girder end is jammed into the corner between the column flange and the extension of the column side plate beyond the flange.
- As the structure begins to cool the contraction of the structure pulls the end of Girder 79-44 eastward across the seating plate at Column 79.
- At the end of cooling the girder end is solidly seated and in good contact with the column side plate.

Figure 78: 800°C Filled Flutes Case 4 - Column 79 Seat Connection at Ambient

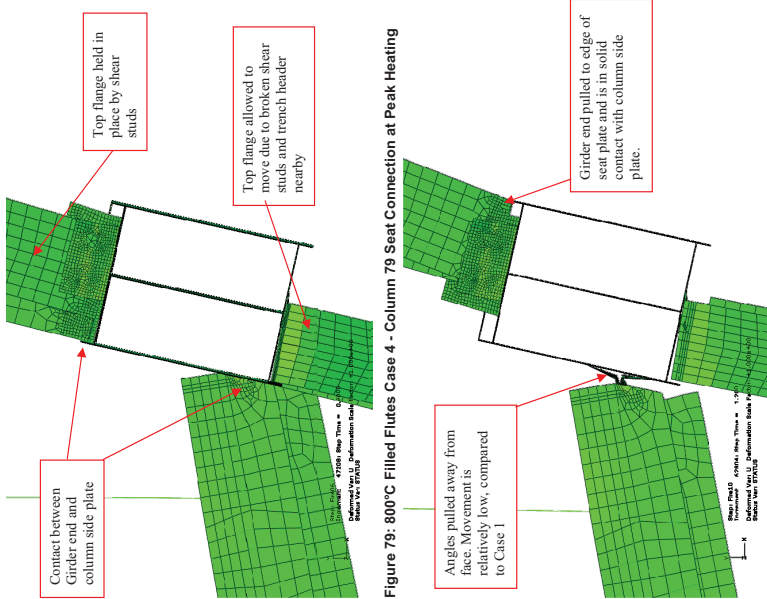
Figure 79: 800°C Filled Flutes Case 4 - Column 79 Seat Connection at Peak Heating

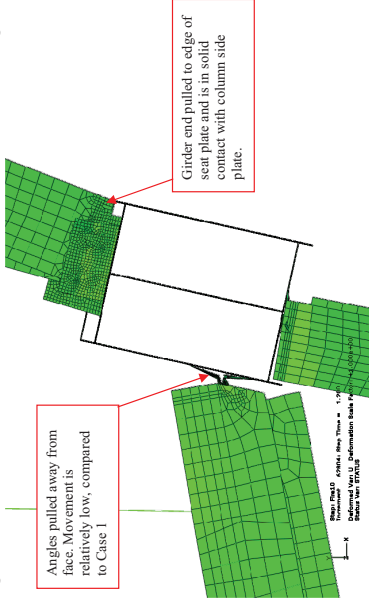
Figure 80: 800°C Filled Flutes Case 4 - Column 79 Seat Connection at End of Cooling

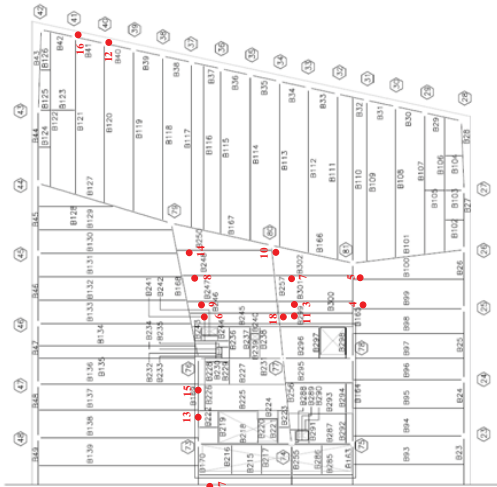
Figure 93 shows the location and sequence of connection failures observed during the analysis. Refer to Table 5 for times of failures.

Figure 93: Locations and sequence of connection failures (sequence numbers correspond to Table 5)

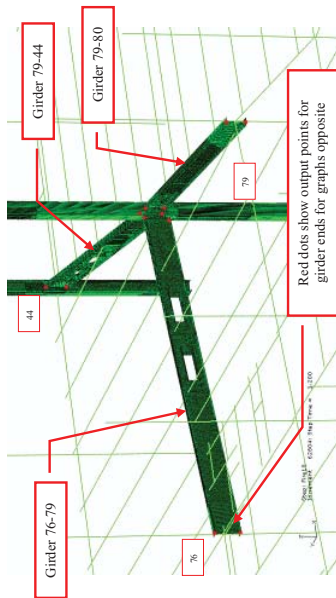
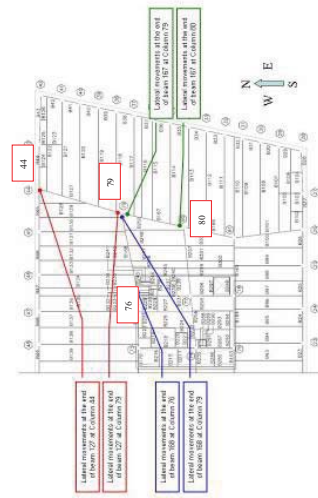
- **Girder 79-44**
The girder is pushed and pulled laterally by the secondary beams to the extent that late in cooling it is sitting precariously on the eastern edge of its seat at Column 79.
- **Girder 76-79**
As the girder expands and contracts with heating and cooling its movements are accommodated by ductility in the knife angle plates. Angle plates remain intact and do not tear.
- **Girder 79-80**
As the girder expands and contracts with heating and cooling its movements are accommodated by ductility in the knife angle plates. Angle plates remain intact and do not tear.

Figure 97: Lateral movements (top and bottom) at each end of the girders framing into Column 79. Images on the left show the locations of the output points on each girder.
