11-4403-cv

United States Court of Appeals *for the* Second Circuit

JOINT APPENDIX Volume 12 of 16 (Pages JA-3067 to JA-3320)

-----	x	
	:	
IN RE: SEPTEMBER 11 PROPERTY DAMAGE	:	21 MC 101 (AKH)
AND BUSINESS LOSS LITIGATION	:	
	:	
-----	:	
AEGIS INSURANCE SERVICES, INC., et al.,	:	04 CV 7272 (AKH)
	:	
Plaintiffs,	:	
-against-	:	SUPPLEMENTAL AND
	:	AMENDED SECOND
7 WORLD TRADE CENTER COMPANY, L.P.,	:	DECLARATION OF
et al.,	:	COLIN G. BAILEY
Defendants.	:	
-----	x

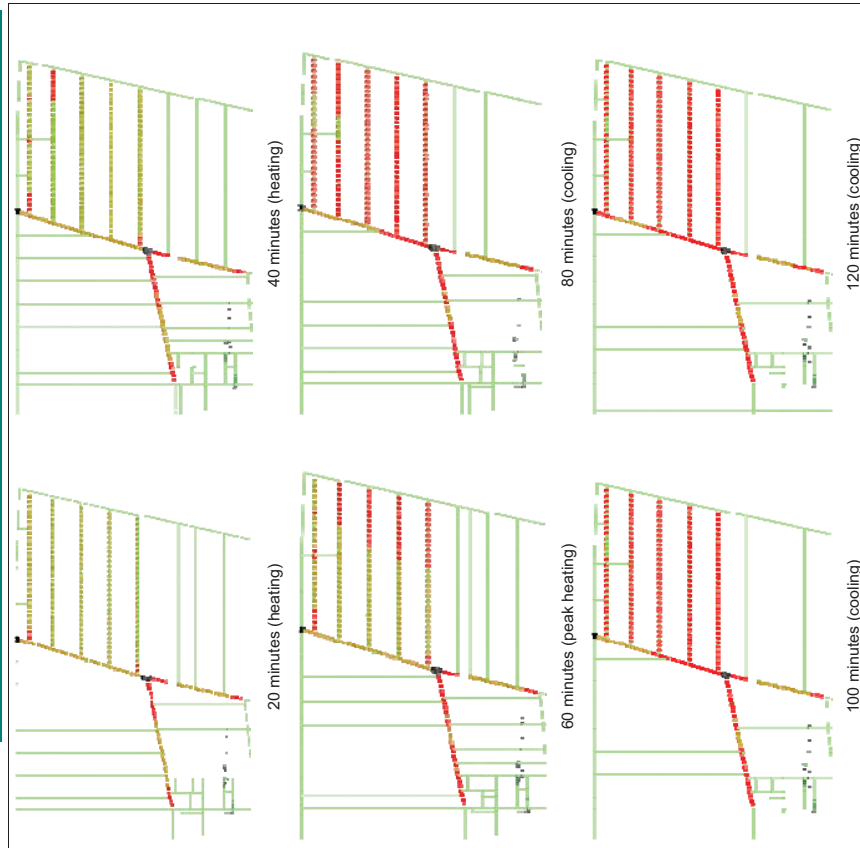
Figure 99: Shear stud failures within the north-east bay at 20 minute intervals throughout the duration of the analysis. Brown markers indicate unbroken shear studs while red markers indicate broken shear studs

During the heating phase of the fire, shear stud breakages are observed at either end of Girders 76-79 and 79-80 and also on the eastern third of beams in the north-east bay.

During the initial cooling phase, a significant number of shear studs break due to differential cooling between the concrete slab and the steel beams. These include almost all shear studs on the secondary beams and the majority on each of the three girders into Column 79.

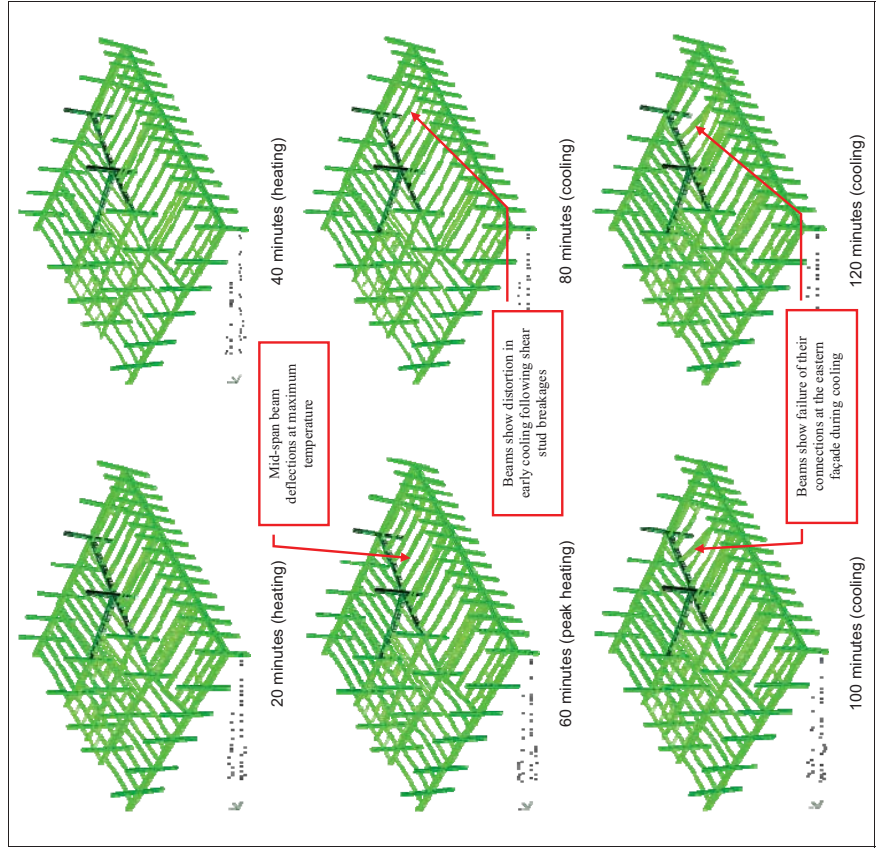
Figure 102: Deformed structure images of the structural frame in the north-east region of Floor 13 at 20 minute intervals throughout the analysis

Two secondary beams in the north-east bay fail at their connections to the eastern facade columns as the beams contract due to cooling and create large tension forces.
Girder 79-44 is pulled across its seat plate during cooling by the secondary beams and is left resting precariously at the eastern side of this plate

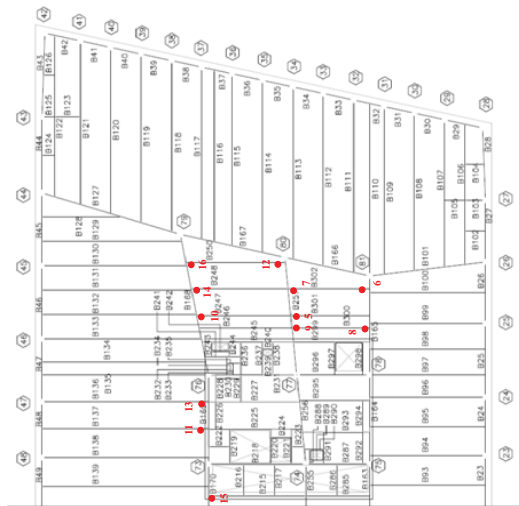
17	120	Vertical mid-span deflections continue to decrease because structure is cooling. Largest mid-span deflections in the floor plate are observed in the north-east corner i.e. 425mm (16.7") at the end of cooling. Greater recovery of deflections is observed in Beam 98 in the south, i.e.: 352mm (13.9"). Analysis completes. No structural collapse	153
----	-----	---	-----

Figure 103 shows the location and sequence of connection failures observed during the analysis. Refer to Table 6 for times of failures.

Figure 103: Locations and sequence of connection failures (sequence numbers correspond to Table 6)

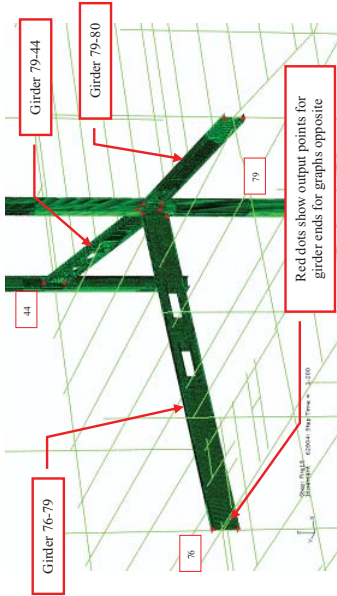
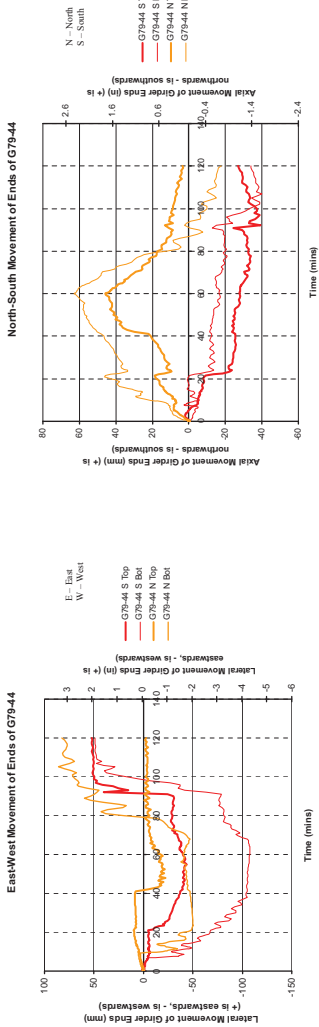
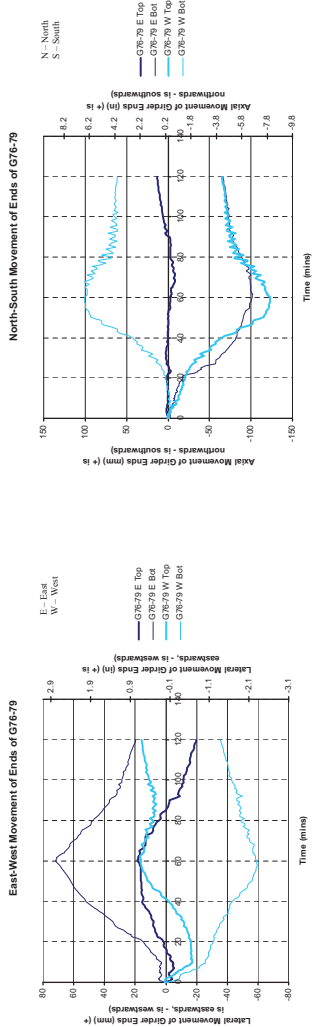
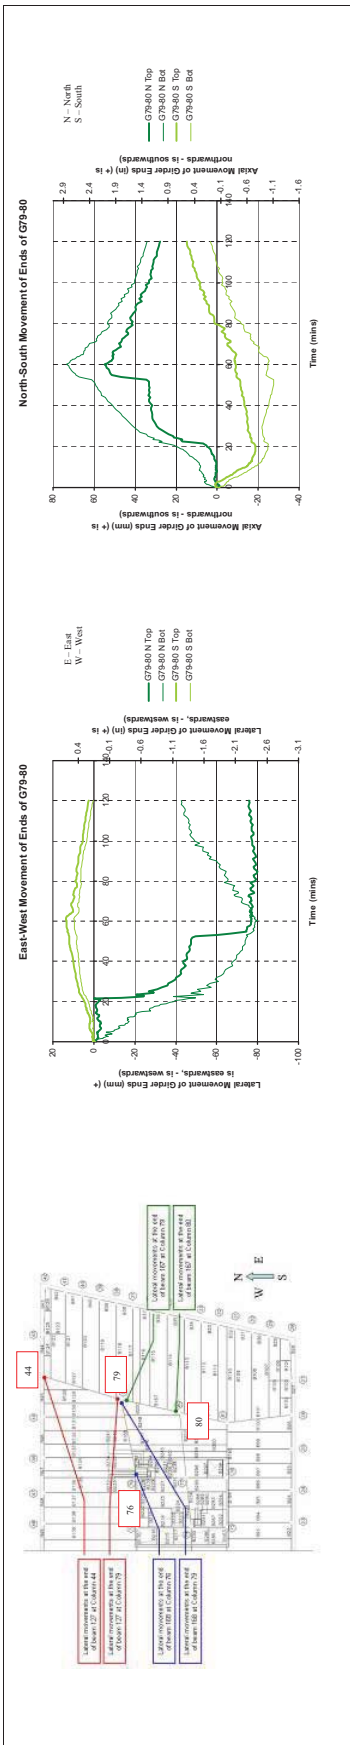
- Girder 79-44**
The girder remains stable on its seats at Column 79 and Column 44 throughout the entire analysis despite all its connection bolts breaking early in the fire. It is pushed and pulled laterally by the secondary beams but does not fall off its seats.
- Girder 76-79**
As the girder expands and contracts with heating and cooling, its movements are accommodated by ductility in the knife angle plates. Angle plates remain intact and do not tear.
- Girder 79-80**
As the girder expands and contracts with heating and cooling its movements are accommodated by ductility in the knife angle plates. Angle plates remain intact and do not tear.

Figure 107: Lateral movements (top and bottom) at each end of the girders framing into Column 79. Images on the left show the locations of the output points on each girder.

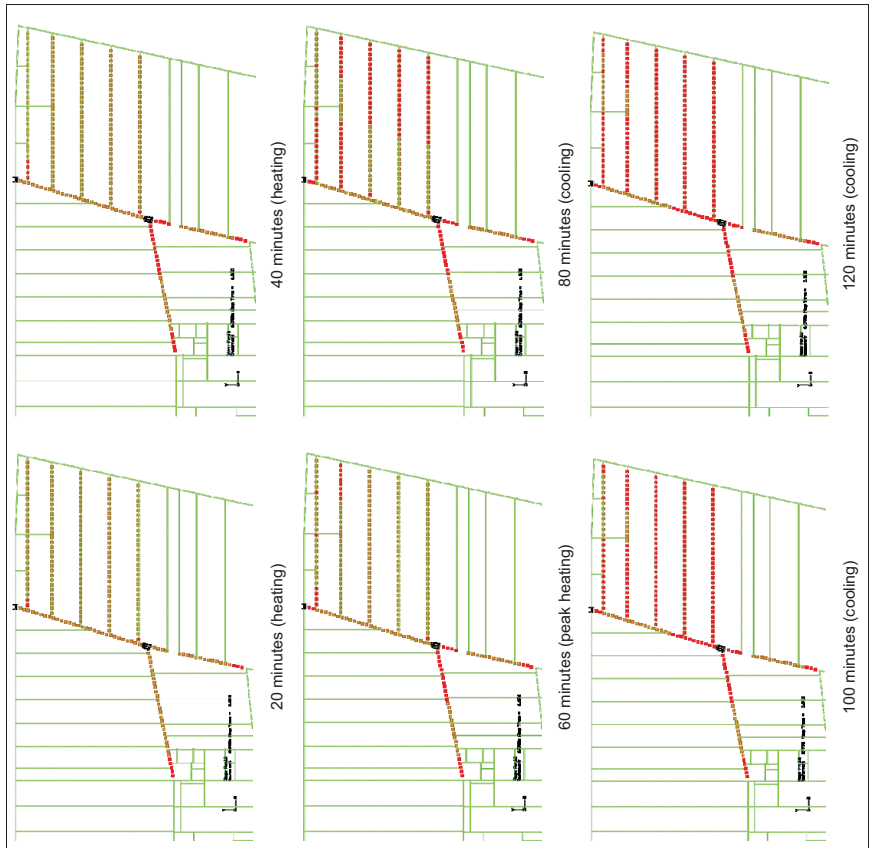
Figure 109: Shear stud failures within the north-east bay at 20 minute intervals throughout the duration of the analysis. Brown markers indicate unbroken shear studs while red markers indicate broken shear studs

During the heating phase of the fire, shear stud breakages are observed at both ends of Girders 76-79 and 79-80 and on Girder 79-44 near to Column 44.

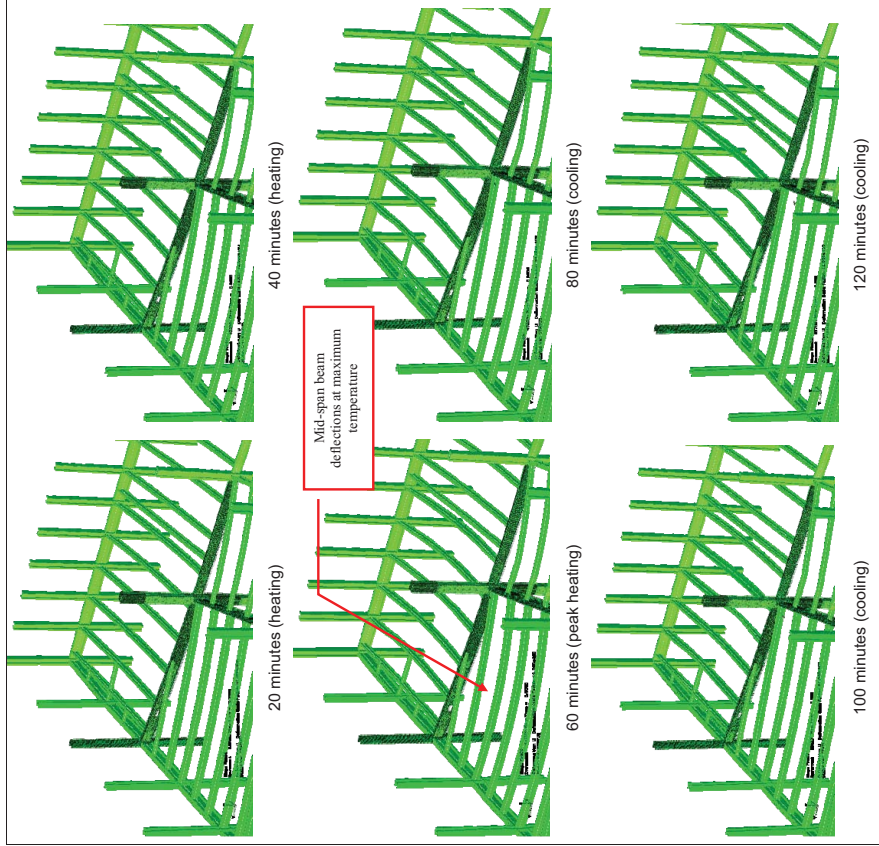
Figure 112: Deformed structure images of the structural frame in the north-east region of Floor 13 at 20 minute intervals throughout the analysis

The structural frame of Floor 13 remains stable throughout both the heating and cooling phases.
The secondary beams and girders exhibit vertical deformations, some of which are partially recovered during the cooling phase.
No initiating collapse mechanism is observed.

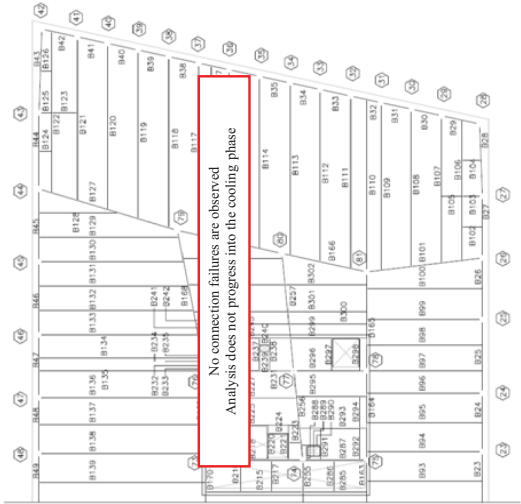
Figure 113 shows that no connection failures were observed during the analysis. Cases 1, 2 and 4 all progress into cooling and show connections to fail in tension as the beams they support contract.

Figure 113: Locations and sequence of connection failures (sequence numbers correspond to Table 7)

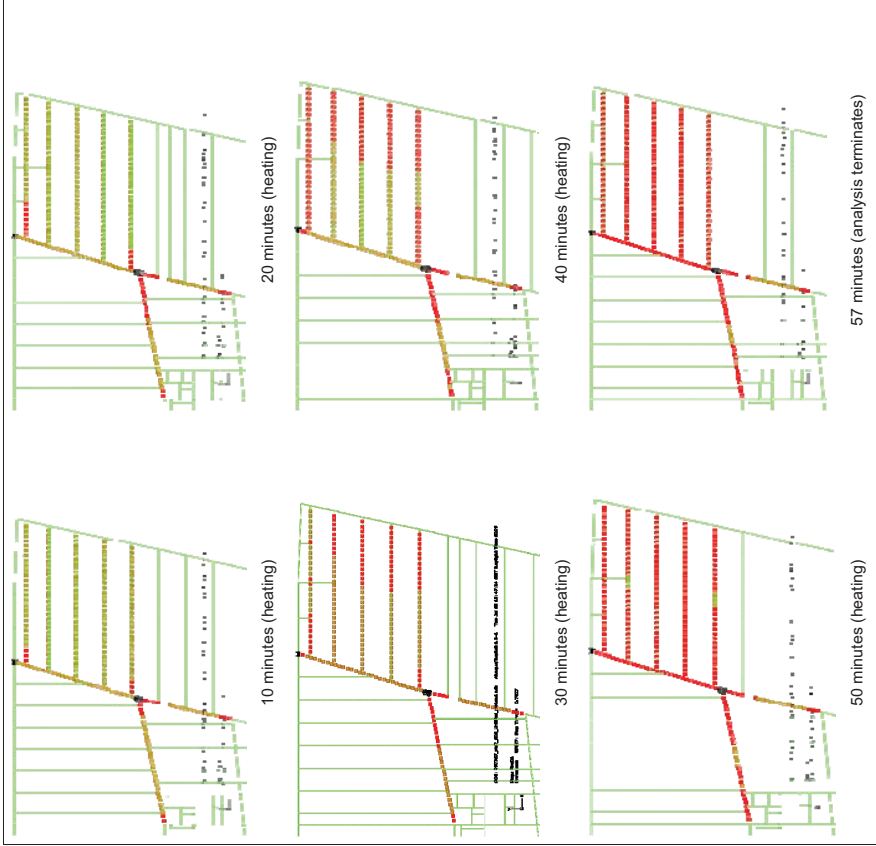
Figure 119: Shear stud failures within the north-east bay at 20 minute intervals throughout the duration of the analysis. Brown markers indicate unbroken shear studs while red markers indicate broken shear studs. During the early heating phase, shear stud breakages are mainly observed at either end of Girders 76-79 and 79-80 and also on the eastern half of beams in the north-east bay. A large proportion of shear studs break at 40-50 minutes (late heating) to the extent that almost all shear studs have broken with the exception of those on Girder 79-80 south of the trench header.

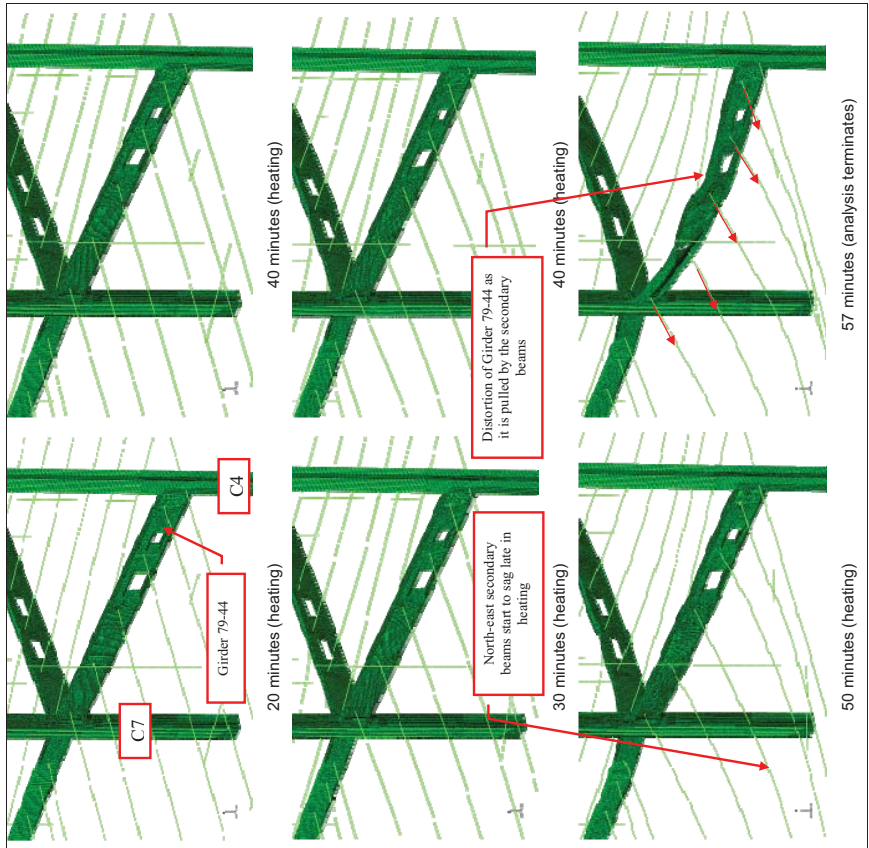
This analysis shows a potential initiating collapse mechanism towards the end of the heating phase. Girder 79-44 at Column 79 is pulled to the east across its seating plate and is about to be pulled off. The analysis terminated at this point due to a numerical instability associated with the failure mechanism, however all indications are that localised structural collapse is imminent.

Figure 122: Deformed structure images of the Girder 79-44 in the north-east region of Floor 13 at 10 minute intervals throughout the analysis

Girder 79-44 is pulled across its seat plate late in heating by the secondary beams as they sag due to high temperature. The analysis terminated due to a numerical instability associated with the observed behaviour. The movement of the girder to the east at Column 79 forms the basis of a potential initiating collapse mechanism.

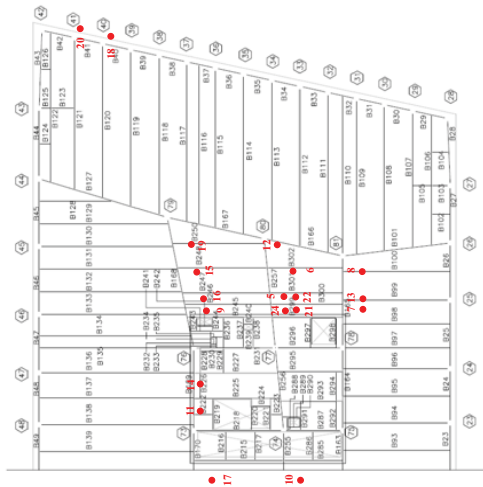
Figure 123 shows the location and sequence of connection failures observed during the analysis. Refer to Table 8 for times of failures.

Figure 123: Locations and sequence of connection failures (sequence numbers correspond to Table 6)

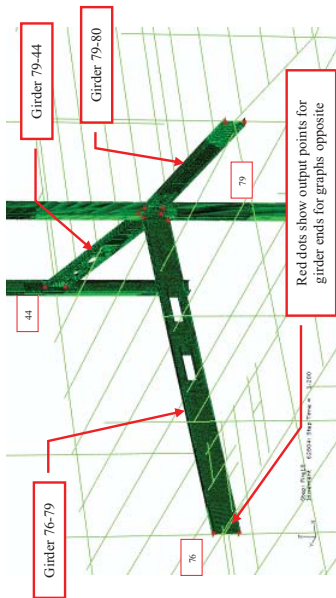
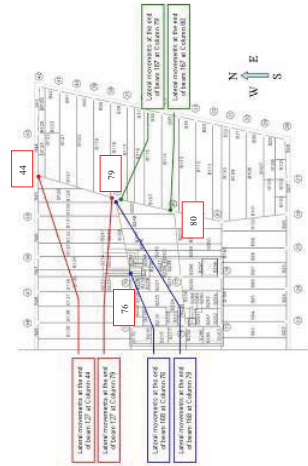
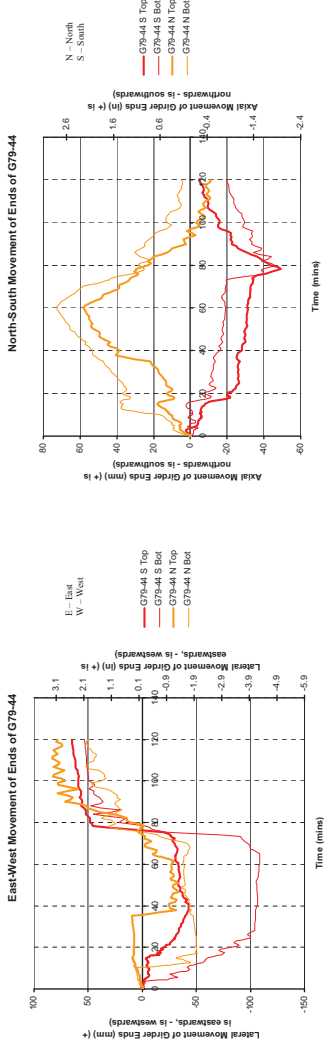
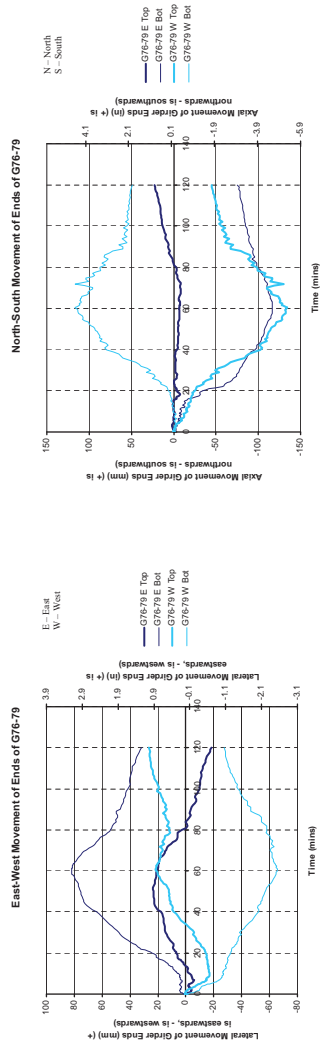
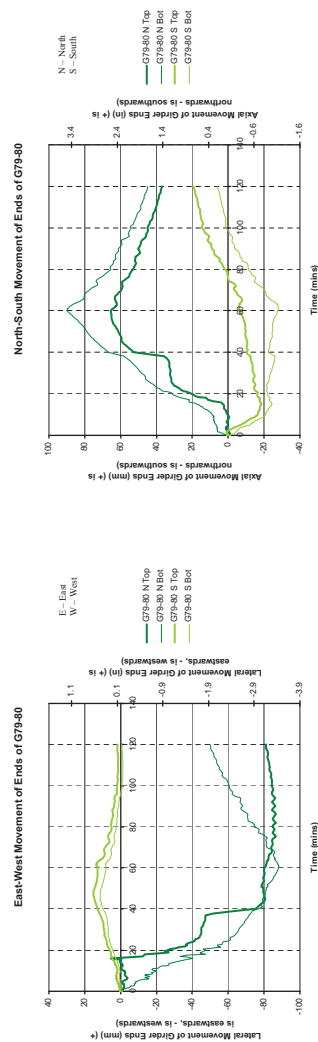
- **Girder 79-44**
The girder remains stable on its seats at Column 79 and Column 44 throughout the entire analysis despite the bolts breaking early in the fire. It is pushed and pulled laterally by the secondary beams but does fall off its seats.
- **Girder 76-79**
As the girder expands and contracts with heating and cooling its movements are accommodated by ductility in the knife angle plates. Angle plates remain intact and do not tear.
- **Girder 79-80**
As the girder expands and contracts with heating and cooling its movements are accommodated by ductility in the knife angle plates. Angle plates remain intact and do not tear.

Figure 127: Lateral movements (top and bottom) at each end of the girders framing into Column 79. Images on the left show the locations of the output points on each girder

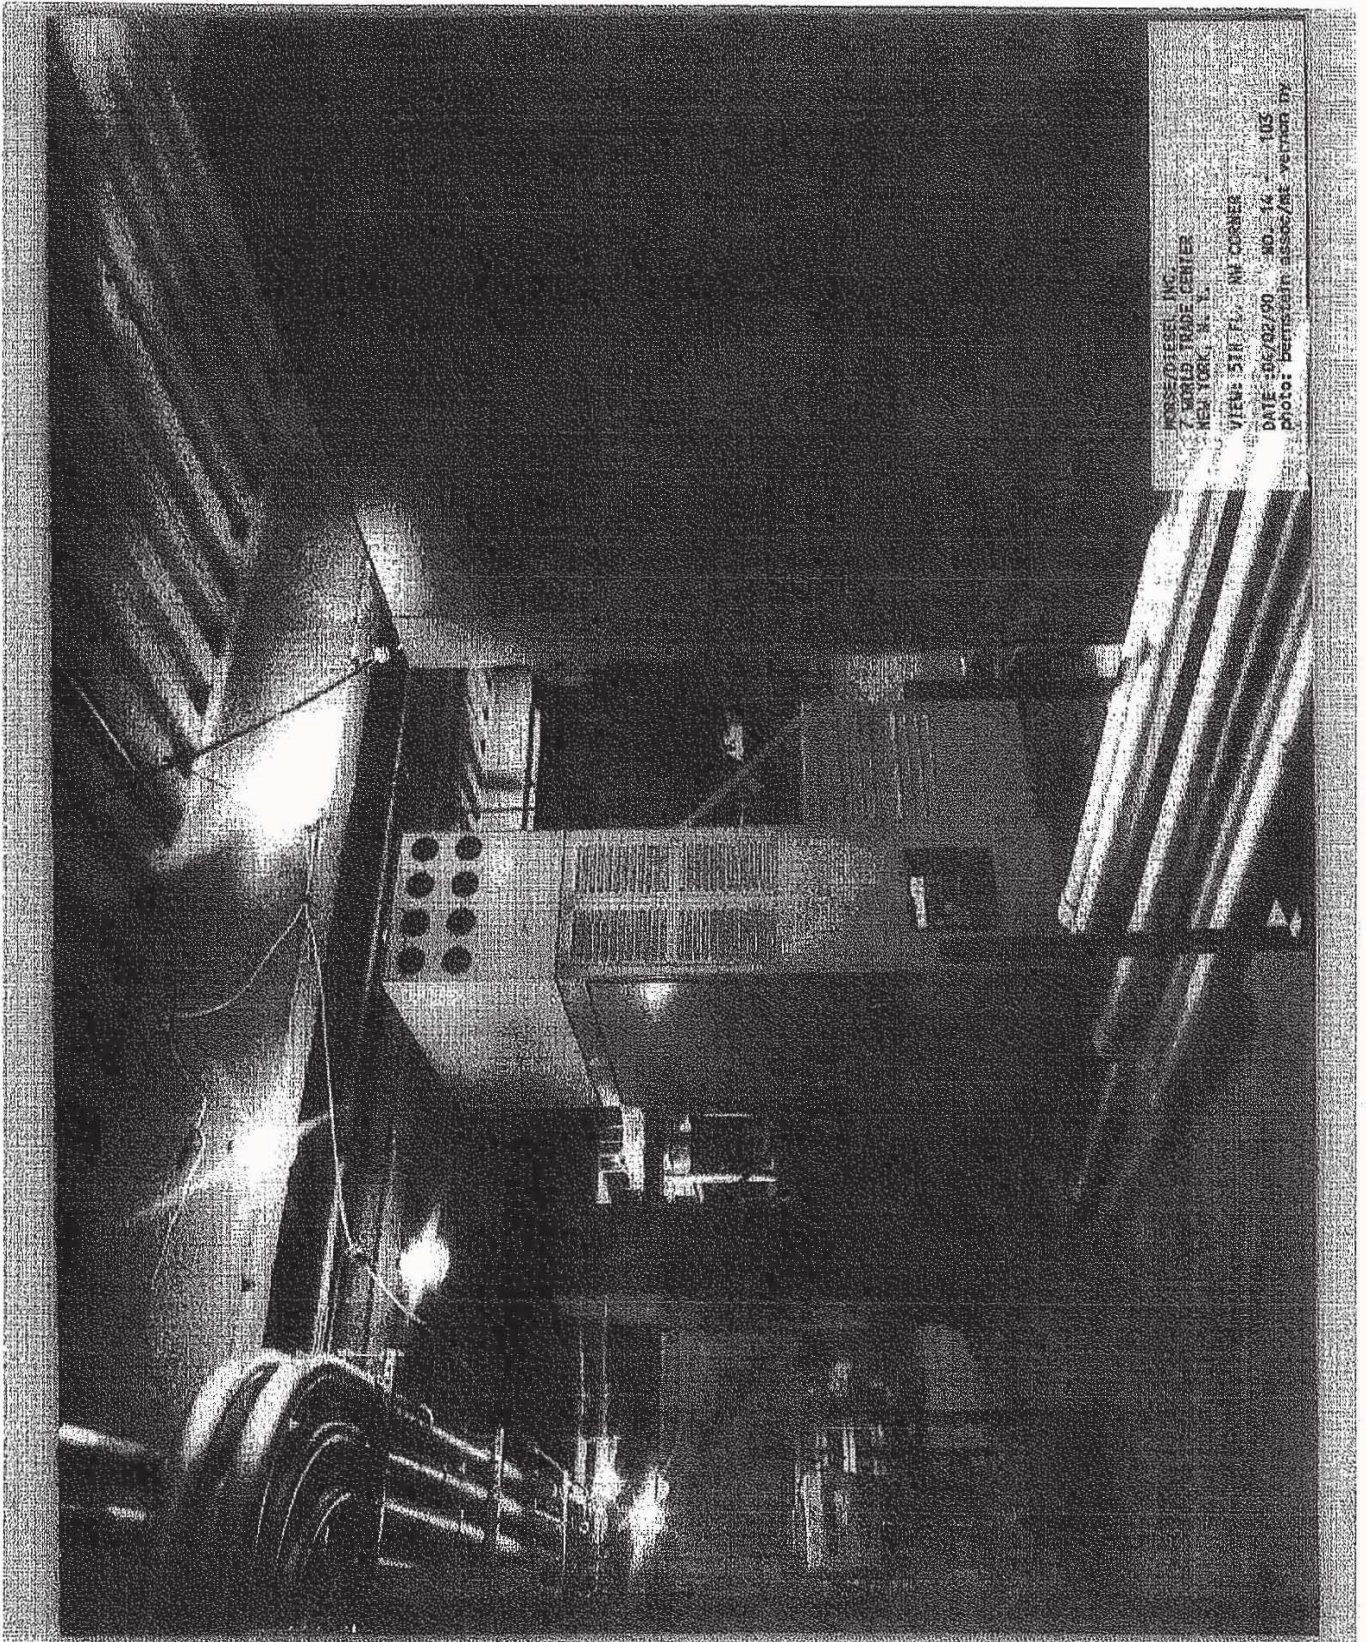
ROSE DIESEL, INC.
7 WORLD TRADE CENTER
NEW YORK, N. Y.
VIEW: 5TH FL., NW CORNER
DATE: 06/02/90 NO. 14
photo: Bernstein Assoc./M. Vetterl

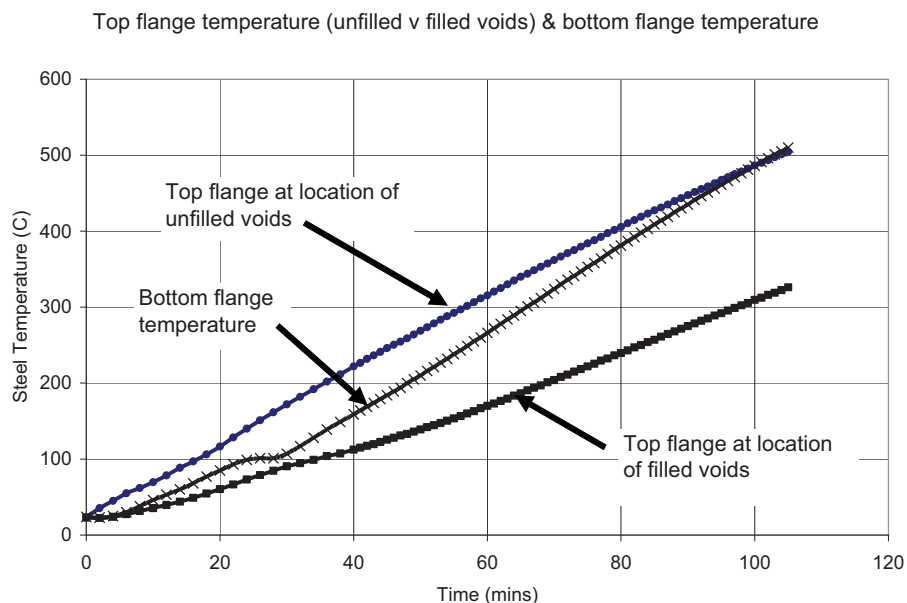
Figure C4 *Top flange temperatures at location of filled and unfilled voids for trapezoidal deck (PMF CF60) with normal weight concrete (Bottom flange temperatures also shown)*

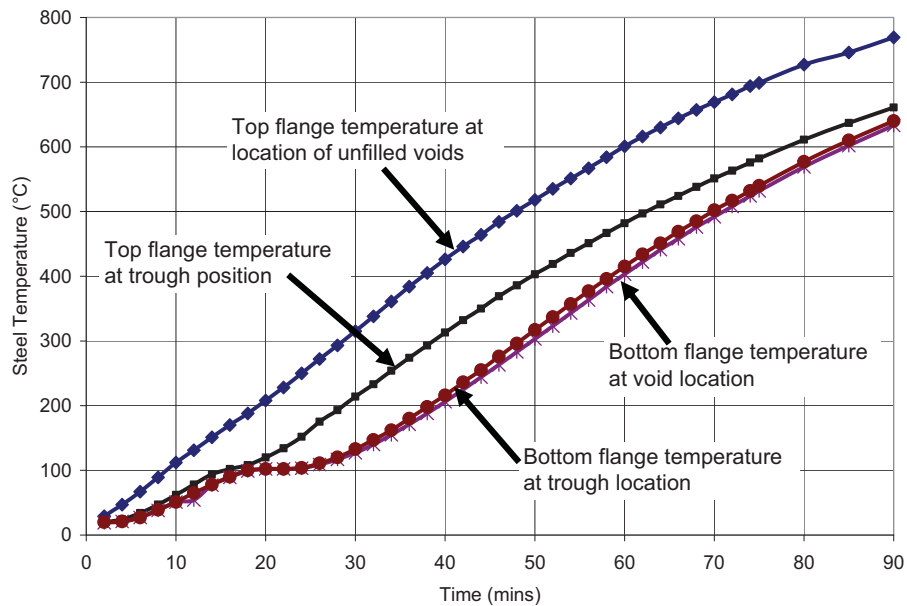
The temperatures recorded for Test 3 on the top flange (at the unfilled void location and trough location) and the bottom flange are shown in Figure C6. It can be seen that the top flange temperatures at the unfilled void location are greater than the temperatures at the trough location. In addition the top flange temperatures are greater than the bottom flange temperatures. If the voids were filled the top flange temperatures would be lower than the bottom flange temperatures. This was shown in Test 1, which had filled voids, with the temperatures shown in Figure C7.

Figure C6: Steel temperatures for Test 3; cementitious spray and voids unfilled.

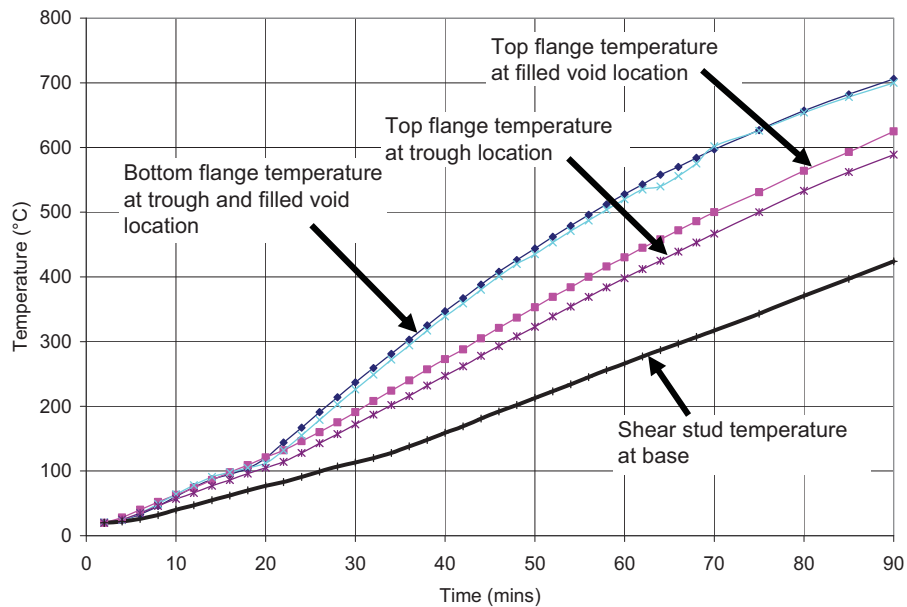
Figure C7 *Steel temperatures for Test 1; board protection voids filled.*

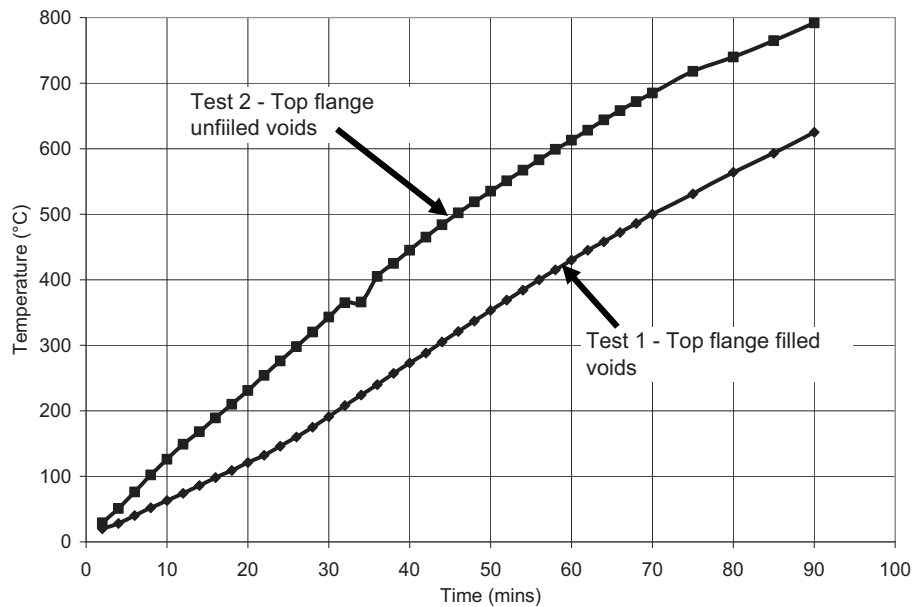
One interesting comparison is between Test 1 and Test 2, which although had a board protection, shows the direct comparison between filled and unfilled voids. The difference in top flange temperature is shown in Figure C8.

Figure C8 *Difference of top flange temperatures for Test 1 (filled voids) and Test 2 (unfilled voids)*

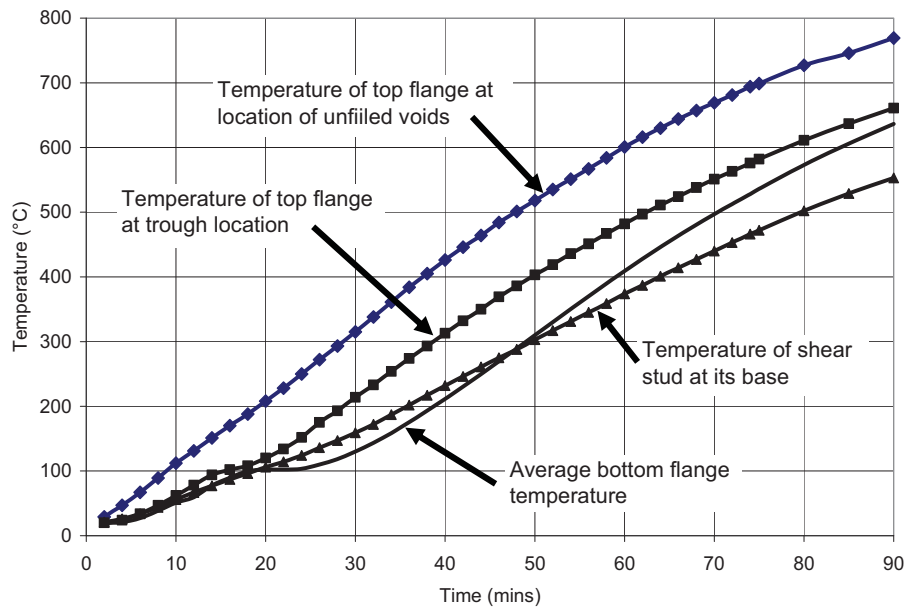
In the series of tests the temperature of the shear studs were measured. The temperature at the base of the shear stud in Test 3 is shown in Figure C9, where it can be seen that the stud temperature is only 84°C lower than the bottom flange temperature at 90 mins.

Figure C9 Stud temperature and steel temperature for Test 3

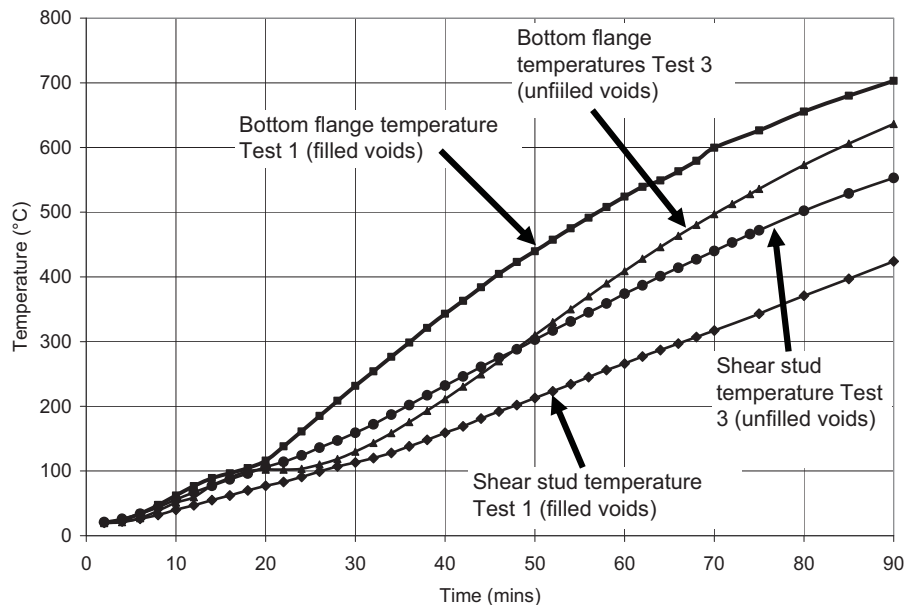
As a comparison for Test 1, the stud temperature is significantly lower than the bottom flange (279°C) at 90mins. A comparison between the bottom flange temperatures and shear stud temperatures for Tests 1 and 3 is shown in Figure C10. It is important when considering Figure C10 that comparisons are only made between stud and bottom flange temperatures and not between tests, since different fire protection systems are used.

Figure C10 Comparison between bottom flange temperatures and stud temperatures for Tests 1 and 2.

The shear stud temperatures are significantly higher when the voids are unfilled leading to the possibility of shear stud failure. It should also be noted that the studs in the reported tests were placed in the centre of the trough whereas in practice they would be placed off-centre leading to even higher temperatures.

2. With unfilled voids the temperature of the shear studs increases compared to the case where the voids are filled. This will reduce the strength of the studs and could lead to shear failure of the studs.

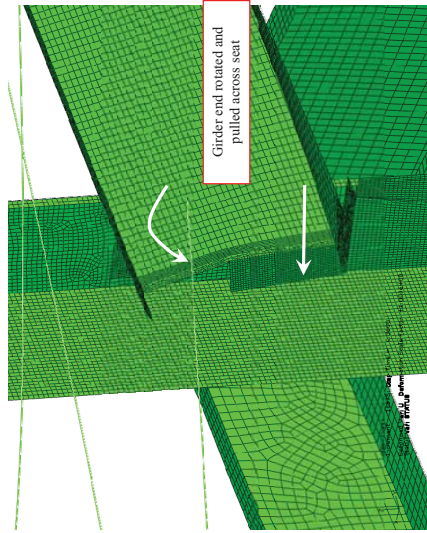
- Finally, at the end of 120 minutes of heating and cooling the end of the girder is sitting precariously at the side of the seat (Figure 17).
The structural response described above is presented in more detail in the following sections.
A more detailed timeline may be found in Section 5.5.

Figure 17: 700°C Unfilled Flutes Case 1 - Column 79 Seated Connection at End of Cooling

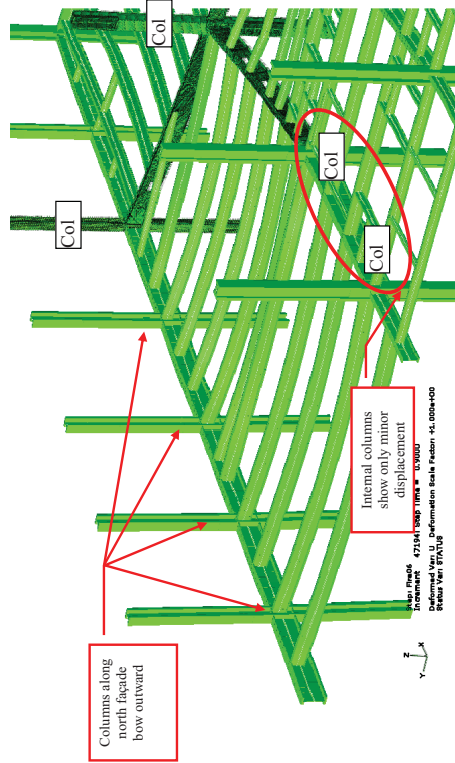
No column buckling was observed in the model during the analysis. Figure 18 shows the undeformed shape of the columns.

Figure 18: Deflected shape of structure along the north façade

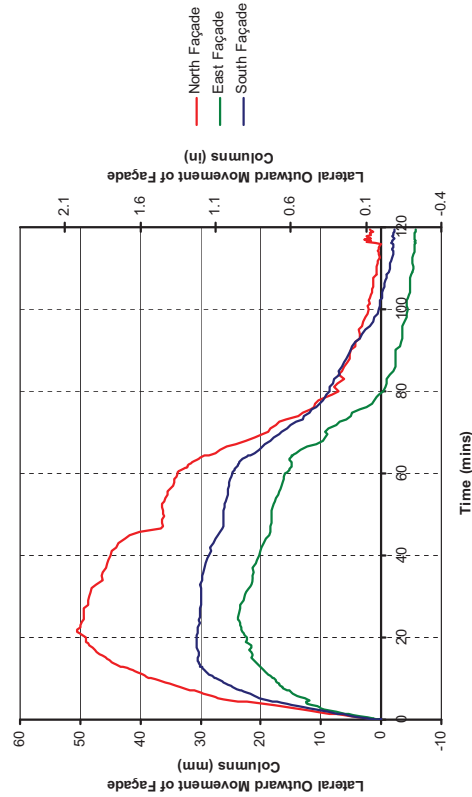
Figure 19 shows the outward movements as a function of time of selected columns along the north, south and east façades.

Figure 20 indicates the location of the columns being compared. The greater outward movement of the north and south façade columns is attributed to the thermal expansion of the north-south beams spanning onto these columns (Figure 21), which is resisted by the beams in the central bays and the cold core.

Figure 19: Outward movements of selected columns along the perimeter of the building. (Positive (+) movement indicates outward movement) Refer to the Figure below for the positions of the columns that were plotted.

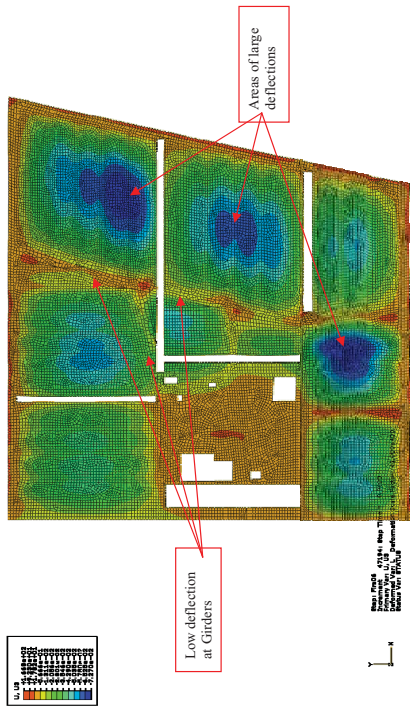
Throughout the heating phase the combined effects of restrained thermal expansion and thermal bowing act to increase floor deflections. This is the most visible response of a structure to fire, however a simple analysis of deflection does not give the full picture due to the ability of structures to redistribute loading. Please refer to Figure 23 for an example of deflections at peak heating.

Figure 23: 700°C Unfilled Flutes Case 1 - Vertical Deflection Contours at Peak Heating

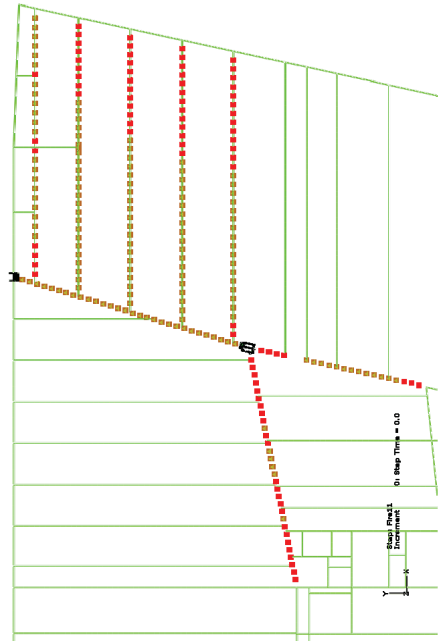
During the heating phase of the WTC7 analysis less than half the available shear studs in the north-east bay fail (Figure 24). This indicates that composite action is still largely available, assisting the strength and stiffness of the structure.

Figure 24: 700°C Unfilled Flutes Case 1 - Shear Stud Breakage (highlighted as red dots) at Peak Heating. Intact shear studs are shown in brown.

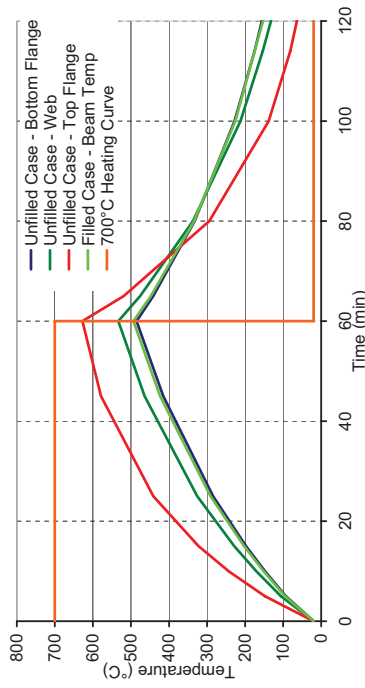
An example of heating in different parts of a beam is indicated in Figure 26. This figure shows the difference between a fully protected beam and a beam with unfilled flutes, as occurs in Case 1. Significant differences in temperature between the top and bottom flange are introduced due to the unprotected top surface of the top flange.

Figure 26: Comparison of temperatures of a typical beam/girder with flutes filled and unfilled condition.

In the 700°C fire case with unfilled flutes the top flange reaches approximately 675°C, indicating that if composite action has been fully lost then the north-east corner beams will fail during heating. This is not observed in the model, and therefore composite action must still exist to some degree, even if some shear studs have been broken.

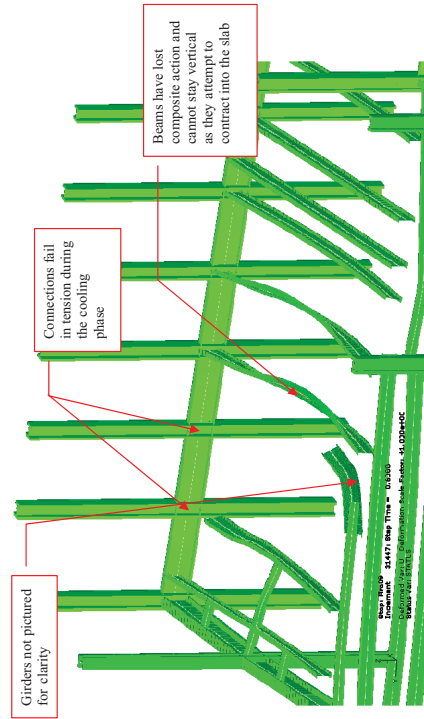
As indicated in Figure 27 the loss of composite connection between the slab and beams can lead to the secondary beams rotating around their long axis, reducing their bending strength.

Figure 27 also indicates that the large tensile forces developed as the secondary beams contract against the slab are sufficient to rupture their connections leading to local failure.

- Large displacements in north-east corner are not recovered during cooling
- Secondary beam connection failure reduces robustness of north-east corner floor
- Contraction of secondary beams act to pull Girder 79-44 eastward on seated connection

Figure 27: 700°C Unfilled Flutes Case 1 - Beam Orientation During Cooling Phase (90 minutes, Girders not pictured for clarity)

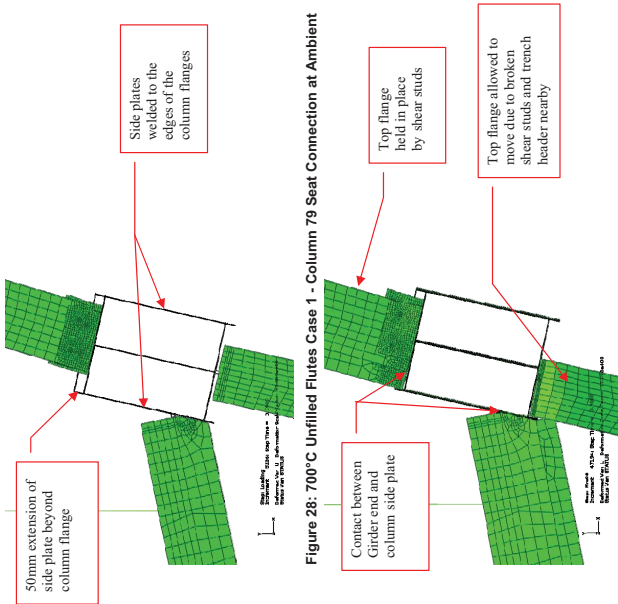
Figure 28: 700°C Unfilled Flutes Case 1 - Column 79 Seat Connection at Ambient

- Seating bolts break early in the fire due to longitudinal expansion of Girder 79-44. The longitudinal expansion of the girder is particularly important in this case because thermal expansion in the girder is not being transformed into vertical deflections.
- End of girder is then free to be moved about on the seating plate
- Toward the end of heating the girder end is jammed into the corner between the column flange and the extension of the column side plate beyond the flange (see Figure 29)
- During cooling the contraction of the secondary beams pulls the girder end back across the seating plate
- At the end of the analysis the girder end sits precariously at the edge of the seat

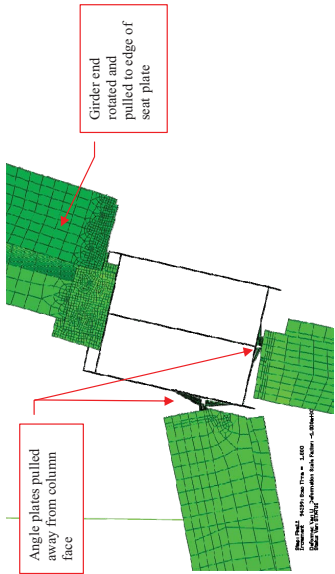
Figure 30: 700°C Unfilled Flutes Case 1 - Column 79 Seat Connection at End of Cooling

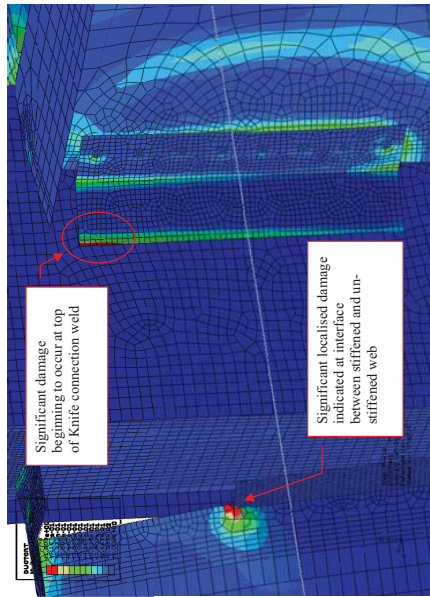
- As the girders contract during the cooling phase the angle plates of the connection are pulled off the face of the column (Figure 32) thus relieving the forces shown in Figure 33.

Figure 33: 700°C Unfilled Flutes Case 1 - Knife Connection Damage at End of Cooling (Red indicates heavy damage, dark blue indicates no damage)

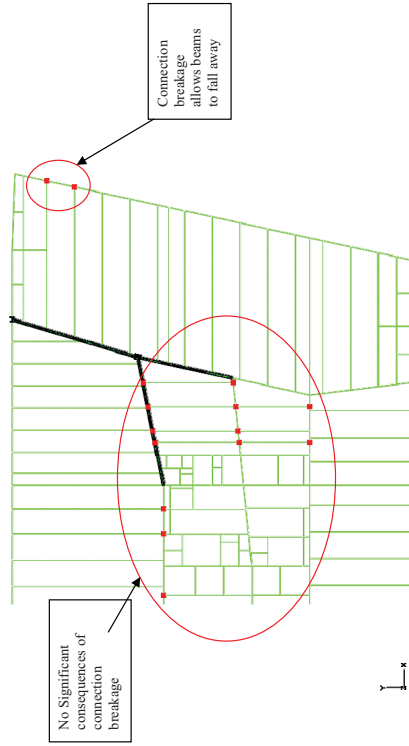
As indicated in Figure 34 there are a small number of simplified connections that break during the analysis. All of these connections break during the cooling phase and are therefore linked to increasing tension forces generated as the secondary beams contract.

- The trench headers do not significantly affect this redistribution due to the composite connection between the beams and the slab.
- In the case of the 2 connections in the north-east corner, breakage of these connections allows the beams to fall away as they have also lost all shear studs. Connection failure occurred due to tension forces acting on the connections during the contraction of the beams during the cooling phase.

- Failure of these connections introduces a sudden redistribution of load between the failing beams and the beams directly adjacent to them.
- Local breakage of secondary beam connections does not cause global collapse. This is because the floor loading is redistributed into the floor slab which resists it through tensile membrane action. The slab is able to transfer this load directly into the surrounding primary girders and edge beams.

Figure 34: 700°C Unfilled Flutes Case 1 - Breakage of Simplified Connections at locations indicated by red dots

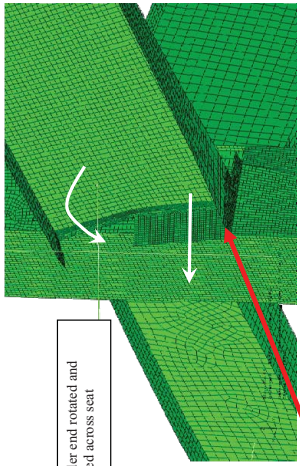
Figure 40: 700°C Unfilled Flutes Case 1 - Column 79 Seat Connection @ End Cooling

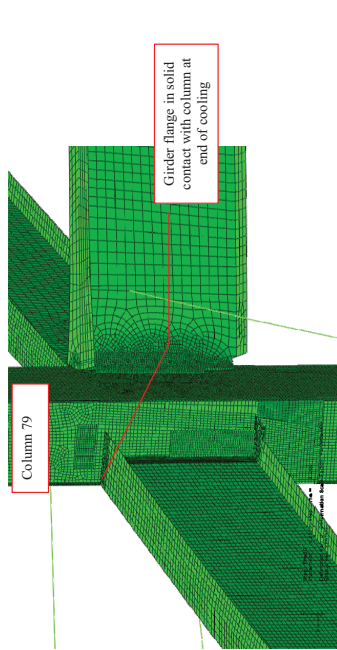
- At the end of 120 minutes of heating and cooling, the analysis shows that there is no structural collapse. The girder 79-44 at column 79 remains on its seat and is in solid contact with the inside face of the column side plate, unlike Case 1 where the girder end is left in a precarious position at the ends of the seating plate.

Figure 41: 700°C Filled Flutes Case 2 - Seated connection of girder 79-44 at the end of cooling

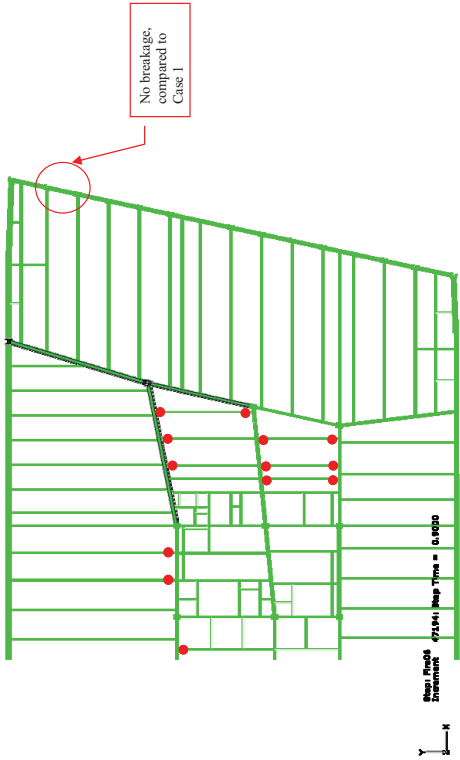
- Figure 50 shows that a number of numerically simplified connections break during the analysis. All of these connections break during the cooling phase in the numerical model.

- The connections break in tension due to the tension forces generated in the associated secondary beams as they contract during the cooling phase.
- The breakages of the connections do not significantly affect the response of the structure, nor cause significant deformation, as the floor loads are redistributed directly to the primary girders via the concrete slab. In Case 2 none of the secondary beams fall away after breaking their connections. This is because, despite the presence of trench headers, all affected beams are attached to the slab numerically by the rigid links which represent the shear studs. Please refer to the Modelling Assumptions report for more information. This type of response, i.e. secondary beams remaining attached to the slab after connection breakage, has been observed in the Cardington tests. It is therefore considered that this type of behaviour will not significantly affect global stability.

Figure 50: 700°C Filled Flutes Case 2 - Locations of simplified connections that break throughout the analysis, up to the end of cooling

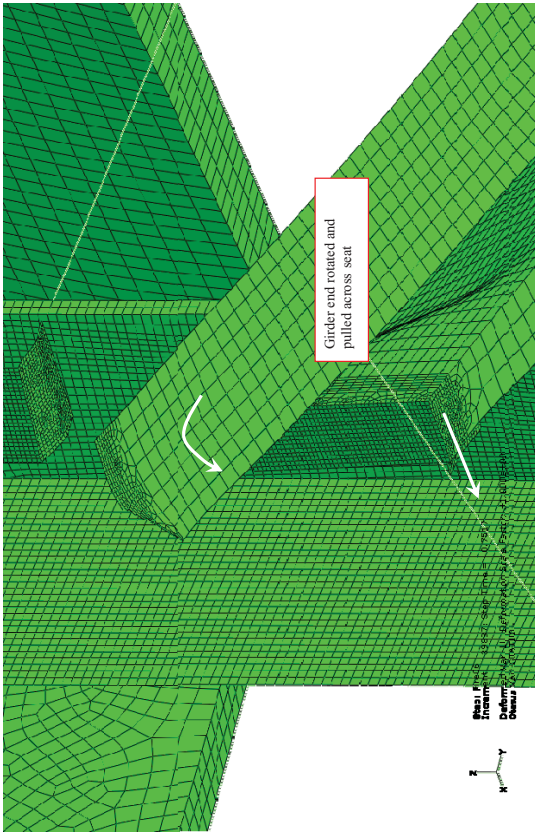
The structural response described above is presented in more detail in the following sections, with the mode of failure shown in Figures 56 to 58.

Figure 56: 800°C Unfilled Flutes Case 3 - Column 79 Seated Connection at Analysis Termination
