11-4403-cv

United States Court of Appeals *for the* Second Circuit

JOINT APPENDIX Volume 12 of 16 (Pages JA-3067 to JA-3320)

-----	x	
	:	
IN RE: SEPTEMBER 11 PROPERTY DAMAGE	:	21 MC 101 (AKH)
AND BUSINESS LOSS LITIGATION	:	
	:	
-----	:	
AEGIS INSURANCE SERVICES, INC., et al.,	:	04 CV 7272 (AKH)
	:	
Plaintiffs,	:	
-against-	:	SUPPLEMENTAL AND
	:	AMENDED SECOND
7 WORLD TRADE CENTER COMPANY, L.P.,	:	DECLARATION OF
et al.,	:	COLIN G. BAILEY
Defendants.	:	
-----	x

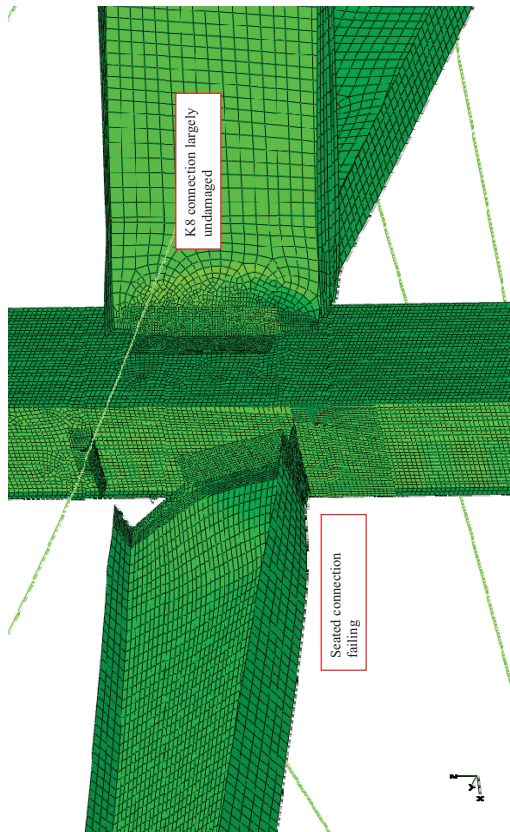
Figure 57: 800°C Unfilled Flutes Case 3 - Column 79 Seat and K8 Connections at Analysis Termination

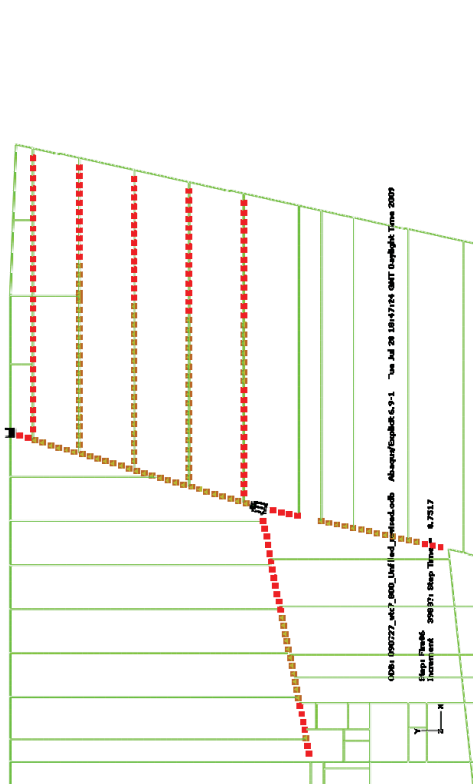
Figure 61: 800°C Unfilled Flutes Case 3 - Shear Stud Breakage 640°C Girder Top Flange Temperature (to be compared to Figure 24)

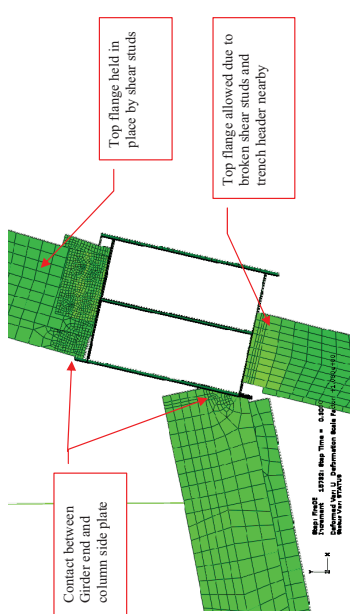
- Seating bolts break early in the fire due to longitudinal expansion of Girder 79-44. Top clip bolts fail shortly afterward
- End of girder is then free to be moved about on the seating plate
- Toward the middle of the heating phase the girder end is jammed into the corner between the column flange and the extension of the column side plate beyond the flange
- At approximately 47 minutes into the heating phase runaway failure of the north-east corner begins, focussed around the Column 79 seated connection

Figure 65: 800°C Unfilled Flutes Case 3 - Column 79 Seat Connection at 30 Mins

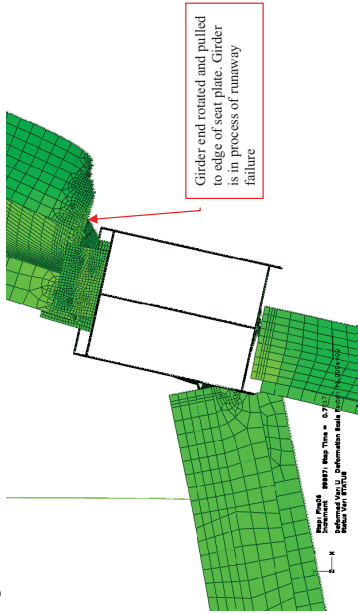
The movement of the 3 connections around Column 79 are imaged in Figure 64, Figure 65 and Figure 66. These images are taken at ambient, halfway through the heating phase and just before the end of heating (failure), respectively.

Figure 66: 800°C Unfilled Flutes Case 3 - Column 79 Seat Connection at Analysis Termination

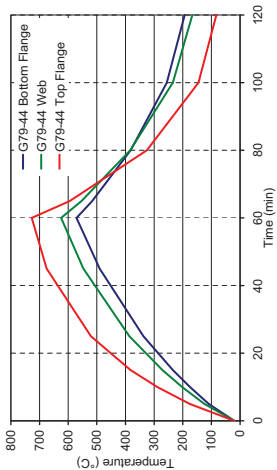
Figure 67: 800°C Unfilled Flutes Case 3 - G79-44 Temperatures

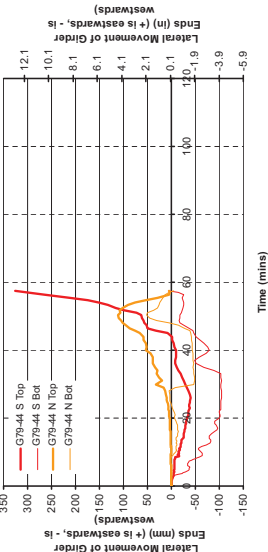
Figure 68: 800°C Unfilled Flutes Case 3 - G79-44 End Displacements (East-West)

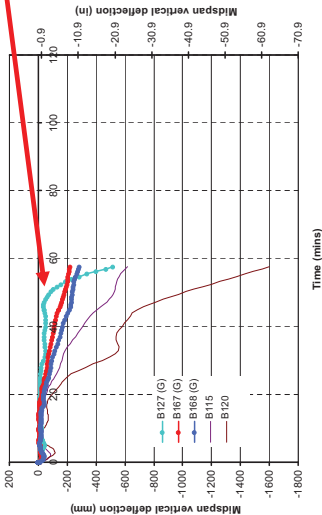
Figure 69: 800°C Unfilled Flutes Case 3 - Selected Beam and Girder Vertical Deflections

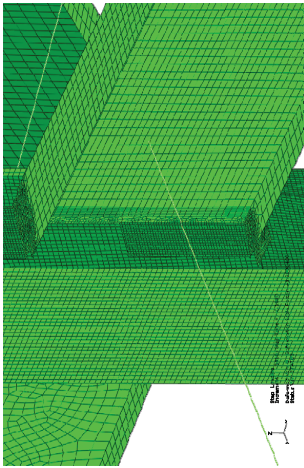
Figure 70: 800°C Unfilled Flutes Case 3 - Column 79 Seat Connection @ Ambient

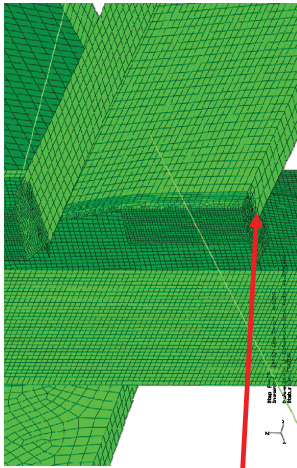
Figure 71: 800°C Unfilled Flutes Case 3 - Column 79 Seat Connection @ 30 Mins

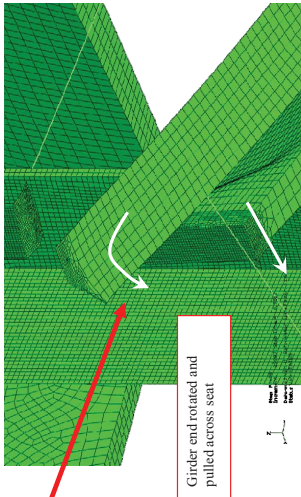
9	57	Analysis terminates due to numerical issues caused by on-going failure of structure	717

Figure 72: 800°C Unfilled Flutes Case 3 - Column 79 Seat Connection @ Analysis Termination

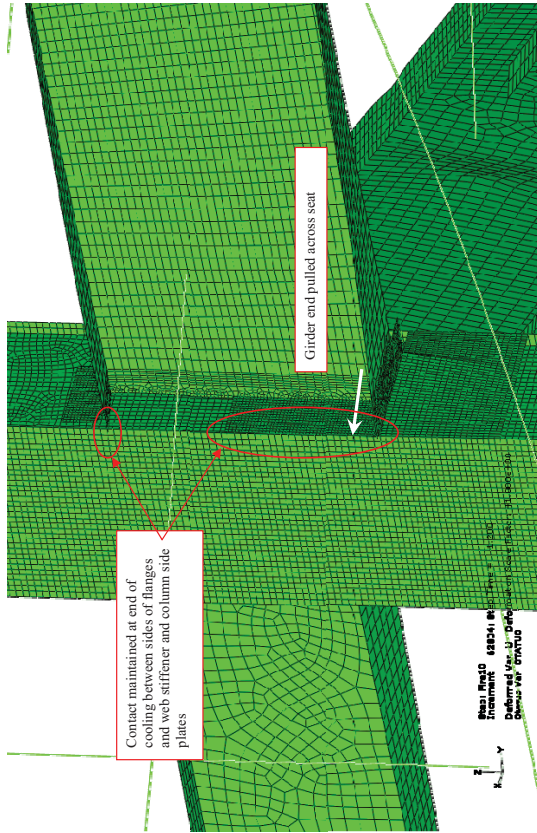
- This leads to greater longitudinal expansion, compared to vertical deflections caused by thermal bowing.
- When the girder between Column 44 and Column 79 is subjected to this lateral expansion it breaks it's bottom two bolts on the seat at column 79 and on the seat at column 44 during the early stages of heating (temperatures of girder top flange is between 75°C and 170°C). This allows the girder to be moved around on the seat plate at Column 79 and 44.

Figure 73: 800°C Filled Flutes Case 4 - Column 79 Seated Connection at End of Cooling

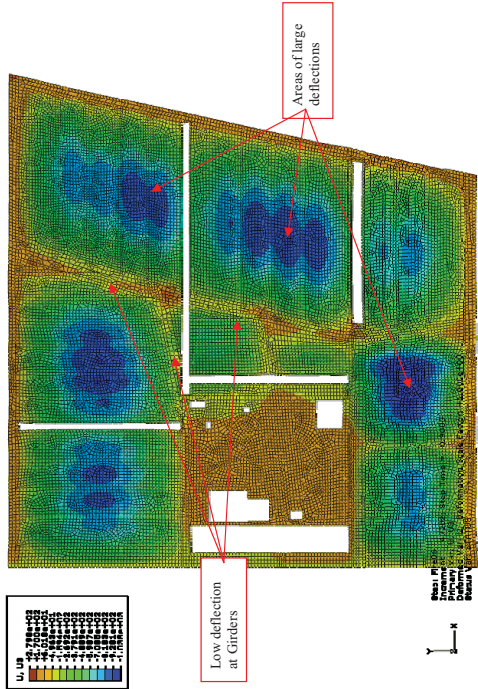
- Figure 74 presents the vertical deflection contours of the Case 4 floor slab at peak heating. At this point the top flange of Girder 79-44 is approximately 560°C. The floor steel has undergone lesser heating compared to the Case 3 model at peak temperature; however, the general trends in terms of location of maximum deflections are similar.

Figure 74: 800°C Filled Flutes Case 4 - Vertical Deflection Contours at Peak Heating

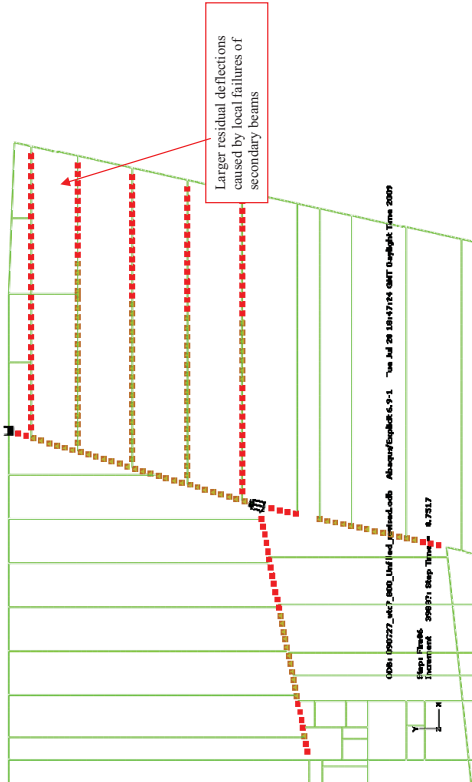
- During the heating phase a significant number of shear studs are broken, however it is considered that the secondary beams and girders retain enough connection to the slab in heating to act in a largely composite manner.

- Fewer than half of the shear studs on the secondary beams in the north-east bay are broken during the heating phase. It is therefore considered that a substantial amount of composite action is still retained. This compares well to Case 1, where the differences in heating regime and protection provide a heating case that is similar. This response is different to both Case 2 and Case 3 where significantly different heating regimes cause lesser or greater breakage, respectively.

Figure 75: 800°C Filled Flutes Case 4 - Shear Stud Breakage at Peak Heating
