A Structural Reevaluation of the Collapse of World Trade Center 7

Final Report

INE Report 18.17

March 2020

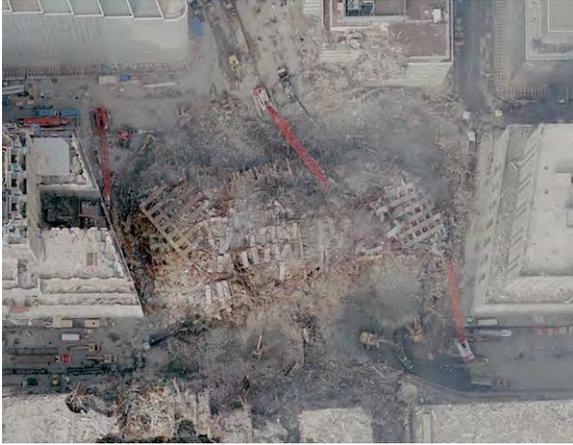
Figure 1.7 WTC 7 debris pile (NOAA, September 23, 2001).

2. The debris pile of WTC 7 was contained mostly inside the building's footprint. Furthermore, it did not have large pieces of concrete flooring or intact structural framing that would be expected in a building collapse (see Figure 1.7).

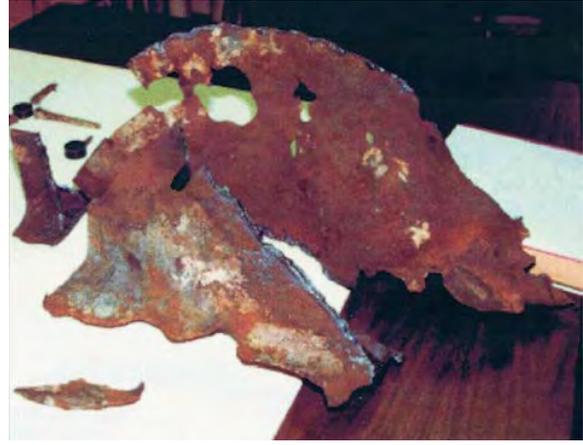
Figure 1.8 Steel from WTC 7 that experienced oxidation and sulfidation (FEMA, 2002).

3. According to Appendix C of FEMA's May 2002 report, a steel member recovered from WTC 7 was found to have experienced corrosion due to a combination of oxidation and sulfidation at 1,000°C, resulting in the formation of a liquid eutectic (see Figure 1.8). Researchers have hypothesized that the presence of thermate, which is a form of thermite

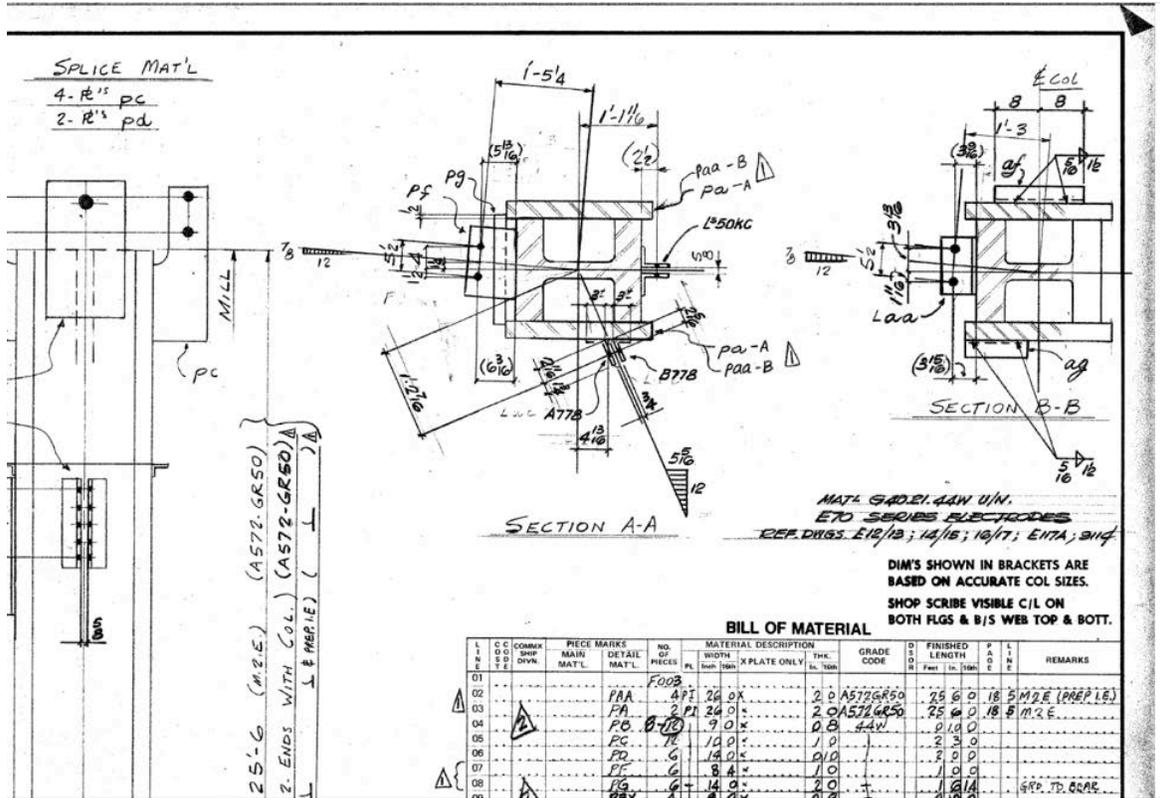
Figure 1.12 Part of the drawing for Column 79 of Floor 13.

zoomed-in view of the drawing in Figure 1.10. The view is of the core area for Floors 12 and 13. Figure 1.12 shows the details of Column 79 at Floor 13, which illustrate that Column 79 was a built-up column.

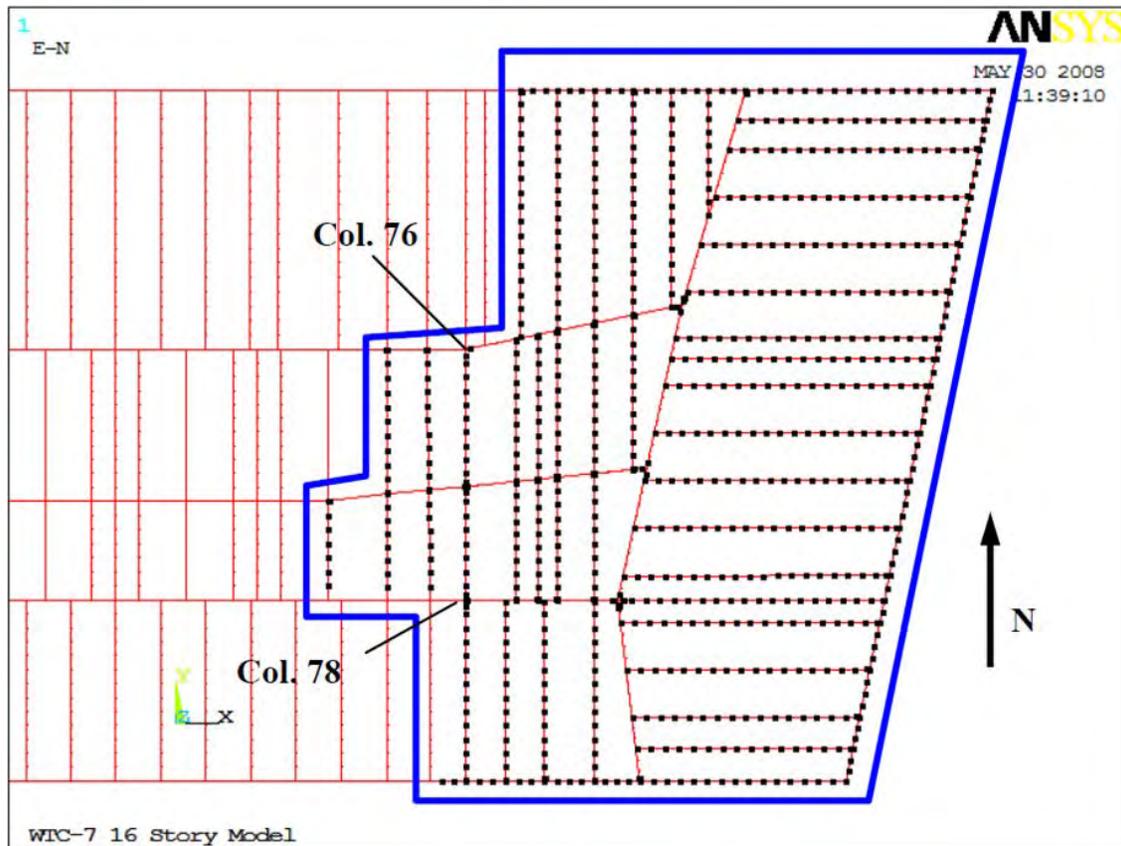
Figure 2.5 Area of floor where connection failure was modeled by NIST

In the NIST investigation, the failures of the floor-framing connections and the shear studs were modeled with break elements on Floors 8 to 14. Outside the selected area in Figure 2.5 shown below, structural damage — such as buckling of the steel frame and crushing and

cracking of the concrete slab — was modeled over the entire floor, but connection failures were not modeled over the entire floor. Connections were also not modeled in the exterior moment frame, as no failures were observed there prior to the onset of global collapse (NIST, 2008, NCSTAR 1A).

By not modeling connections in the outside frame, NIST overestimated the rigidity of the outside frame. That assumption and inconsistent modeling for the framing connections resulted in the stiffness of the east side of the building being different than that of the west side. This resulted in the stiffness being compromised across the plan of the building.

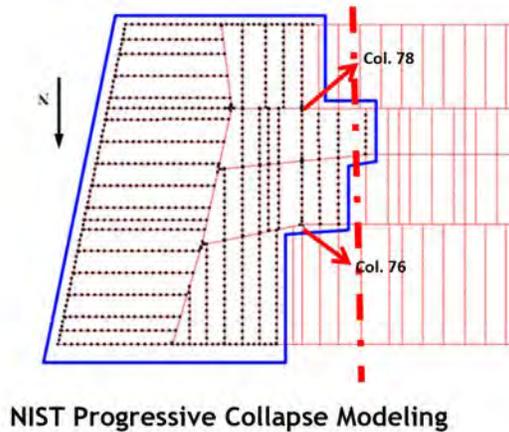
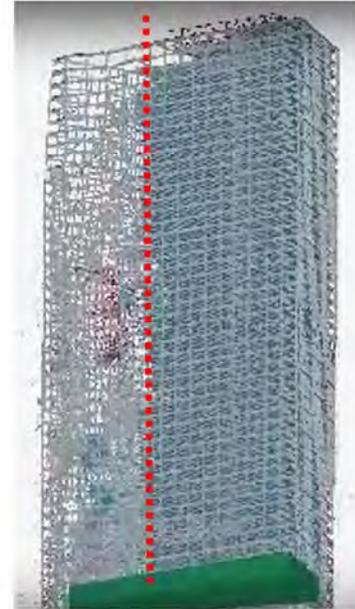
Figure 2.6 Progressive collapse separated into two parts.

The NIST simulation of the collapse illustrated that the west side of the building acted differently from the east side. The structural response to failure would more closely resemble the actual collapse if the connections had been accounted for throughout the structural frame. By not modeling the connection failures outside the selected area shown in Figure 2.5 above, NIST appears to have reduced the stiffness in the area outside the selected area and separated its progressive collapse simulation into two parts (see Figure 2.6).

Connections were not modeled; outside selected blue space.

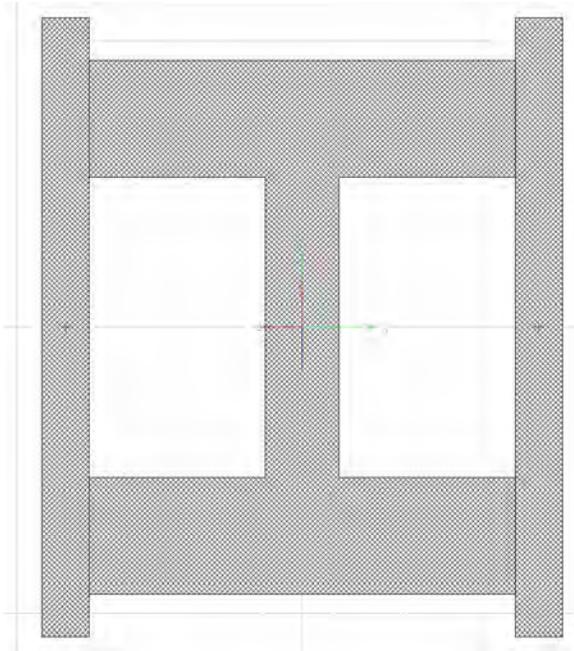
Figure 2.16 Cross section of Column 79.

Column 79 at Floor 13 was a built-up column consisting of W14×730 and two steel plates 2 inches thick by 26 inches wide welded on the sides. Figure 2.16 shows the cross section of Column 79. Figure 2.17 shows the mechanical properties of steel against temperature (Engineering tool box, 2011). A buckling analysis was conducted for Column 79 according to the AISC Steel Construction Manual (AISC, 2011). Figure 2.18 shows the load capacity of Column 79 versus the effective length at different temperatures assuming a pinned-pinned condition. The two red lines mark the effective length of 12 feet 9 inches and 25 feet 6 inches. The two effective lengths are the single floor height and the double floor height. The loading capacity of Column 79 at double floor height (25 feet 6 inches) would be the load capacity of the column during the fire if Column 79 were to lose its support on one floor. It is clear from Figures 2.17, 2.18 and Table 2.1 that the buckling load capacity was significantly higher than the acting load over a two-story unsupported length. Thus, a buckling failure due to vertical loading and heat caused by a fire could not have occurred.

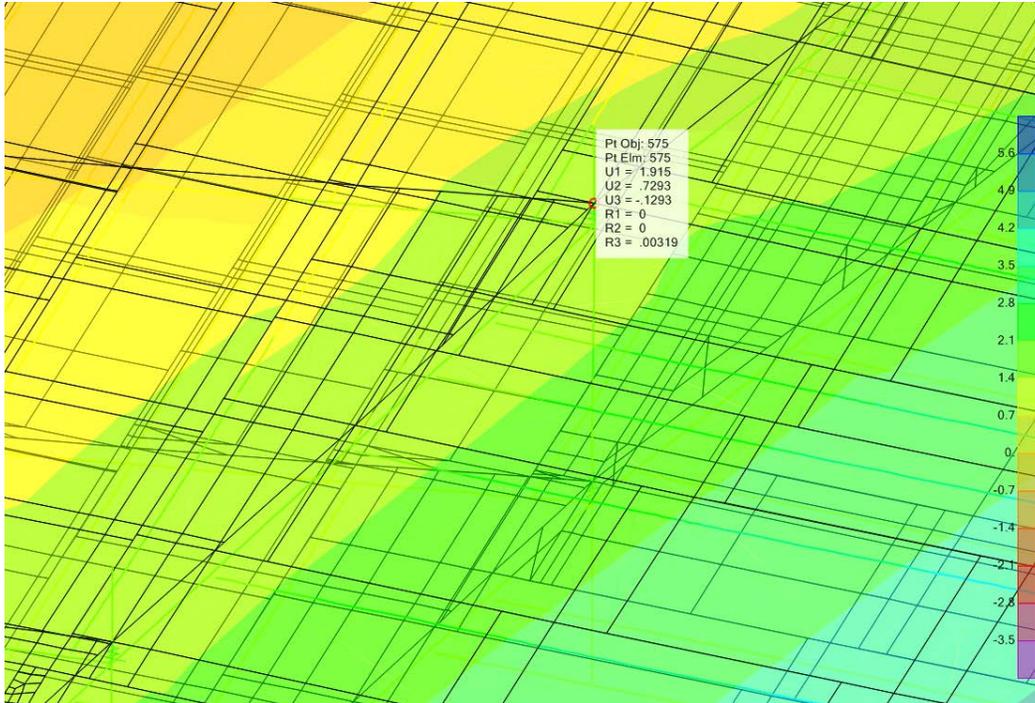
Figure 2.59 shows the displacement of the floor system surrounding Column 79. The displacement at Column 79 in the x -direction was 1.915 inches east (and not west), and the displacement at Column 79 in the y -direction was 0.7293 inches north. Note that this is the overall displacement of the floor system. The westward displacement of girder A2001 relative to Column 79 was found to be less than 1 inch, which differs substantially from the 6.25 inches of westward movement of girder A2001 reported by NIST. We believe this is because NIST treated the exterior frame as infinitely stiff and fixed it against horizontal movement. Our analysis was based on using the actual external frame stiffness, which was very flexible.

Figure 2.59 Displacement (inches) of the floor system surrounding Column 79.

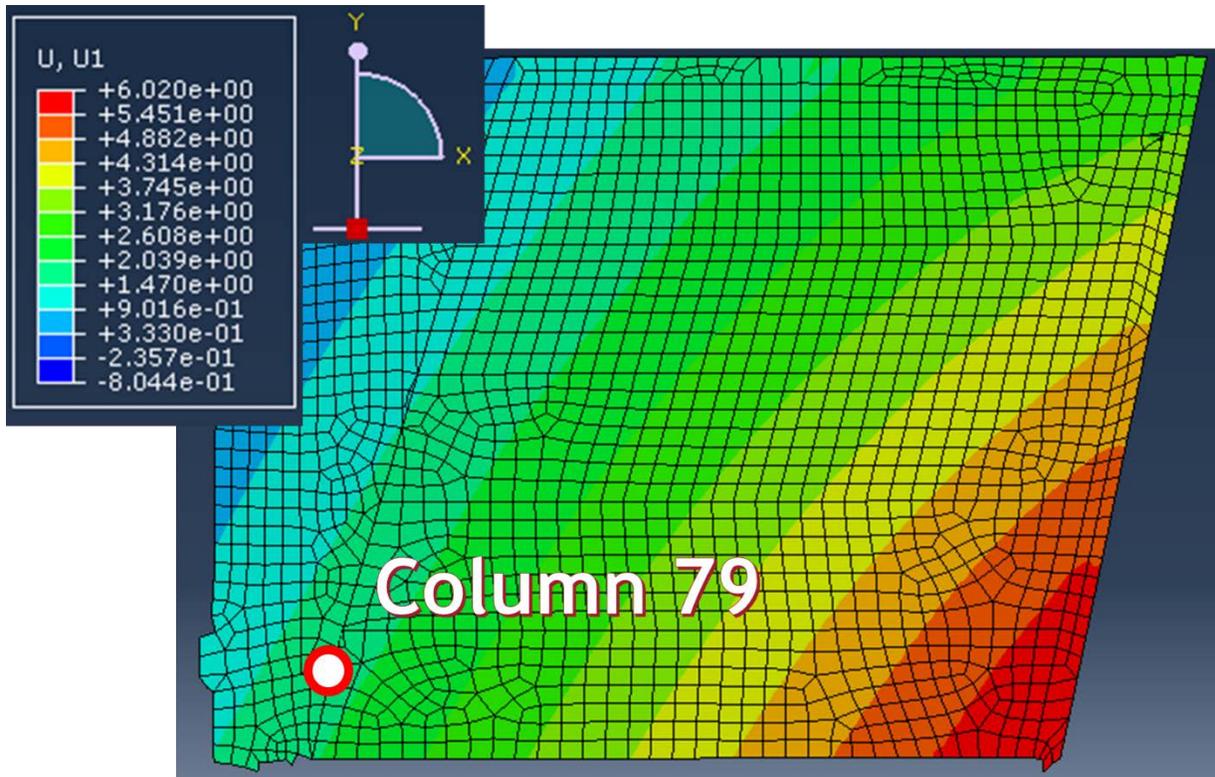
Figure 2.63 Movement (inches) in x -direction at Floor 13 around Column 79.

According to NIST, the initiating failure occurred at the connection between Column 79 and girder A2001 at Floor 13 due to a relative displacement of girder A2001 of 6.25 inches. Our ABAQUS analysis corroborated the findings of our SAP2000 analysis, showing that girder A2001 would undergo less than one inch of westward displacement relative to Column 79 under the worst-case fire condition. Examining all possible conditions, our analysis found that the westward movement of girder A2001 relative to the base plate on Column 79 was 3.68” for non-composite, 2.18” for partially composite and less than 1” for composite behavior (the condition at time of the fire).

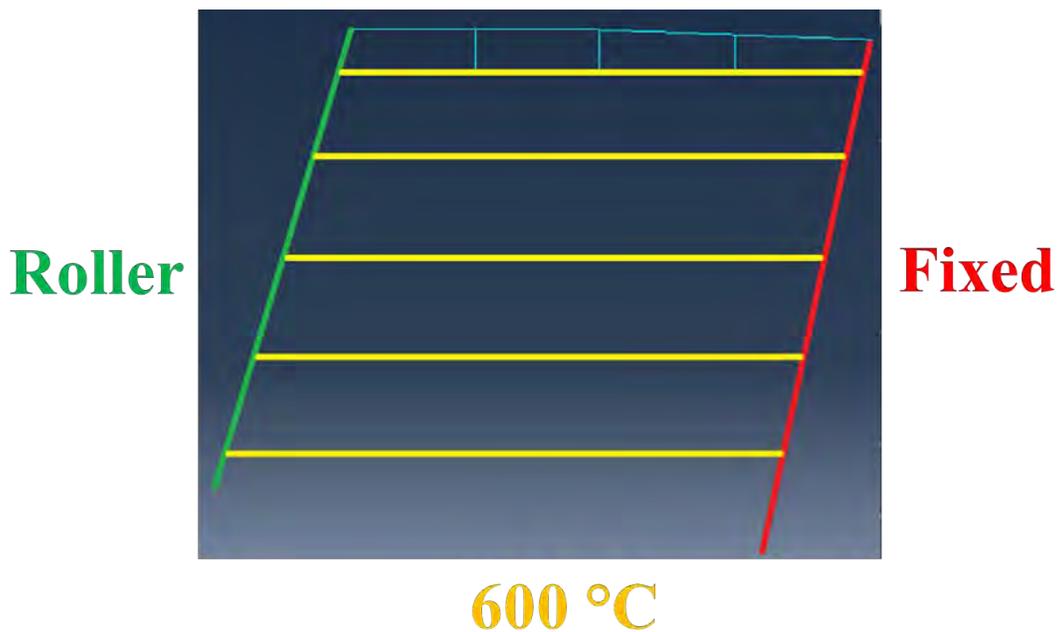
The boundary conditions reported by NIST and the assigned temperature distribution are shown in Figure 2.65 below. The concrete deck was not included in this model to ensure free expansion of the steel frame. The assigned temperature is also higher than the expected fire condition.

Figure 2.65 Local frame boundary conditions reported by NIST.

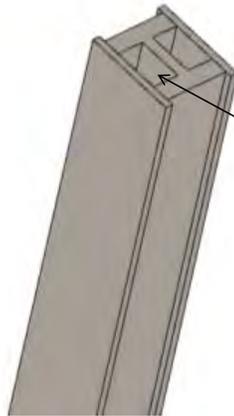
Figure 3.3 shows the built-up configuration of Column 79 with its protruding side plates. Using the assumptions made by NIST, we analyzed the thermal response of Floor 13.

2" x 26" build-up side plates

W14 x 730 standard structural shape

Figure 3.3 Column 79 section showing side plates welded to a W14x730.

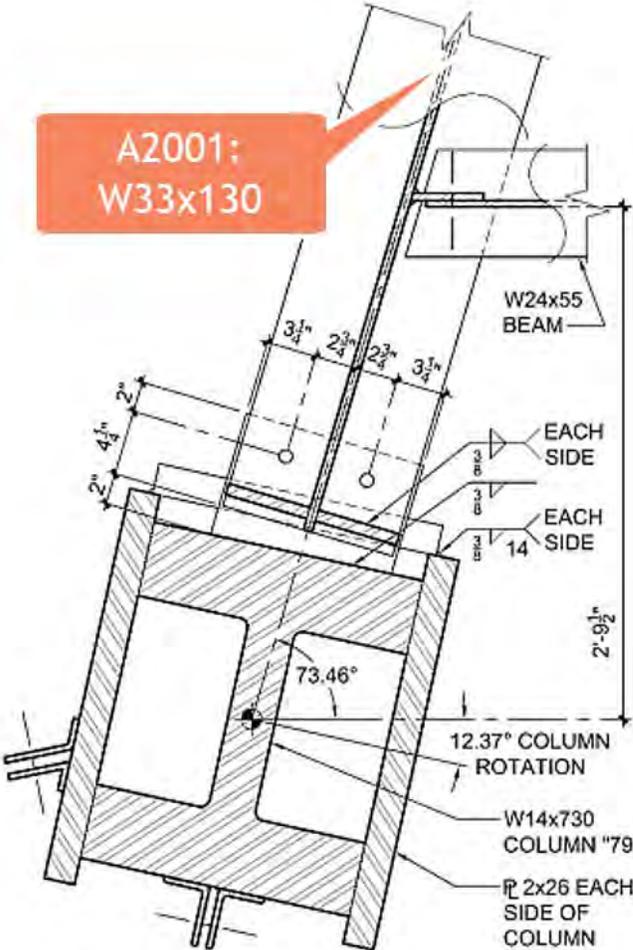
Figure 3.5 shows the girder bearing seat at Column 79 is 12 inches wide. The flange width for W33 x 130 girder A2001 is 11.510 inches wide and centered on the seat; its web is 0.580 inches thick. This would require a lateral travel distance of 6.290 inches for the web to be beyond the seat. However, the distance between the column side plates is 17.89 inches. The girder and bearing seat are slightly off center to the east, with just 3.678 inches between the girder's western edge and Column 79's western side plate. Thus, the side plate prevents the girder's web from traveling beyond the bearing seat.

Given that the Column 79 side plate prevents the girder's web from traveling beyond the bearing seat, it appears that the structural analysis performed by NIST either minimized the side plate protrusion on Column 79 (nominally 1.79 inches) or ignored it altogether.

Figure 3.5 Plan View for Floor 13 at Column 79 and girder A2001 seat connection (Data from Frankel Steel Limited, 1985, Drawing 9114; figure prepared by Brookman, 2012).

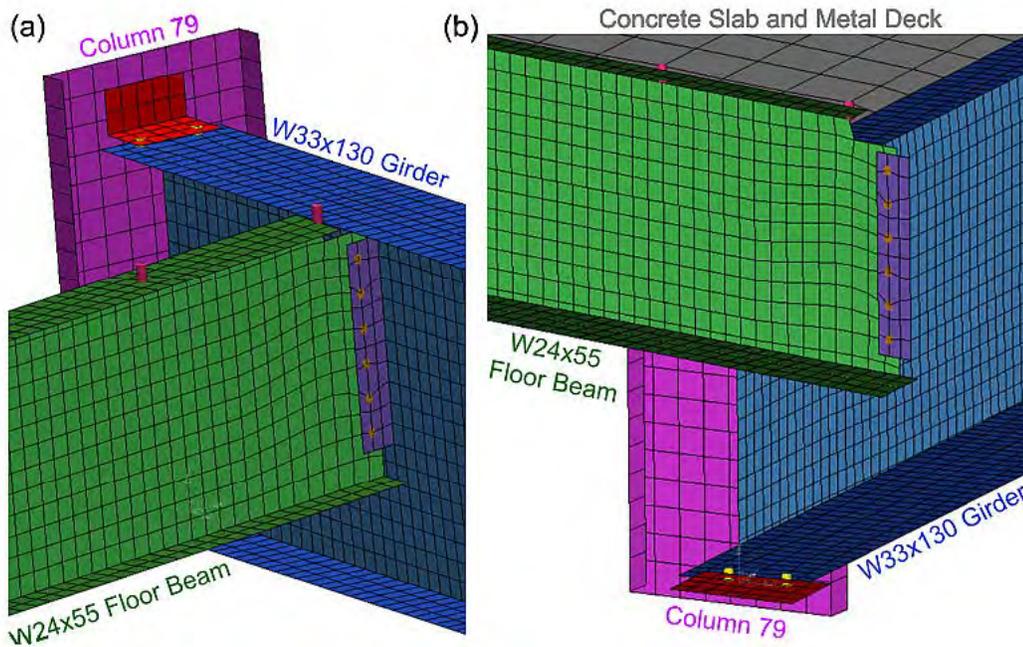
Figures 3.9 and 3.10 below, which are from the NIST report, show that the NIST report’s drawing and analysis figures omit these web stiffeners. Figures 3.5 and 3.6 show the actual configuration.

Figure 3.10 Figure 8-23 of the NIST report showing NIST's finite element analysis of the Column 79 and girder A2001 seated beam connection.

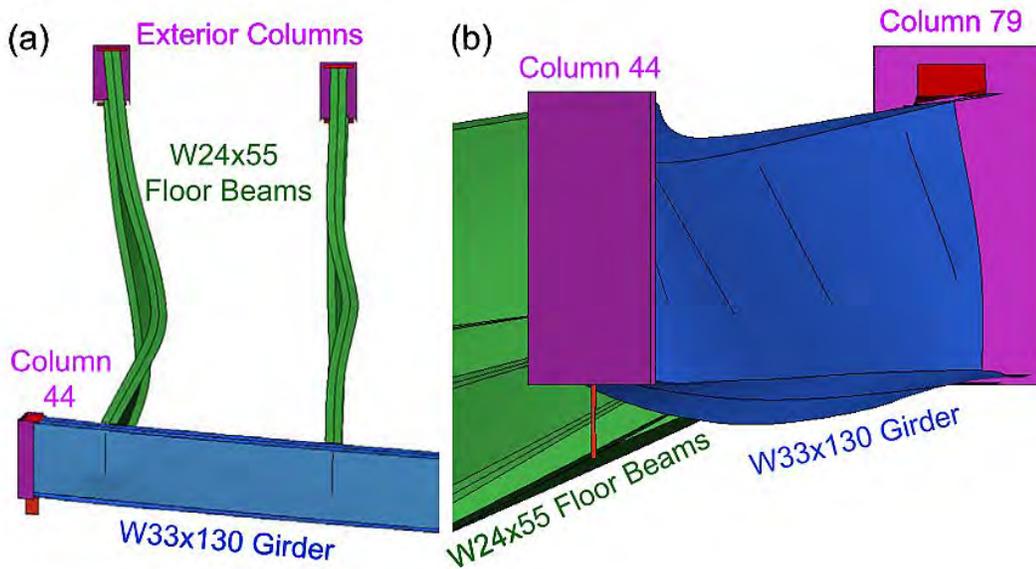
Figure 3.13 Figure 8-27 of the NIST report shows results of a finite element analysis where lateral support beams connecting to G3005 were not included (NIST, 2008, NCSTAR 1-9, Vol. 1, Page 354).

When the NIST constraints are followed, our analysis showed that beams D3004 and K3004 would have also buckled (see Figures 3.11 to 3.14). The NIST results were based upon erroneously selected boundary conditions, wherein NIST assumed the east exterior wall was extremely stiff and acted as a fixed restraint against thermal movements. As discussed previously, this was not the case.

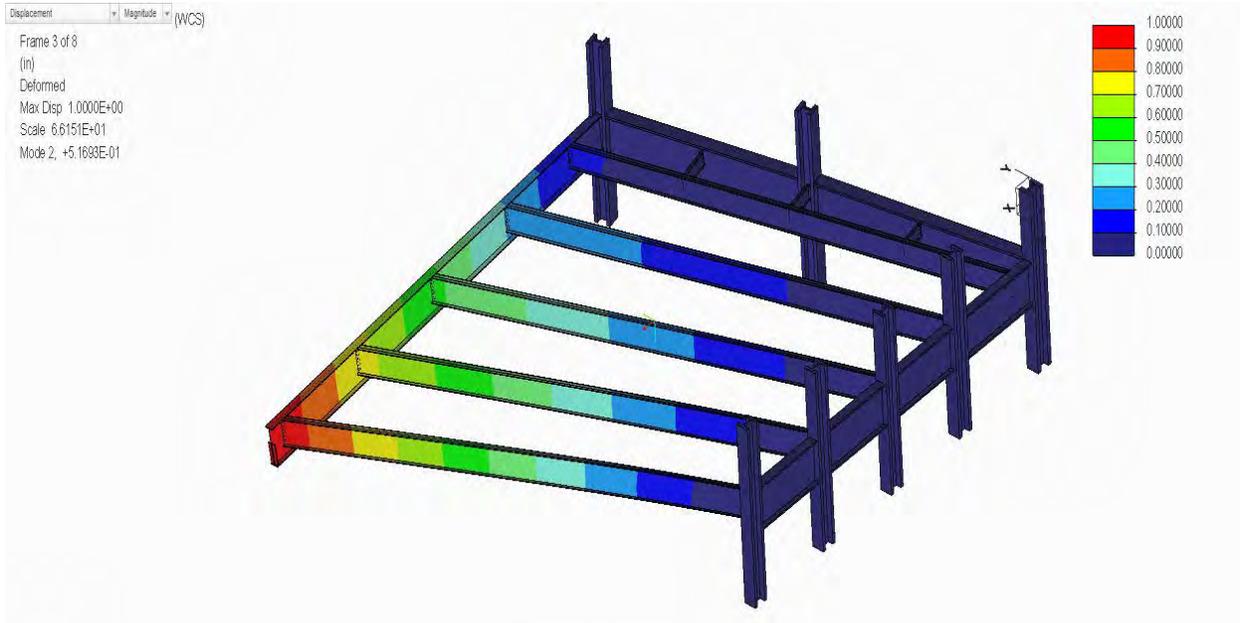
To determine the stiffness of the falling Floor 13 beam and girder assembly, a finite element modal analysis was performed with the assembly constrained at the north and east exterior walls and the girder sitting on its bearing seat at Column 44 with the bolts at the girder seat broken there. The results are shown in Figure 3.15. The first mode of 22 Hz involved only the beams moving in a transverse direction and was not relevant. The second mode of 0.52 Hz involved the participation of the entire beam and girder assembly in the vertical direction and was relevant.

Figure 3.15 The relevant 0.52 Hz mode of the falling beam and girder assembly.

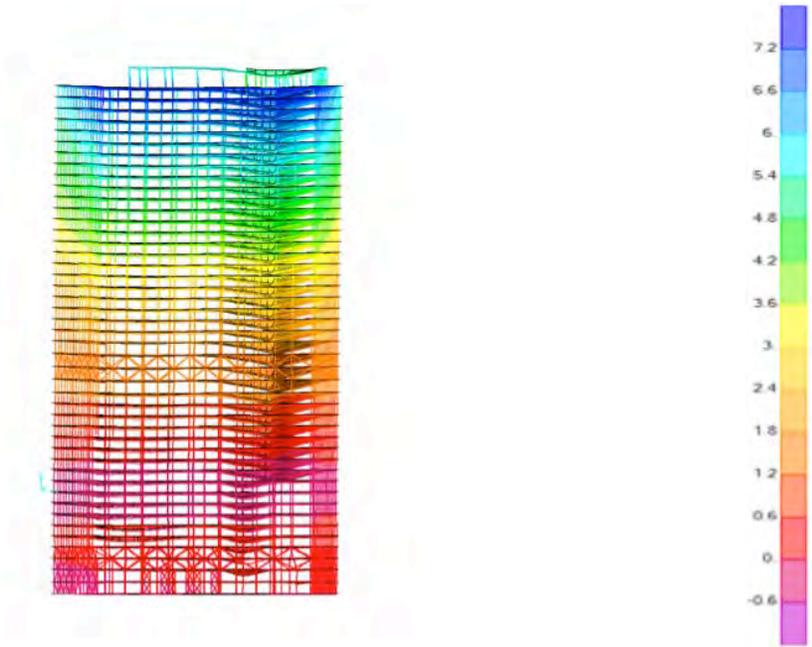
Figure 4.3 Columns 79, 80, and 81 are removed from Floor 13 to Floor 21. The building tilts to the east 7.2 inches. The penthouse does not collapse.

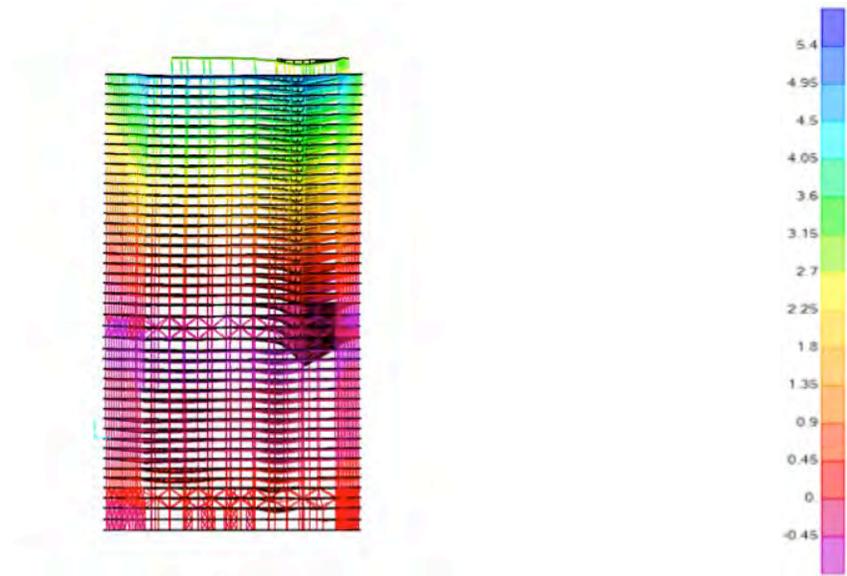
Figure 4.4 Columns 79, 80, and 81 are removed from Floor 21 to Floor 29. The building tilts to the east 5.4 inches. The penthouse does not collapse, though penthouse deflection increases.

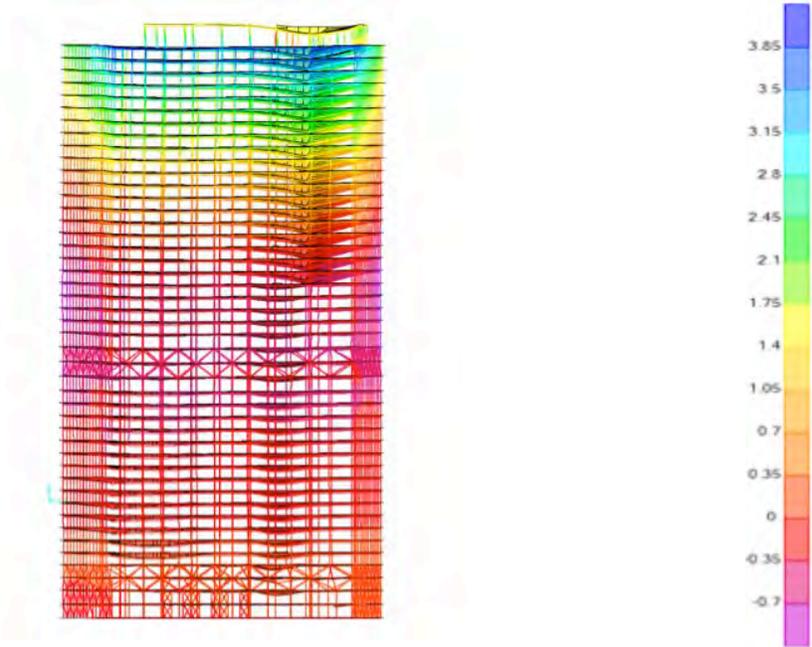
Figure 4.5 Columns 79, 80, and 81 are removed from Floor 29 to Floor 37. The building tilts to the east 3.85 inches. The penthouse does not collapse, though its deflection increases.

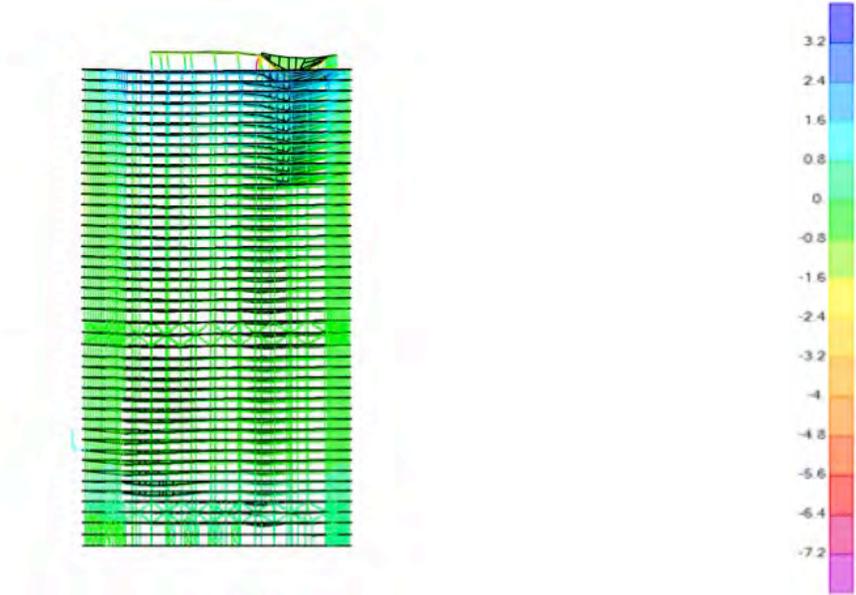
Figure 4.6 Columns 79, 80, and 81 are removed from Floor 37 to Floor 45. Tilting of the building is now negligible, whereas the deflection of the penthouse is now much greater.

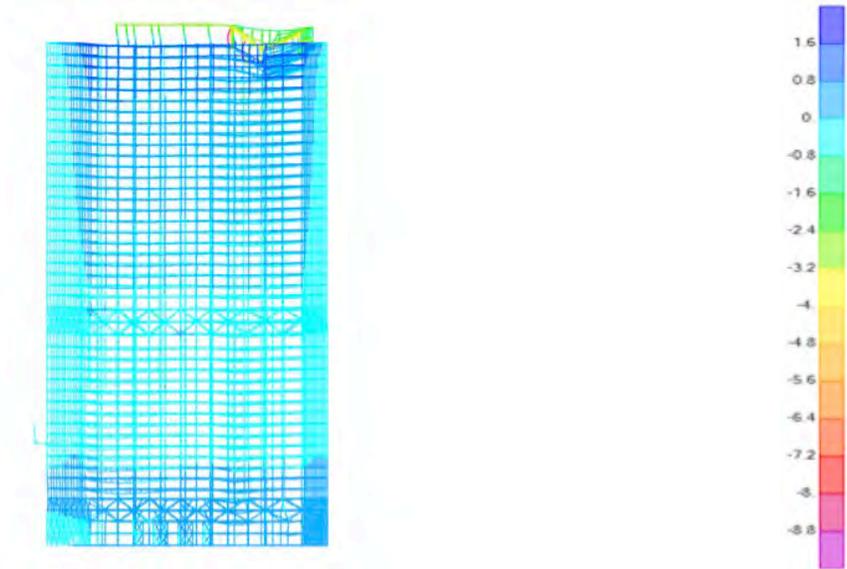
Figure 4.7 Columns 79, 80, and 81 are removed from Floor 45 to the penthouse. Tilting of the building is now negligible. The penthouse now collapses, as demonstrated from the significant amount of deflection given in the figure.

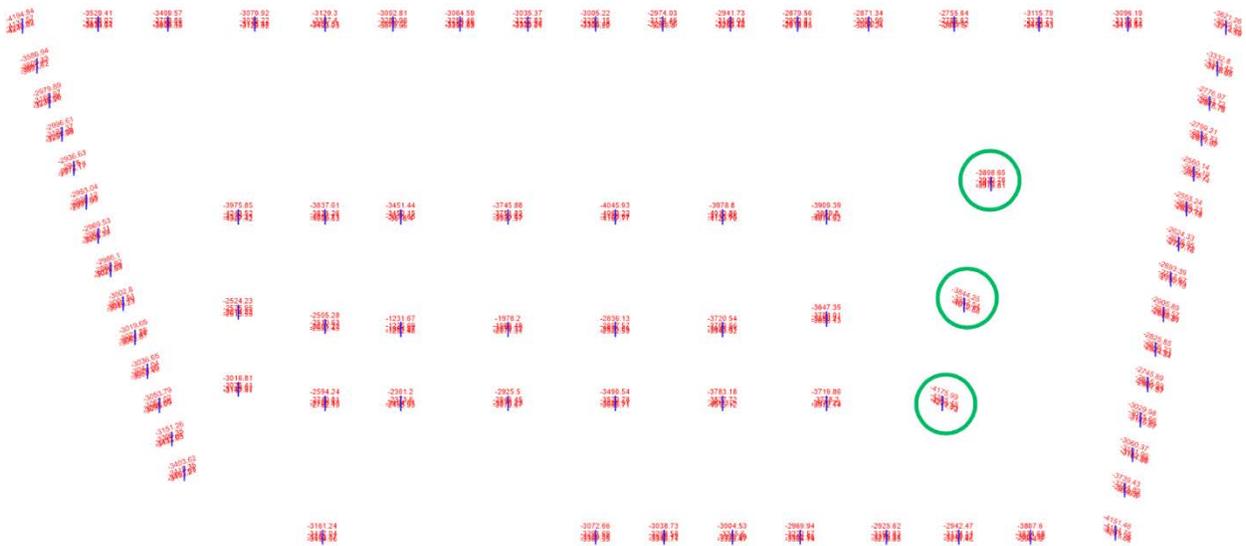
Figure 4.8 Linear static analysis of Columns 79 to 81 (circled in green) being removed.

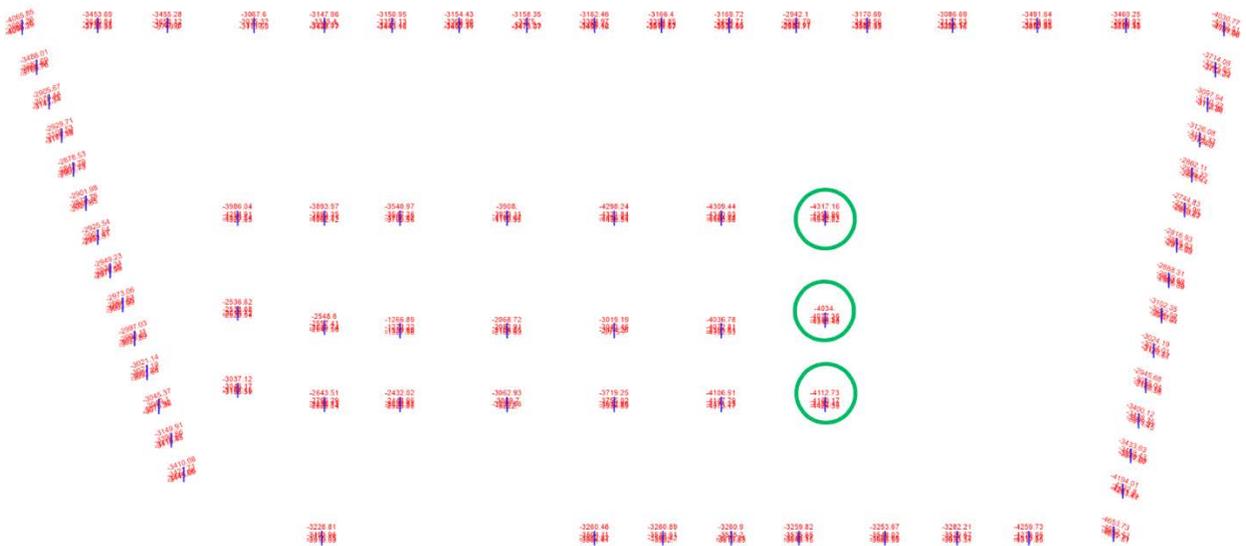
Figure 4.9 Linear static analysis of Columns 76 to 78 (circled in green) also being removed.

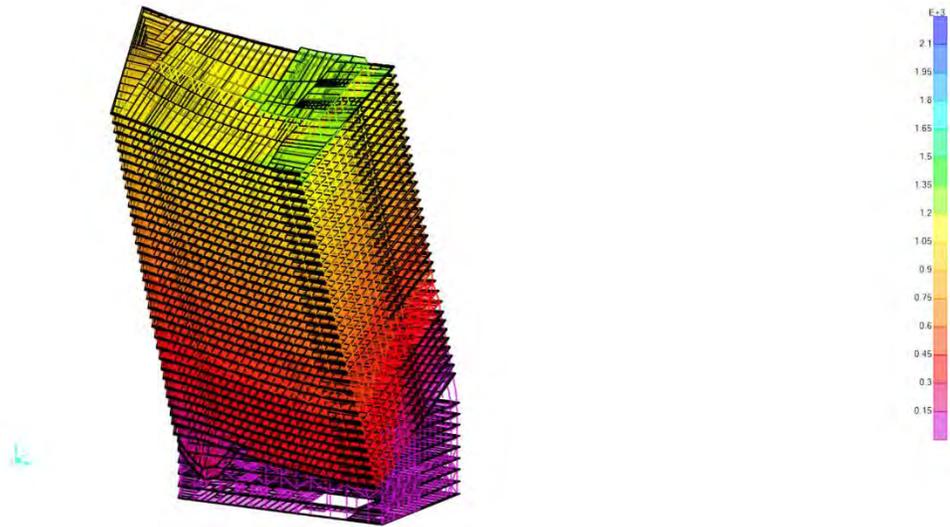
Going one step further, we simulated the failure of Columns 76, 77, and 78, even though these columns would not buckle due to the loss of Columns 79, 80, and 81. With the removal of six core columns on the eastern side of the building (Columns 76 through 81), we found that a total collapse of the building would ensue. First, the axial loads on the exterior columns around the southeastern corner of the building would exceed design loads, causing these exterior columns to fail. The failure of these exterior columns would then cause the axial loads on most of the remaining core columns and some of the remaining exterior columns to exceed design loads, resulting in those columns failing and leading shortly thereafter to total collapse. However, rather than a straight-down collapse as observed, the building would tip to the southeast, as illustrated in Figures 4.14, 4.15, and 4.16 below.

Figure 4.14 A visualization of linear static analysis, from the southeast, showing movement to the southeast when Columns 76 to 81 are removed. The movement shown is highly amplified for clarity. The actual scale of the displacements are presented to the right.

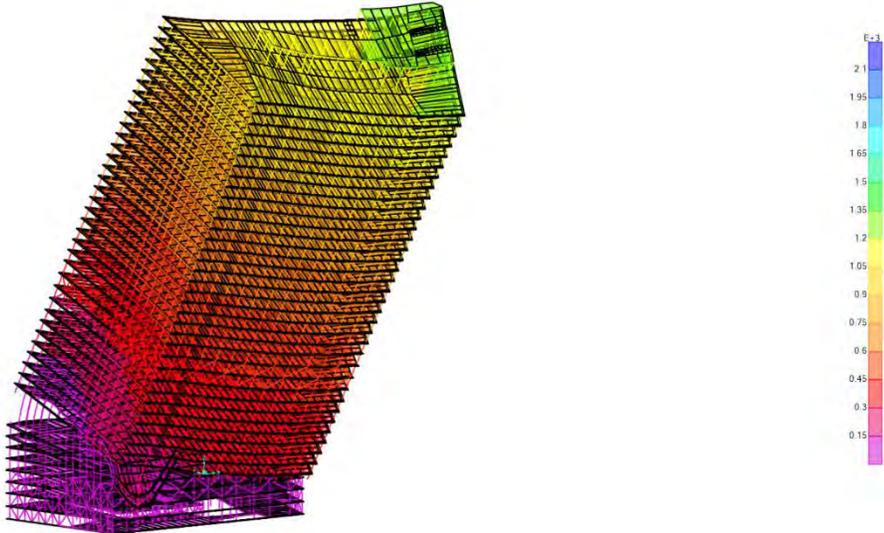
Figure 4.15 Visualization of linear static analysis, from the southwest, showing the building tipping to the southeast after the hypothetical failure of Columns 76 to 81. The movement shown is highly amplified for clarity. The actual scale of the displacements are presented to the right.

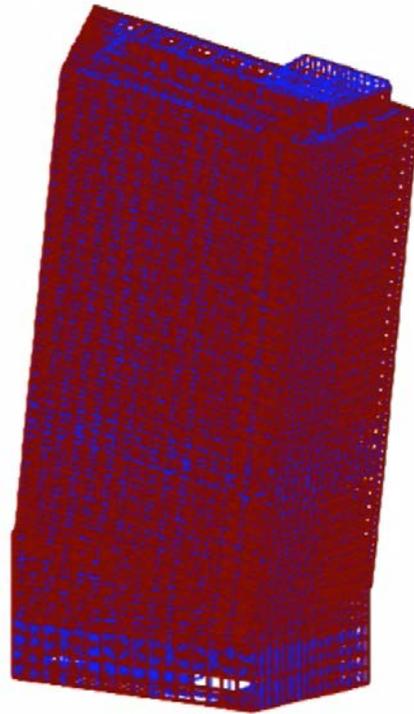
Figure 4.16 Dynamic analysis results showing the building tipping to the southeast after the hypothetical failure of Columns 76 to 81. The movement shown is highly amplified for clarity.

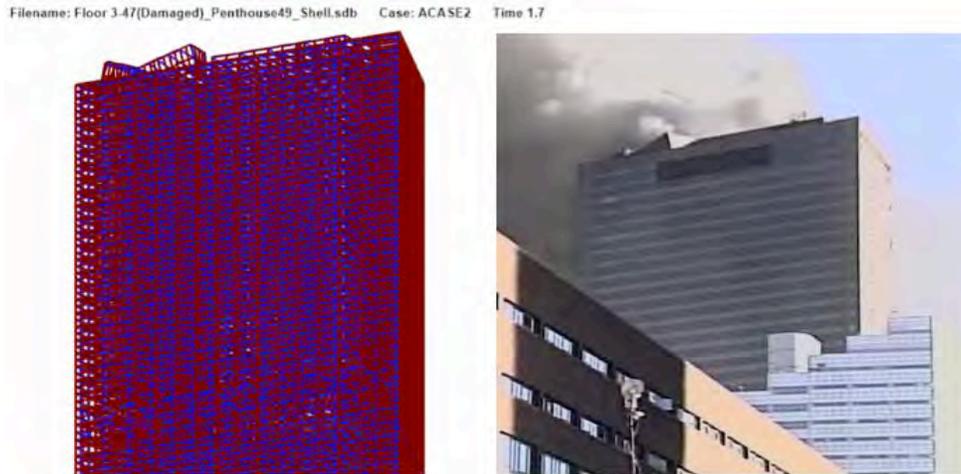
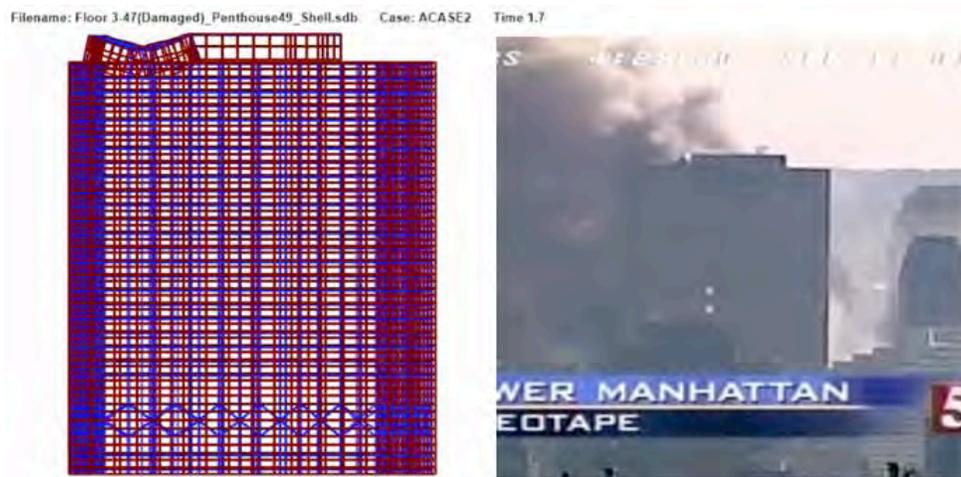
Figure 4.17 (a) Comparison of simulated collapse to perspective 1; (b) comparison of simulated collapse to perspective 2.

Based on this analysis, we found that the simultaneous failure of all core columns followed by the simultaneous failure of all exterior columns produces almost exactly the behavior observed in videos of the collapse. The computer time history model accounted for mass and acceleration during collapse in which an acceleration time dependent function accounted for impact resistance over time. Specifically, the simulated velocity and acceleration of the building in our SAP2000 model, shown in Figure 4.18, matches almost exactly with the motion measured by David Chandler (Chandler, 2010), including the approximately 2.5 seconds of free fall, shown in Figures 4.19 and 4.20 below.

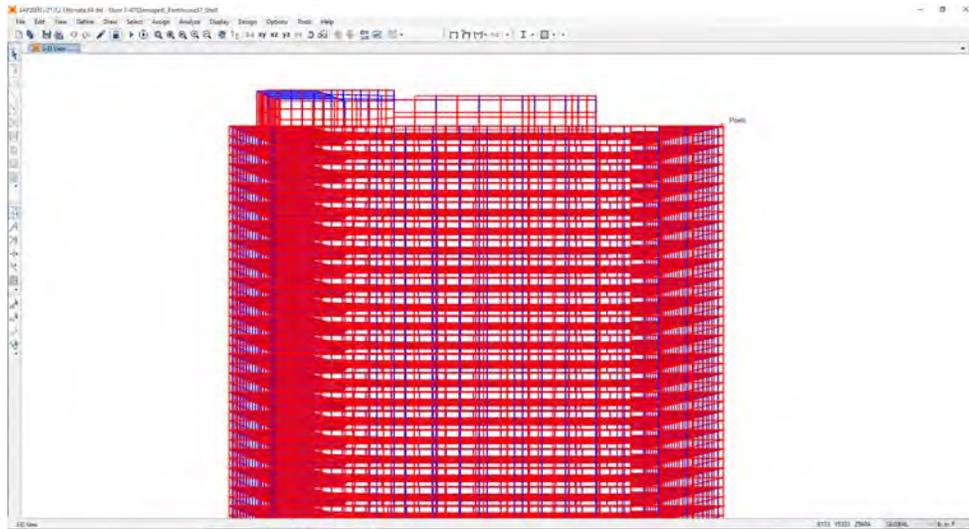
Figure 4.18 UAF Simulation of core column-exterior column failure scenario.

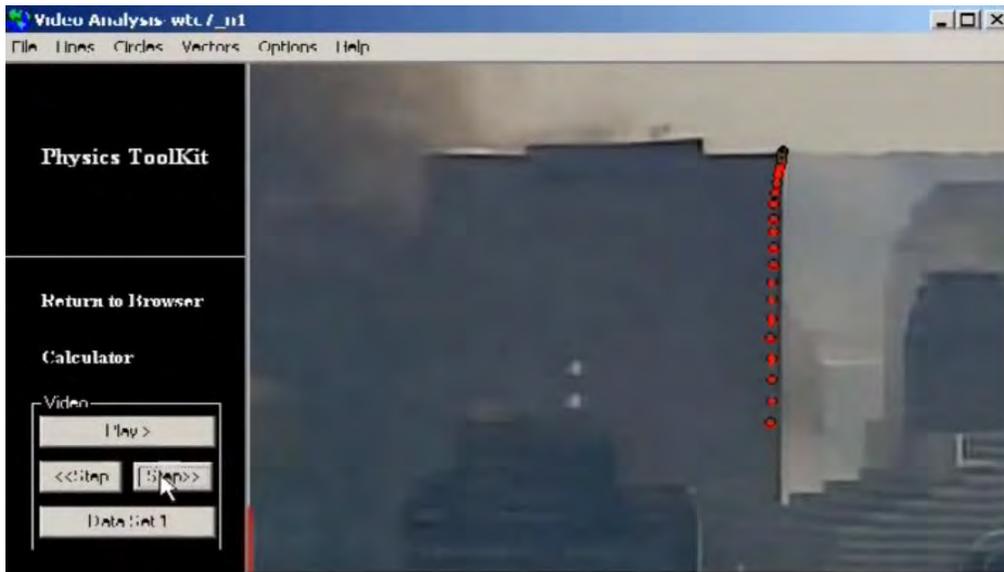
Figure 4.19 Velocity analysis by David Chandler (Chandler, 2010).

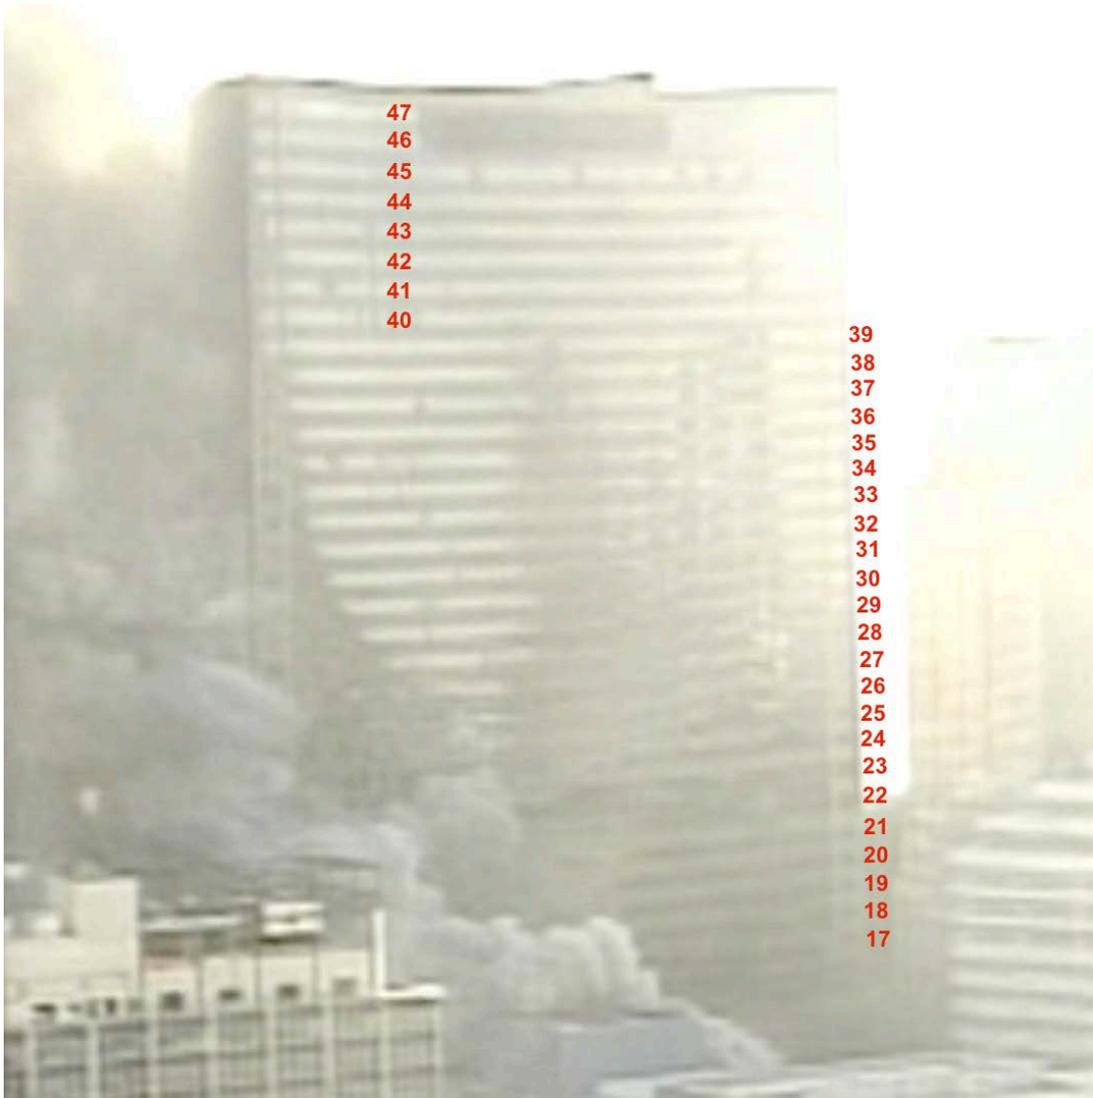
It should be noted that we conducted two separate simulations involving the failure of the core columns and exterior columns over 8 stories: One was the failure of all columns from Floor 12 to Floor 19; the second was the failure of all columns from Floor 6 to Floor 13. The two simulations were identical in terms of the downward velocity and acceleration of the northwest corner at the top of building. We therefore found that the collapse could have started at various floors. Based on our subsequent review of video footage, we found that Floor 16 is the uppermost floor where the collapse could have initiated, because the video shows Floor 17 to Floor 47 falling uniformly as a unit (see Figure 4.21 below). Although some floors below Floor 17 are somewhat visible in the video, it cannot be determined with confidence that they are falling as a unit with the floors above.

Figure 4.21 Floors 17 to 47 falling uniformly as a unit (CBS).
