**NIST NCSTAR 1A**

# **Final Report** on the **Collapse of** **World Trade Center Building 7**

November 2008

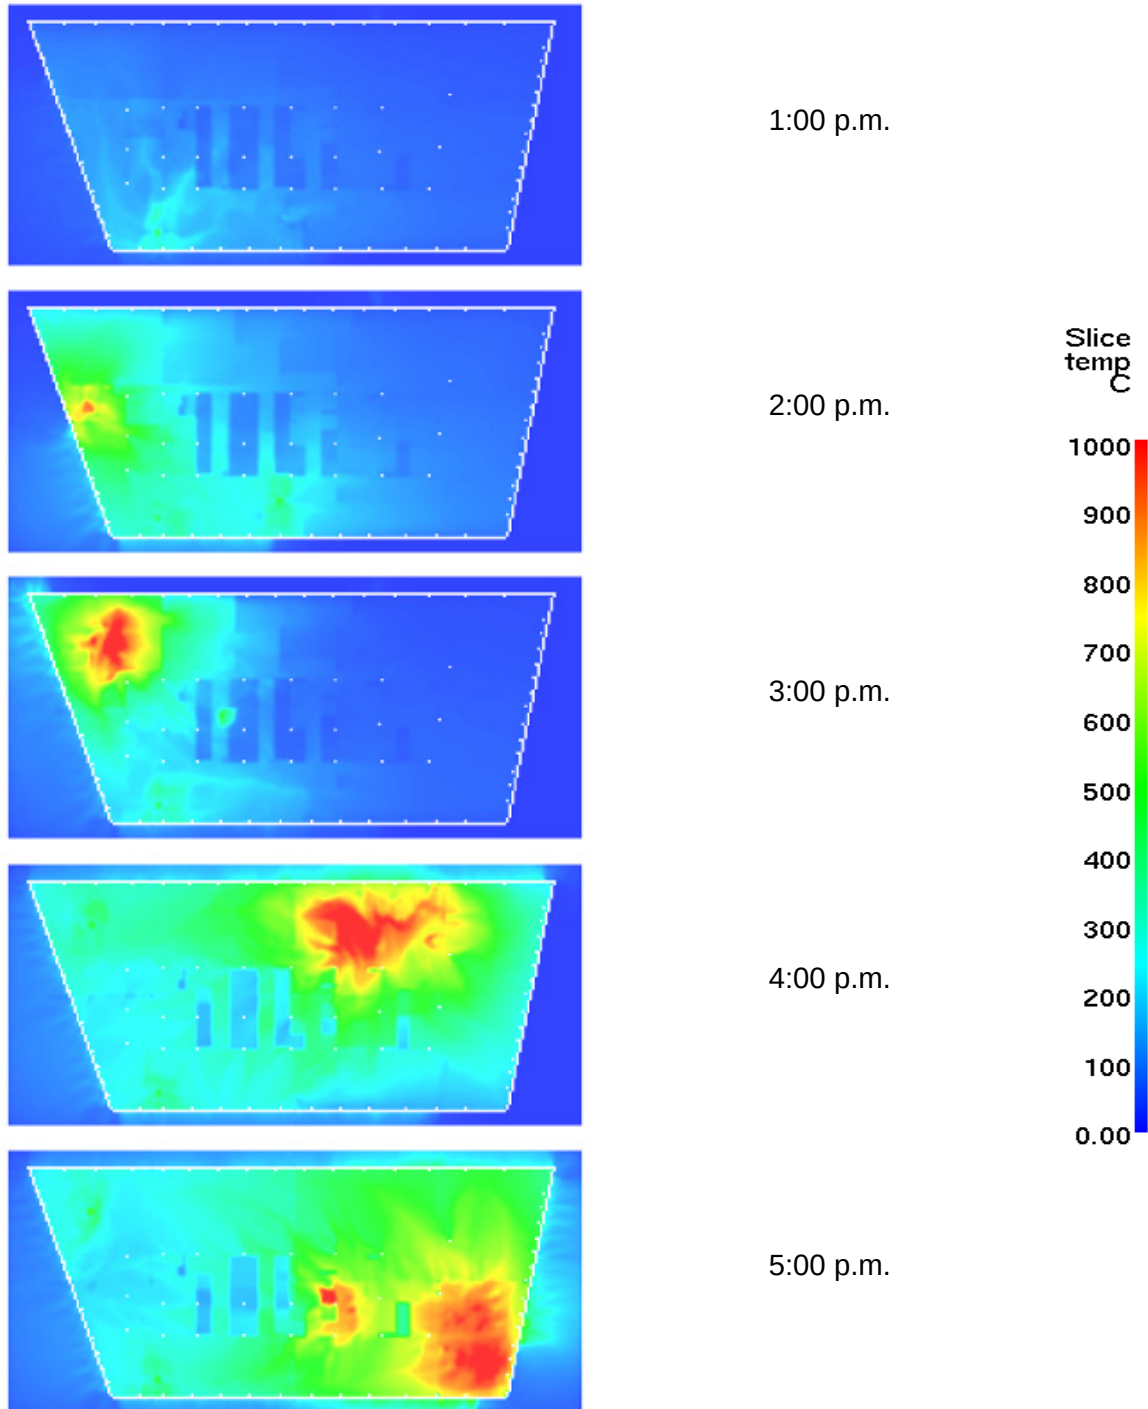
**Figure 3–5. Progression of simulated fire on Floor 8 of WTC 7 showing gas temperatures near the ceiling.**

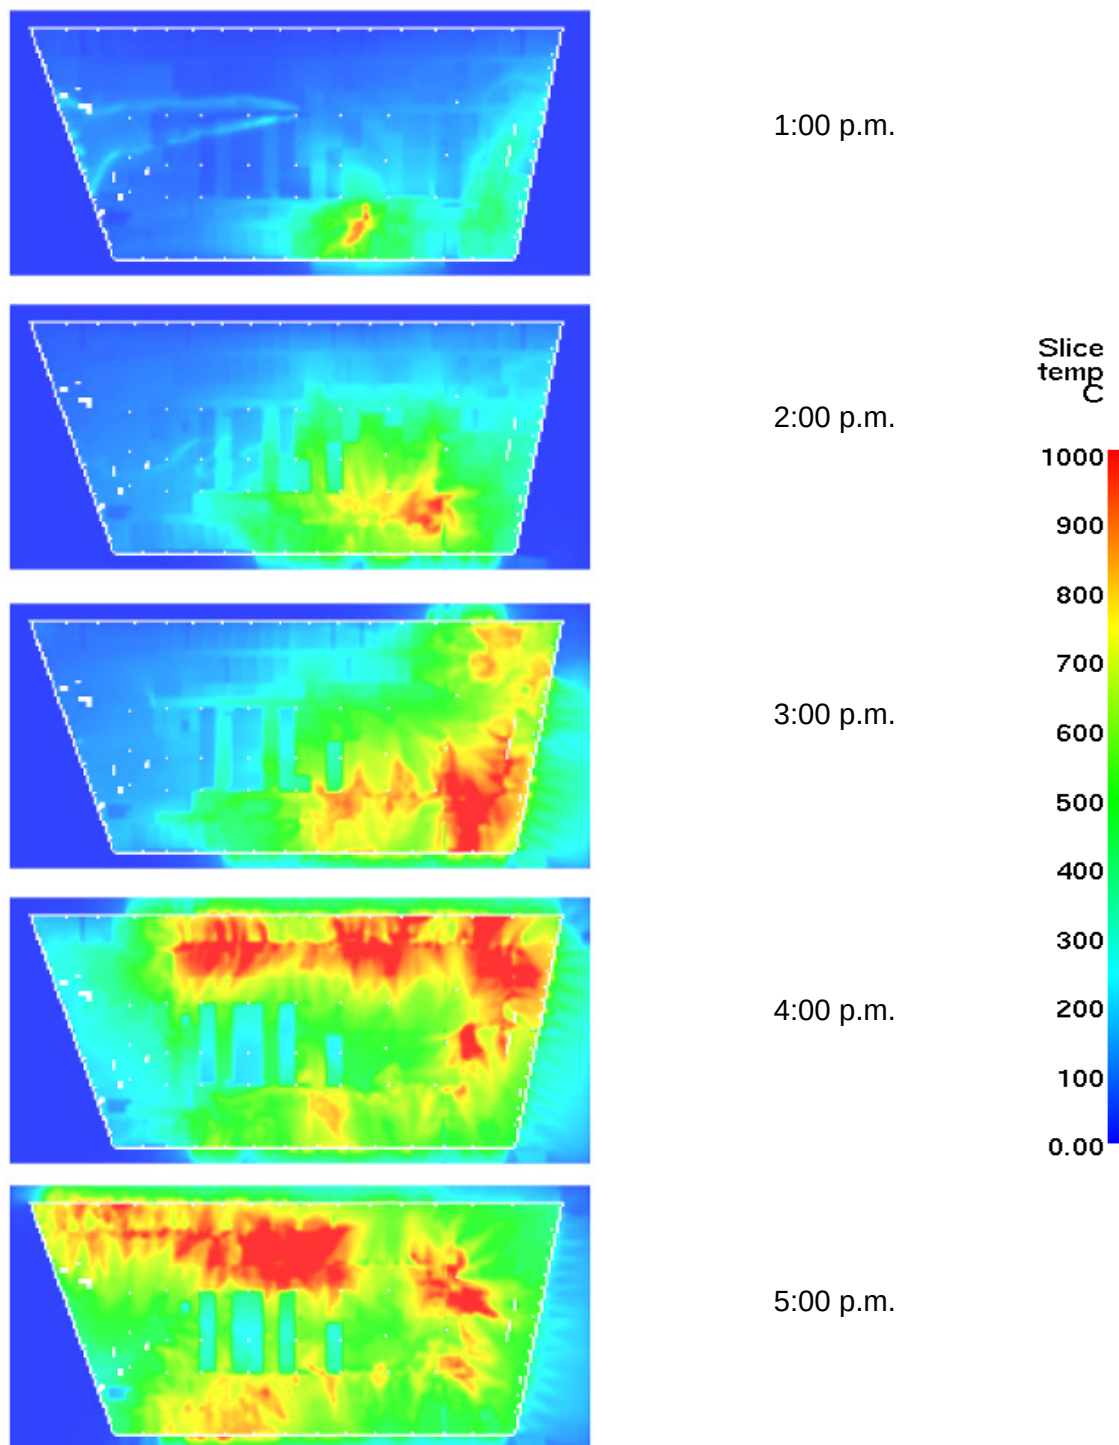
**Figure 3–6. Progression of simulated fire on Floor 12 of WTC 7 showing gas temperatures near the ceiling.**

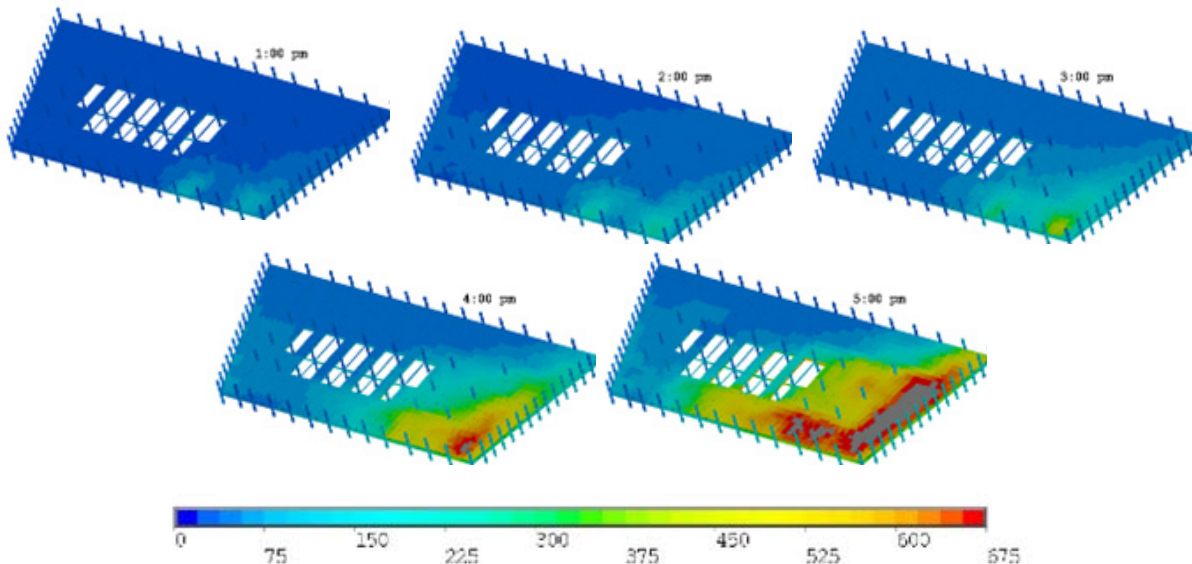
Figure 3–7 shows the calculated heating of the structural steel on the lower 16 floors of WTC 7 for the Case B temperatures from the fire simulation. The floor slabs have been removed from the figure for clarity. Figure 3–8 is a typical rendition of the calculated heating of the top of a floor slab as a result of the Case B fire.

**Figure 3–8. Computed temperature distribution (°C) in the top layer of the concrete slab of Floor 12 at five different instants in time.**

Grey shading indicates temperatures >675 °C

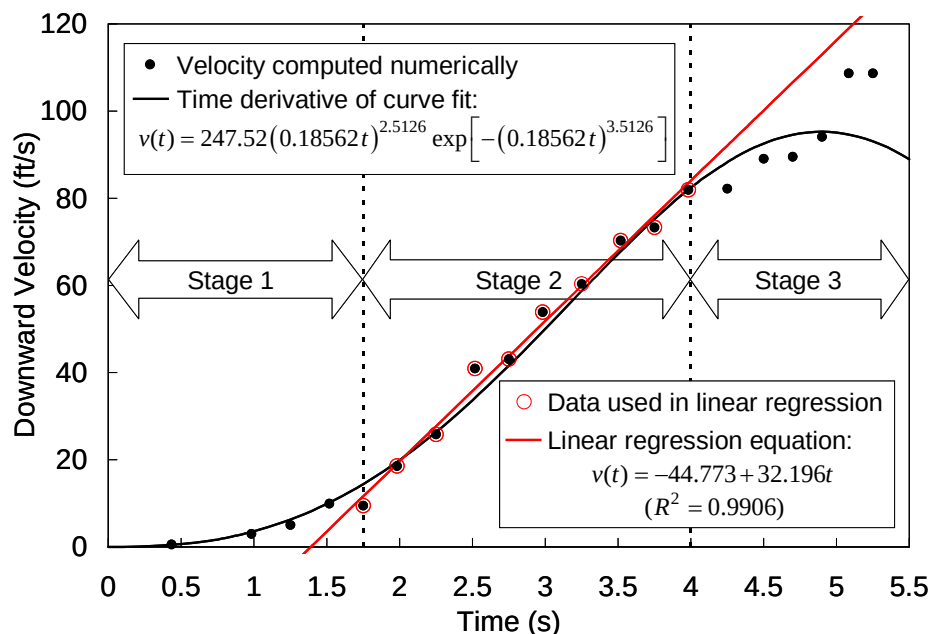
A more detailed examination of the same video led to a better understanding of the vertical motion of the building in the first several seconds of descent. NIST tracked the downward displacement of a point near the center of the roofline, fitting the data using a smooth function.<sup>3</sup> (The time at which motion of the roofline was first perceived was taken as time zero.) The fitted displacement function was then differentiated to estimate the downward velocity as a function of time, shown as a solid curve in Figure 3-15. Velocity data points (solid circles) were also determined from the displacement data using a central difference approximation.<sup>4</sup> The slope of the velocity curve is approximately constant between about 1.75 s and 4.0 s, and a good straight line fit to the points in this range (open-circles in Figure 3-15) allowed estimation of a constant downward acceleration during this time interval. This acceleration was 32.2 ft/s<sup>2</sup> (9.81 m/s<sup>2</sup>), equivalent to the acceleration of gravity  $g$ .

For discussion purposes, three stages were defined, as denoted in Figure 3-15:

Figure 3-15. Downward velocity of north face roofline as WTC 7 began to collapse.
