**Federal Building and Fire Safety Investigation of the
World Trade Center Disaster**

**Structural Fire Response and
Probable Collapse Sequence of
World Trade Center Building 7**

VOLUME 1

National Institute of Standards and Technology

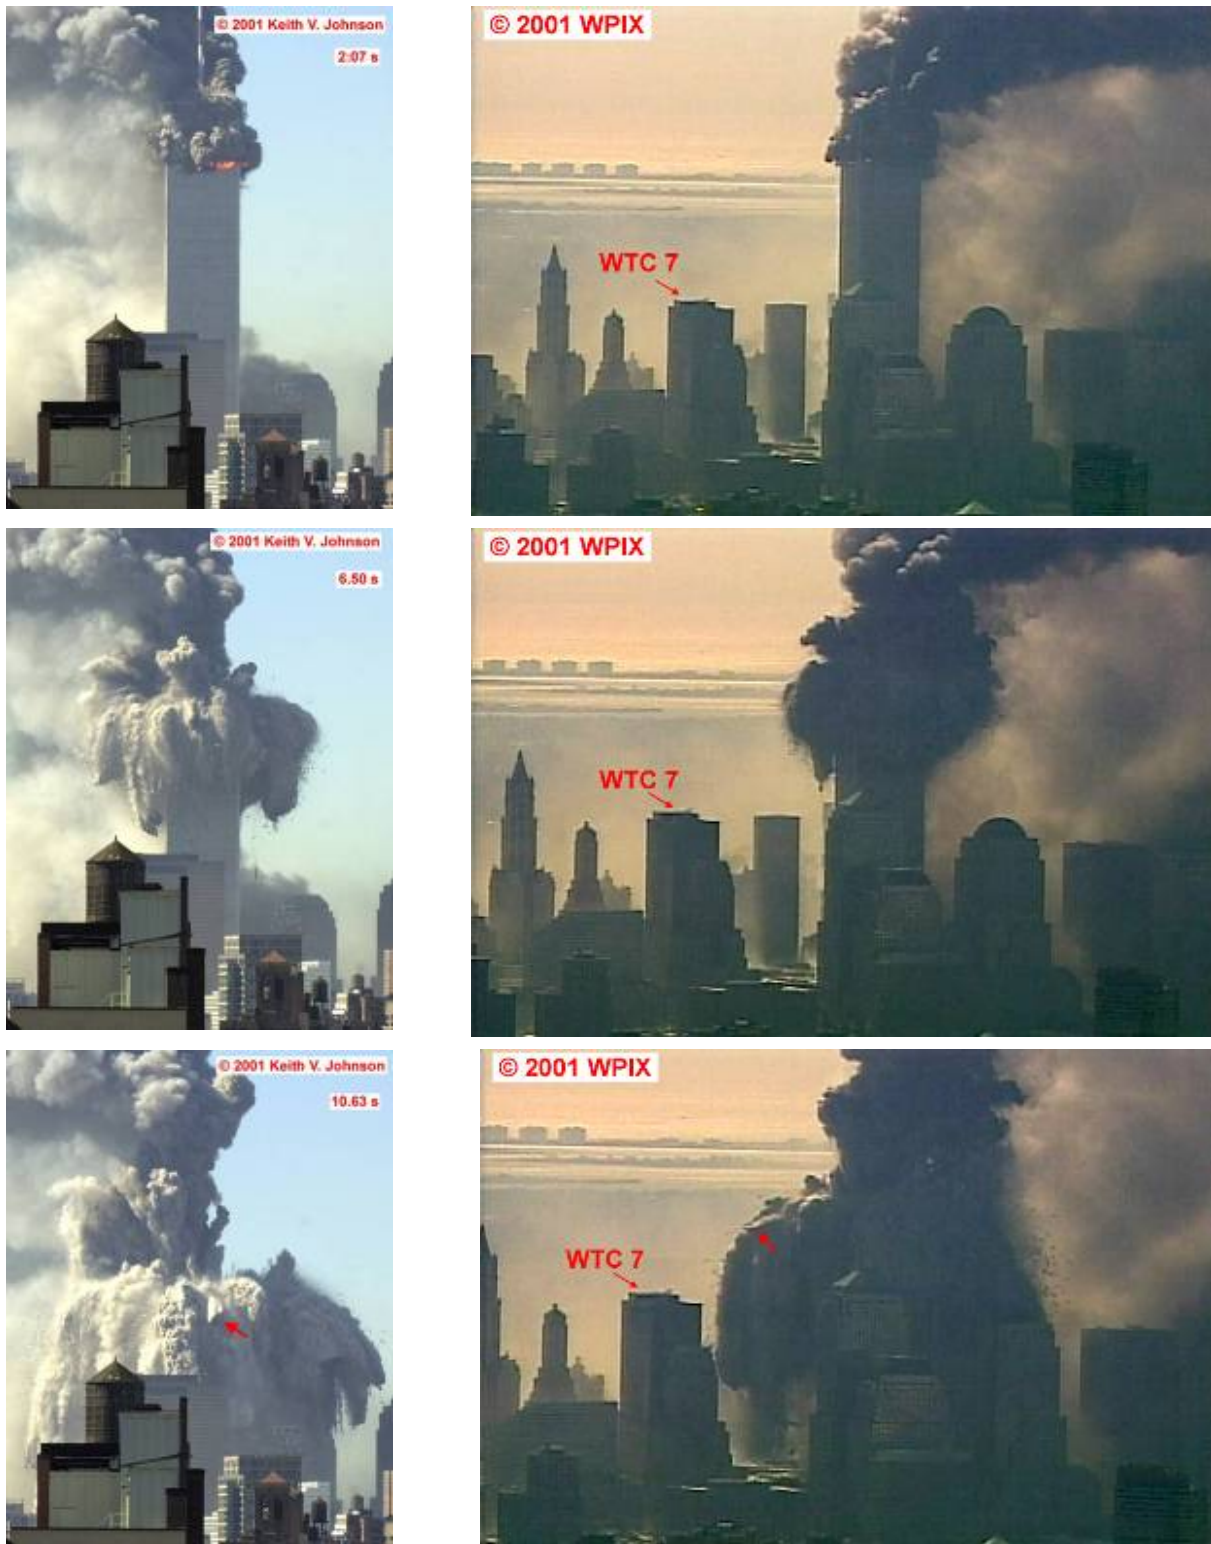
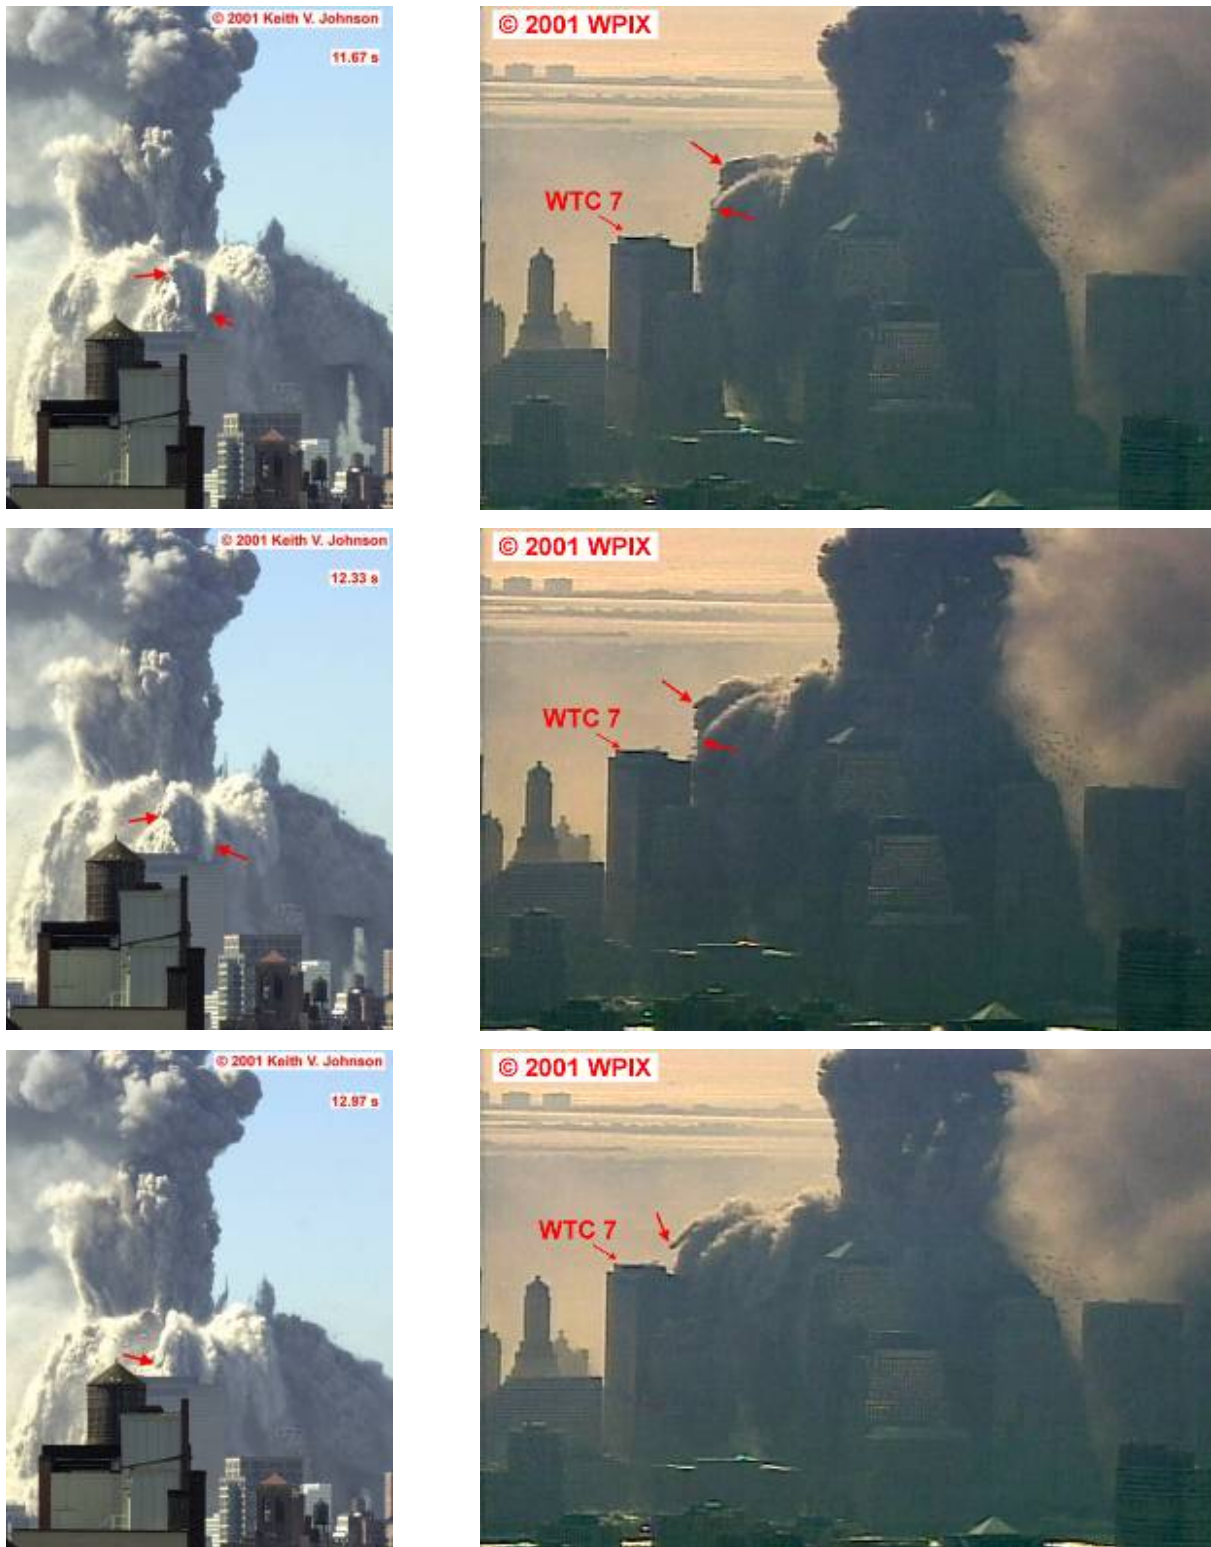
The video frame taken 6.50 s after the collapse started shows that the initial large debris created by the collapse fell close to the outer wall of WTC 1. As the collapse continued, the debris extended further outward from WTC 1, but the west view shows that the majority of the debris was still falling well away from WTC 7 10.63 s after the collapse began and 0.5 s after the first debris reached the ground. However, starting around this time, several substantial pieces of debris were expelled outward toward WTC 7 from the main cloud of the falling material. The first of these is visible in the images taken at 10.63 s (marked with arrows). Several of these pieces appeared to arc downward toward the south face of WTC 7.

In the images taken at 11.67 s, the arc (marked with arrows) formed by the initial ejected building section is distinct in both views. In the north photograph, this falling debris is visible above WTC 7 just to the right of the west penthouse. An additional piece of debris (also marked with arrows) is just beginning to emerge from the cloud. The western view at 12.33 s shows that the arc from the initial ejected debris is approaching WTC 7. The additional debris to the left and above has fully emerged and is moving outward from the main debris cloud. By 12.97 s, the later ejected material (marked with arrows) has formed a distinct arc as seen from the west, and appears just above the west penthouse in the corresponding photograph from the north.

Figure 5–40. A series of cropped photographs shot from the north and frames from a video shot from the west show the collapse of WTC 1.

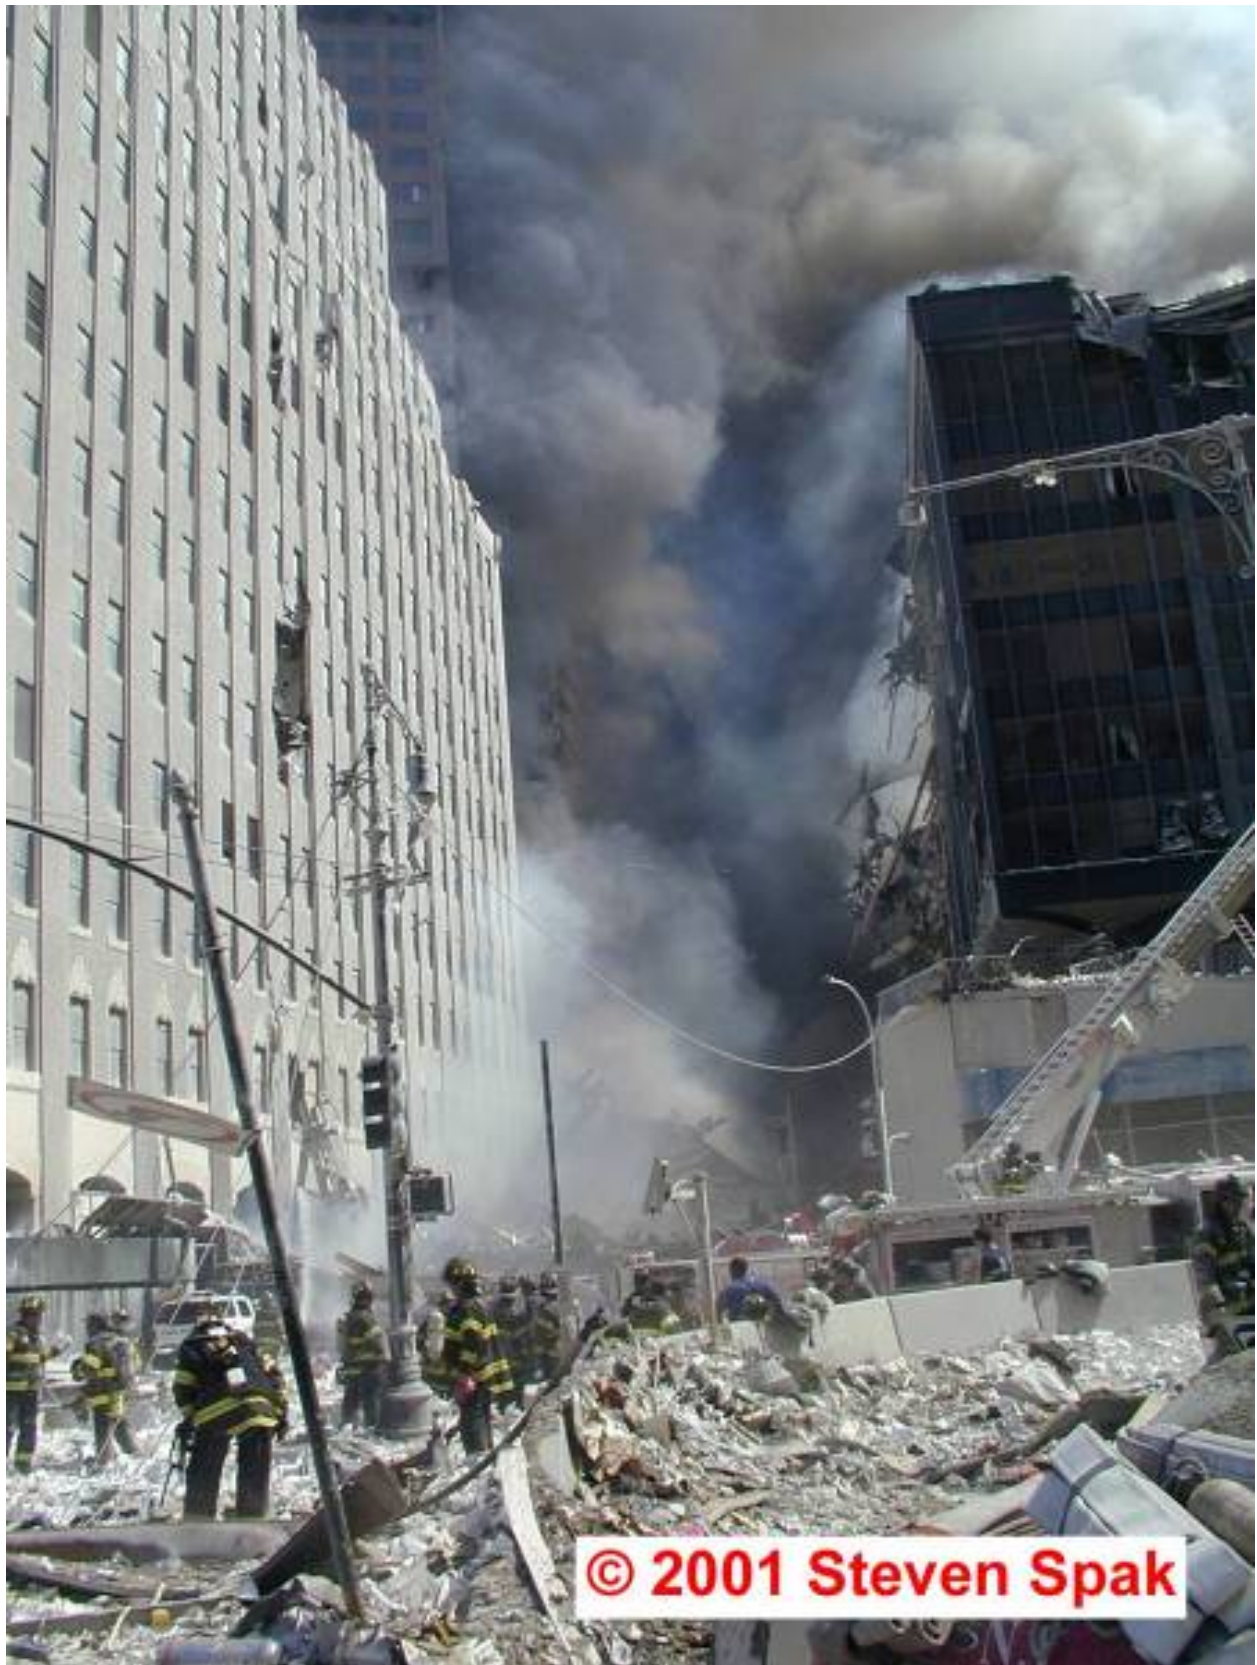
Figure 5–52 is another photograph showing damage to the south face of WTC 7. It was shot from West Street looking down Vesey Street. The Verizon Building is on the left, WTC 7 is behind it, and WTC 6 is on the right. Even though this image provides a more oblique view than the photograph in Figure 5–48, it is possible to see locations closer to the street.

Figure 5–52. Photograph showing a portion of the south face of WTC 7 at 12:46:39 p.m.

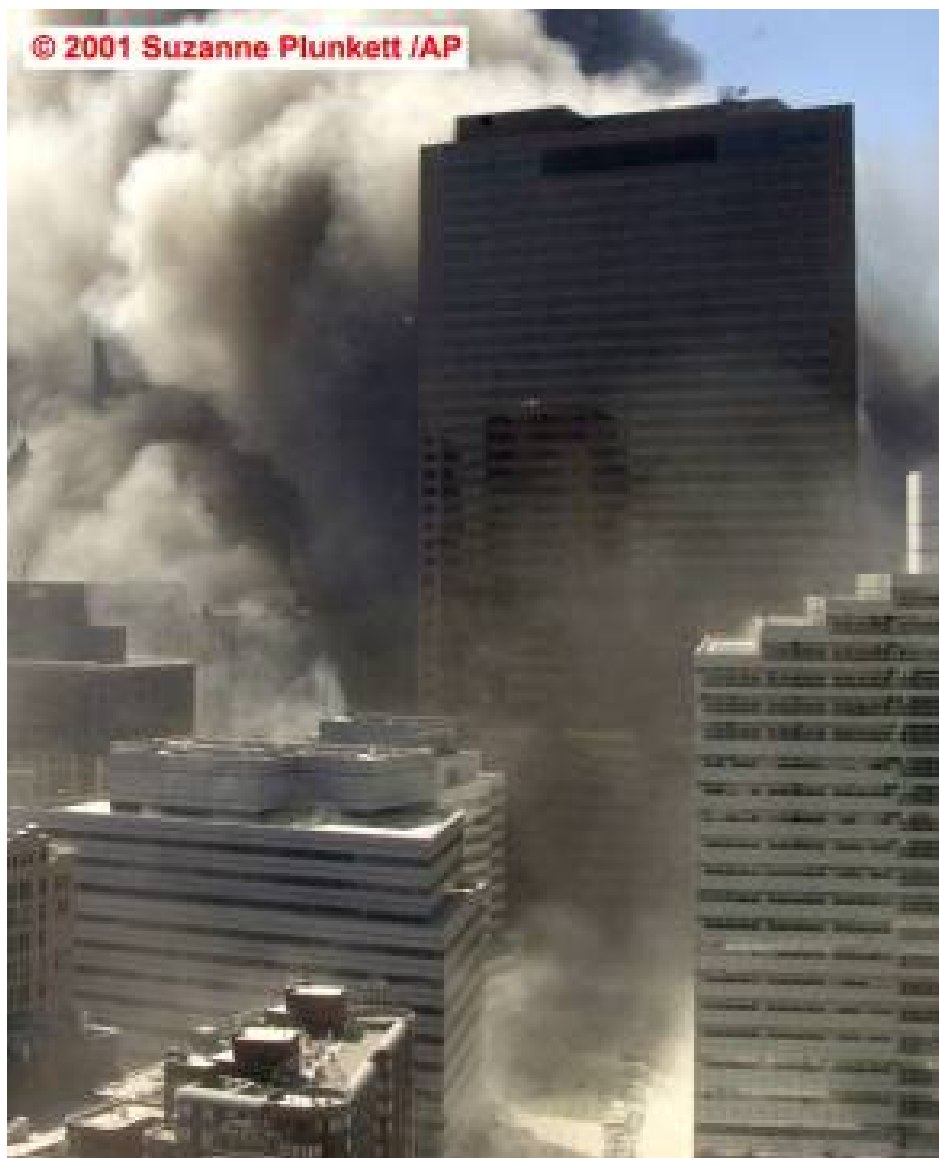
The large dust clouds generated by the collapse of WTC 1 hid the lower portions of WTC 7 from view for over 20 min following the collapse. However, as time passed, the dust began to settle, and the faces became less obscured. Figure 5–104 shows a view of the north face of WTC 7 taken at 11:28:15 a.m., i.e., close to one hour after the collapse of WTC 1. Even though some light dust is evident in front of the face, it is possible to discern the base of the building. There is no sign of fire or heavy smoke on the portion of the north face that is visible.

In Figure 5–104, there appears to be a heavy smoke column rising from an area just to the north and east of WTC 7. The location of the smoke relative to the buildings in the area suggests the smoke was coming from or near West Broadway.

Figure 5–104.
Cropped
photograph
showing the north
face of WTC 7, shot
at 11:28:15 a.m.
from the upper
story of a nearby
building looking
down Greenwich.
The intensity levels
have been adjusted.

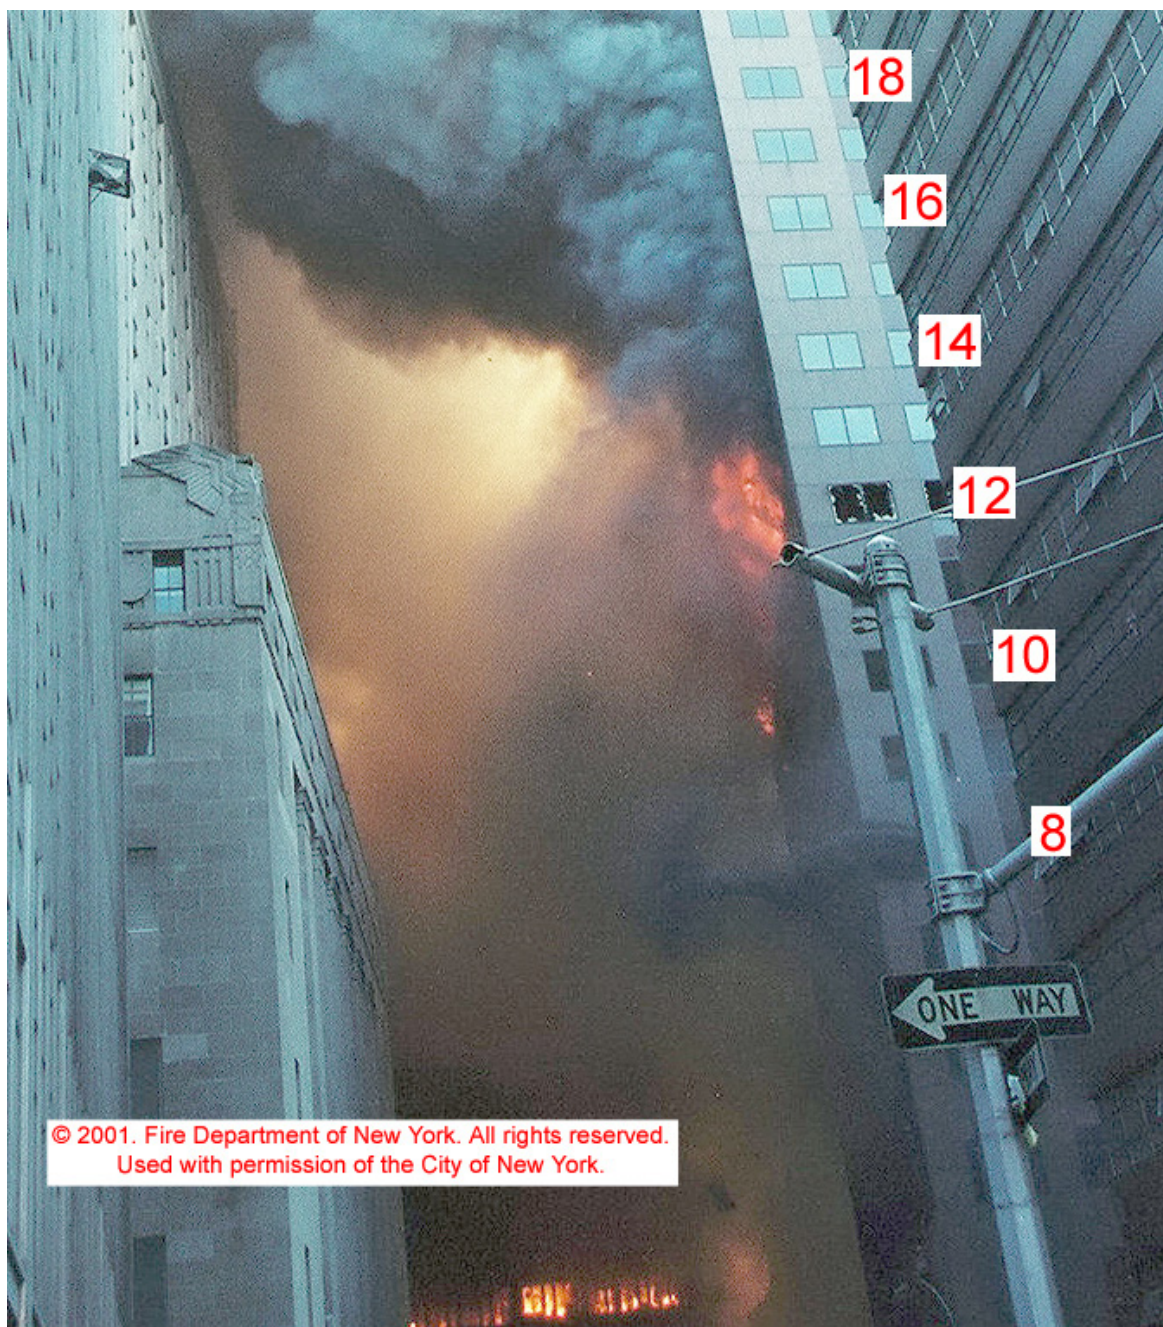
It is difficult to identify how fire moved onto the north side of the 13th floor from Figure 5-130 and Figure 5-134. A photograph (Figure 5-135) taken at an unknown earlier time, estimated as between 3:20 p.m. and 3:40 p.m., provides an important clue. This image, shot from near the corner of West Broadway and Park Place, shows an oblique view of the east face. Intense flames appear to be coming from windows 13-39 to 13-41 on the 13th floor. A much smaller flame can be seen in window 13-41A. Despite the steep viewing angle, there seems to be a line of flames extending across most of the east face on the 13th floor. Heavy smoke is rising from these fires. There also appears to be lighter smoke lower down on the east face, but it is not possible to identify its source.

Windows at the east edge of the north face are also visible in Figure 5-135. Windows 13-42A to 13-42C still have glass in place on the 13th floor, which means that this image was taken prior to Figure 5-134. The heavy smoke pouring from open window 8-42A on the 8th floor indicates that a significant fire was burning on this floor at this time, even though it is clear from Figure 5-134 that nearby windows still have intact glass. Windows 12-42A to 12-42C are open on the 12th floor with no sign of flames nearby, indicating that this photograph was taken well after the aerial view in Figure 5-123, which was taken around 3:10 p.m. and shows heavy flames in these corner windows.

Figure 5–135. Cropped photograph showing the east edge of the north face and an oblique view of the east face of WTC 7, taken from near the corner of West Broadway and Park Place.

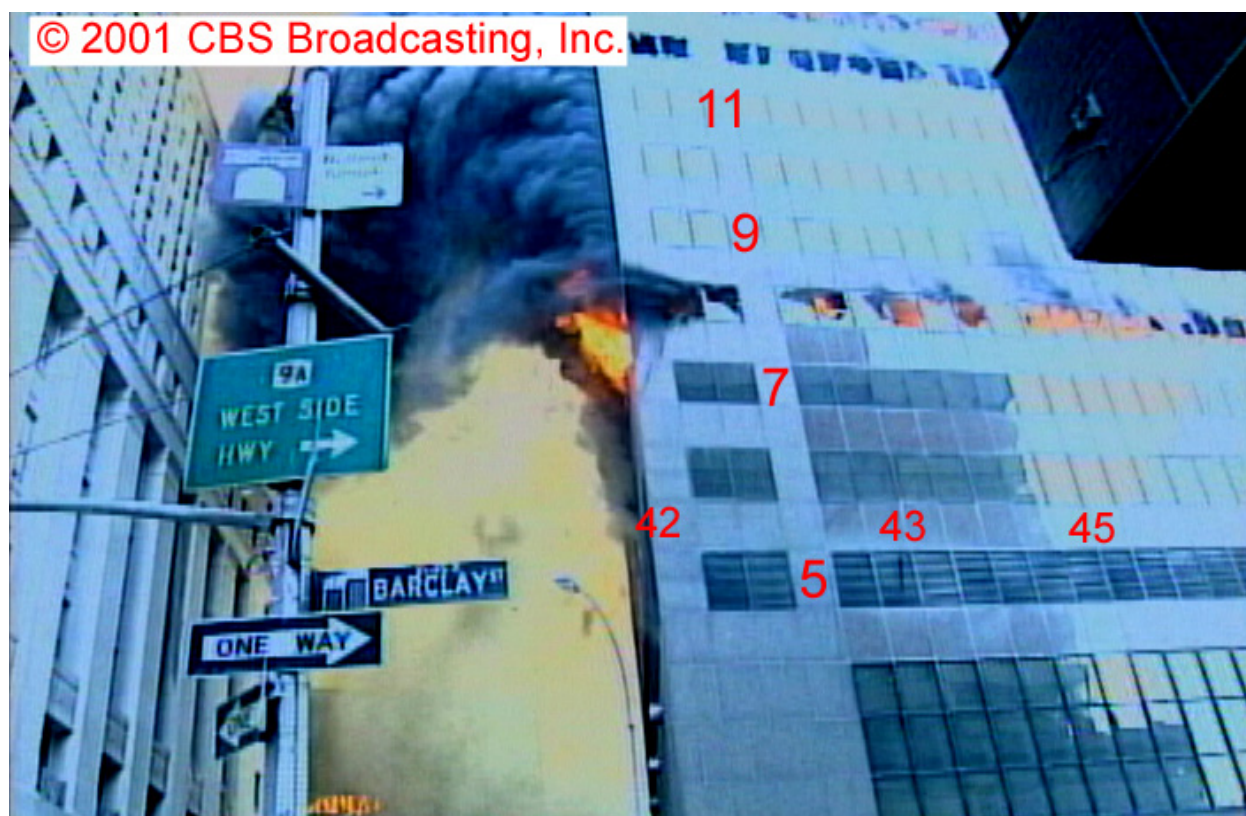
Another frame from a video clip recorded roughly 2 min later showing the lower northeast corner of WTC 7 is reproduced in Figure 5–142. The changes on the north side of the 8th floor were substantial over this short period. Additional windows have opened near the eastern edge, and the fires have grown substantially in intensity. While not readily apparent in Figure 5–142, flames were visible in window 8-42A during the short video clip.

Figure 5–142. Frame taken from a video shot near the corner of West Broadway and Barclay Street showing the lower northeast corner of WTC 7 between 3:55 p.m. and 4:04 p.m.

Some of the more interesting observations from Figure 5–142 are on the east face. Very intense flames were coming from multiple windows on the 8th floor at this time. A close-up of these flames, taken from a video clip recorded about a minute later is shown in Figure 5–143. Note that additional glass has broken out of window 8-42C during the short period between the two frames. Comparison of the flames near the northeast corner on the north and east faces provides a vivid demonstration of the different burning behaviors on these two faces. On the north face, the flames are mostly inside the windows, which was generally true for fires observed on this face, while very intense external burning, similar to that observed on the east side of the 12th floor much earlier, is taking place on the east face. These observations provide additional evidence that pressure differences generated by the ambient wind affected the local fire behaviors observed on different faces.

Closer inspection of Figure 5–142 reveals what appears to be a relatively light plume of white smoke rising from near the top of the louvers that spanned the 5th and 6th floors on the east face. It was not possible to identify the exact location of the plume relative to the edge of the building. At a minimum, the presence of this plume suggests that smoke had been transported to the 5th or 6th floors before being vented. It is also possible that the source of the smoke was a fire burning somewhere on these two floors. The available imagery does not provide evidence indicating which of these two alternatives is correct.

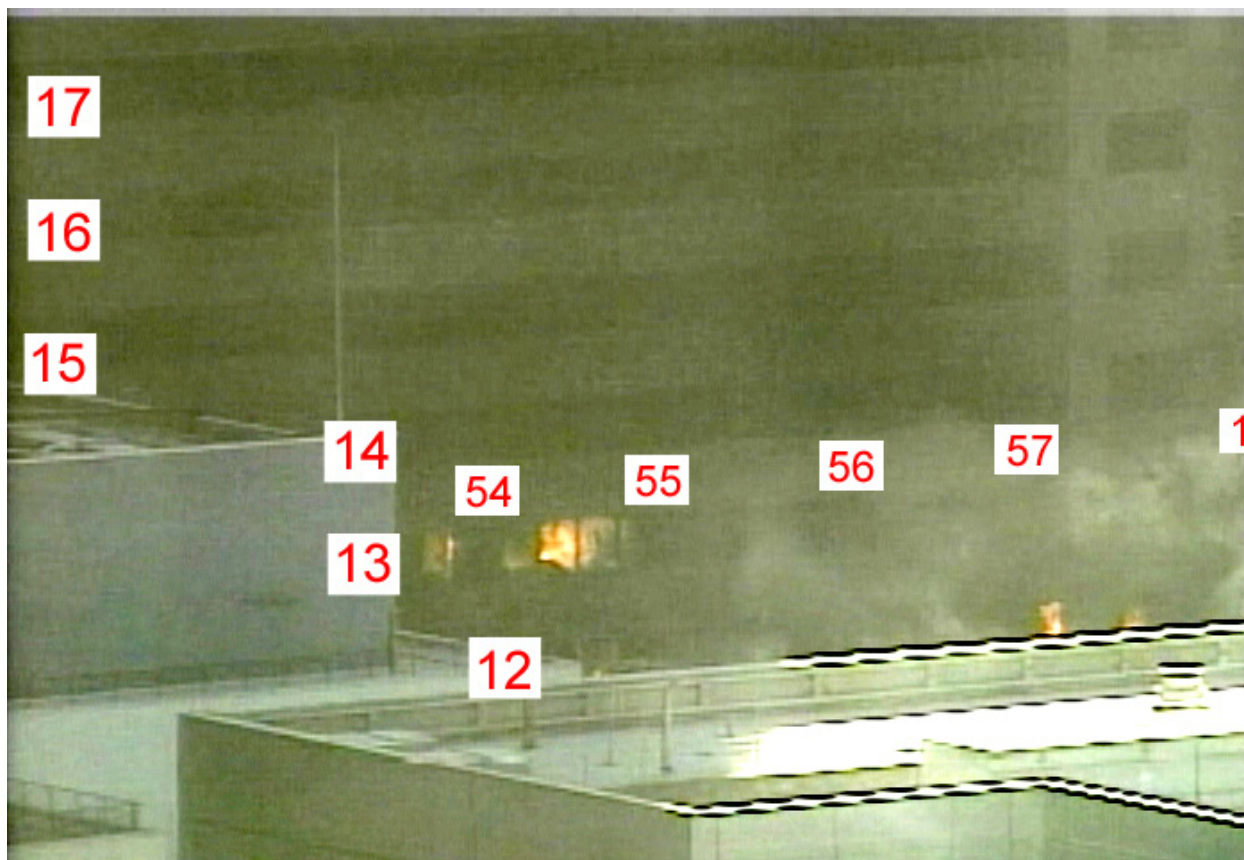
Figure 5–152 shows a limited view of the north face shot from the northeast over the tops of the two buildings to the north of WTC 7. The time was crudely estimated as being around 5:00 p.m. based on the pattern of sunlight and shadow on the building to the immediate north of WTC 7. Only the 12th to 17th floors are visible. Fires are burning on the 12th and 13th floors. On the 12th floor, the fires that were slowly spreading across the north face to the west have reached the northwest corner, with flames barely visible in windows 12-57A and 12-57B. Recall that fire was observed between Columns 55 and 56 around 4:00 p.m. At 2:00 p.m., the 12th floor was burning near the southeast corner. Apparently it took roughly three hours for fire to spread all of the way from the southeast corner to the northwest corner.

Figure 5–152. Frame taken from a video clip shot over the buildings at 30 West Broadway and 70 Murray Street, showing the western edge of the north face of WTC 7 at about 5:00 p.m.

The fire on the 13th floor has burned westward as far as Column 55. In Figure 5–144, which was estimated to have been taken around 3:55 p.m., flames were observed as far west as Column 50. This fire was continuing to work its way to the west. There are no indications of fire burning in this area on floors higher than the 13th floor. In the video clip, some light smoke was visible blowing across the north face, but there was apparently little smoke coming from the open windows on the 12th and 13th floors, consistent with earlier observations that the effluent for fires on these floor vented at remote locations on other faces.

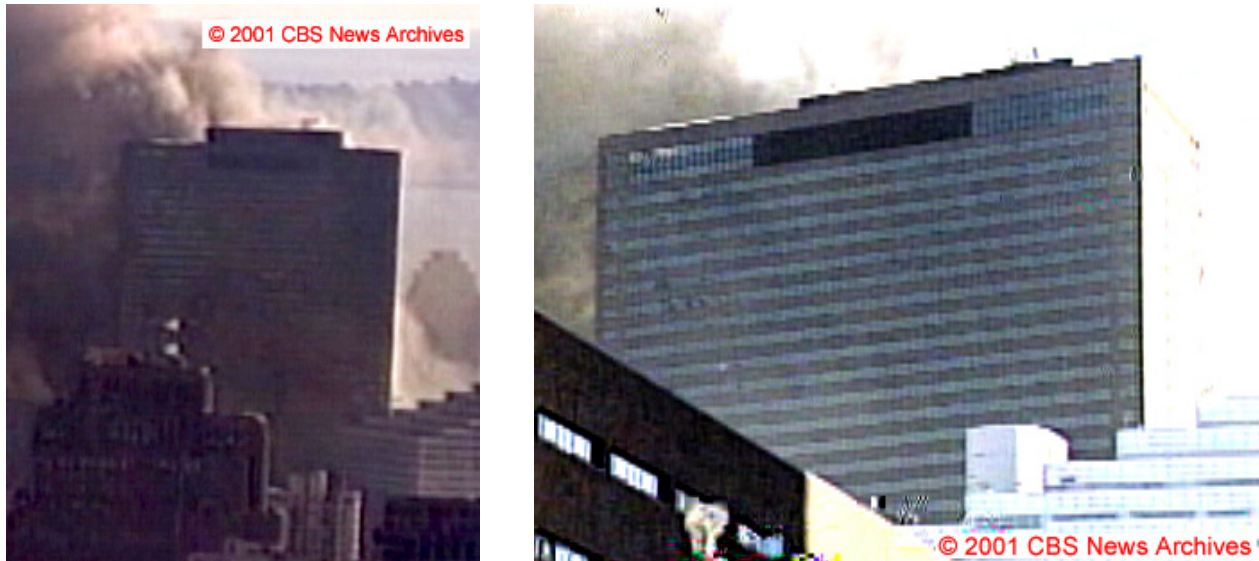
Figure 5-197. Cropped frames from the Camera 2 video clip and the Camera 3 video clip, showing the north face of WTC 7 $3.5 \text{ s} \pm 0.1 \text{ s}$ after the east penthouse began to move downward.

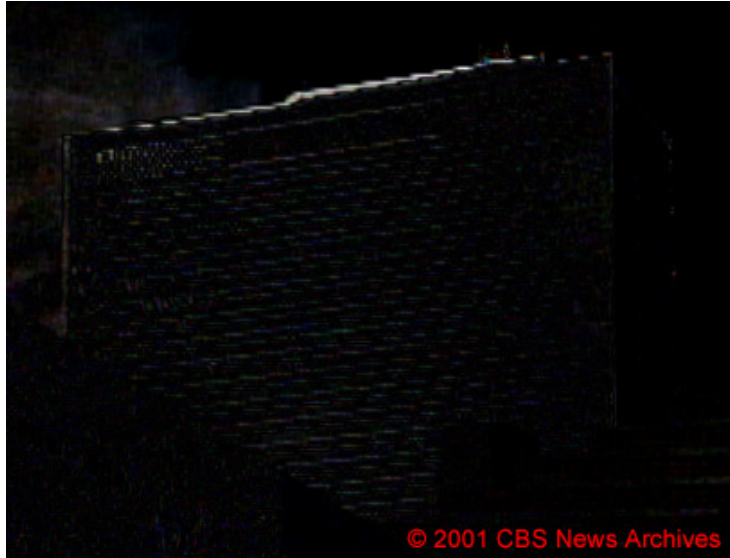
Figure 5–201. Cropped difference frame at $7.5 \text{ s} \pm 0.1 \text{ s}$ after the east penthouse began to move, created by subtracting the frame reproduced in Figure 5–199 from the Camera 3 video clip shown in Figure 5–200.

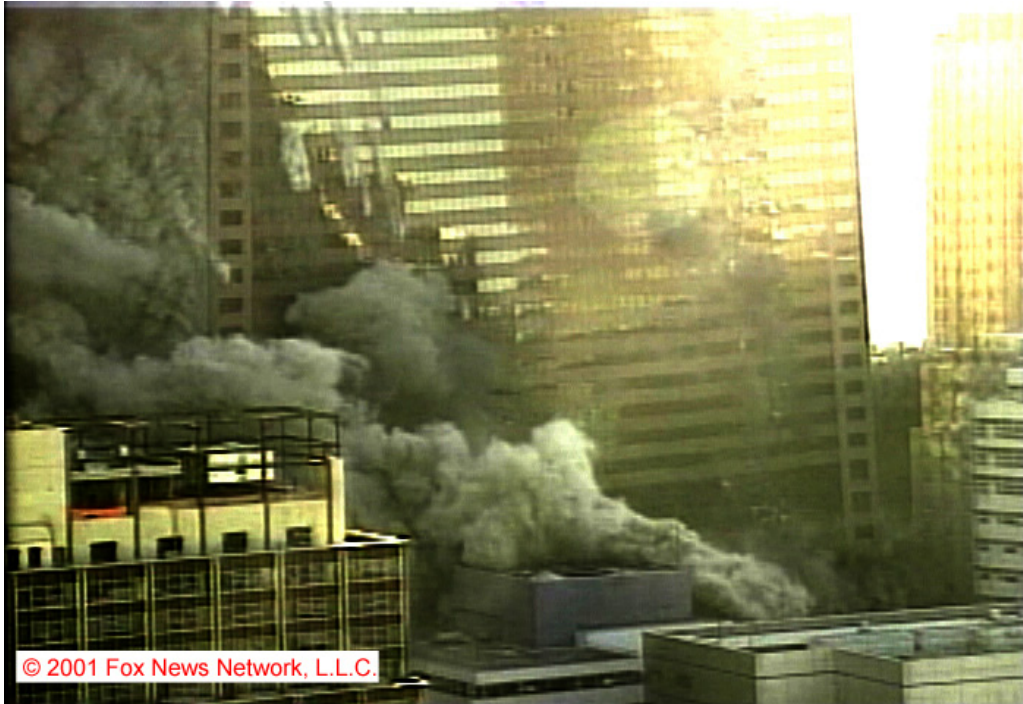
Figure 5–209 shows a frame from Camera 6 of the north face of WTC 7 recorded 10.0 s after the east penthouse began to collapse. Dust trails are flowing from the open windows on the east and west sides of the building. Numerous windows are open near the center of the face, but no dust flows are evident from these windows. The kink in the face near Column 47 observed near the top of building in Figure 5–208 appears to extend at least as far down as the mechanical floors on the 22nd and 23rd floors.

Figure 5–209. Frame from the Camera 6 video clip in Figure 5–189, showing the north face of WTC 7 $10.0 \text{ s} \pm 0.2 \text{ s}$ after the east penthouse began to descend. The intensities have been adjusted.

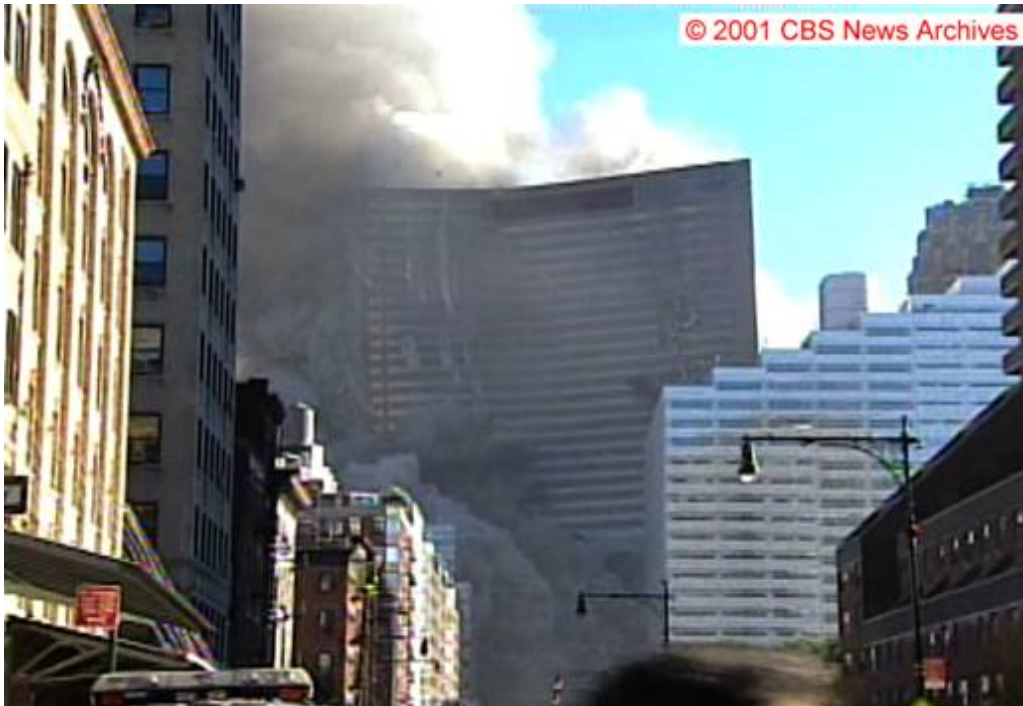
Figure 5–210 is a frame from the Camera 9 video showing the collapse at the same time looking up Greenwich Street. The appearance of the collapsing north face is consistent with the descriptions above. The appearance of the dust cloud at the base of the building has not changed markedly from that seen in Figure 5–192.

Figure 5–210. Frame from the Camera 9 video clip in Figure 5–192, showing the north face of WTC 7 $10.0 \text{ s} \pm 0.2 \text{ s}$ after the east penthouse began to move downward. The intensities have been adjusted.

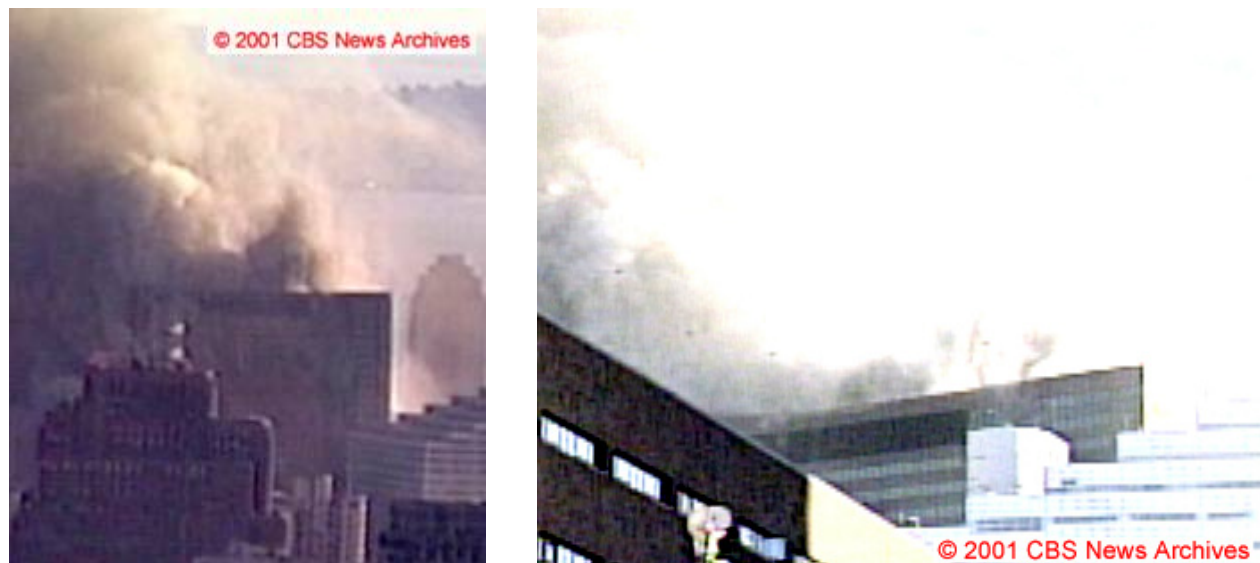
During the next second, the north face of WTC 7 moved downward nearly 6 stories. Figure 5–211 shows the Camera 2 distant and Camera 3 West Street views at 11.0 s following the initial downward movement of the east penthouse. WTC 7 is just about to pass out of sight behind the foreground building in the West Street view. While dust clouds continue to pass over the face, it is remarkable how many windows are still intact at the top of the building. The amount of dust pouring from the open windows of the falling north face is more evident in the distant view. It is also clear that a large amount of dust has been ejected through the roof at the two locations on the east side and near the center.

Figure 5–211. Cropped frames from the Camera 2 video clip in Figure 5–185 and the Camera 3 video clip in Figure 5–186, showing the north face of WTC 7 $11.0 \text{ s} \pm 0.1 \text{ s}$ after the east penthouse began to move downward.
The intensities have been adjusted.

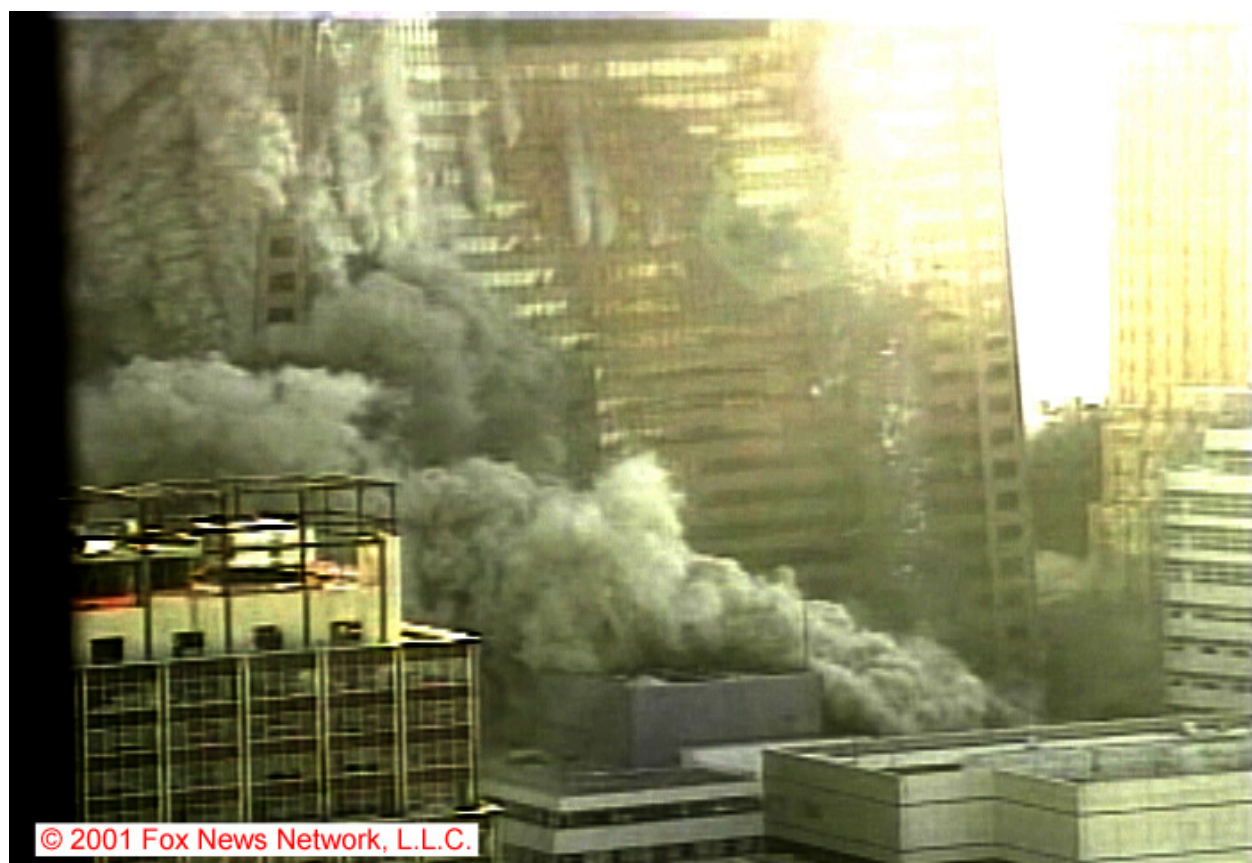
Figure 5–212. Frame from the Camera 6 video clip in Figure 5–189, showing the north face of WTC 7 $11.0 \text{ s} \pm 0.2 \text{ s}$ after the east penthouse began to move downward.
The intensities have been adjusted.

Figure 5–212 and Figure 5–213 show frames from the northeast (Camera 6) and Greenwich Street (Camera 9) video clips for the same time as the images in Figure 5–211. In both frames, the distortions of the falling building stand out. The kink near Column 47 is prominent in Figure 5–213, while in Figure 5–212, a strong distortion is present near the east edge of the north face. Both frames also show the large amount of dust being pushed out of open windows higher up in the building and the huge dust clouds forming near its base. In Figure 5–212, large amounts of dust have been pushed from near the base of the building on the east, north, and west sides. A prominent feature in Figure 5–213 is the large pulses of dust flowing upward through the roof on the east side and near the center.

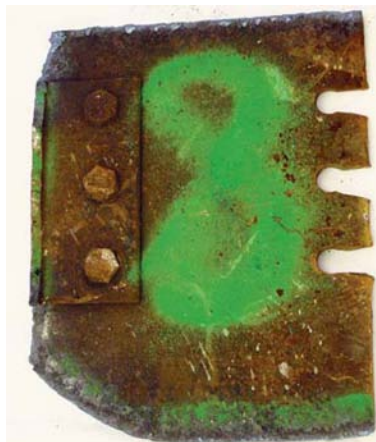
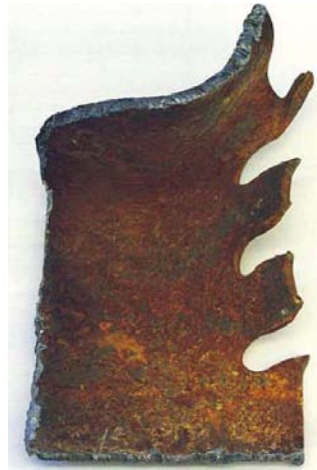
Figure 8–15. Steel samples recovered from WTC 5, showing tear-out of beam web.

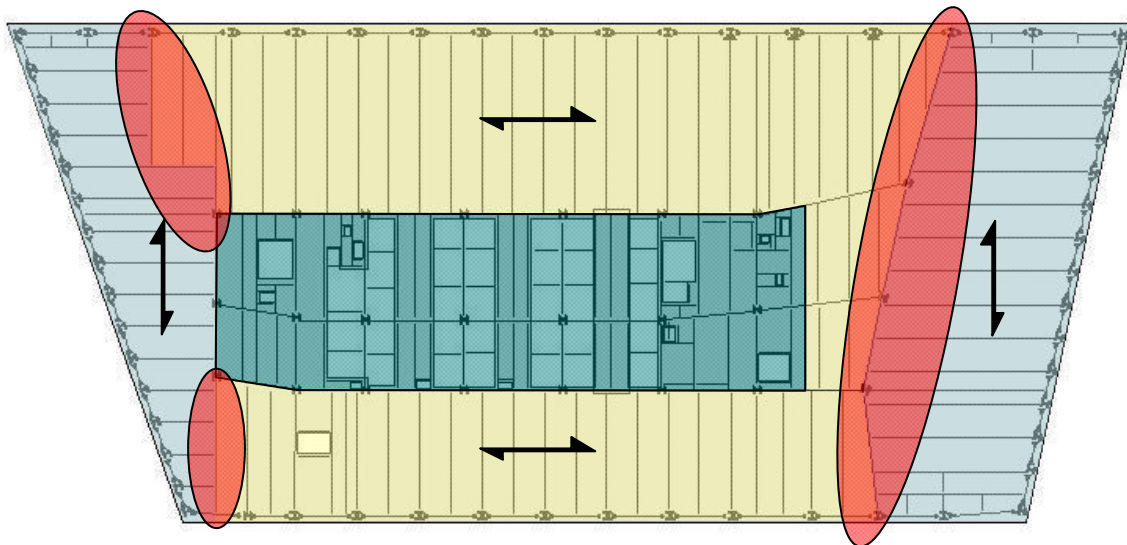
Floor beams framed into only one side of a girder in several locations in WTC 7, as shown in the highlighted areas in Figure 8–18. (Arrows indicate directions that the metal deck spanned.) Of particular interest was the northeast corner of the building. The relevance of this framing condition, in concert with the presence (or absence) of shear studs, and the use of seated connections under the effect of fire-induced thermal expansion is covered next.

Figure 8–18. Floor framing where beams frame into only one side of the girder.

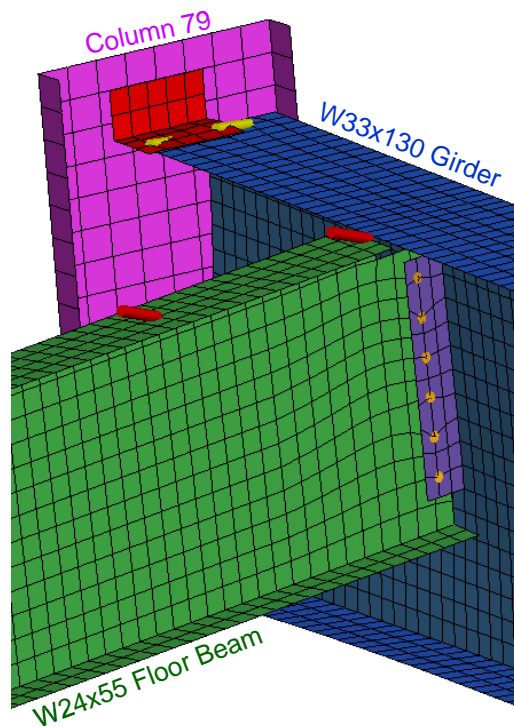
The predicted response of the system is summarized in Table 8–2. The first failures observed were of the shear studs, which were produced by axial expansion of the floor beams, and which began to occur at fairly low beam temperature of 103 °C. Axial expansion of the girder then led to shear failure of the bolts at the connection to Column 79; and, at a girder temperature of 164 °C, all four erection bolts had failed, leaving that end of the girder essentially unrestrained against rotation. Continued axial expansion of the floor beams pushed the girder laterally at Column 79, as shown in Figure 8–26, in which failed shear studs and bolts were evident. When the beam temperatures had reached 300 °C, all but three shear studs in the model had failed due to axial expansion of the beams, leaving the top flanges of the beams essentially unrestrained laterally. Continued axial expansion of the girder caused it to bear against the face of Column 79, generating large axial forces that led to failure of the bolts connecting the girder to Column 44. When the girder temperature had reached 398 °C, all four erection bolts at Column 44 had

failed, leaving the girder essentially unrestrained against rotation at both ends. After failure of the erection bolts in the seat at Column 44, continued axial expansion of the floor beams pushed the girder laterally, where it came to bear against the inside of the column flange. Axial compression then increased in the floor beams, and at a beam temperature of 436 °C, the northmost beam began to buckle laterally. Buckling of other floor beams followed as shown in Figure 8–27 (a), leading to collapse of the floor system, and rocking of the girder off its seat at Column 79 as shown in Figure 8–27 (b). The collapse process took time to occur in the LS-DYNA analysis, during which the temperatures had ramped up to their maximum values in the simulation.

Figure 8–26. Lateral displacement of girder due to thermal expansion of floor beam.
 Note: failed bolts and shear studs

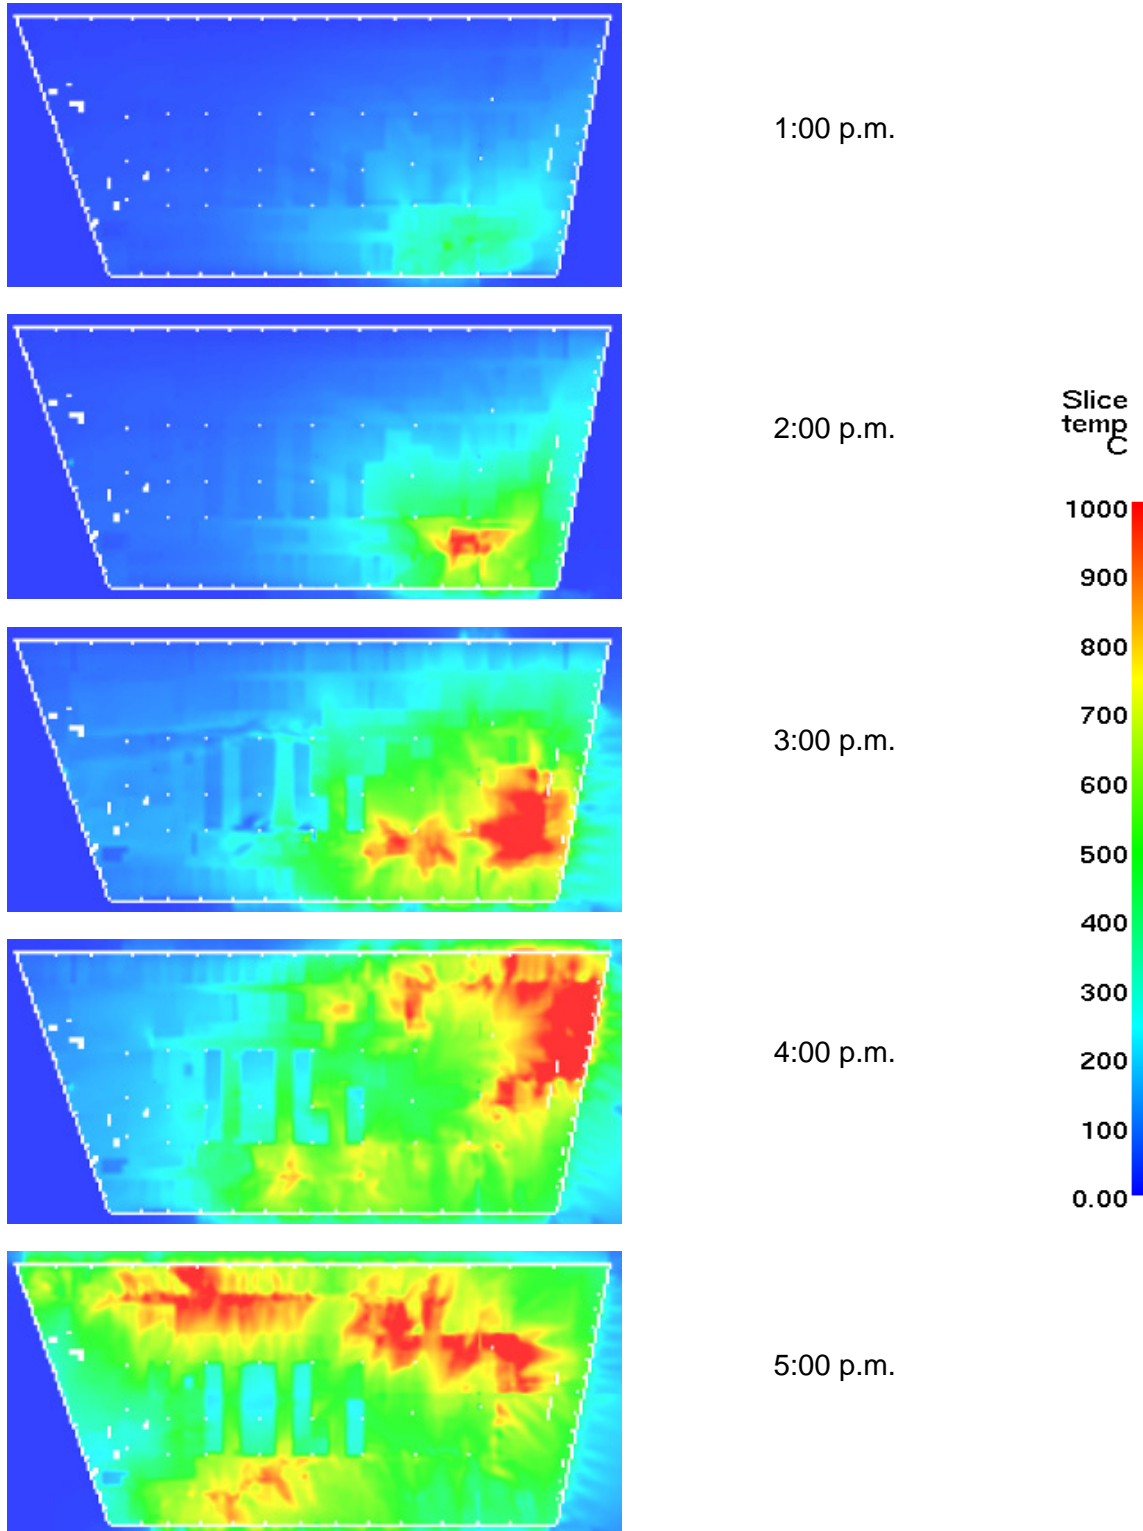
- Decreasing the combustible load on the 12th floor from 32 kg/m² to 20 kg/m² and doubling the strength of the ceiling tiles (Figure 9–12). This floor was heavily segmented into individual offices, and this change effectively slowed the fire movement past the walls and into adjacent offices. This fire spread rate was lower than in the visual evidence.

Figure 9–12. Progression of simulated fire on Floor 12 of WTC 7, with more durable ceiling tile system.

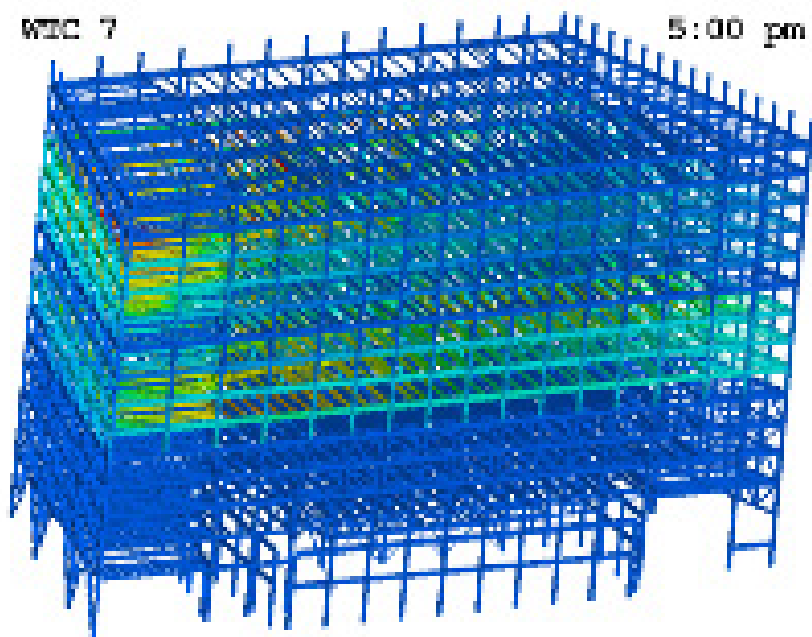
Figure 10–3 shows a view of the same 16 floor simulation from the northeast corner. Here, the concrete slabs have been removed in the image to allow a better view of the internal floor beams and columns.

Figure 10–3. View from the northeast of the computed thermal loading of the 16 lower floors of WTC 7 at 5:00 p.m. (Case A, floor slabs removed).
