**Federal Building and Fire Safety Investigation of the
World Trade Center Disaster**

**Structural Fire Response and
Probable Collapse Sequence of
World Trade Center Building 7**

VOLUME 1

National Institute of Standards and Technology

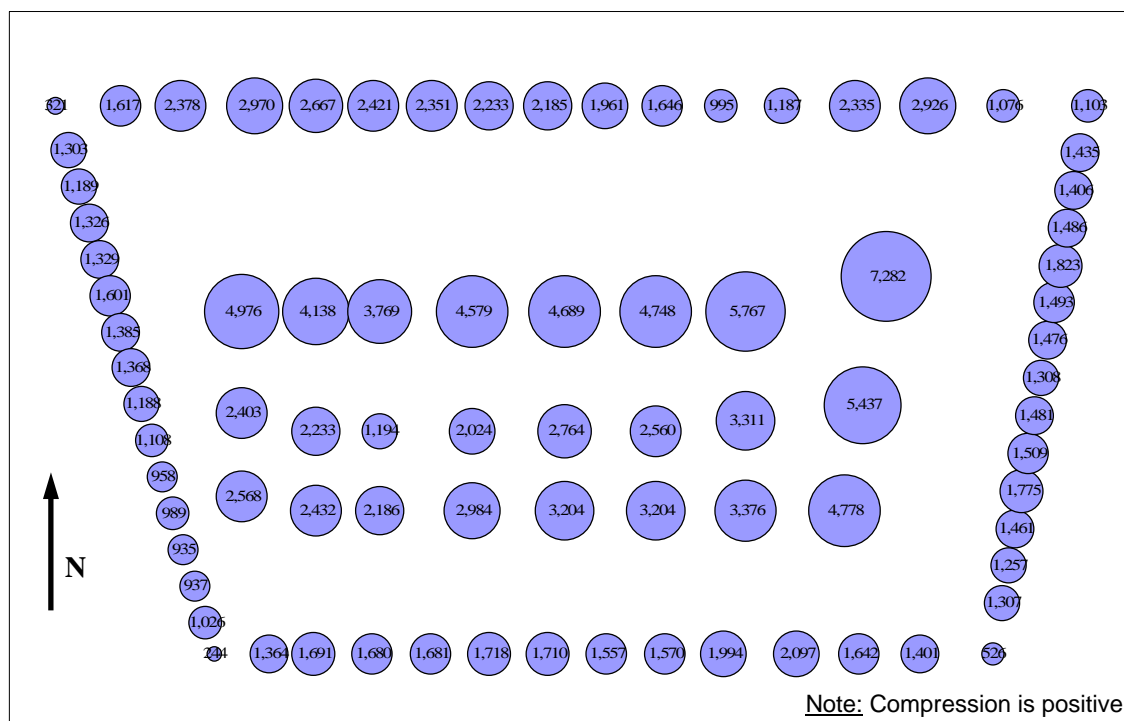
Summation of Column forces:

North: 32,400 kip	East: 19,200 kip
South: 20,850 kip	West: 16,650 kip
Interior: 86,600 kip	Total: 175,700 kip

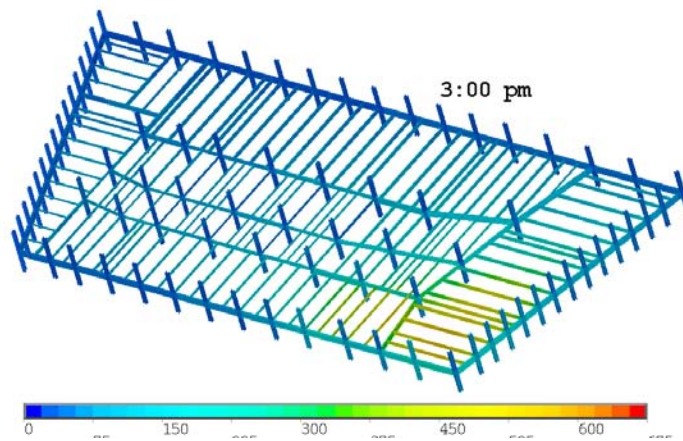
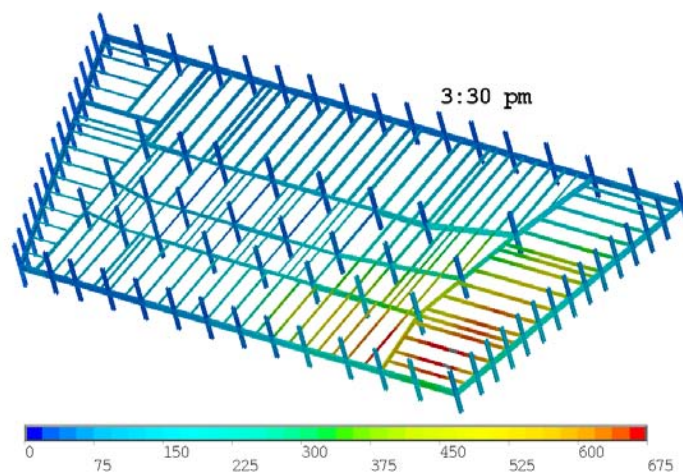
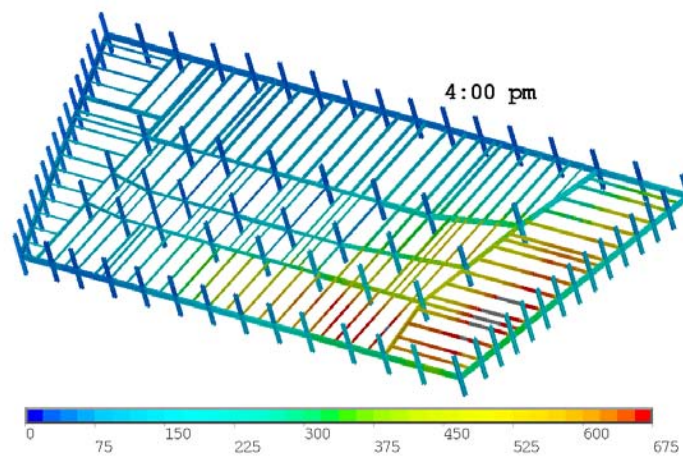
WTC 7 : Floor 13

On Floors 10, 11, and 12, tensile failure of knife connections occurred in the girder between Columns 76 and 79. The temperature of the girder between Columns 76 and 79 on Floor 13 was sufficient to displace Column 76 to the west and Column 79 to the east. The forced displacements at Floors 10, 11, and 12 created a tensile load in the girder knife connections to the columns, and failed the connection fillet weld to the column.

Figure 11–46. Floor 13 Case B temperatures at 3.0 h, 3.5 h, and 4.0 h.

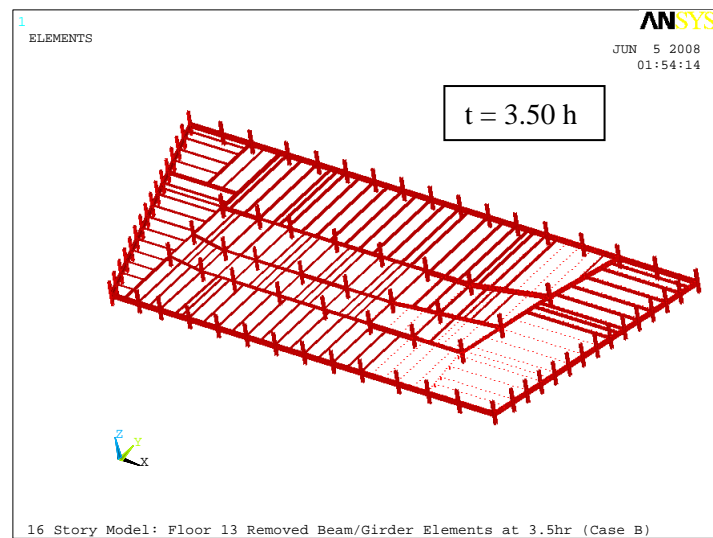
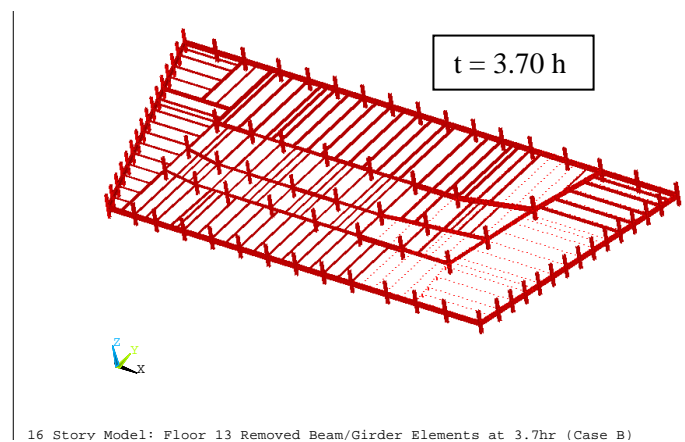
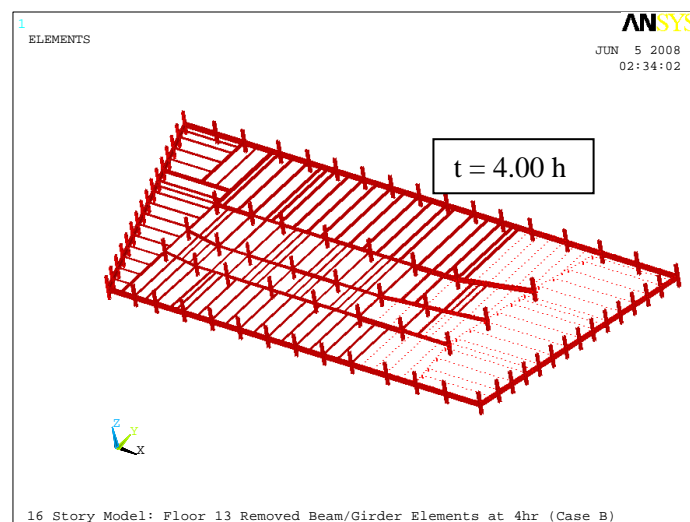
Beams and girders that buckled or had end connection damage are indicated with dotted lines.

Figure 11–48. Floor 13 Case B temperatures at 3.5h to 4.0 h.

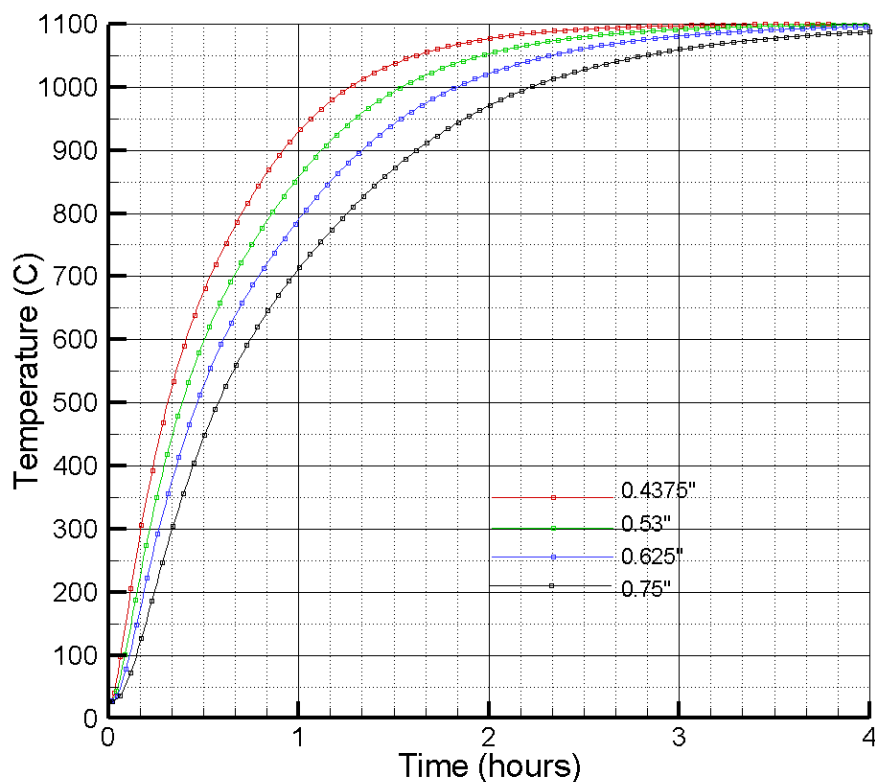
Figure 11–51.
Heating of a
typical floor beam
(W24 x 55) subject
to a uniform 1100 °C
gas temperature for
different SFRM
thicknesses.

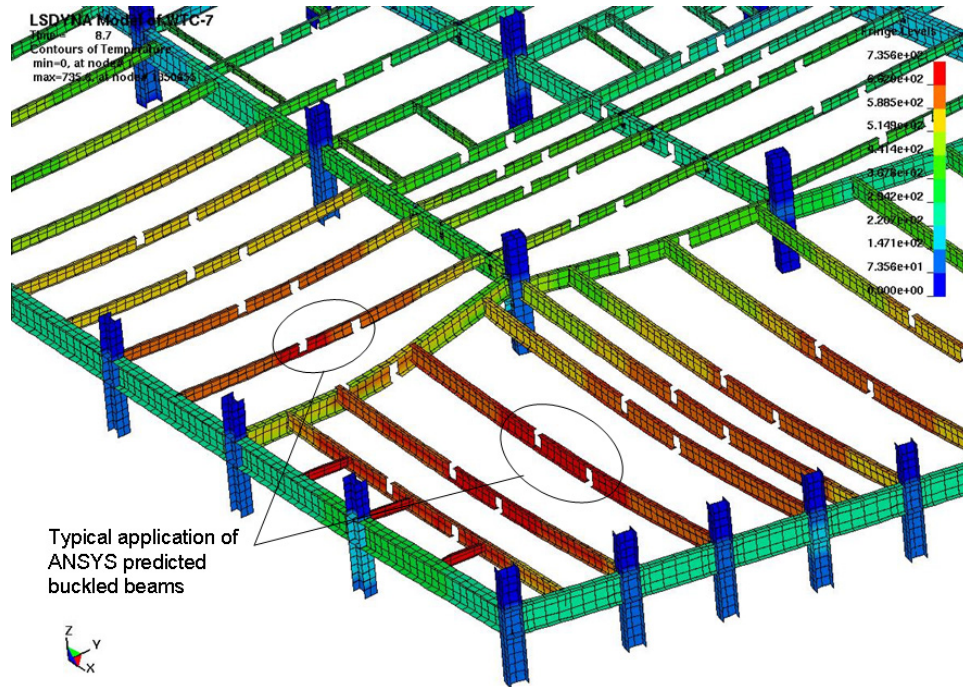
Figure 12-35. Approach used to model buckled beams in LS-DYNA model.

The fire-induced damage included buckled beams and connection damage. Buckled beams were modeled by removing a few flange and web elements, such that the beam would lose its axial and flexural strength, but the weight of the beam would remain in the calculation. An example of how buckled beams were modeled at the southeast corner in Floor 14 of the global model is shown in Figure 12–35. Contours shown are steel temperatures with a range of 0 °C to 736 °C.

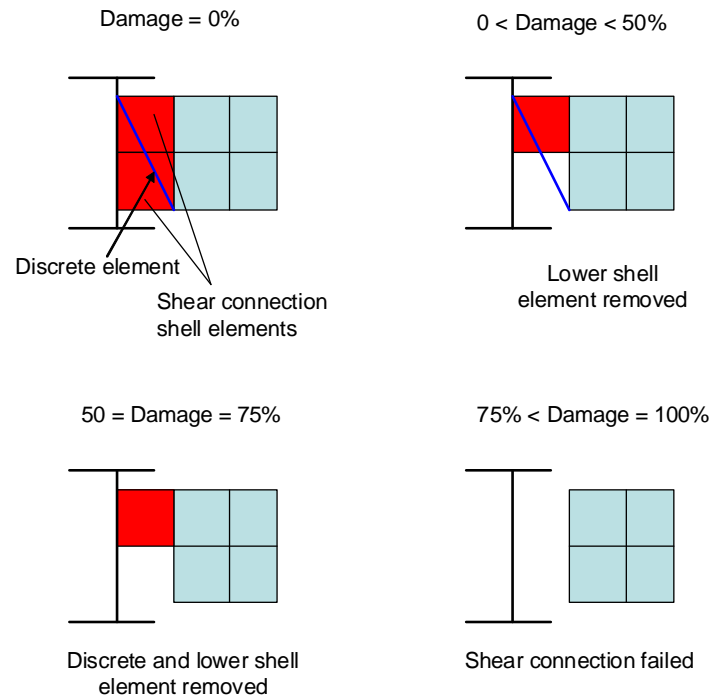
Figure 12-36. Shear connection damage application in LS-DYNA model.

The connection damage data from ANSYS was transferred to the LS-DYNA global model using a damage index (Section 11.5). The damage index described the degree of connection damage according to the following groups: 0 to 0.25, 0.25 to 0.5, 0.5 to 0.75, and 0.75 to 1.0, where 0 was no damage and 1.0 was failure. Horizontal support and vertical support were specified separately. Due to the coarseness of the shell element modeling of the fin, knife, and header connections in the LS-DYNA model, approximations of the damage state were made as shown in Figure 12–36.

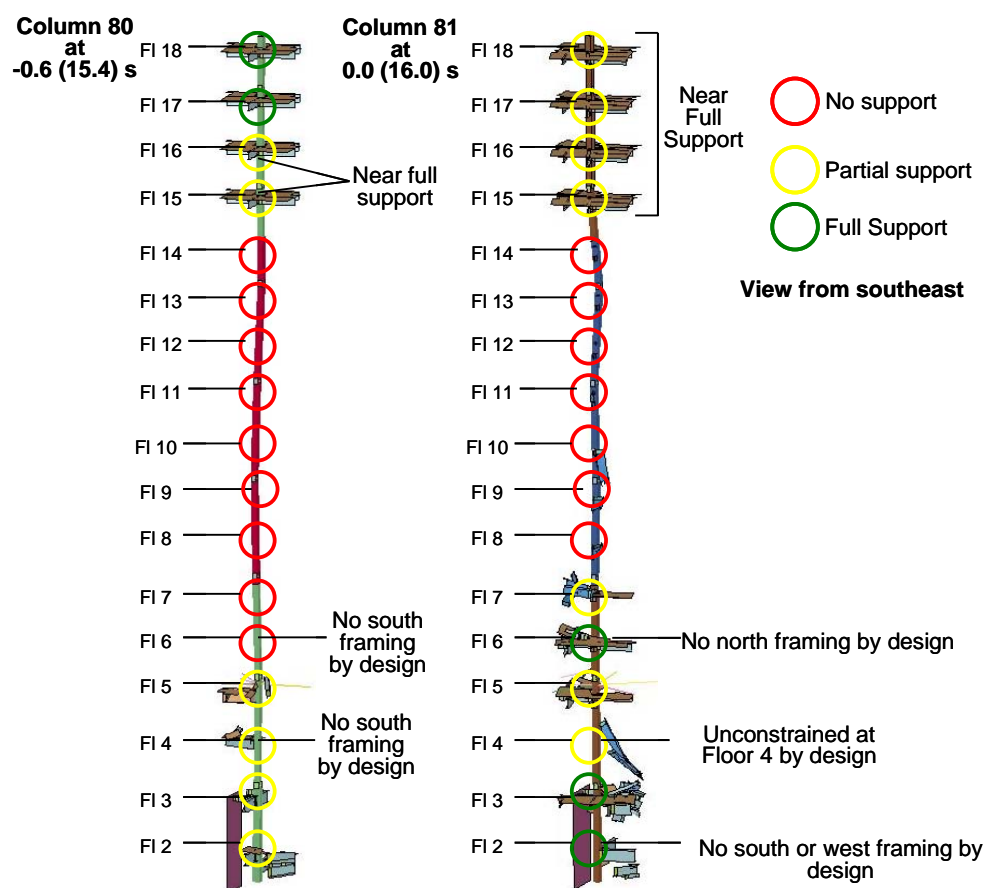
In a similar fashion, Column 81 became laterally unsupported in both directions between Floors 7 to 15, as a result of the progressive floor system failures that occurred as both Columns 79 and 80 buckled (Figure 12–47). Column 81 buckled about 1.3 s after Column 79 buckled, as shown in Figure 12–43. In addition to axial compressive loads that could cause buckling, the columns were subject to lateral loads from falling debris and failure of girder connections occurred. These lateral perturbations aided the onset of column buckling. Note that Columns 80 and 81 buckled after the vertical progression of floor failures around Column 79.

Figure 12-47. Columns 80 and 81 lateral support status at time of buckling initiation.

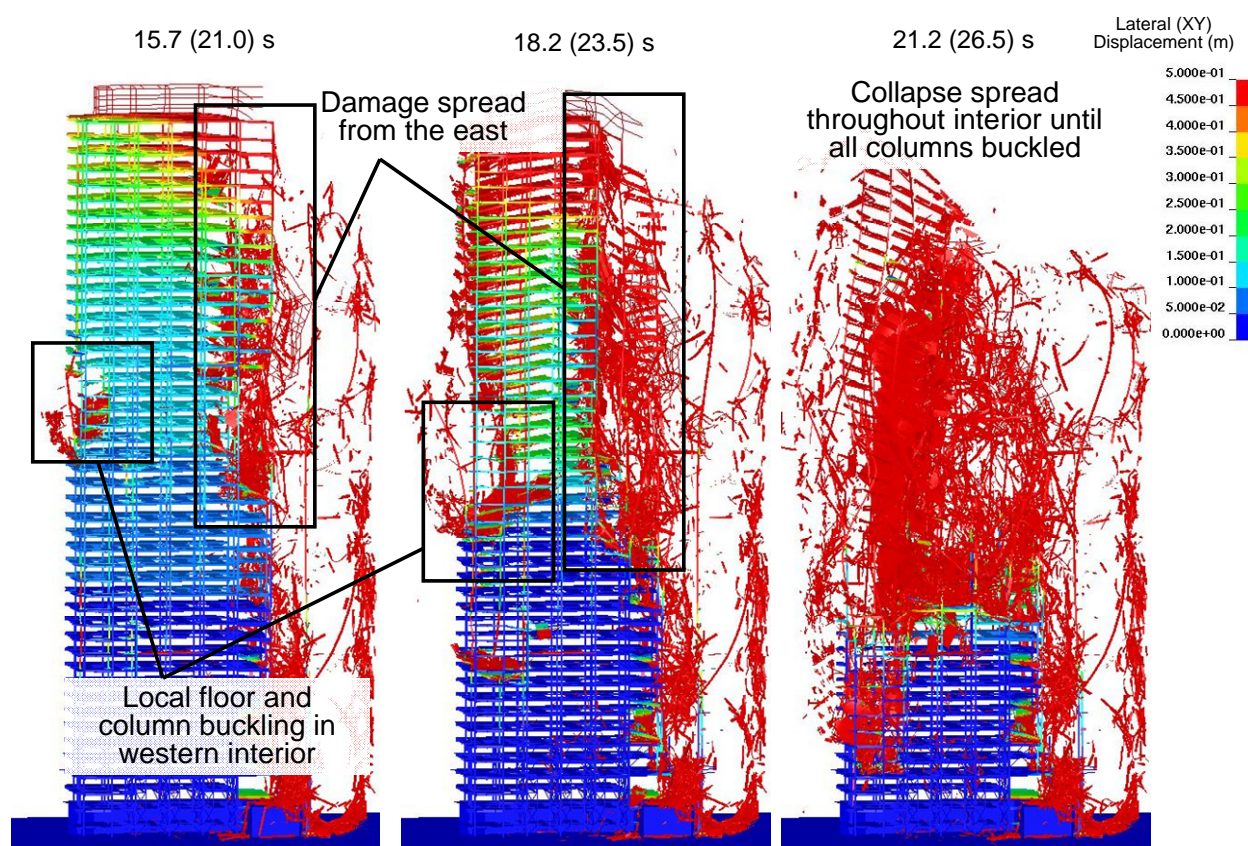
Figure 12–72 shows the structural response of the interior columns between 15.7 s (21.0 s) and 21.2 s (26.5 s). Column damage continued to spread westward with Column 73 buckling at about 15.0 s (20.3 s) between Floors 35 and 37. Column 58 buckled at 14.7 s (20.0 s), following a column splice failure at Floor 31 that occurred 8 s earlier, at about 6.9 s (12.2 s), but did not cause column failure. The column splice initially failed due to relative twisting and shearing motions between floors that were most acute in the northwest corner of the building. The global building motions grew in response to the column and floor structure failures in the eastern interior. The relative motions at the Column 58 splice were magnified compared to other surrounding columns due to the relatively large area supported by Column 58 and the limited shear stud connections in the northwest corner of the building, which together provided relatively less twisting resistance from the composite floor slab. As a result, the Column 58 splice above Floor 31 and some surrounding framing connections sustained damage, which continued to accumulate with subsequent building motions.

Figure 12–72. Collapse of the north interior columns from 15.7 s (21.0 s) to 21.2 s (26.5 s). Contours of resultant lateral displacement 0 in. to 16 in. (0 m to 0.4 m).

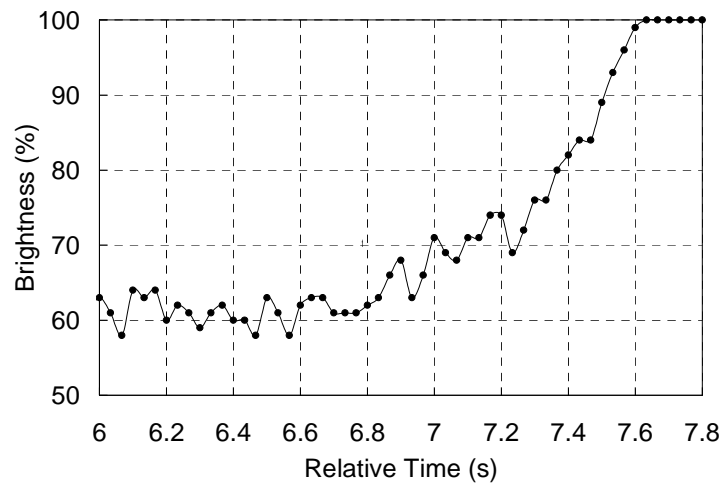
Figure 12–75 Brightness of a pixel on the north face roofline as WTC 7 began to collapse.

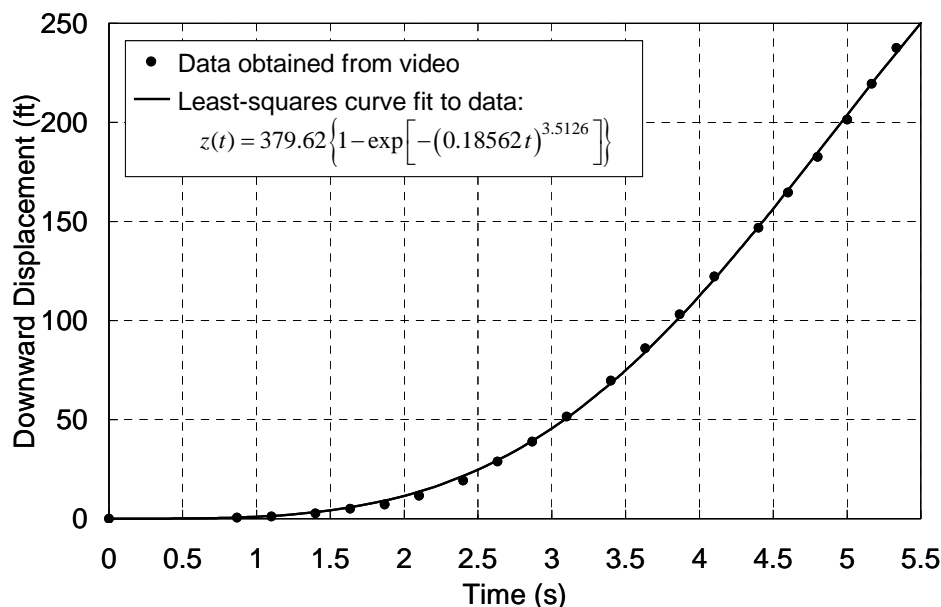
- In Stage 1, the descent was slow and the acceleration was less than that of gravity. This stage corresponds to the initial buckling of the exterior columns in the lower stories of the north face, as seen in Figure 12–62. By 1.75 s, the north face had descended approximately 7 ft.
- In Stage 2, the north face descended at gravitational acceleration, as exterior column buckling progressed and the columns provided negligible support to the upper portion of the north face. This free fall drop continued for approximately 8 stories (105 ft), the distance traveled between times $t = 1.75$ s and $t = 4.0$ s.
- In Stage 3, the acceleration decreased somewhat as the upper portion of the north face encountered resistance from the collapsed structure and the debris pile below. Between 4.0 s and 5.4 s, the northwest corner fell an additional 130 ft.

Figure 12–76
Downward
displacement of
north face roofline
as WTC 7 began to
collapse.

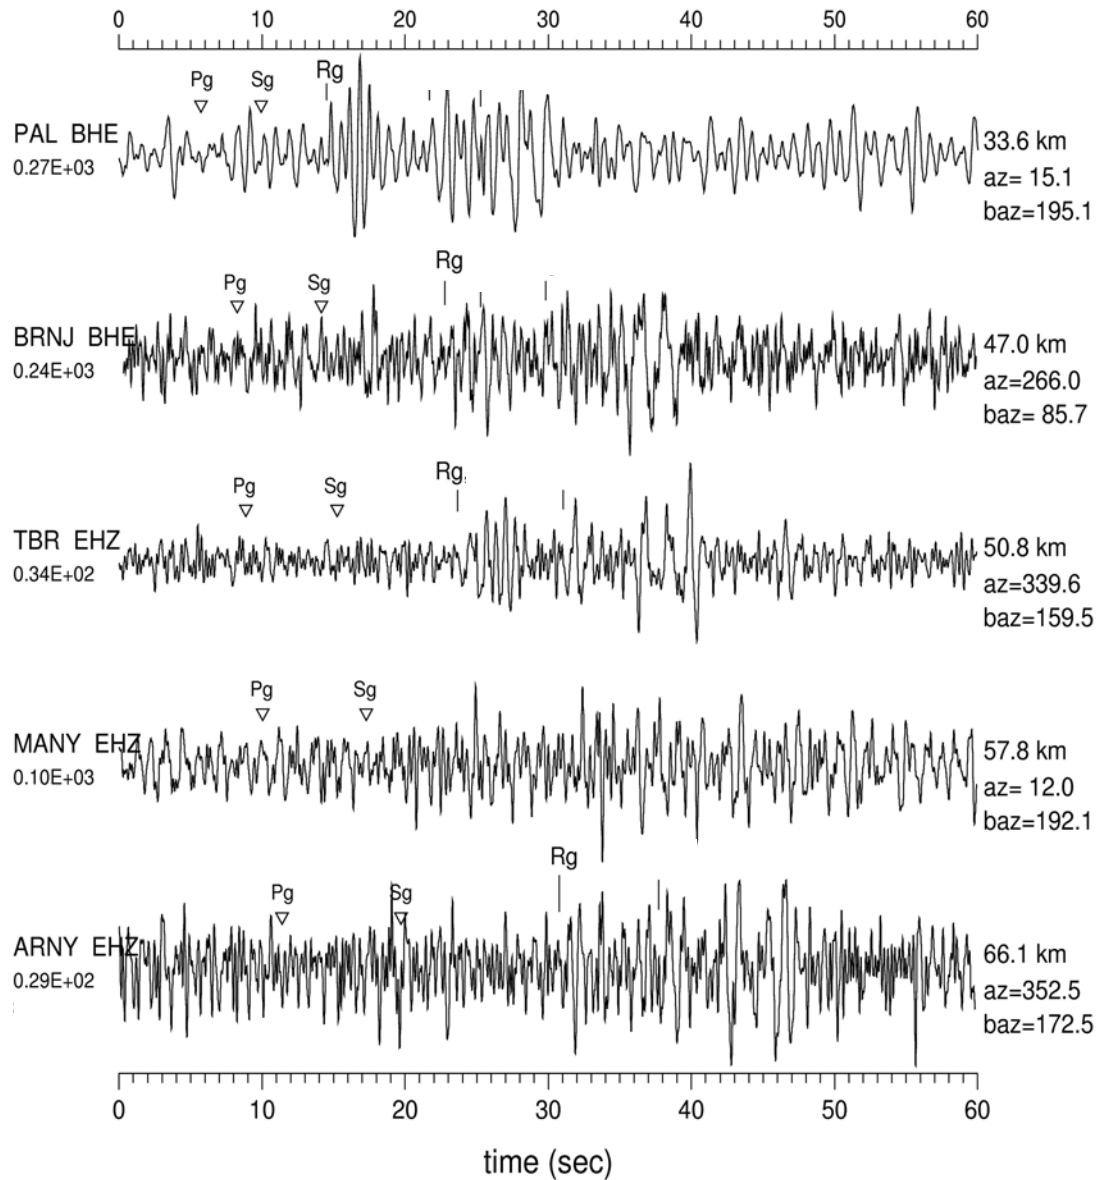
The WTC 7 building collapse was observed to have two distinct phases. First, an internal structural failure occurred which led to the observed east penthouse movement, when it sank below the roofline. Second, the entire building began to collapse about 7 s later, when the roofline and building exterior were observed to start moving downward. The first phase resulted in interior debris falling to the lower floors of WTC 7 on the east side, which transmitted impact loads to the foundation. The debris fell over several

Figure B-5. East-west (BHE) and vertical (EHZ) component seismic records, 0.6 Hz to 5 Hz filtered, at PAL, BRNJ, TBR, MANY and ARNY from collapse of WTC 7.

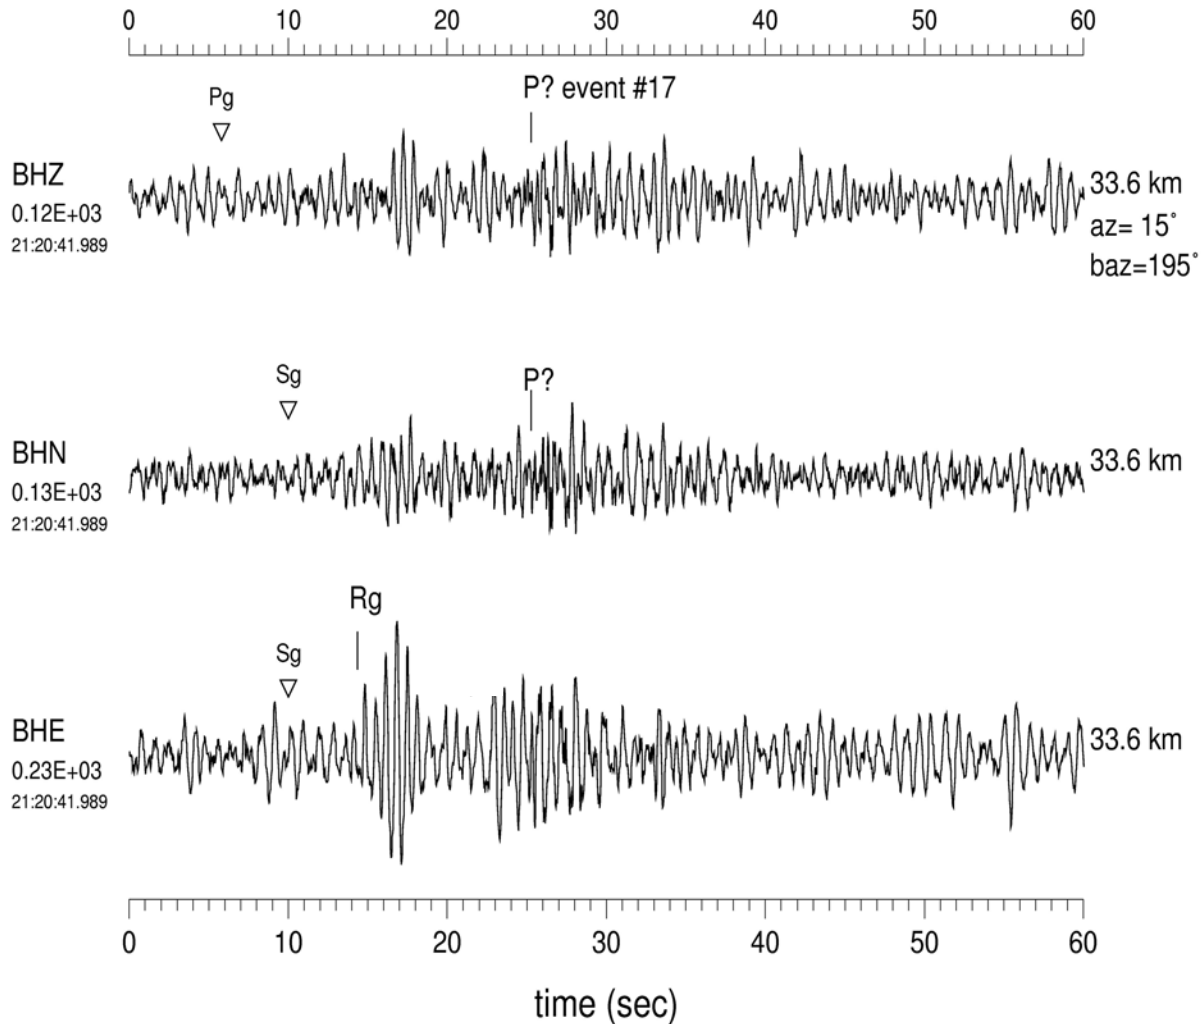
Figure B-6. Three-component seismic records, 1 Hz to 10 Hz filtered, at PAL from collapse of WTC 7.

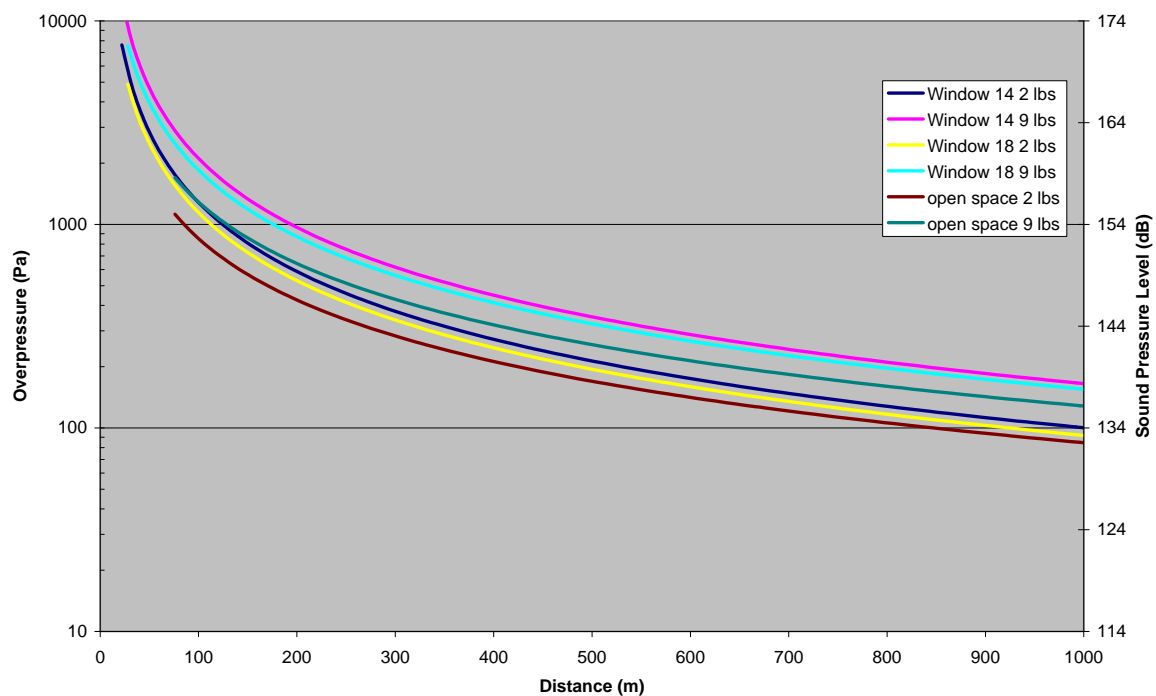
Figure D-17 and Figure D-18 show the results of the acoustic analysis for both floor layouts, in which overpressure and sound pressure level vs. distance from the opening are plotted. Intense audible sound was predicted from all building faces for all four combinations of layout and charge size. If propagation were unobstructed, as would be the case for a person standing on a street with a direct view of any WTC 7 face with open windows, the sound level from all building perimeter openings at 1 km would be approximately 130 to 140 dB. Adjacent buildings and their effect on the sound propagation was not considered in this analysis. The analysis was intended to be a simple estimate of the sound potential emanating from the building due to blast pressures.

Figure D-18. Layout 3 acoustic overpressure-distance predictions.
