NIST Response to the World Trade Center Disaster

Federal Building and Fire Safety Investigation of the World Trade Center Disaster

August 26, 2008

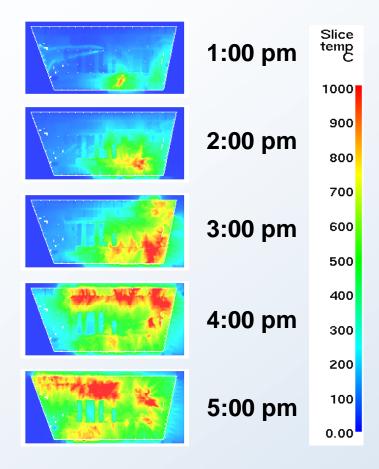
Progression of fires on Floor 12

- The major fires in WTC 7 were modeled using the Fire Dynamics Simulator (FDS).
- There were far fewer photographs and videos of WTC 7 than of the towers.
- The fire simulations for WTC 7 were conducted for each floor individually.
- Sustained and/or late fires were observed only on Floors 7 through 9 and 11 through 13.
- The actual fires on these floors were most likely initiated at the time of the collapsing towers.

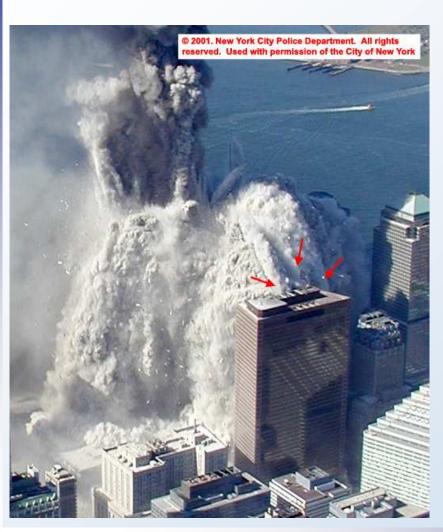
Summary of Probable Collapse Sequence (1)

Collapse of the WTC Towers.

- Collapse of WTC 2 did not cause any structural damage or start any fires in WTC 7.
- Collapse of WTC 1 damaged seven exterior columns on the lower floors of the south and west faces and initiated fires on 10 floors between Floors 7 and 30.

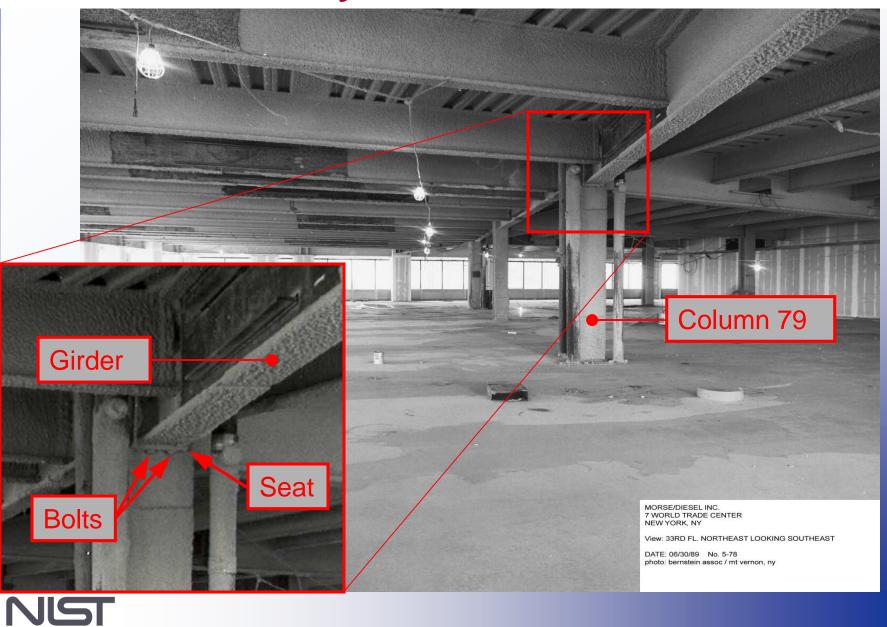
North East Floor System Near Column 79

- Initial Local Failure for Collapse Initiation.
 - Fire-induced thermal expansion of the floor system surrounding Column 79 led to the collapse of Floor 13 and triggered a cascade of floor failures.
 - This, in turn, led to loss of lateral support to Column 79 over nine stories, resulting in the buckling failure of Column 79.

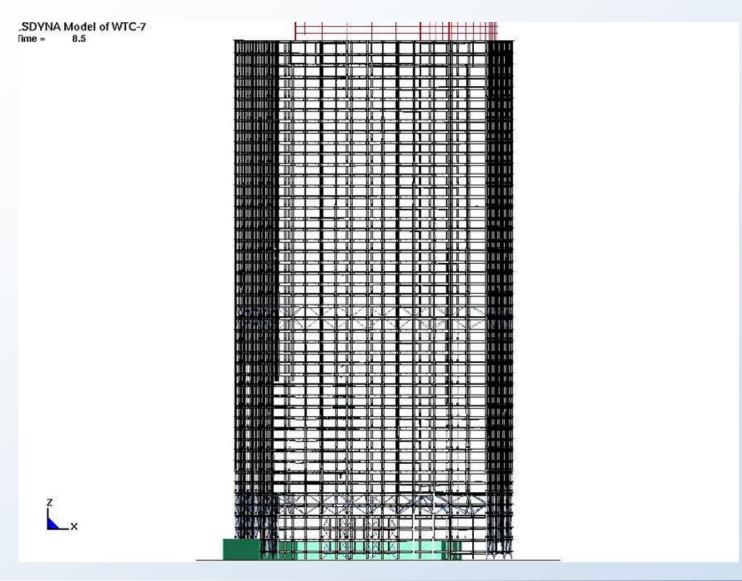
Physics-Based Visualization of WTC 7 Collapse

- The exterior columns buckled between Floors 7 and 14 due to load redistribution to these columns as the building core moved downward.
- The entire building above the buckled-column region then moved downward in a single unit, as observed.

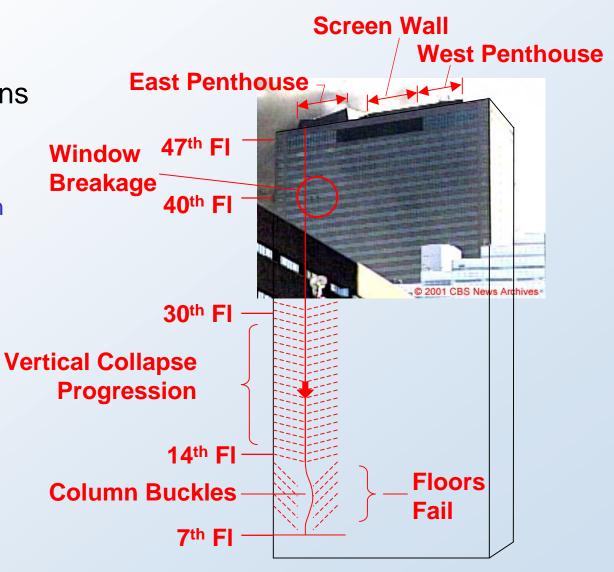
Exterior Observations

- ☐ East Penthouse Kinks
- Windows break on East Side of North Face
